## NATIONAL TRANSPORTATION SAFETY BOARD

### SUMMARY OF AIRPLANE EXAMINATION

**(WPR14FA286)**

Location:	Fall City, Washington
Date:	July 8, 2014
Aircraft:	Cessna 182, N5816B
NTSB Investigator-in-Charge	Thomas Little

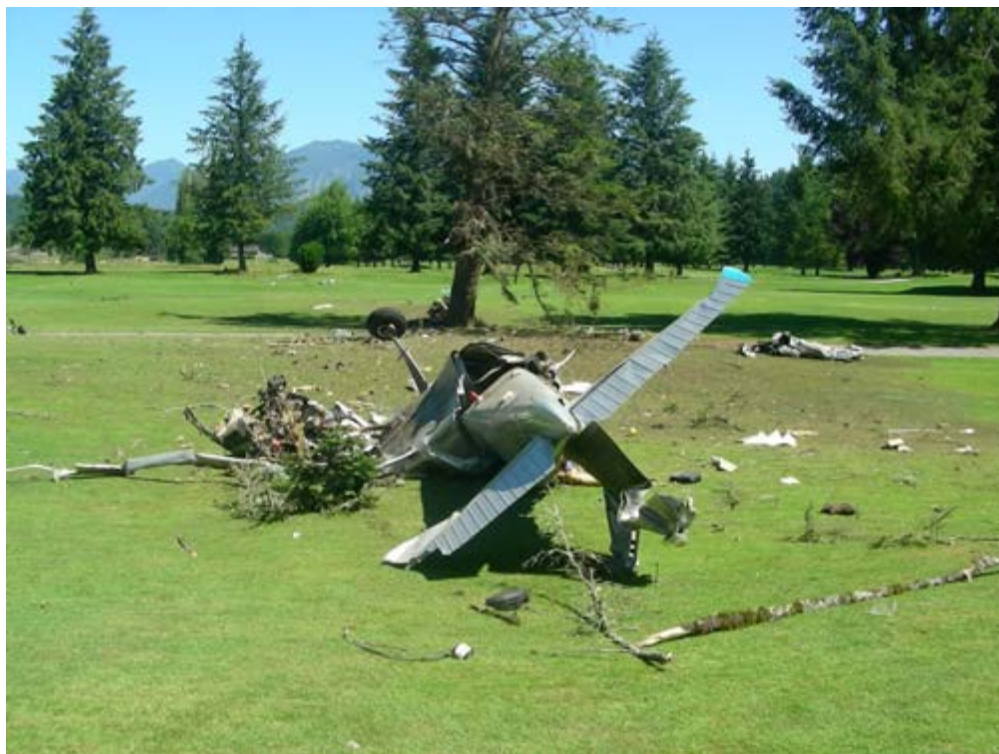
Figure 1 - accident site looking east

A survey of the accident site by representatives from the NTSB and the Federal Aviation Administration (FAA), revealed that the airplane's initial impact was on a measured magnetic heading of about 270 degrees, and with a tree about 80 ft in height, at about the 15-foot level with its right outboard wing section. The airplane then proceeded across a fairway on the golf course heading west for about 200 ft prior making impact with a second tree of about equal height as the first, and at about the 18-foot level head on with the engine at a very high rate of speed; the engine separated from the airplane and was located at the base of the tree. The airplane, minus its engine, then traveled about another 60 ft to the west before coming to rest in the middle of an adjacent fairway on a measured magnetic heading of 090 degrees. The

airplane was observed to have been severely fragmented, and there was no postcrash fire. All components necessary for flight were accounted for at the accident site.

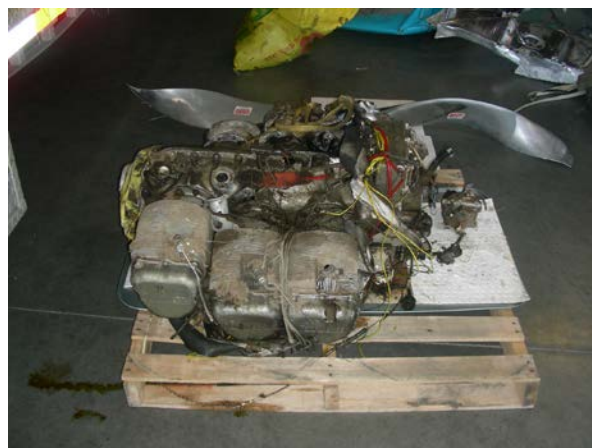
The engine sustained impact damage that resulted in the separation of the magnetos and carburetor, the partial separation of the #4 and #5 cylinders, as well as a fractured crankcase. The impact-related damage precluded any functional testing of any of the components. In addition, rotation of the crankshaft was not possible due to the fractures of the crankcase and cylinder damage. However, examination of the engine and its components did not reveal any anomalies that would have prevented the production of full power.

Figure 2 - picture of engine and propeller as received

The #4 and #5 cylinders were partially separated from the crankcase. The topside of the crankcase was fractured permitting a view inside the engine in the area of the four aft cylinders.

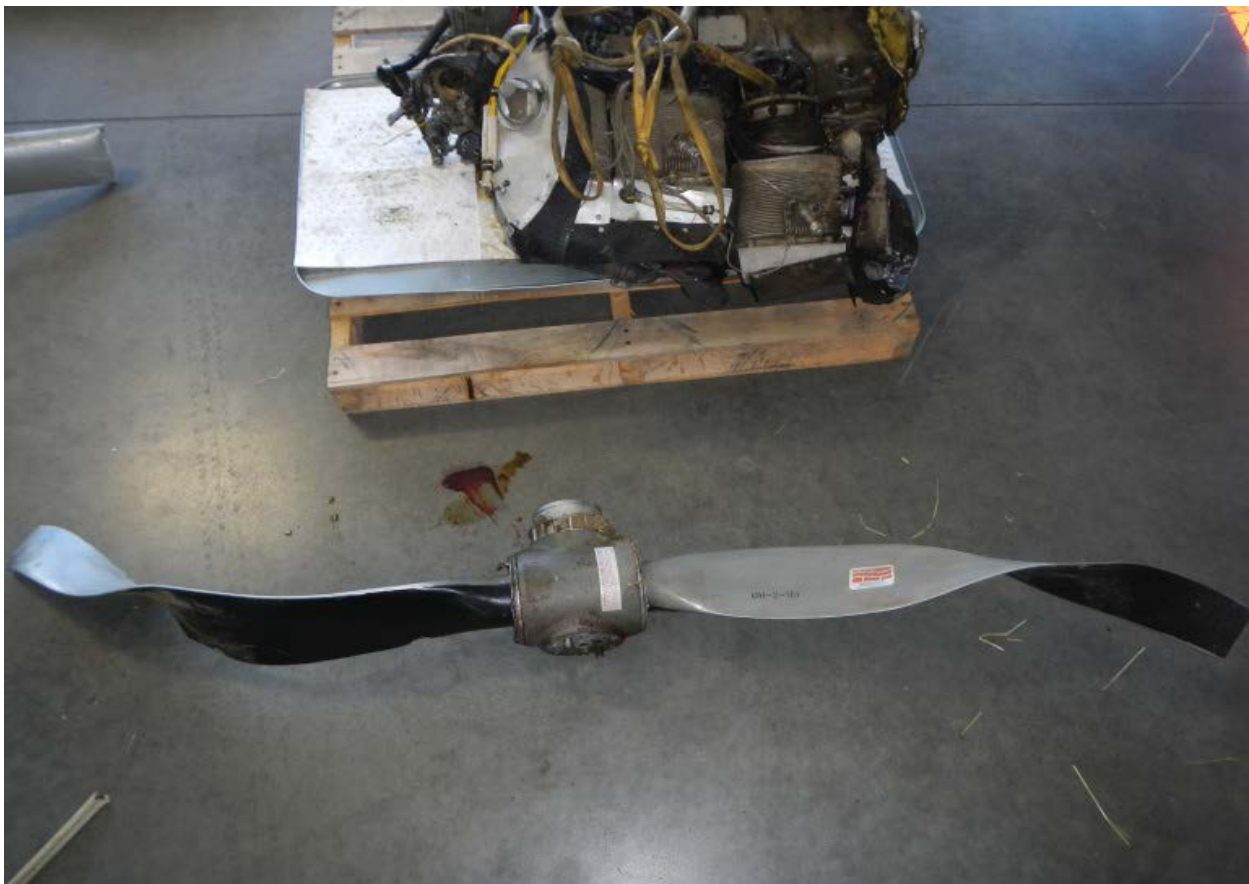
The propeller separated from the engine crankshaft propeller flange. The two-bladed propeller assembly blades remained attached to the hub. Both propeller blades exhibited twisting toward the non-camber side, and leading edge polishing. All six propeller bolts remained with the propeller flange. The aft spinner bulkhead was deformed aft around the topside of the crankcase. The two-bladed propeller was lying on the floor adjacent to the engine. Both blades remained attached to the hub, both were twisted toward low pitch, and both displayed a polished erosion of the paint from the tips. One of the blades also displayed s-bending signatures. The threaded areas of the hub where the propeller bolts are normally positioned displayed distortion and elongation signatures. The propeller mounting dowels were also displaced.

Figure 3 - picture of propeller blades (courtesy of Continental Motors, Inc.)
