## **NATIONAL TRANSPORTATION SAFETY BOARD**

### **SUMMARY OF AIRPLANE EXAMINATION**

**(WPR14FA320)**

Location:	San Diego, California
Date:	July 30, 2014
Aircraft:	Mooney M20L
NTSB Investigator-in-Charge	Thomas Little

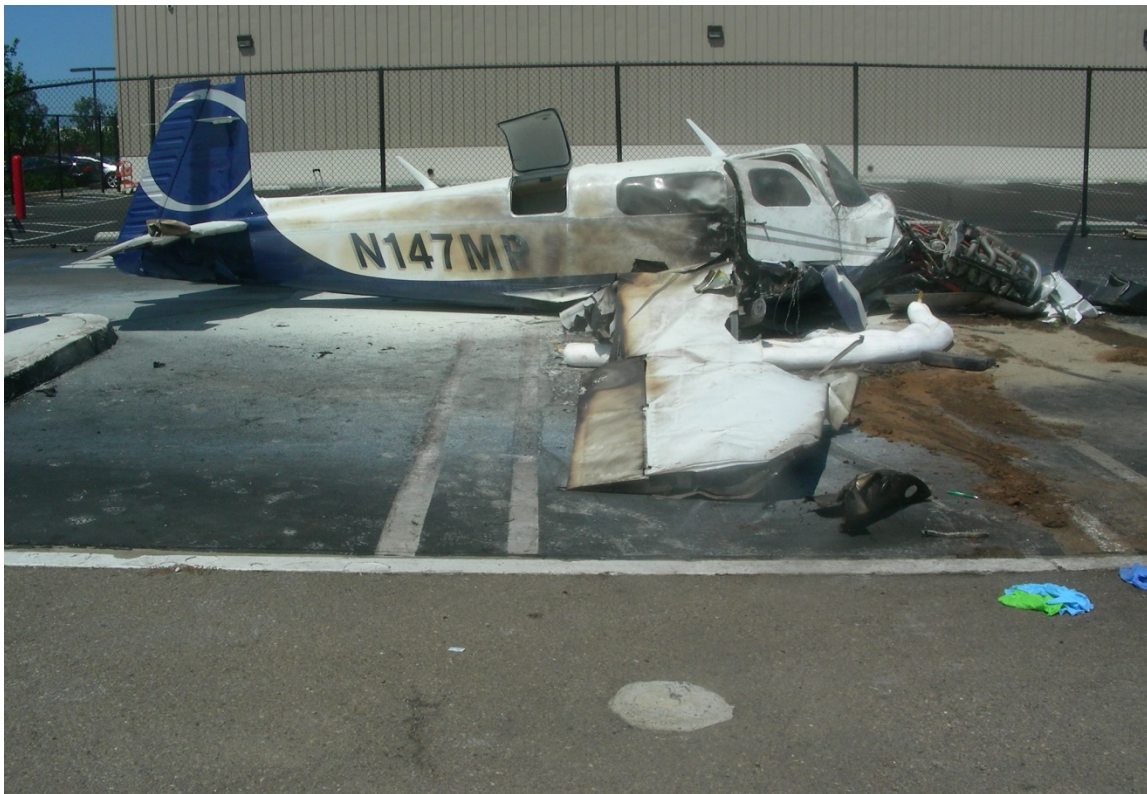
A survey of the accident site by the NTSB IIC and representatives from the Federal Aviation Administration (FAA) on the day following the accident, revealed that the airplane initially impacted a rooftop air-conditioning unit situated atop a retail building, about 28 feet above ground level with its right wing tip. It then proceeded across the rooftop on a measured magnetic heading of 200 degrees for about 40 ft, then impacted the cinder block perimeter barrier with the forward undercarriage structure. Blue paint transfer signatures were observed on top portion of the cinder block structure, which were consistent with the paint scheme on the lower forward section of the airplane. Additionally, the airplane's right main landing gear impacted the roof's perimeter barrier, which came to rest in a fenced in area about 25 feet of where the main wreckage to came to rest in the delivery parking area on the southwest side of the building. Subsequent to the right main landing gear being separated, the airplane's right wing impacted a 40-foot tall light standard, also located on the southwest side of the building. The airplane then fell the pavement and rotated about 150 degrees to the right prior to coming to rest upright on a heading of about 350 degrees. A subsequent fire ensued. All components necessary for flight were accounted for at the accident site.

Figure 1 - photo of accident site looking west

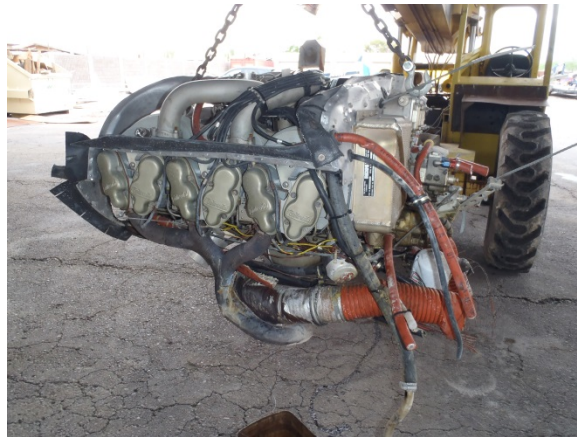
The results of the initial engine examination, according to the Continental Motors air safety investigator, revealed that the engine sustained impact damage concentrated to the bottom portion of the engine. The exhaust was bent and crushed, the oil sump was partially crushed, and the right rear engine mount was broken. The oil filter sustained impact damage and had broken free from the oil filter adapter; the oil cooler also sustained impact damage and had a large dent.

Figure 2 - photo of engine as received prior to initial examination

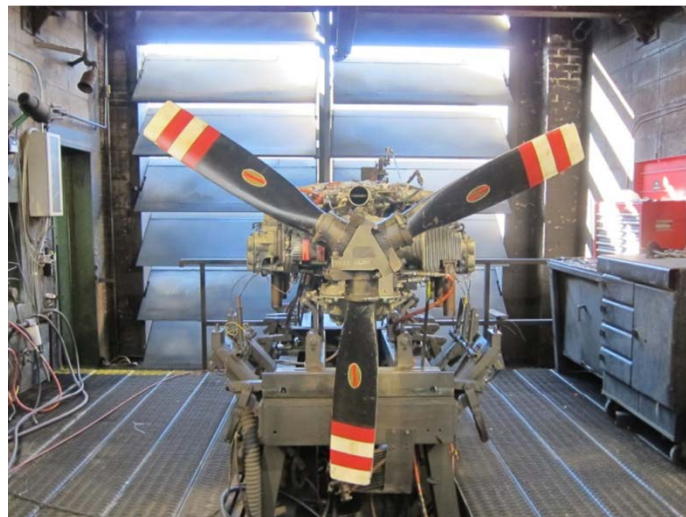
The engine experienced a normal start on the first attempt without hesitation or stumbling in observed RPM. The engine RPM was advanced in steps for warm-up in preparation for full power operation. The engine throttle was advanced to 1200 RPM and held for five (5) minutes to stabilize. The engine throttle was advanced to 1600 RPM and held for five (5) minutes to stabilize. The engine throttle was advanced to 2450 RPM and held for five (5) minutes to stabilize. The engine throttle was advanced to full open position and held for five (5) minutes to stabilize. The engine throttle was rapidly advanced from idle to full throttle six times where it performed normally without any hesitation, stumbling or interruption in power.

It was noted that there was an oil leak in the left rear of the engine; the oil leak was consistent with the impact damage to the oil filter adapter and the oil cooler.

Throughout the test phase, the engine accelerated normally without any hesitation, stumbling or interruption in power and demonstrated the ability to produce rated horsepower.

Figure 3 - photo of engine on test stand

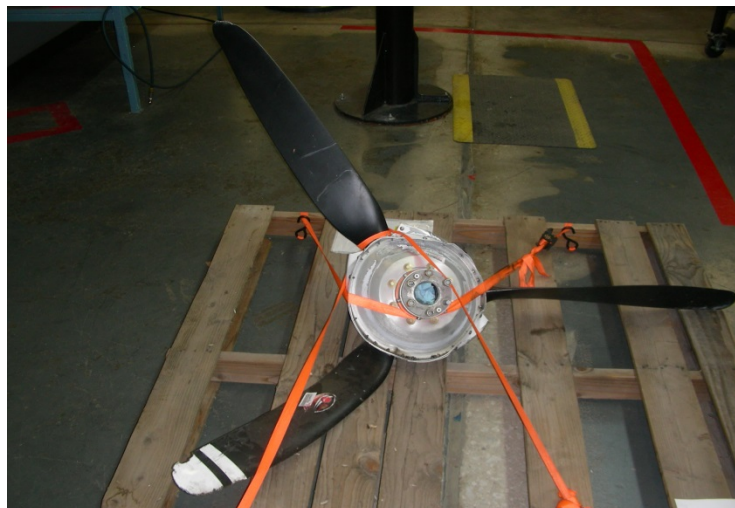
- The propeller had damage as a result of impact. There were no indications of any type of propeller failure or malfunction prior to impact.
- The propeller had indications of some mid-level amount of rotational energy absorption (above windmilling and below full power) during the impact sequence. Exact engine power level was not determined.

- The propeller had no impact signature markings or component positions indicating angle disagreement between blades at impact. All 3 propeller blades had indications of operating in the normal angle range at impact (~16 to 40 degrees reference angle measured at the 30" blade spanwise station). Exact blade angles at impact were not determined. This approximate blade angle is consistent with a propeller being operated at the concluded power level.

- The propeller had sudden-failure type damage that is typically associated with impact forces; and gross part deflections. The investigation found no evidence of any type of fatigue failure.
- The propeller blade butts had marks from contact with adjacent pitch change hardware during the accident sequence. The position of these marks indicates that all 3 blades were in the normal operating angle range at impact.
- All 3 actuating links were failed. The failure was tension overload type failure related to gross deflection of the blades and the pitch change mechanism during the impact sequence.
- All 3 actuating pins left similar indentations in the blade butts. The depth and direction of material displacement of the indentations corresponded to impact loading from gross deflection of the pitch change piston during the impact sequence.

The propeller blade bending, twisting, and overall propeller assembly damage was typical of that associated with some mid-level (above windmilling and less than full power) rotational energy absorption at impact.

Figure 4 - photo of propeller prior to teardown examination
