NATIONAL TRANSPORTATIONS SAFETY BOARD
Office of Aviation Safety
Washington, DC 20594

SUMMARY OF OPERATIONAL FACTORS

-- CEN17FA072 --

Location: Cleveland, Ohio
Date: December 29, 2016
Time: 2257 eastern standard time
Aircraft: Cessna 525C (Citation CJ4) airplane (s/n 525C0072), N614SB

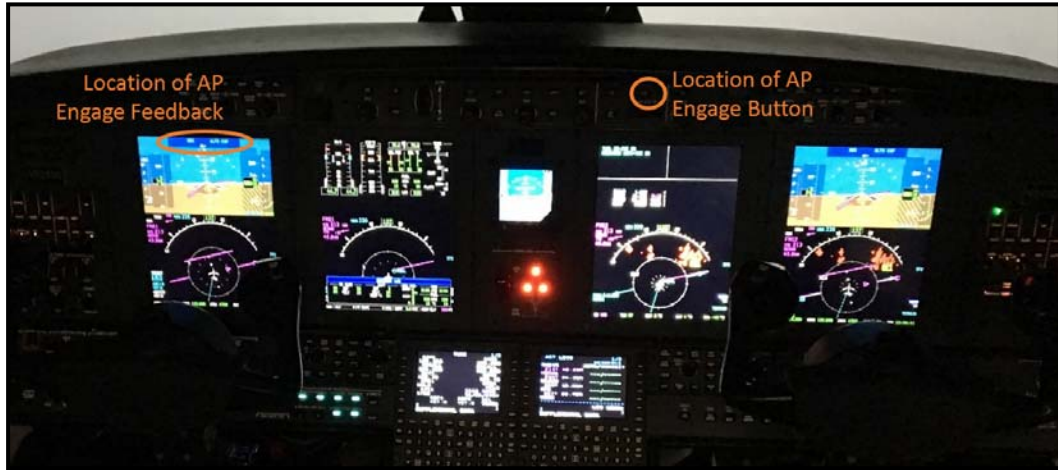
Figure 16-16. Flight Guidance Panel

The flight guidance panel (FGP), located on the glareshield, allows the pilot to select manual or autopilot guidance for airplane control. The autopilot button is located on the upper row of button controls near the right side of the panel.

Autopilot engagement is indicated in the flight control system display area along the upper portion of the primary flight display (PFD). There is no indication of the autopilot status on or near the autopilot button on the flight guidance panel.

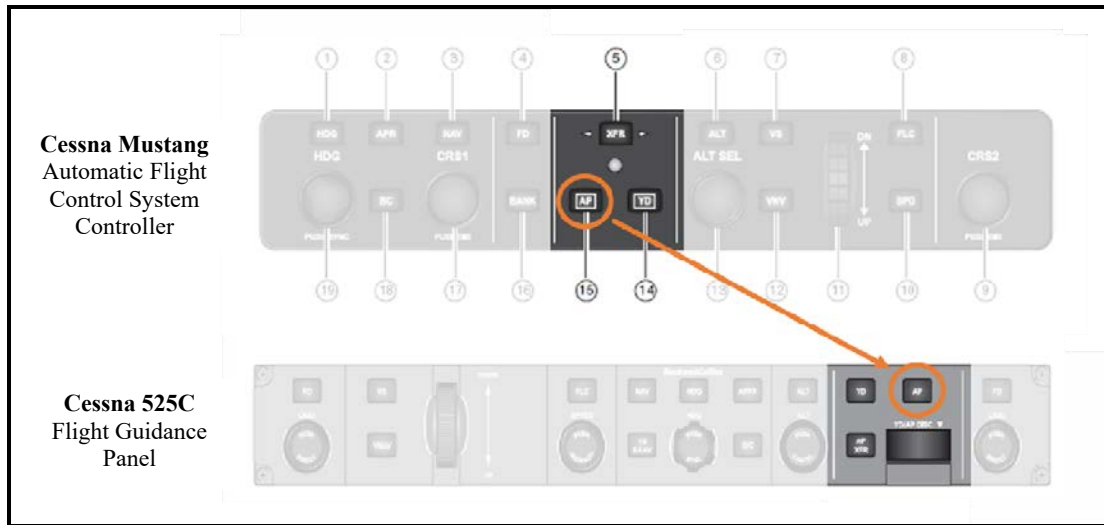
A comparison of the Cessna 525 systems and those of the airplane previously flown by the pilot, a Cessna 510, revealed that the autopilot engagement button on the Cessna 510 is located in a slightly different location on the Automatic Flight Control System (AFCS) panel. In the Cessna 510, autopilot engagement is indicated along the upper portion of the PFD similar to the accident airplane. In addition, an indicator light adjacent to the autopilot button on the AFCS panel is illuminated when the autopilot is engaged.
