Supplemental Report Photographs

Rochester, Indiana

HWY19MH003

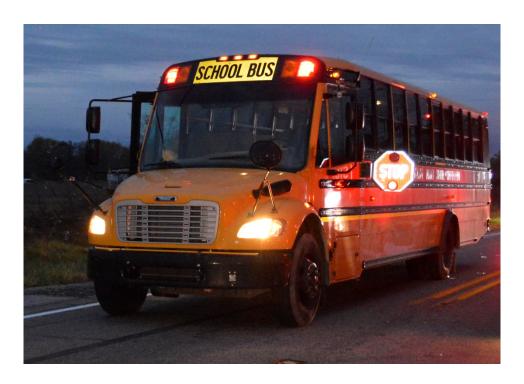
Photo #1 A close-up of the on-scene post-crash view of school bus with lights in operation. (Source: Indiana State Police)

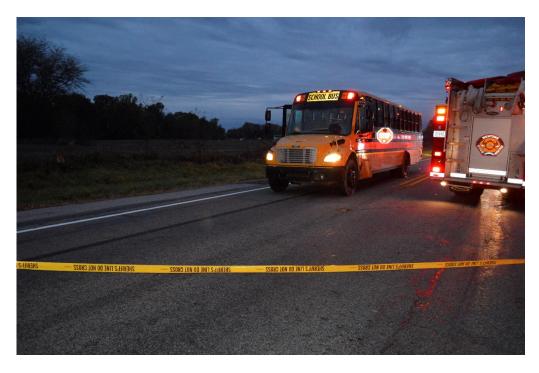
Photo #2 On-scene post-crash view of school bus with lights in operation (Source: Indiana State Police)

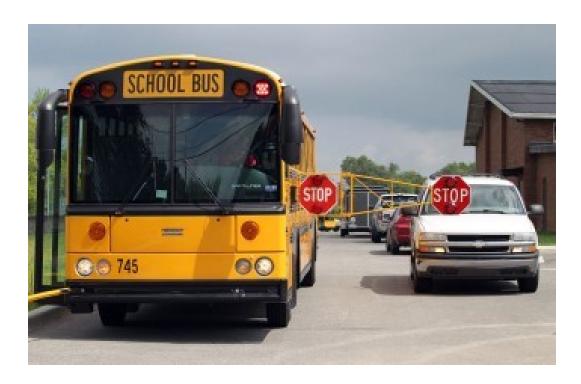
Photo #3 Extended stop arm with two stop signs on school bus (Source: Bus Safety Solutions Inc.)

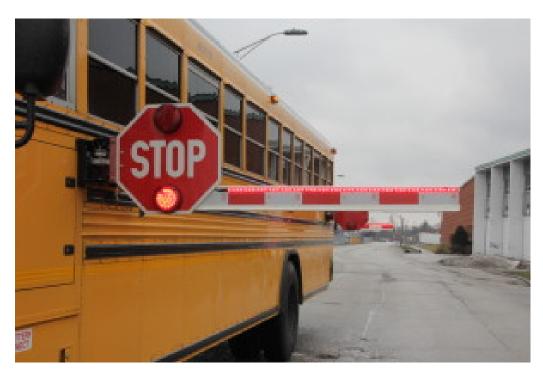
Photo #4 Close-up view of extended stop arm with single stop sign and horizontal stop bar (Source: S.A.F.E. Gates)
