National Transportation Safety Board

Enbridge Line 6B Heavy Crude Oil Release

Marshall Michigan, July 25th 2010

Supporting Information

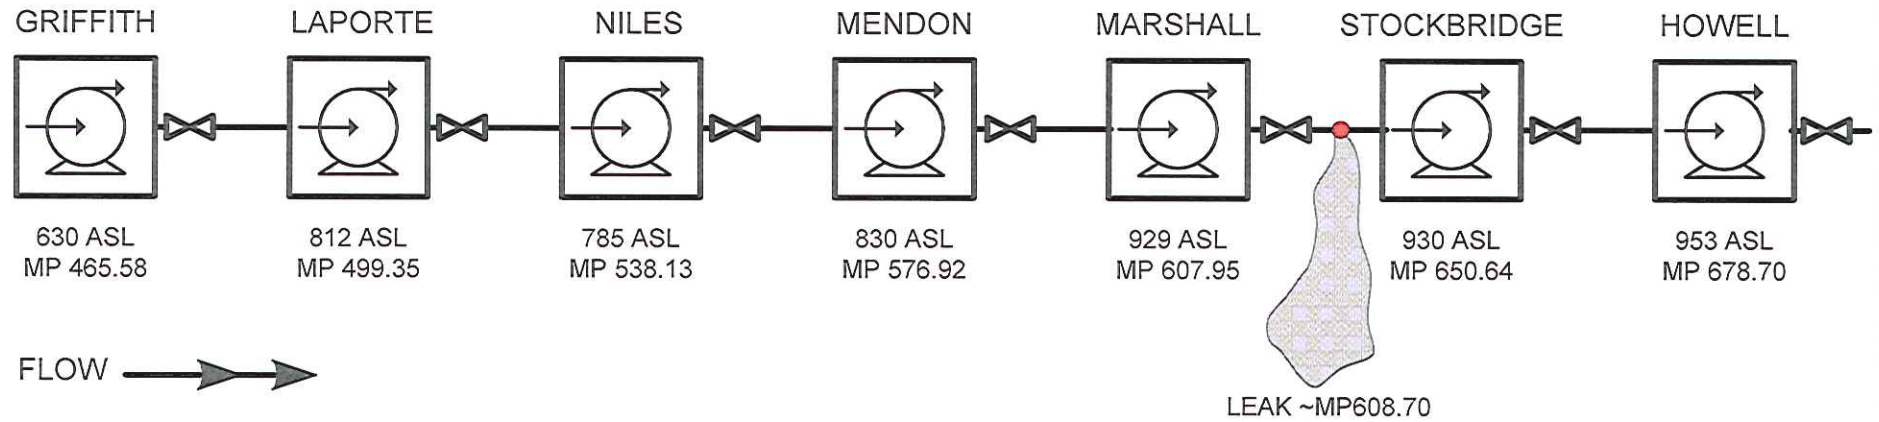
Line Diagram of Enbridge Pump Station Locations

NILES STATION IS BYPASSED DURING START-UP IN PREPARATION FOR AN INLINE INSPECTION TOOL RUNNING IN THE LINE.

THE MARSHALL PUMP STATION SHUTS DOWN ON LOW SUCTION PRESSURE ON JULY 25TH.

STRONG COLUMN SEPARATION INDICATIONS APPEAR AT MARSHALL DURING RESTART THE FOLLOWING DAY, JULY 26TH

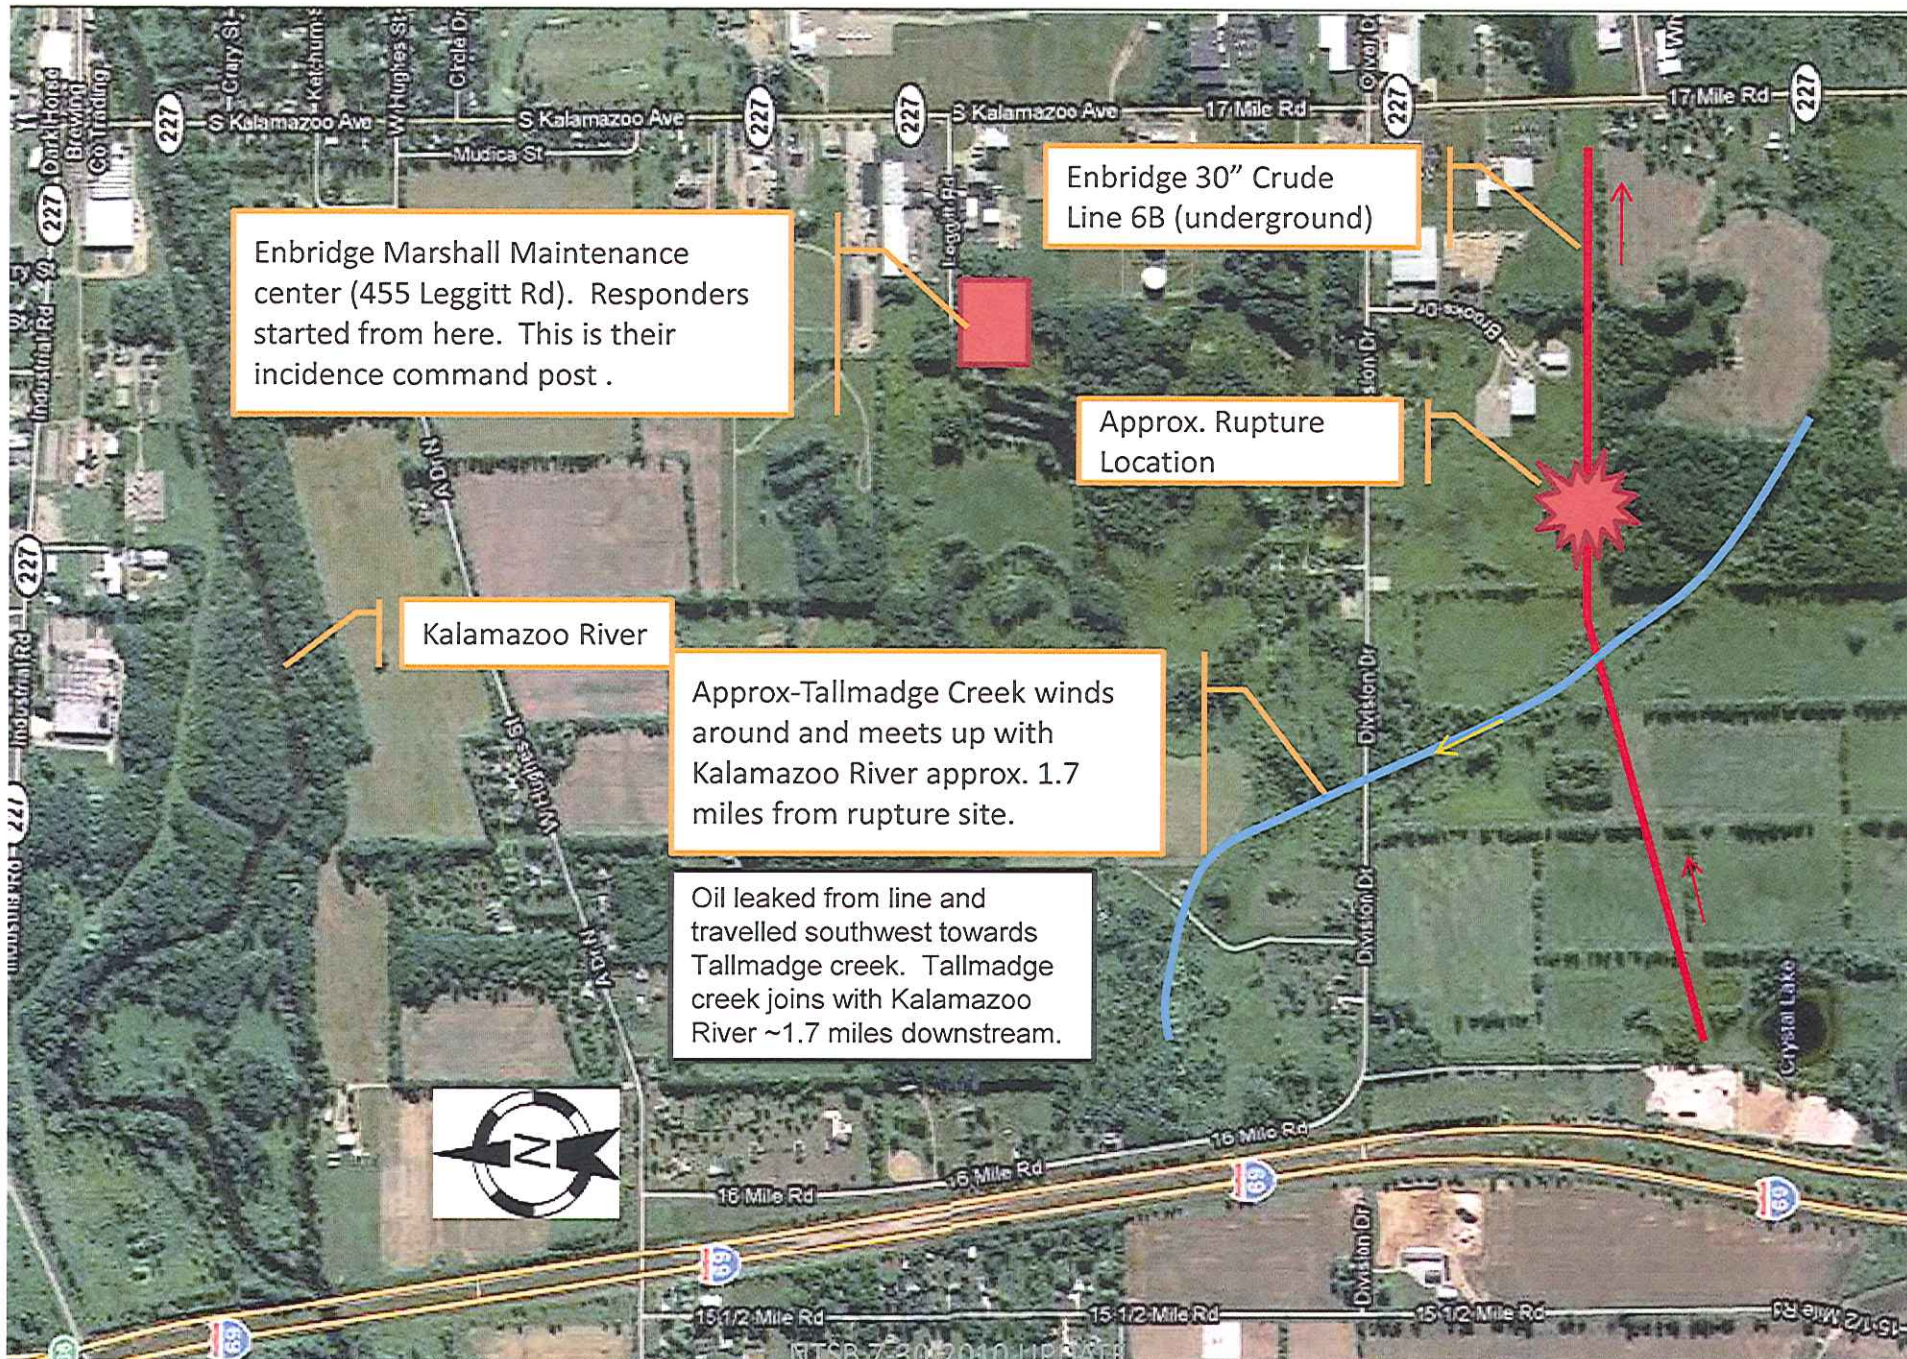
Enbridge Marshall Maintenance center (455 Leggett Rd). Responders started from here. This is their incidence command post .

Approx. Rupture Location

Approx-Tallmadge Creek winds around and meets up with Kalamazoo River approx. 1.7 miles from rupture site.

Oil leaked from line and travelled southwest towards Tallmadge creek. Tallmadge creek joins with Kalamazoo River ~1.7 miles downstream.
