NATIONAL TRANSPORTATION SAFETY BOARD
Vehicle Recorder Division
Washington, DC 20594

Surveillance Video Recorder

Specialist's Factual Report
By Charles Cates

Location: Philadelphia, Pennsylvania
Date: May 12, 2015
Locomotive ID (consist position): Siemens ACS-64 #601 (lead)
Company: Amtrak
NTSB Number: DCA15MR010

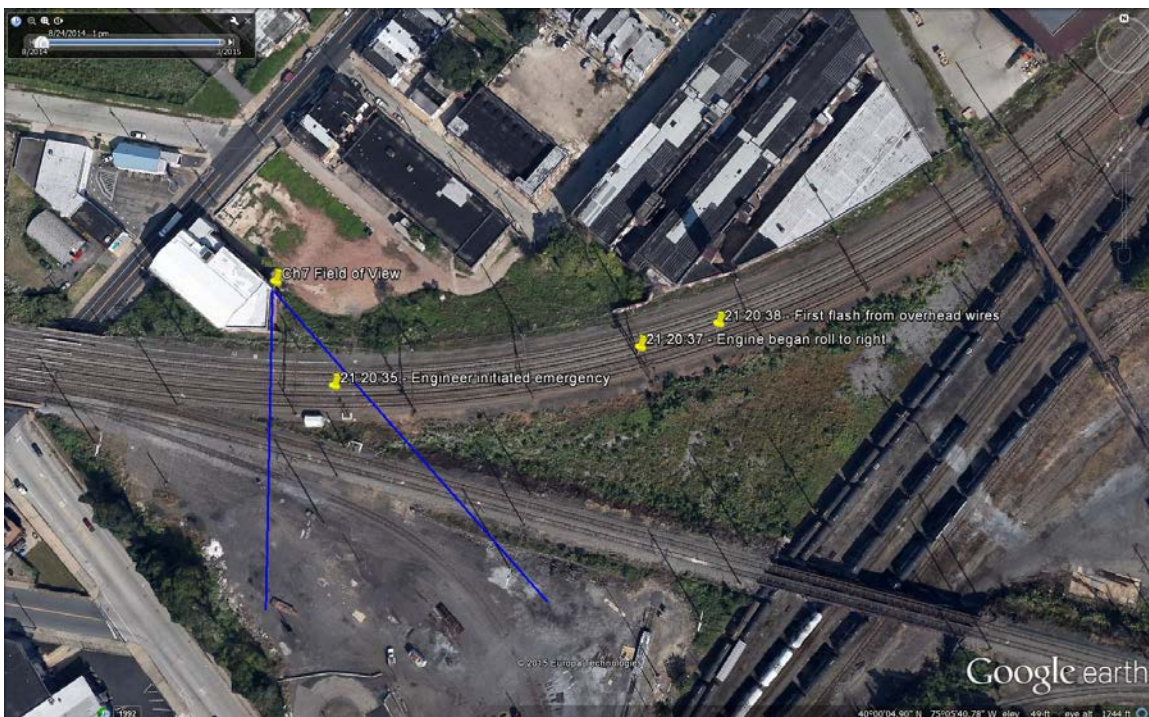
Figure 1. Ch7 approximate field of view, with other events annotated.

The view of this recording was looking perpendicular to the track, near the start of the curve where the accident took place. See figure 1 for the approximate field of view of the camera, with other details annotated from the locomotive Onboard Image Recorder.

Significant events captured in this recording were as follows: The train first came in to view at 9:20:34, in the right side of the frame. The train moved from right to left in the frame, and the locomotive left the view of the camera. At 9:20:38, with passenger cars still visible in the frame, a bright flash from the left briefly illuminated the area. Several frames later, still at 9:20:38, arcing could be seen at the wheels of the last train car. At 9:20:39, another three bright flashes from the left illuminated the frame in rapid succession, as the final car left the view of the camera.

At 9:36:46 search lights illuminated the track area from the left and swept across the frame. At 9:38:06 a person with a flashlight could be seen walking alongside the near side of the tracks from right to left.

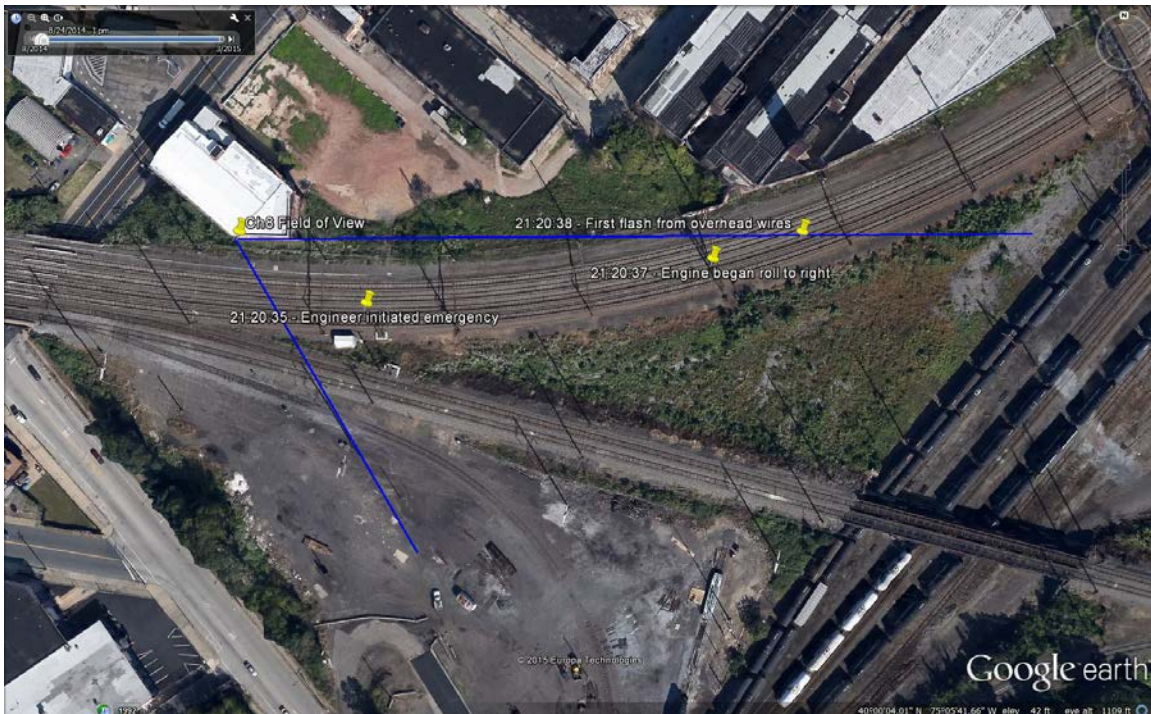
Figure 2. Ch8 approximate field of view, with other events annotated.

The view of this recording was from the southeast to the east, coincident with the track in the direction the accident train was traveling. The beginning of the accident sequence was captured by this camera, however, none of the final resting positions of the cars were seen in this view. See figure two for the approximate field of view of this camera, with other details annotated from the locomotive Onboard Image Recorder.

Significant events captured by this recording were as follows: The train first came in to view at 9:20:34 pm, in the right side of the frame. As the locomotive moved through the frame it was seen that the aft cab lights were illuminated. The windows of the passenger cars were illuminated as well. At 9:20:37 pm, an arc was seen from the roof area of the locomotive, followed by sparks coming from the area around the wheels. At 9:20:38 pm, a flash that was bright enough to saturate the full video image was recorded. After the flash subsided, the windows of the passenger cars were no longer illuminated, and sparks were seen showering down from the area of the overhead wires near the locomotive. At 9:20:38 pm, the back of the last car in the train became visible, and the tail lights were illuminated. At 9:20:39 pm, another two bright flashes from the left side of the image saturated the majority of the image. The train continued to move to the left of the frame with sparks continuing to be generated around the area of the original arc. At 9:20:41 pm, with the last car nearing the edge of the frame, the tail lights of the last car began to roll to the right, before becoming obscured by

dust and debris. By 9:20:44 pm, no more lights from the train were seen. A cloud of dust was seen in the distance.

At 9:36:15, moving lights were seen in the area near where the train cars went out of the view of the camera. At 9:36:38, lights similar to those from a vehicle could be seen approaching the tracks from the north, in the area near where the train cars left the view of the camera. At 9:36:46 a search light swept back across the tracks in the area near the camera. At 9:37:50, a person with a flashlight could be seen walking along the tracks towards the accident site, and additional moving lights were seen in the area where the train cars left the view of the camera.

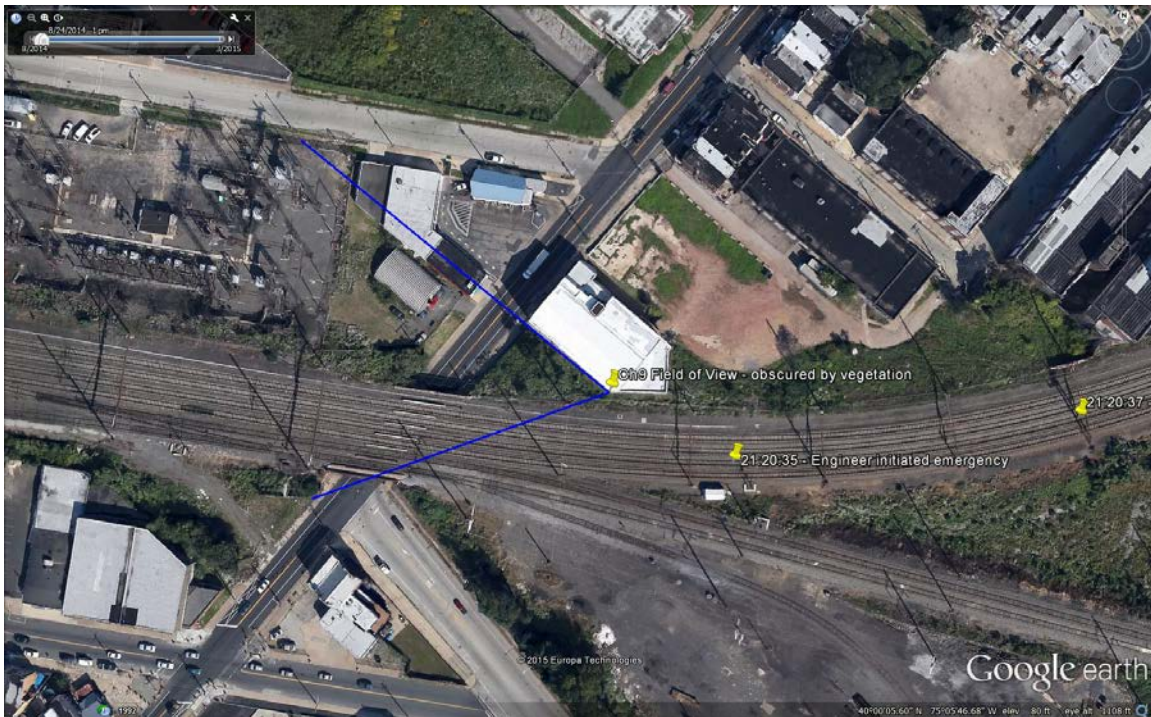
Figure 3. Ch9 approximate field of view, with other events annotated.

The view of this camera was to the east, looking nearly parallel to the tracks in the direction from which the train was coming. Much of the view was obscured by vegetation immediately in front of the camera. See figure 3 for the approximate field of view of this camera, with other details annotated from the locomotive Onboard Image Recorder.

Significant events captured by this recording were as follows: At 9:20:28, the headlight of the train was first seen through the vegetation partially obscuring the view of the camera. At 9:20:37, the light from a flash partially illuminated the vegetation around the camera, and the last car from the train left the video image. At 9:20:38, a bright flash illuminated the vegetation around the camera, and a shower of sparks was seen from a power pole on the north side of the track at the far left end of the image. Additional flashes illuminated the scene, and sparks continued to shower from the power pole until 9:20:42.
