NATIONAL TRANSPORTATION SAFETY BOARD

Group Chairman's Factual Report

SURVIVAL FACTORS

ERA14MA271

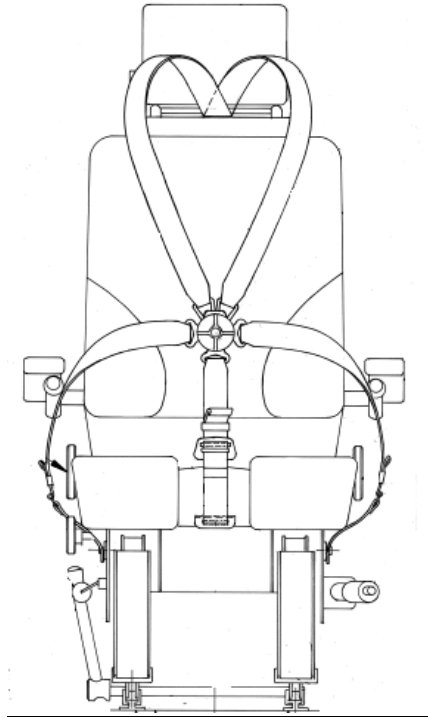
Figure 3. Left cockpit seat.

The left cockpit seat was found with the seatback and seatpan cushions attached to the frame. The seatback cushion fabric was destroyed by fire while the foam portion remained attached to the seat with thermal damage to the entire cushion. The seatpan cushion (photograph 1) was covered in soot with thermal damage on the forward right corner. The seat frame was fully intact (photograph 2) with signs of thermal damage and found locked in the seat tracks aft-most position measuring 5 ¼ inches from the aft seat frame to the aft cockpit wall. Both armrests were found in the up position with the seatbelt insert tab and webbing located between the seatback and inboard armrest. The left cockpit restraint was a 5-point restraint (photograph 3) manufactured by Pacific Scientific Co. An identification code #45402 was stamped into the central rotatory buckle. The part number was illegible. Both shoulder harnesses had retracted into the stowed position and were damaged by the post-crash fire; the inertia reel was not functional. The outboard lap restraint was adjusted to a measurement of 24 ½ inches from the seatbelt attach point and the end of the rotatory buckle. The inboard lap restraint was adjusted to a measurement of 25 inches from the seatbelt attach point and insert tab. The crotch strap was adjusted to a measurement of 16 ¾ inches from the seat attach point to the insert tab.

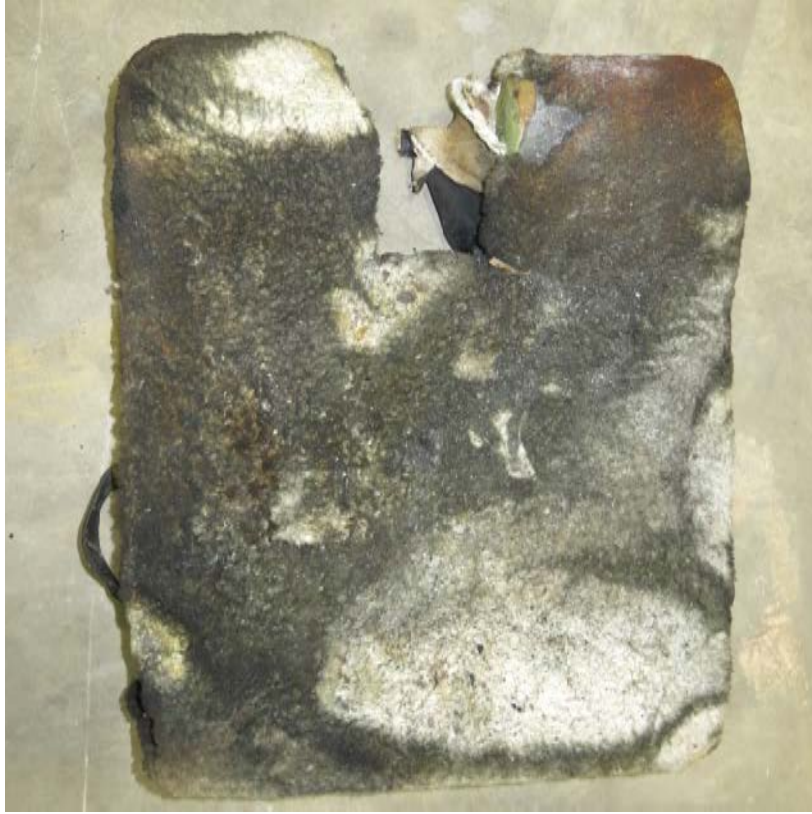
Photograph 1. Left cockpit seatpan cushion.

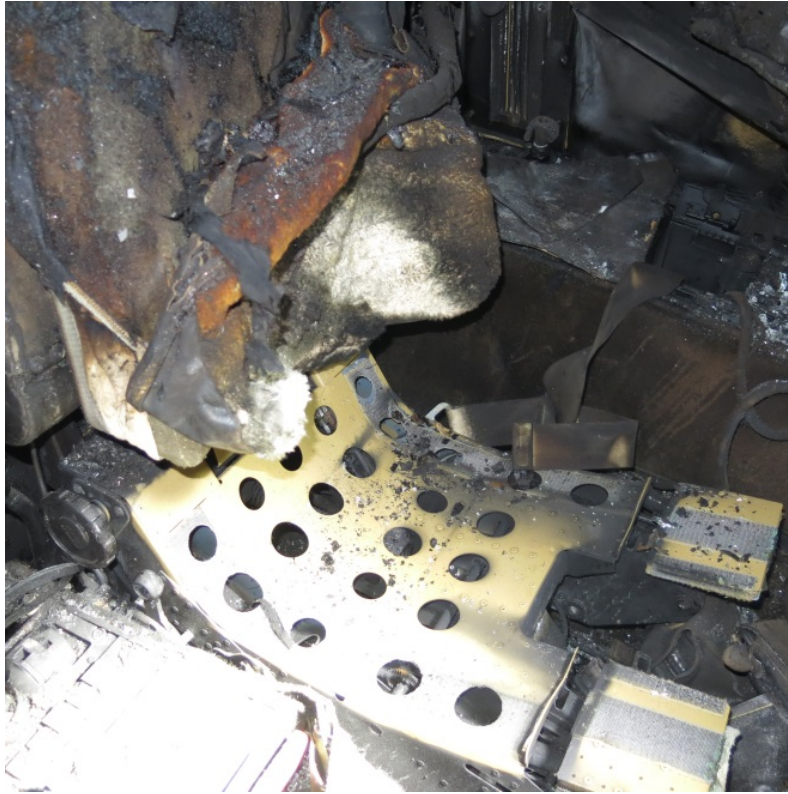
Photograph 2. Left cockpit seat frame.

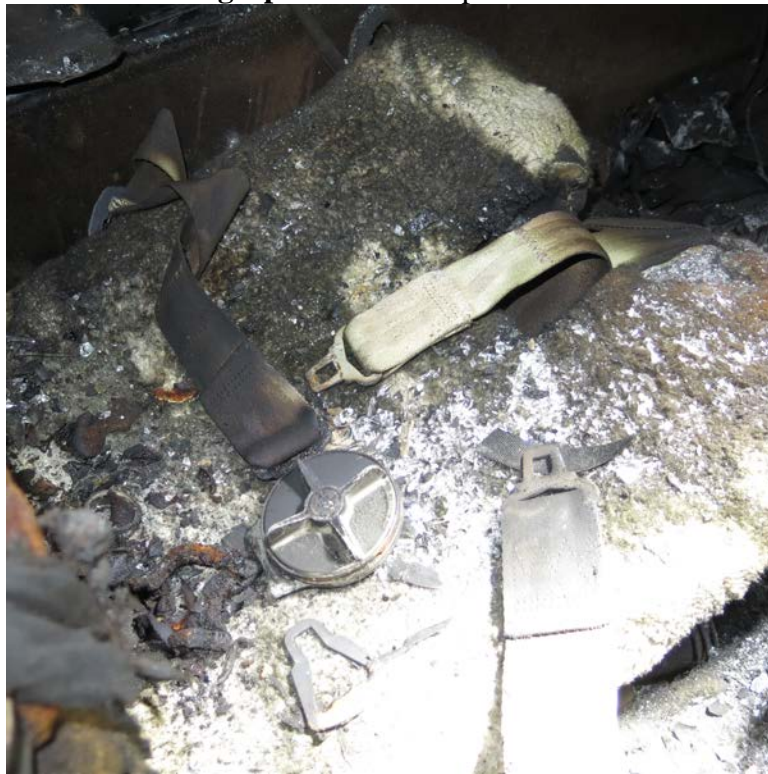
Photograph 3. Left cockpit seat 5-point restraint.

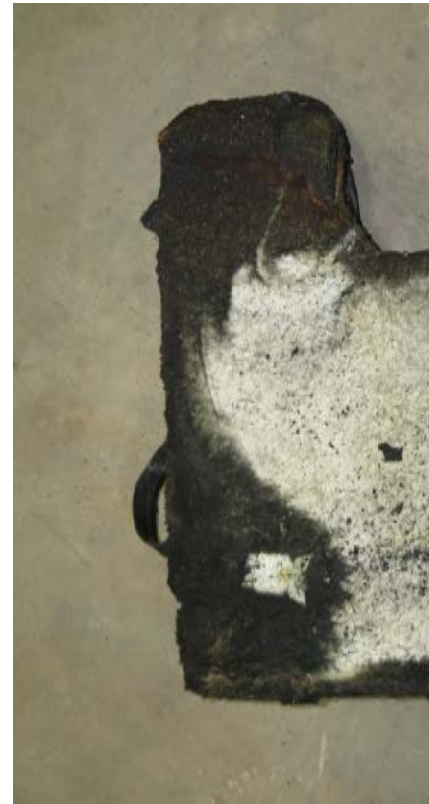
The right cockpit seat was manufactured by Ipeco Inc., P/N 1159SCF213-2. It was found with the seatback and seatpan cushions attached to the frame. The upper portion of the seatback cushion fabric was destroyed by fire with thermal damage to the foam cushion. The lower portion of fabric and foam cushion remained attached to the seat with thermal damage to the midsection of the cushion. The bottom of the seatback cushion fabric was not burnt. The seatpan cushion (photograph 4) was covered in soot with thermal damage on the forward right and forward left corners. The frame was fully intact with signs of thermal damage and found locked in the seat tracks aft-most position measuring 5 1/8 inches from the aft seat frame to the aft cockpit wall (photograph 5). The outboard armrest was found in the down position with the female rotatory buckle and webbing hanging over the armrest. The inboard armrest was found in the up position. The right cockpit restraint was a 5-point restraint manufactured by Pacific Scientific Co. An identification code #45402 was stamped into the central rotatory buckle. The part number was illegible. Both shoulder harnesses had retracted into the stowed position and were damaged by the post-crash fire; the inertia reel was not functional. The outboard lap restraint was adjusted to a measurement of 22 inches from the seatbelt attach point and the end of the rotary buckle. The inboard lap restraint was adjusted to a measurement of 17 1/2 inches from the seatbelt attach point and insert tab. The crotch strap was adjusted to a measurement of 12 3/4 inches from the seatbelt attach point to the insert tab.

Photograph 4. Right cockpit seatpan cushion.

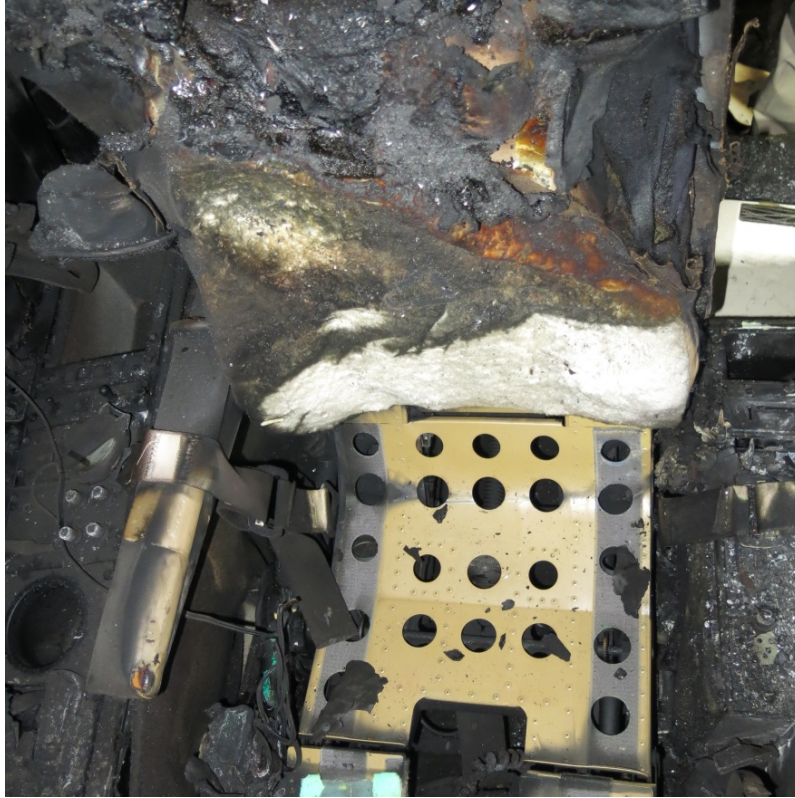
Photograph 5. Right cockpit seat frame.

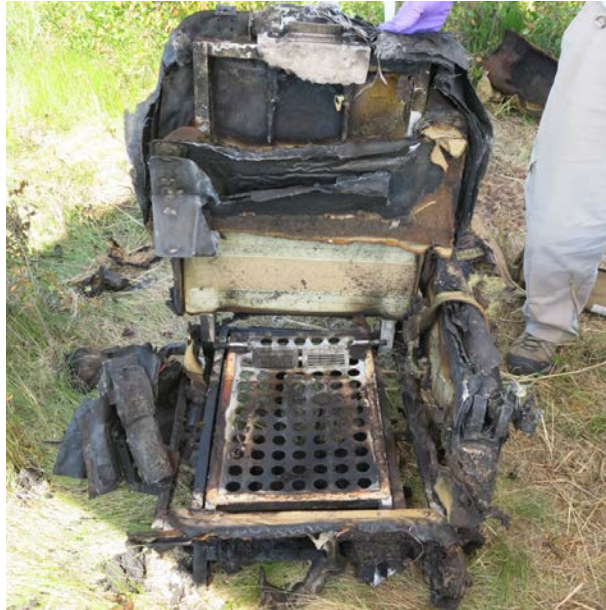
Seat 1L (photograph 7) was found in its original position on the aircraft attached to the floor seat tracks. Hanscom AFB Fire/Rescue cut all four seat posts to remove the seat. The seat

cushions and armrest showed signs fire damage. The seat frame remained intact, with fire damage.

Photograph 7. Seat 1L frame.

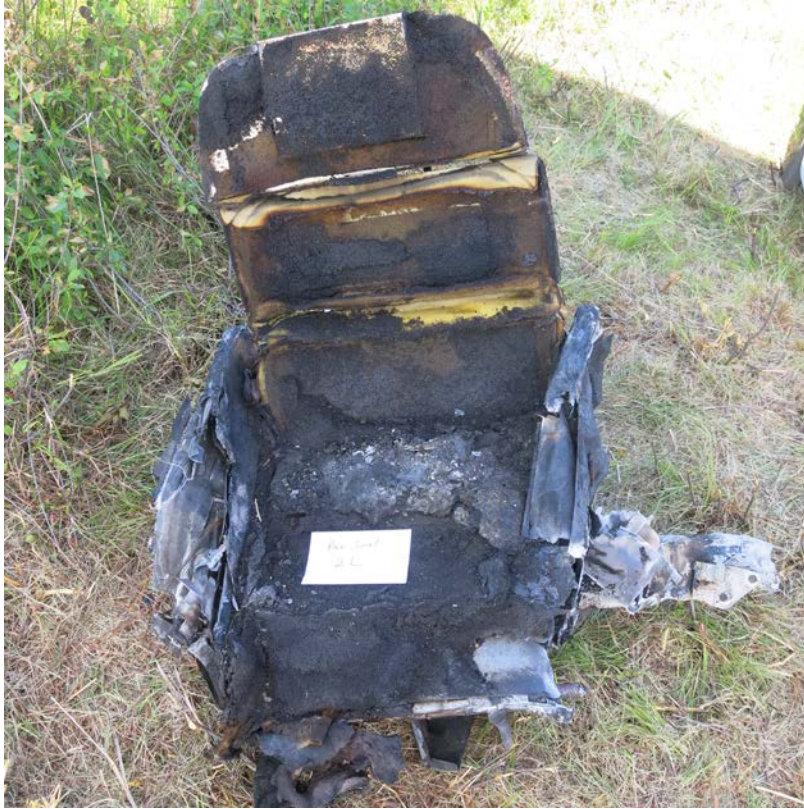
Photograph 8. Seat 2L.

Seat 2L (photograph 8) was found in its original position on the aircraft attached to the seat tracks. Hanscom AFB Fire/Rescue cut all four seat posts to remove the seat. The seat cushions and armrest showed signs fire damage. The seat frame remained intact, with fire damage.

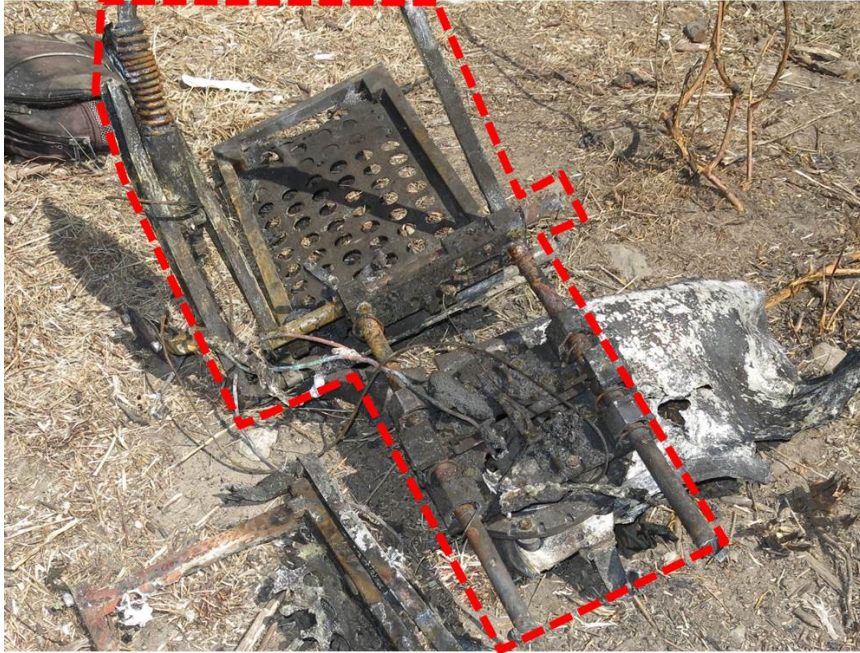
Seat 4L was found in its original position (photograph 9). The seat fabric and cushions were destroyed by fire. The seat frame was attached to the seat tracks. Hanscom AFB Fire/Rescue cut all four seat posts to remove the seat.

Photograph 9. Seat 4L frame outlined in red.

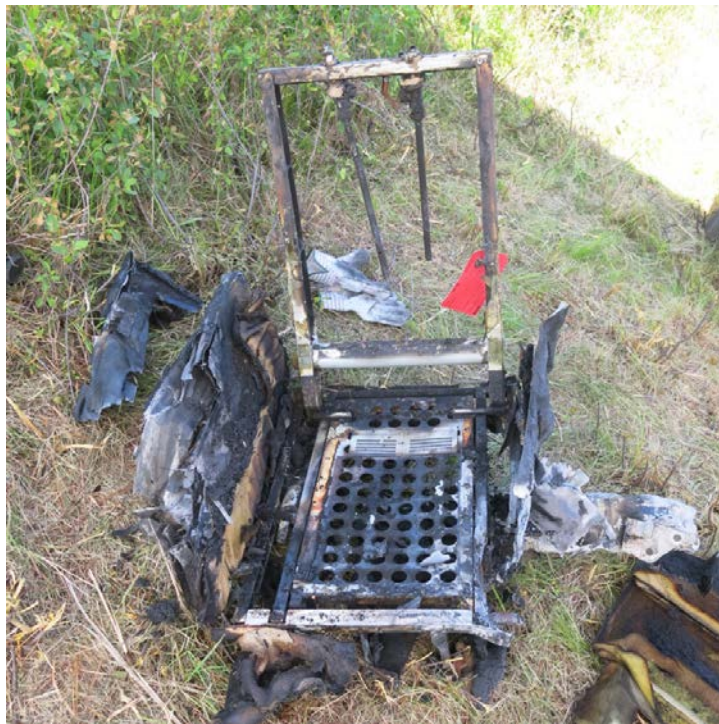
Seat 4LC was found in its original position (photograph10). The seat fabric and cushions were destroyed by fire. The seat frame was attached to the seat tracks. Hanscom AFB Fire/Rescue cut all four seat posts to remove the seat.

Photograph10. Seat 4LC frame.

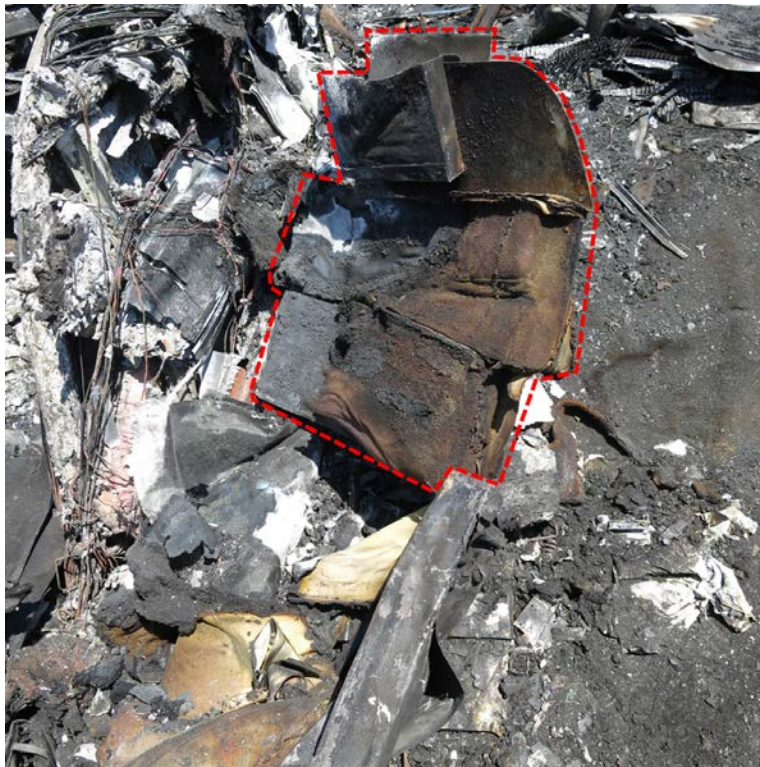
Seat 5L (photograph 11) was found in its original position on the aircraft. The seat cushions and armrest showed signs of fire damage. The seat frame remained intact and attached to the seat tracks, with fire damage.

Photograph 11. Seat 5L outlined in red.

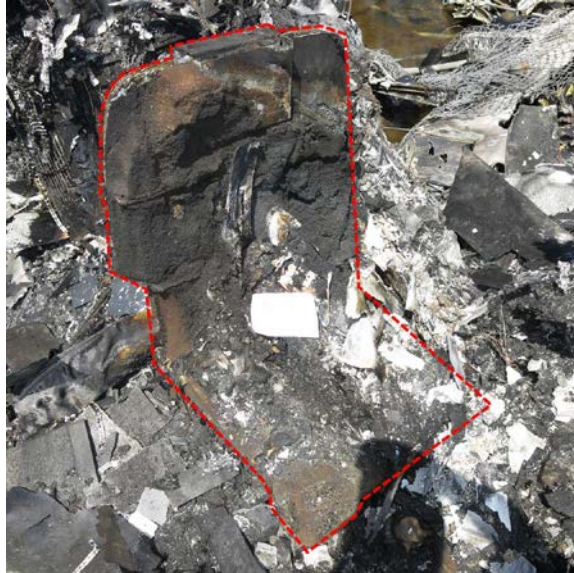
Seat 6L (photograph 12) was found in its original position on the aircraft. The seat cushions and armrest showed signs of fire damage. The seat frame remained intact and attached to the seat tracks, with fire damage.

Photograph 12. Seat 6L outlined in red and partially obstructed by burnt debris.

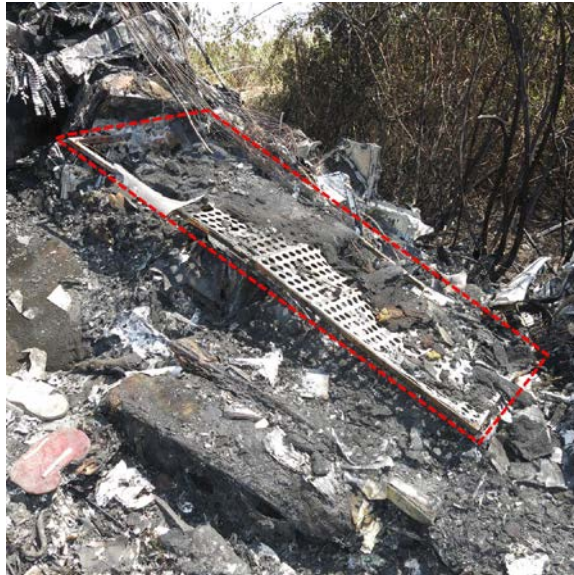
Divan 1R (photograph 13) was found in its original position. The divan fabric and cushions were destroyed by fire. The divan frame was attached to the seat tracks.

Photograph 13.Divan 1R outlined in red.

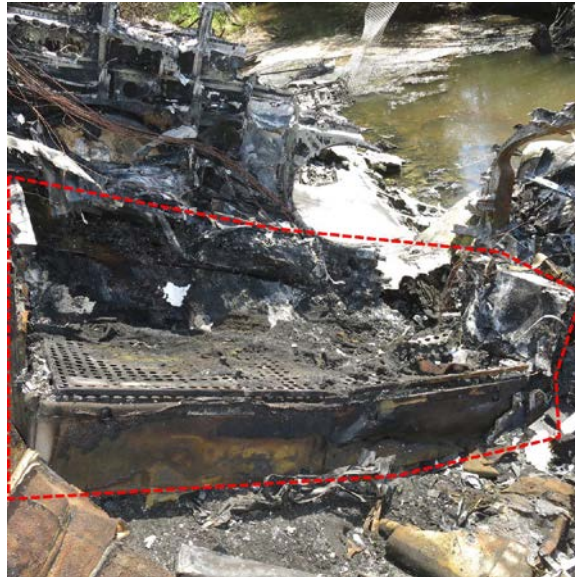
Divan 2R (photograph 14) was found in its original position on the aircraft. The seat cushions and armrest showed signs of fire damage. The seat frame remained intact and attached to the seat tracks, with fire damage.

Photograph 14. Divan 2R frame outlined in red.

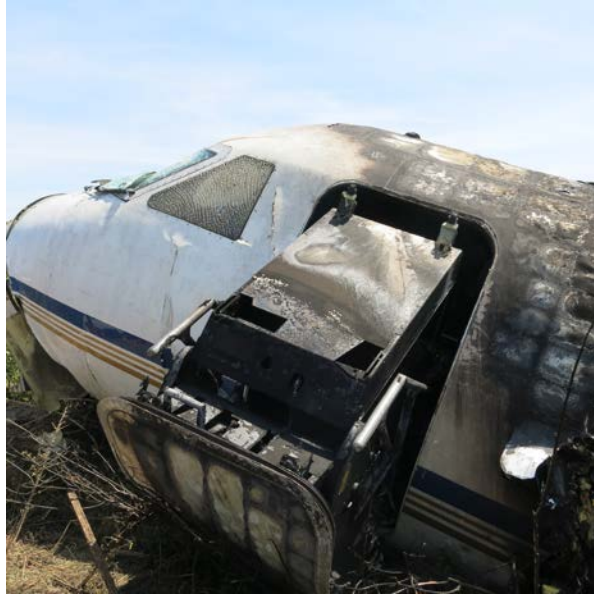
Photograph 19. Main entrance door.

The accident airplane's main entrance door remained closed during the accident sequence and post-crash fire. Recorded radio communications from Hanscom AFB Fire/Rescue indicated that Hanscom AFB firefighters first opened the main entrance door at 2351:42, about 2 hours and 11 minutes after the accident. According to firefighters' statements, a Halligan tool was used to depress the secondary latch release on the lower exterior door. Firefighters then pulled the handle open and the door free fell to a partially-opened position, (photograph 19) terrain obstructions prevented it from opening further.

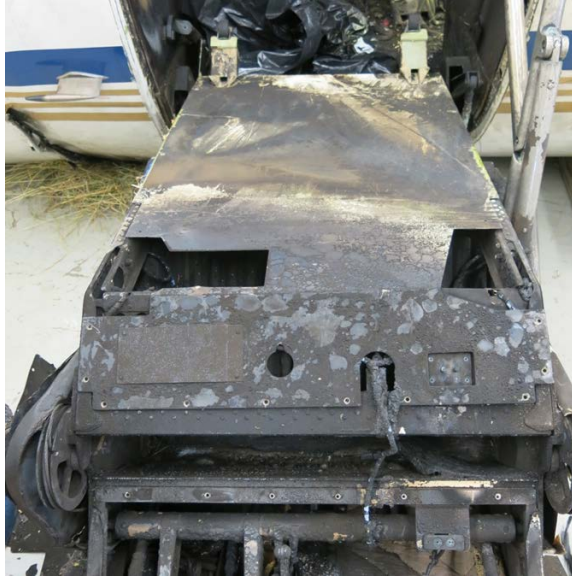
On July 21, 2014, the survival factors team examined the door at Anglin Aircraft Recovery Services in Clayton, DE. Members of the Gulfstream service engineering and a FBI Evidence Response Team from the Baltimore Field Office were also present. During recovery of the occupants the main entrance door stair had been fully extended and locked in place. As a result, to conduct the exam the door stair was unlocked and folded back into the stowed position to expose the door handle, locking lever and interior forward door stair cover. Gulfstream engineering used a lock release tool on the over-center latch to release the latch and allow the stair to rotate into the closed position (photograph 20). Once the over-center latch was released the stair folded back in alignment with the upper portion of the stair as designed. Further examination of the door locking mechanism showed that both inside and outside handles moved in unison as designed for door opening/closing operation. The FBI removed the interior main entry door handle and secondary latch release along with the main entry door stair cover and left cockpit seat oxygen mask from the accident airplane to examine for latent fingerprints. A letter (attachment 1) from the FBI dated September 2, 2014 stated the test resulted in negative findings for any latent fingerprints.

Photograph 20. Main entrance door stair folded at over center latch.

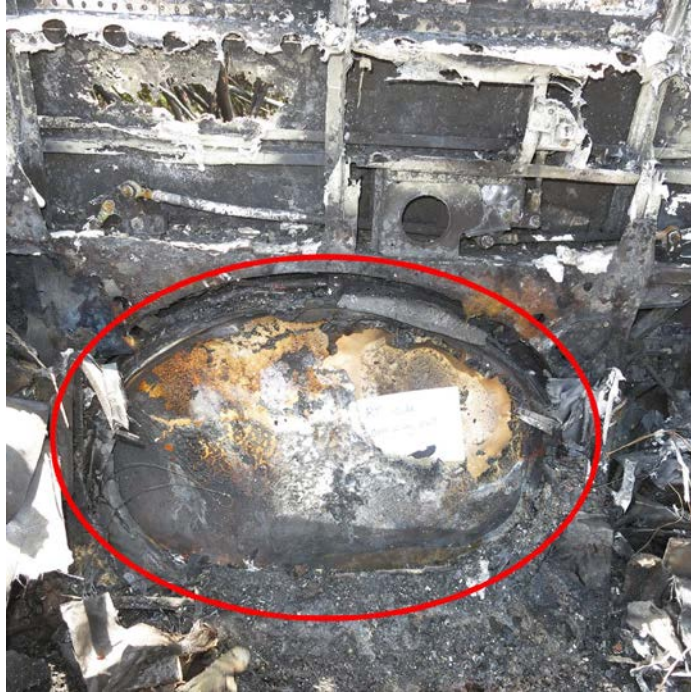
The left side emergency overwing exit windows were totally consumed by fire. The right side forward emergency overwing exit window was found locked in position (photograph 22); and the right side aft emergency overwing exit window was mostly consumed by fire with ¼ of the bottom window frame remaining in position in the airplane's window plug hole opening (photograph 23).

Photograph 22. Right side forward emergency overwing exit window outlined in red.

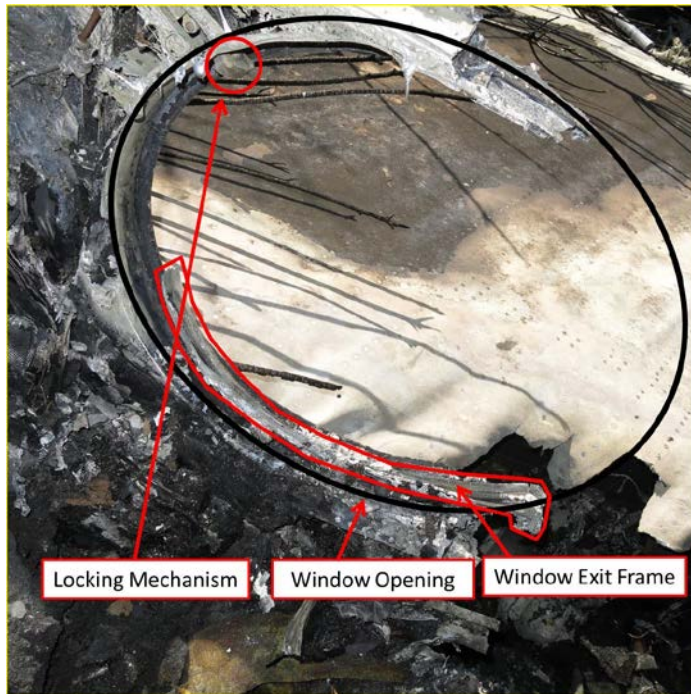
Photograph 23. Right side aft emergency overwing exit windows (outlined in black) depicting the locking mechanism, window opening and remaining window exit frame.

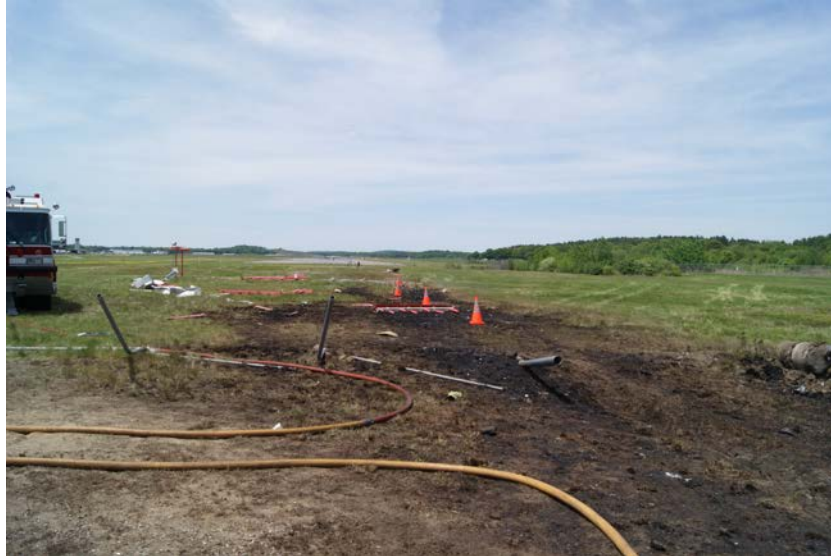
As a result of the accident, part of the approach lighting system, localizer antenna and 39 sections of the airport perimeter fence were destroyed (photograph 25). The lighting system and localizer antenna were located between the runway safety area and perimeter fence and constructed with 2.5 inch aluminum poles, bolted to concrete pillars. The airport perimeter fence was replaced by the airport operator. The FAA replaced the localizer antenna and MALSR light stations with a new lightweight system, anchored with frangible bolts to new concrete pillars.

Photograph 25. Accident airplane path from runway 11 through airport perimeter fence.
