Scaled Composites, LLC  
Koehn Dry Lake, CA  
October 31, 2015  
DCA15MA019

**NATIONAL TRANSPORTATION SAFETY BOARD  
WASHINGTON, D.C.**

ATTACHMENT 1

Photographs

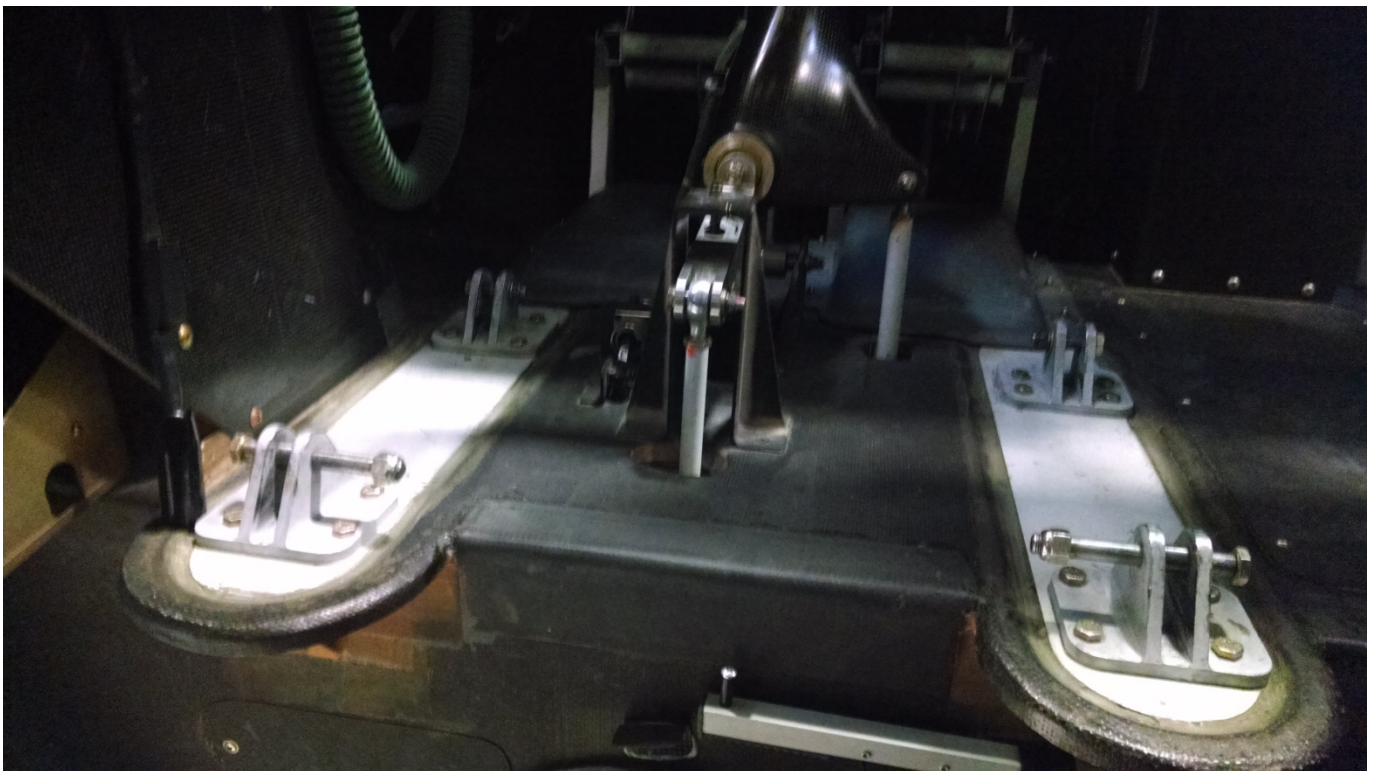
Photo 4. Four seat attachment floor fittings from WK2 after removal of pilot seat.

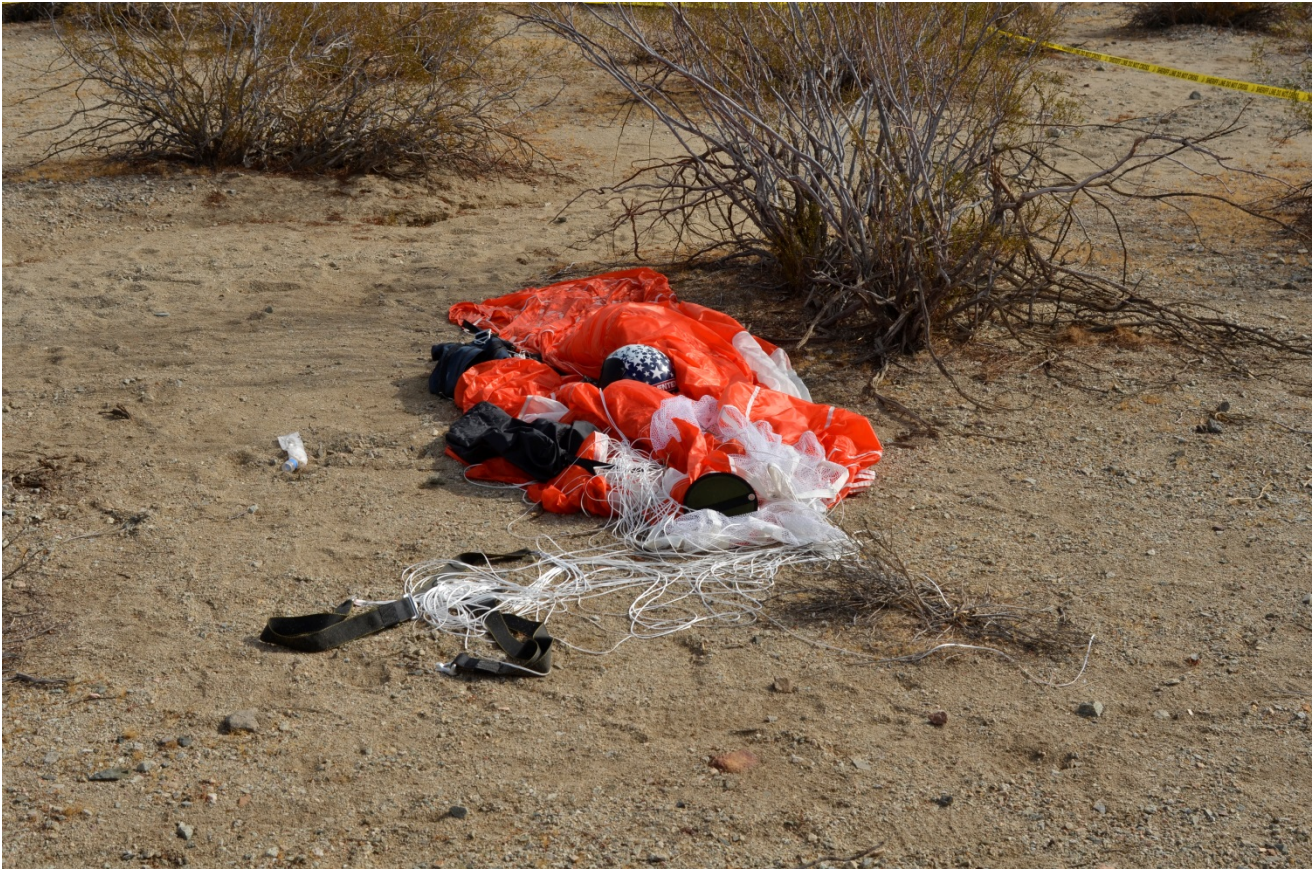
Photo 12. Pilot's parachute as found by KCSO personnel.

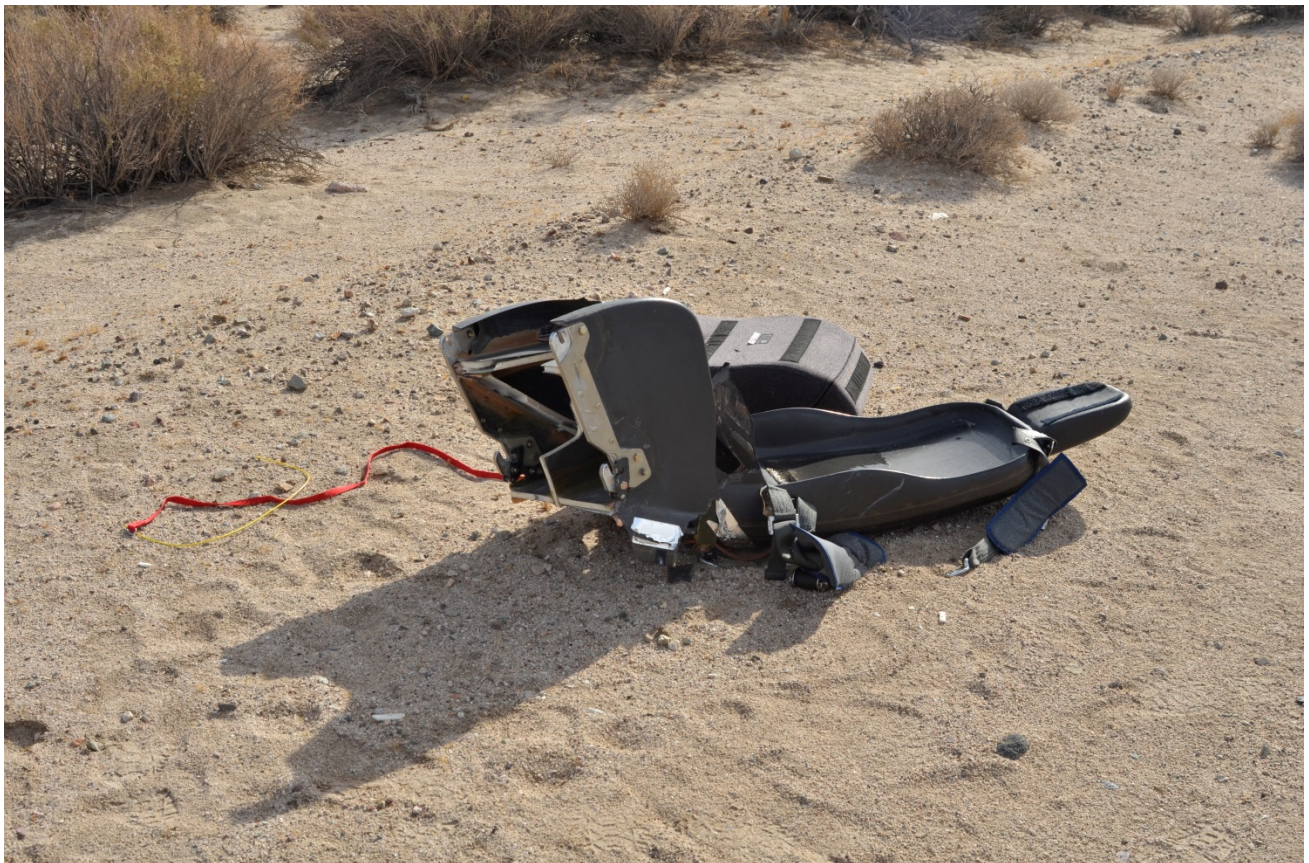
Photo 13. Pilot's seat as found by KCSO personnel.

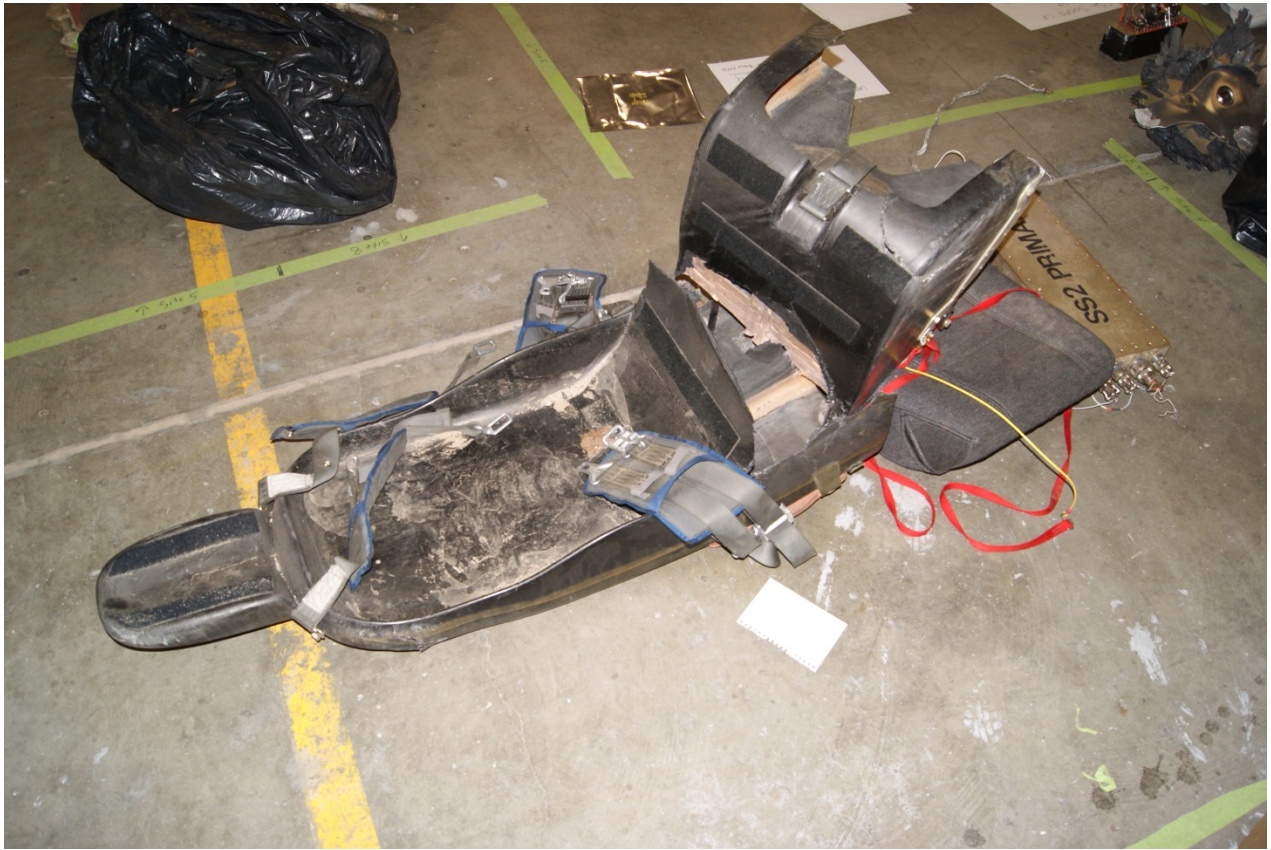
Photo 14. Pilot's seat as found by NTSB survival factors group.

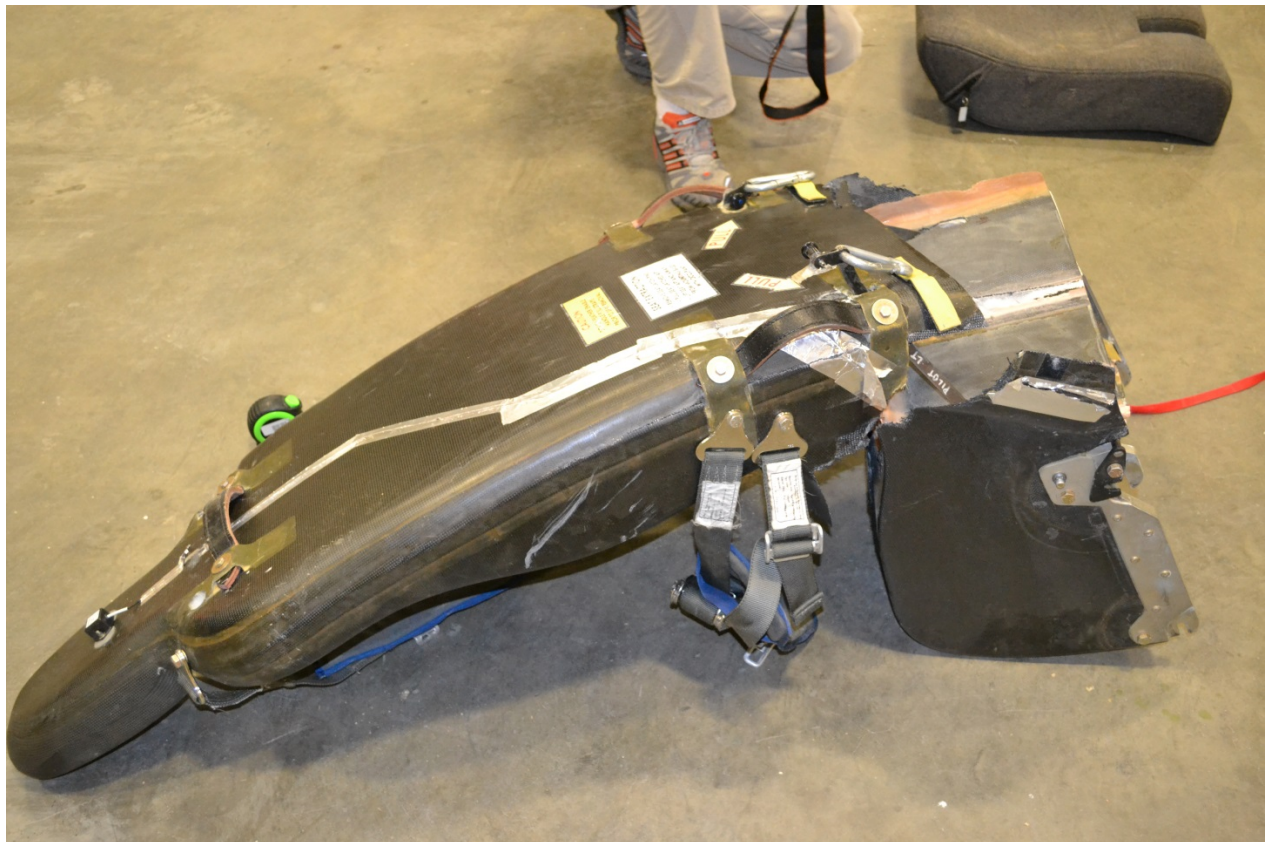
Photo 15. Pilot's seat as found by NTSB survival factors group.

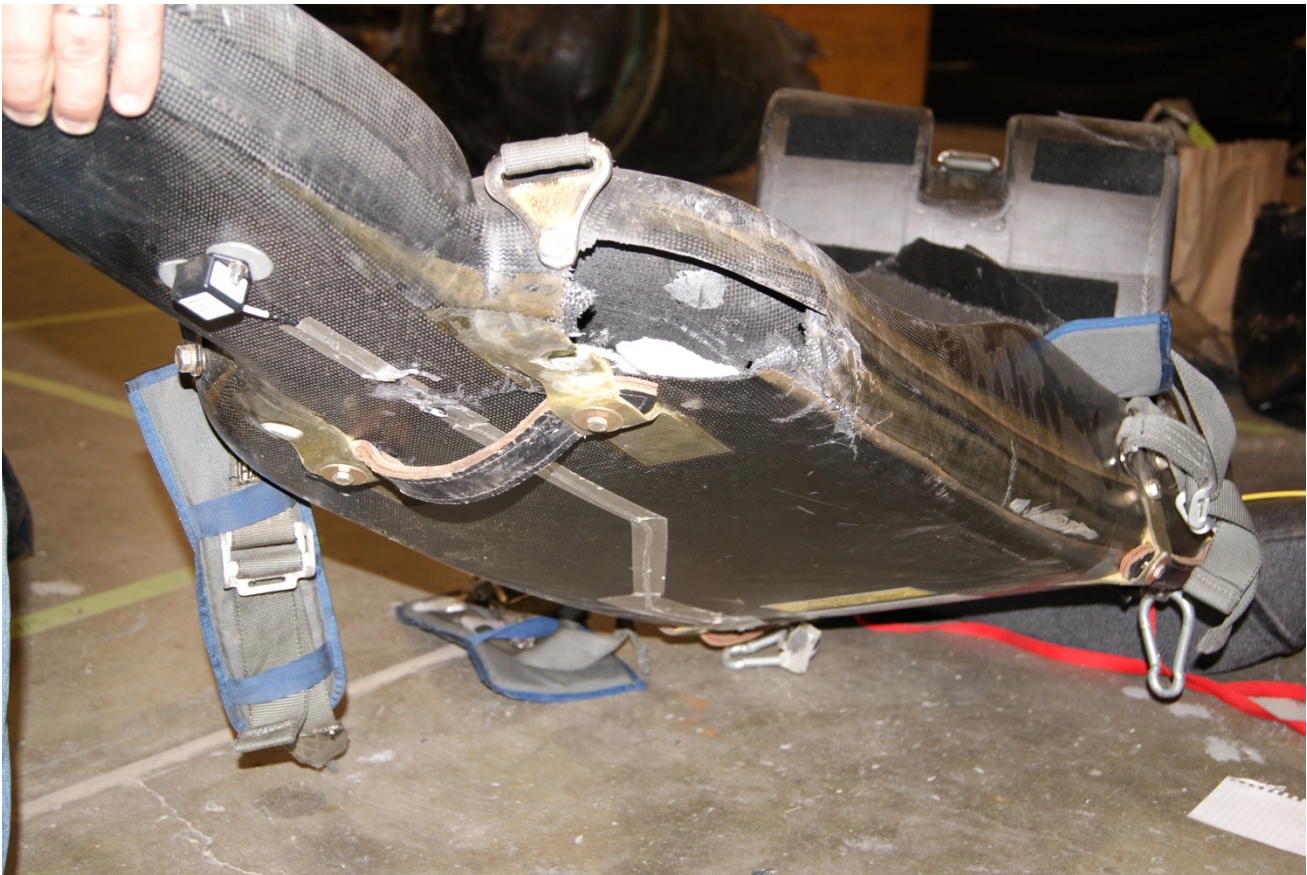
Photo 16. Damage to right shoulder area of pilot's seat.

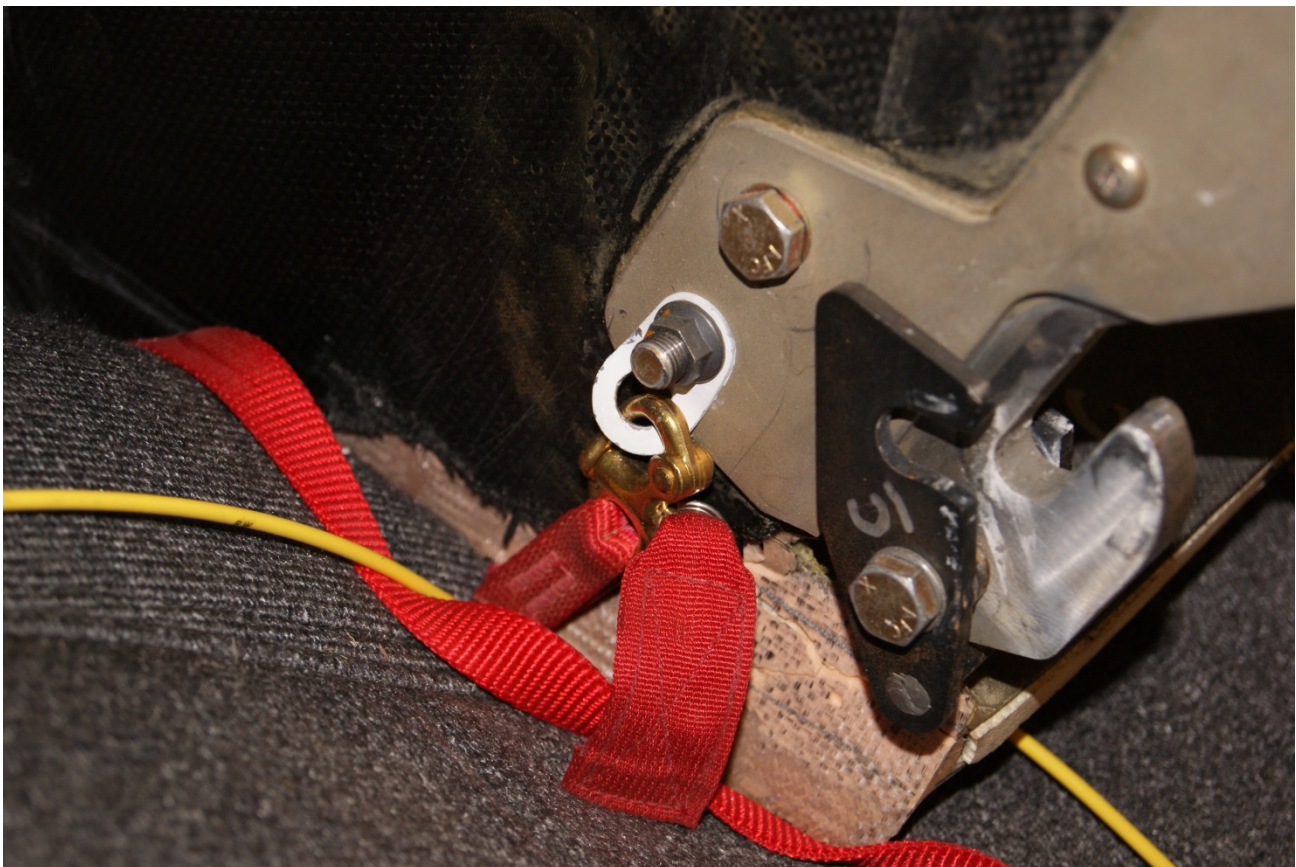
Photo 17. CYPRES 2 red, static line connection to pilot seat.

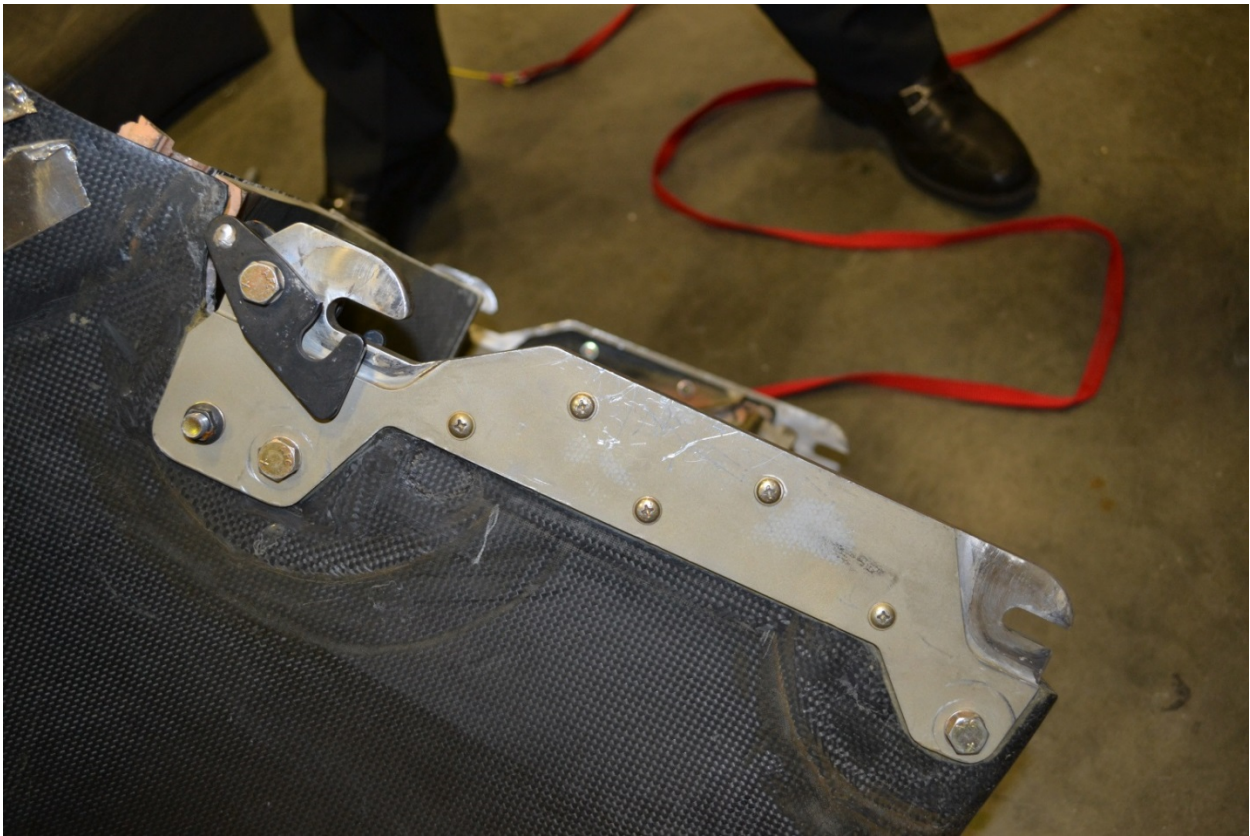
Photo 18. Seat attachment fittings of pilot's seat.

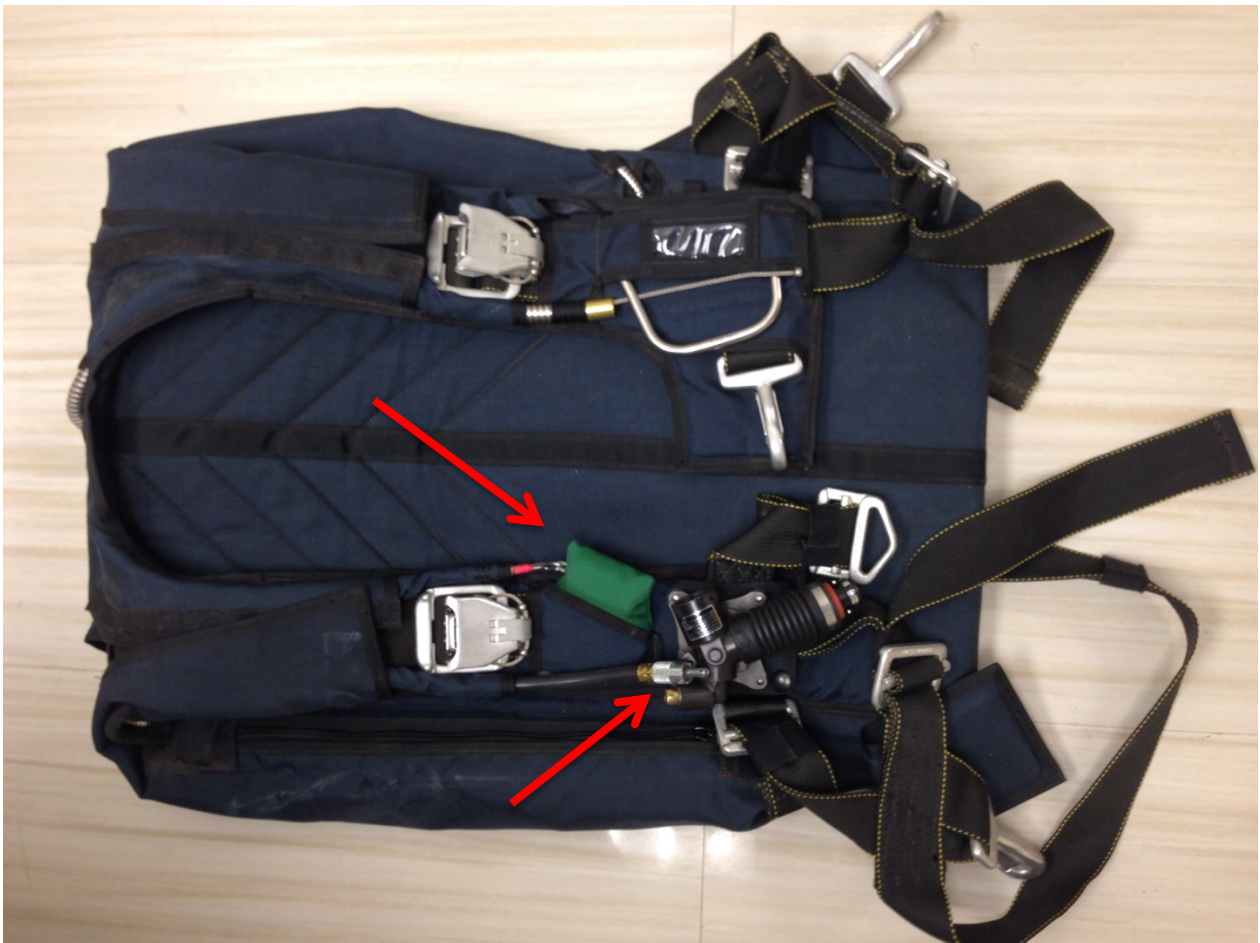
Photo 19. Pilot's parachute harness and container. (Note stowed green pad and disconnected oxygen hose.)

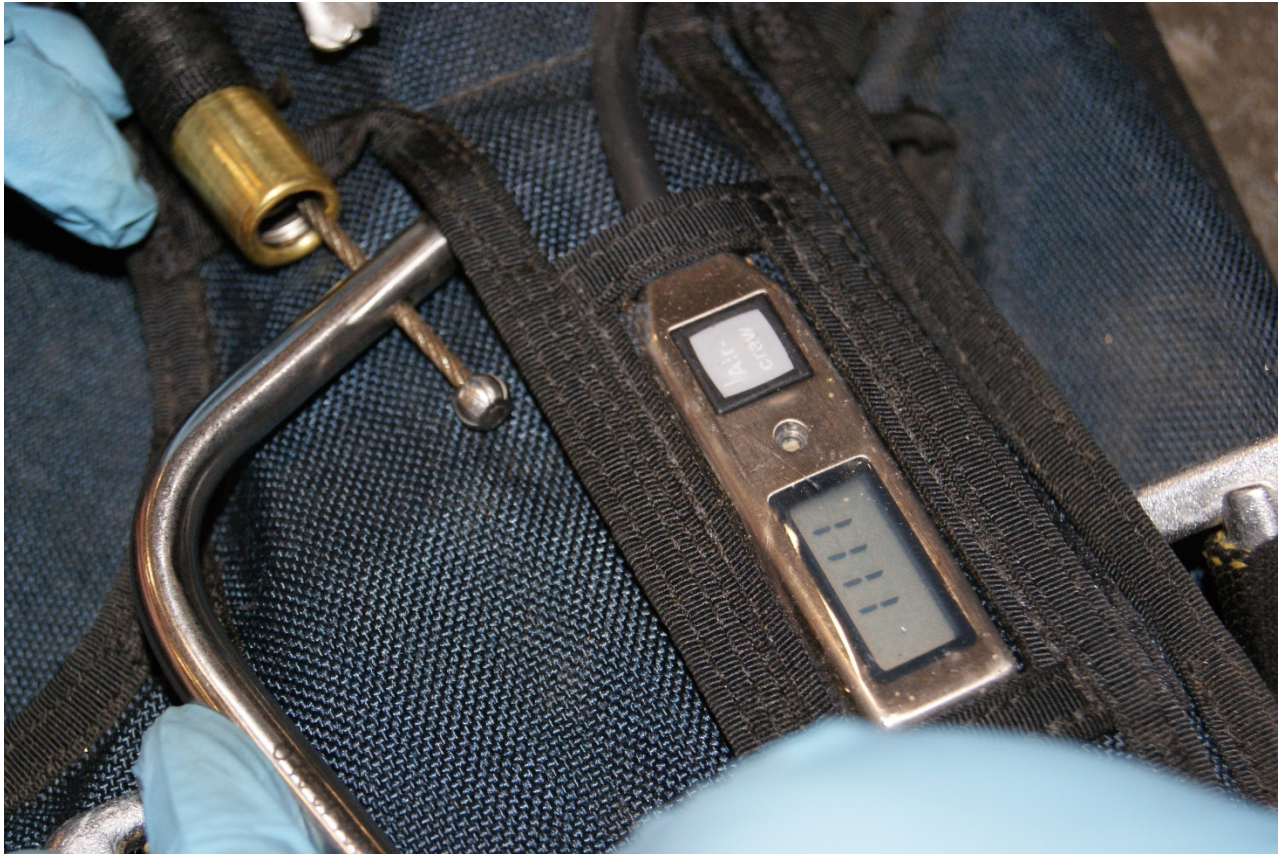
Photo 20. CYPRES 2 device from pilot's parachute (prior to removal).

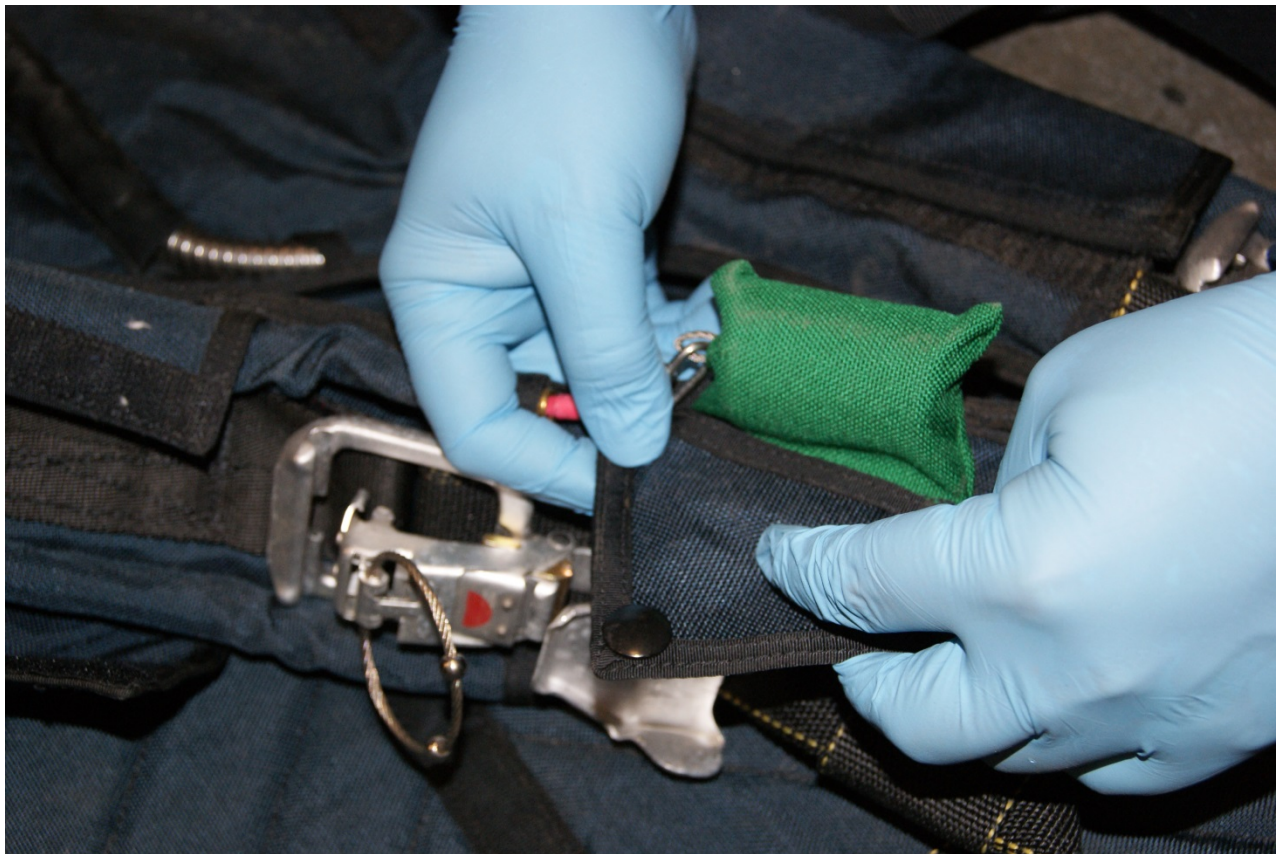
Photo 21. Close-up of the stowed green pud from the pilot's parachute.

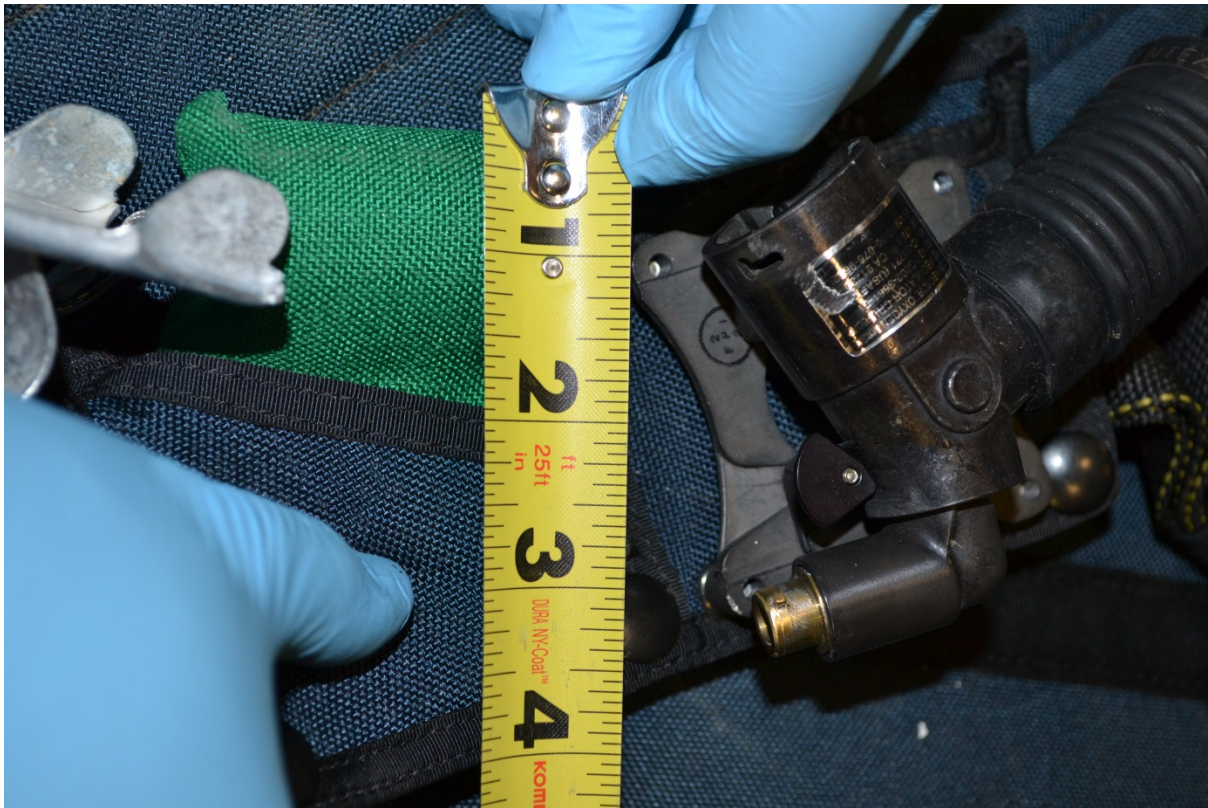
Photo 22. Stowed green pud.

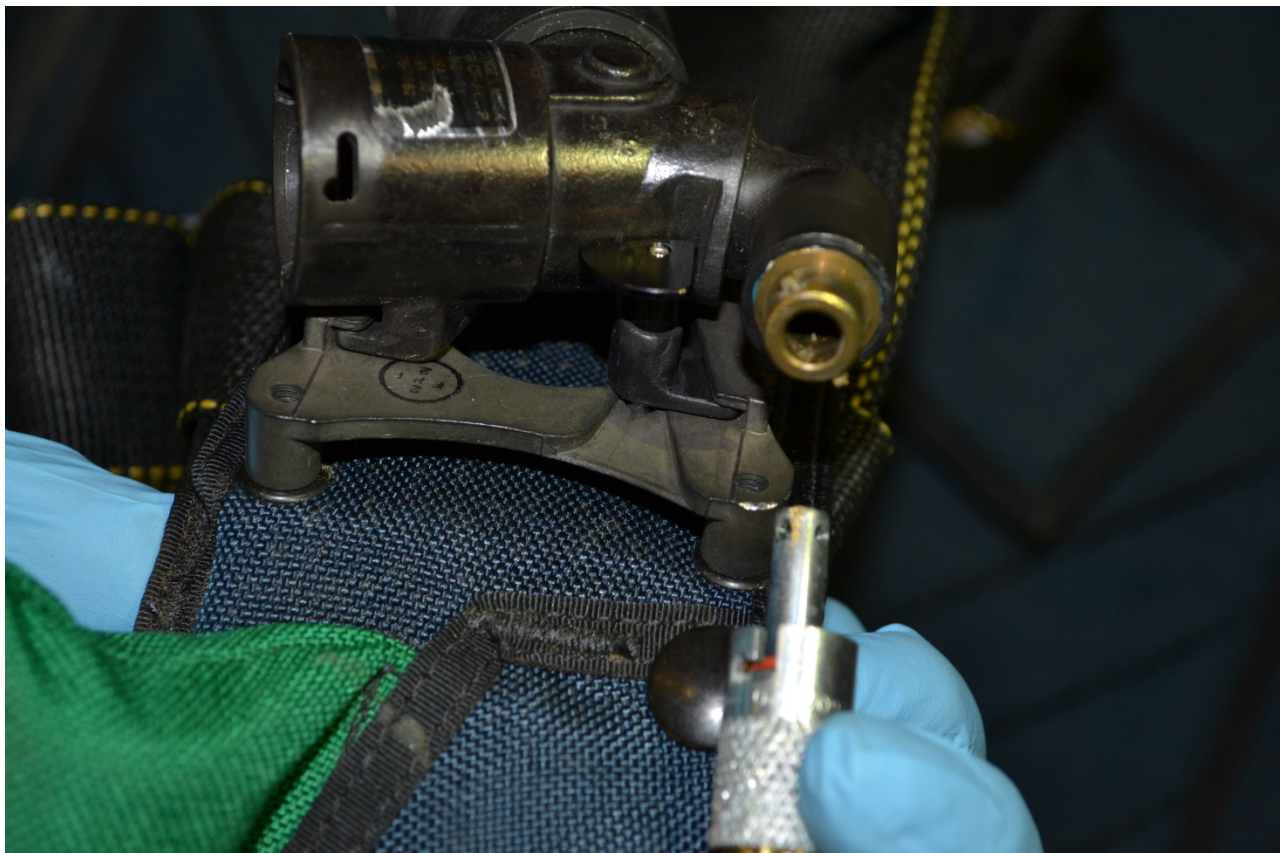
Photo 23. Close-up of disconnected oxygen hose.

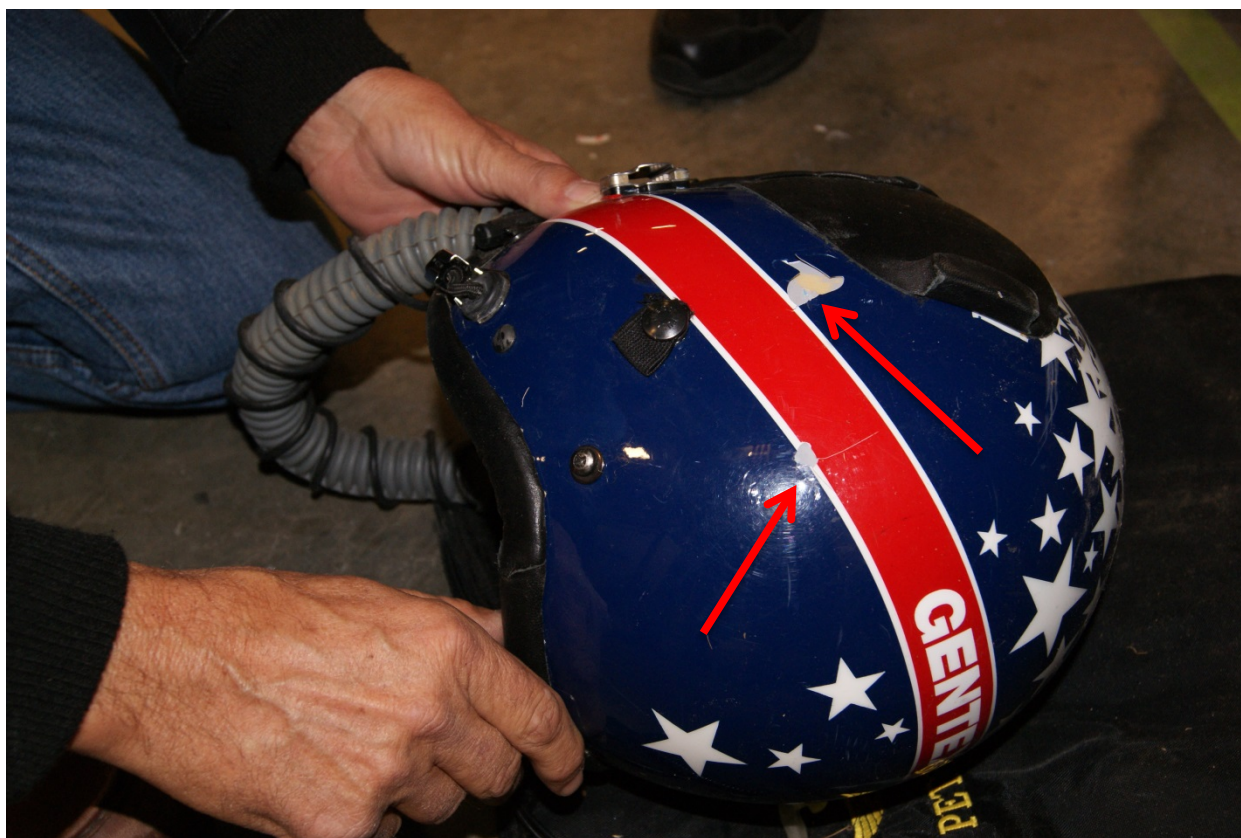
Photo 25. Pilot's helmet. (Note: two small areas of damage).

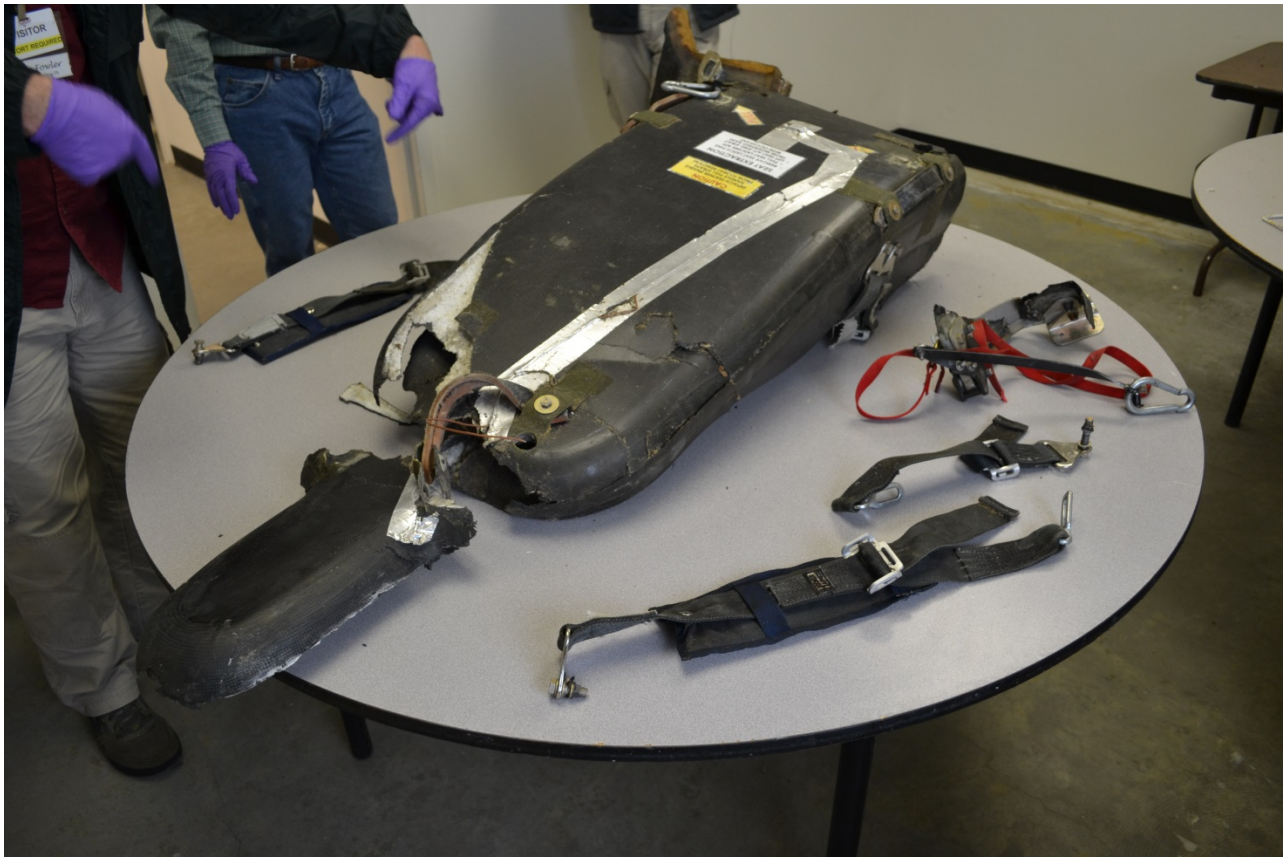
Photo 26. Copilot's seat.

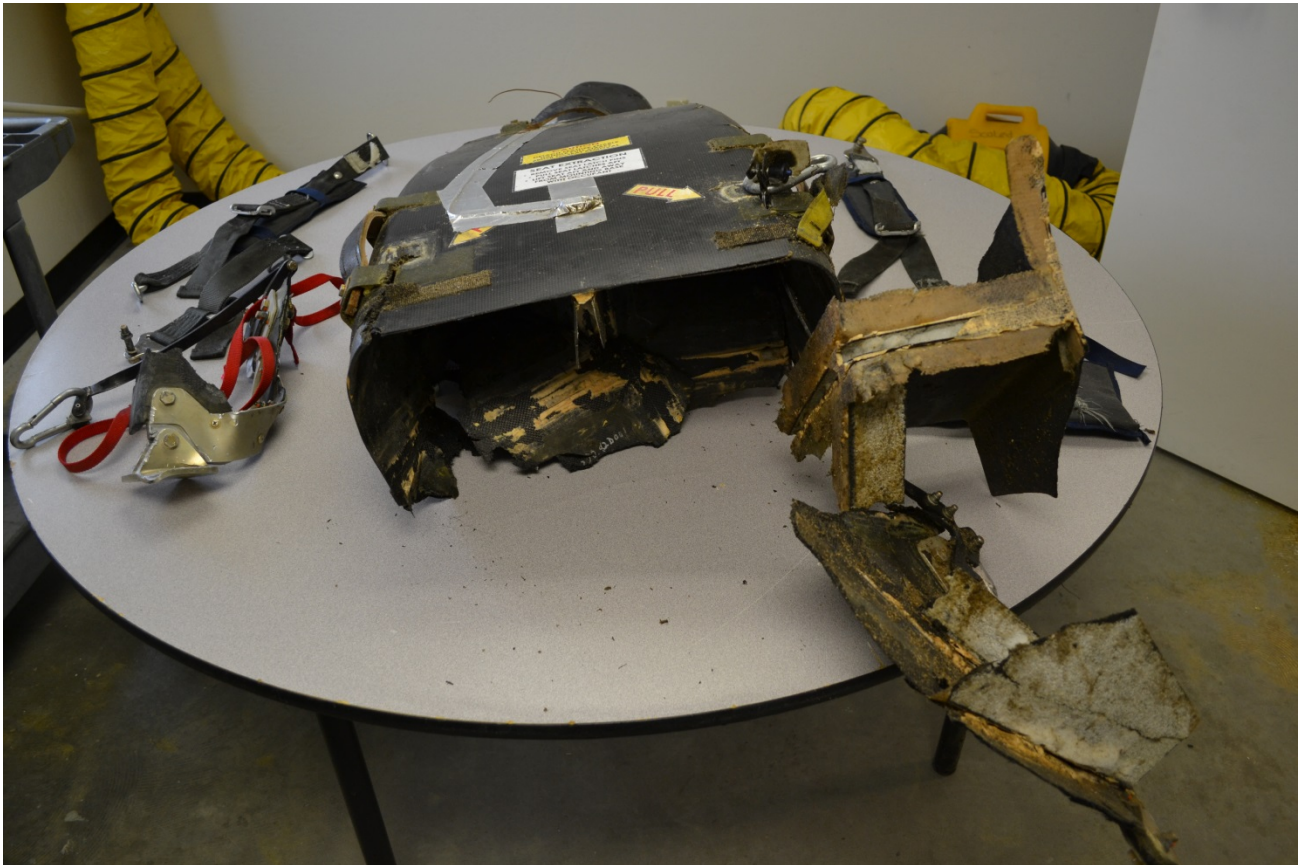
Photo 27. Copilot's seat.

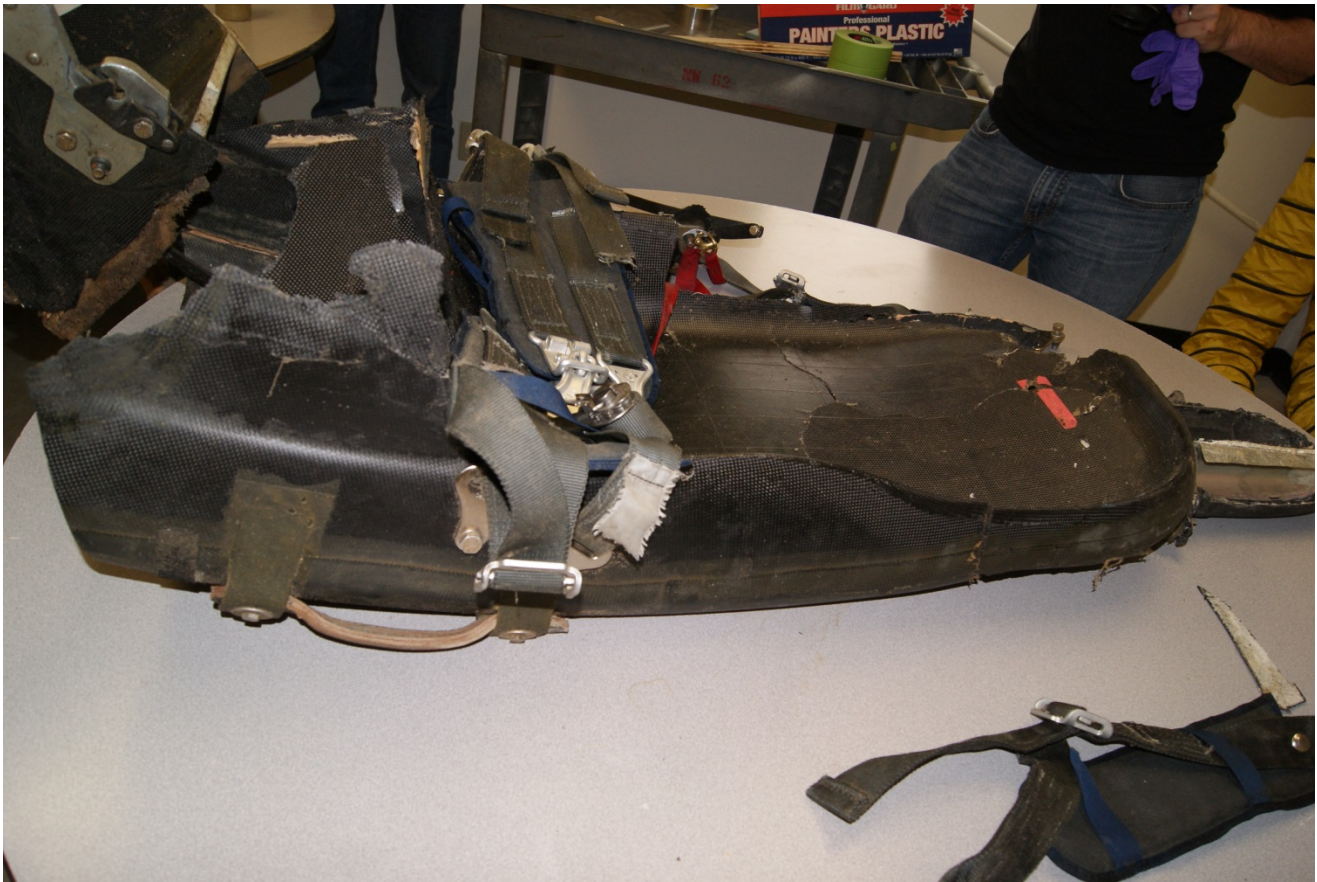
Photo 28. Copilot's seat.

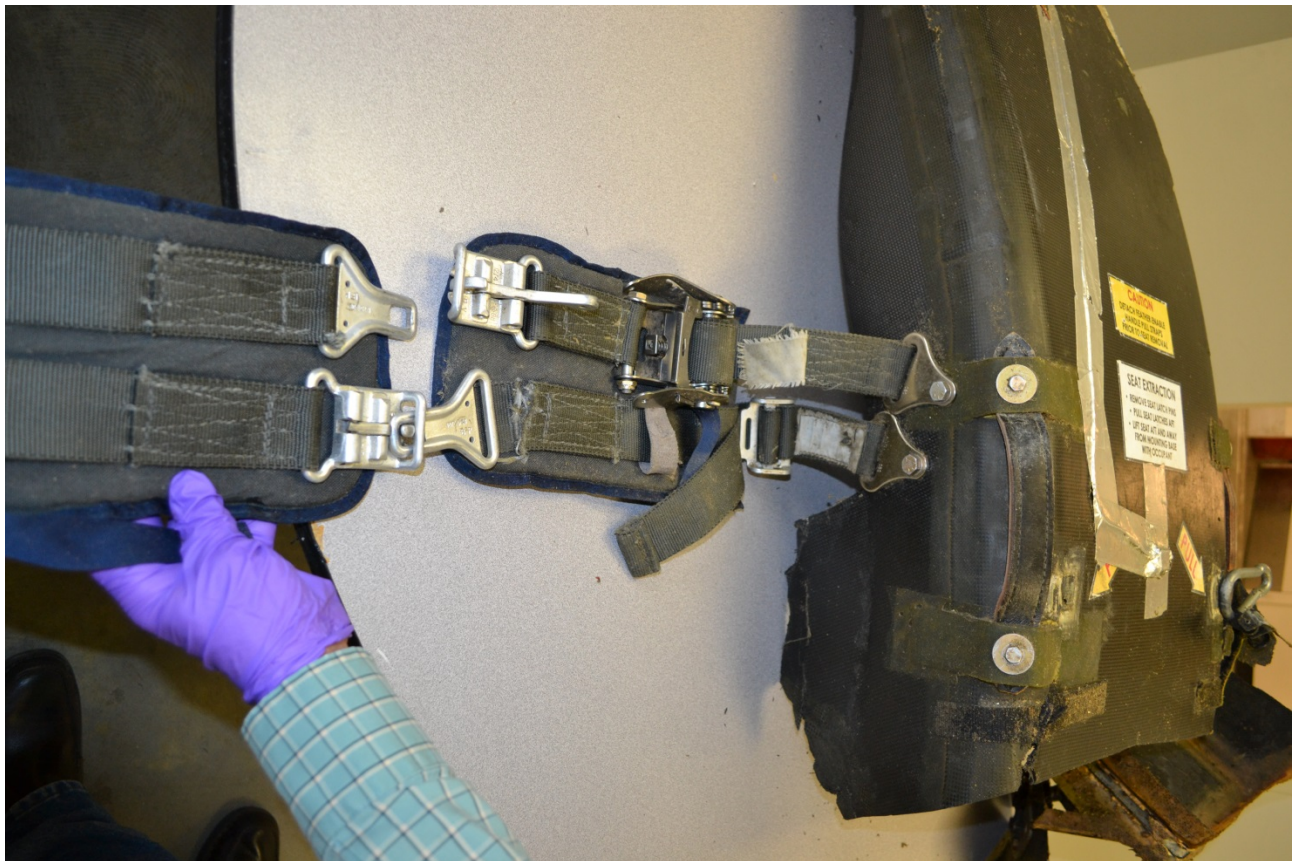
Photo 29. Copilot's seat and lapbelt restraints.

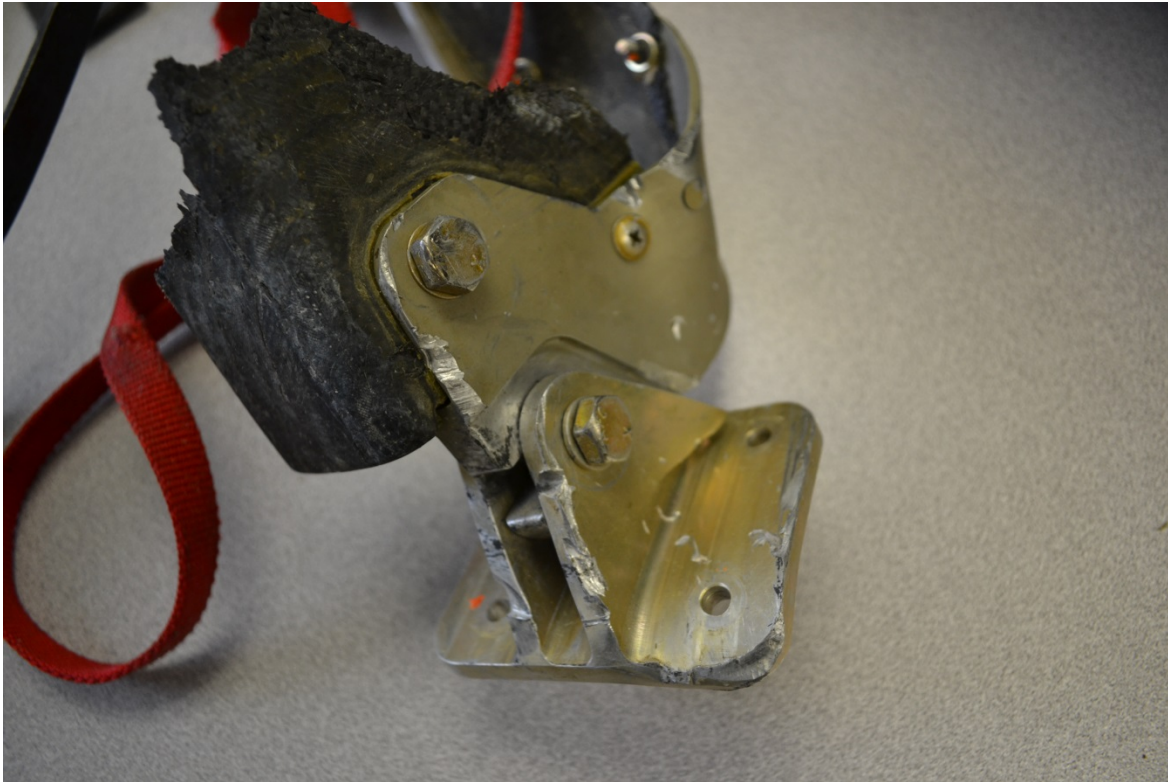
Photo 30. Seat attachment fitting and floor fitting from copilot's seat.

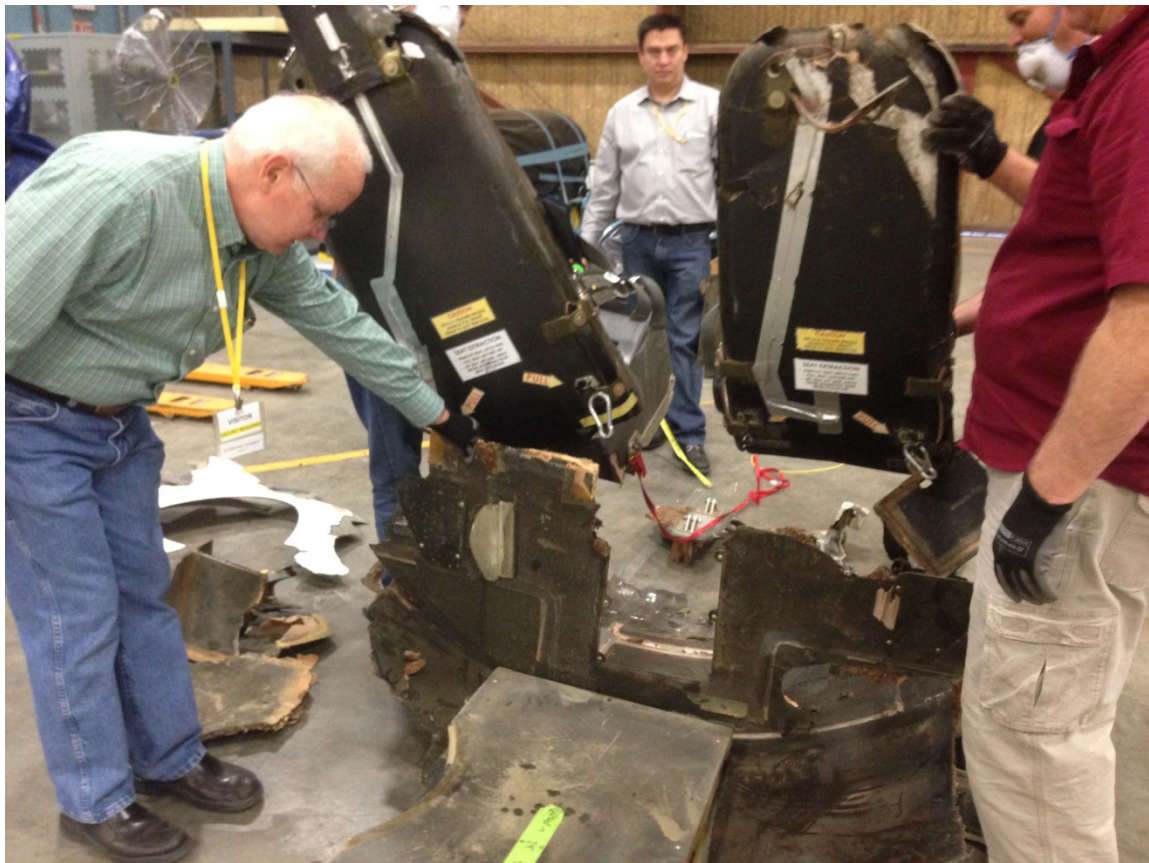
Photo 31. Reconstruction of raised pedestal, crew seats, and flooring of SS2.

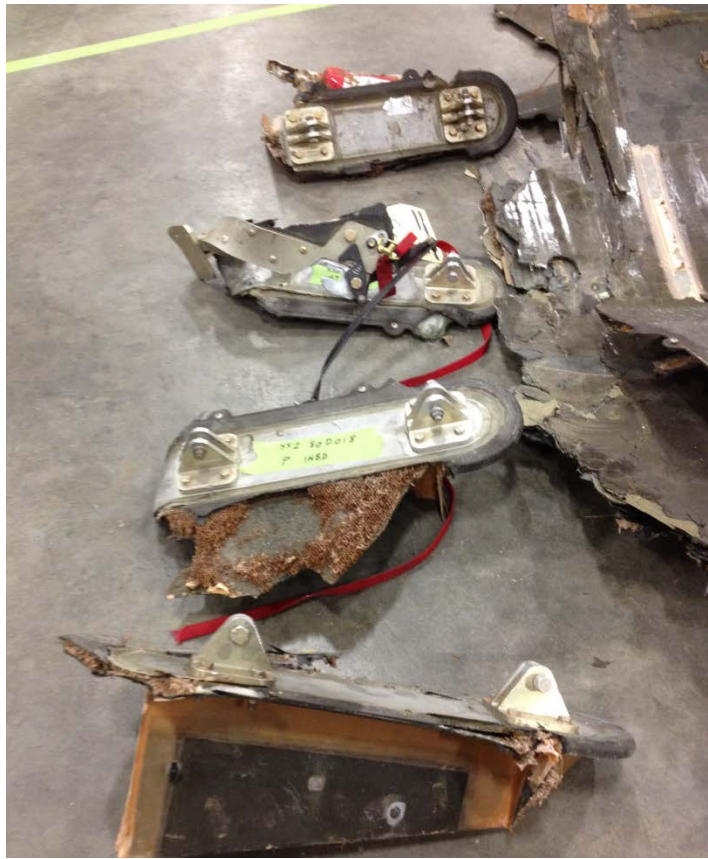
Photo 32. Floor fittings and floor plates from SS2.
