**Survival Factors Group**

**Chesterfield Township, NJ.**

**Factual Report of Investigation**

**Survival Factors Group Chairman's Factual Report**

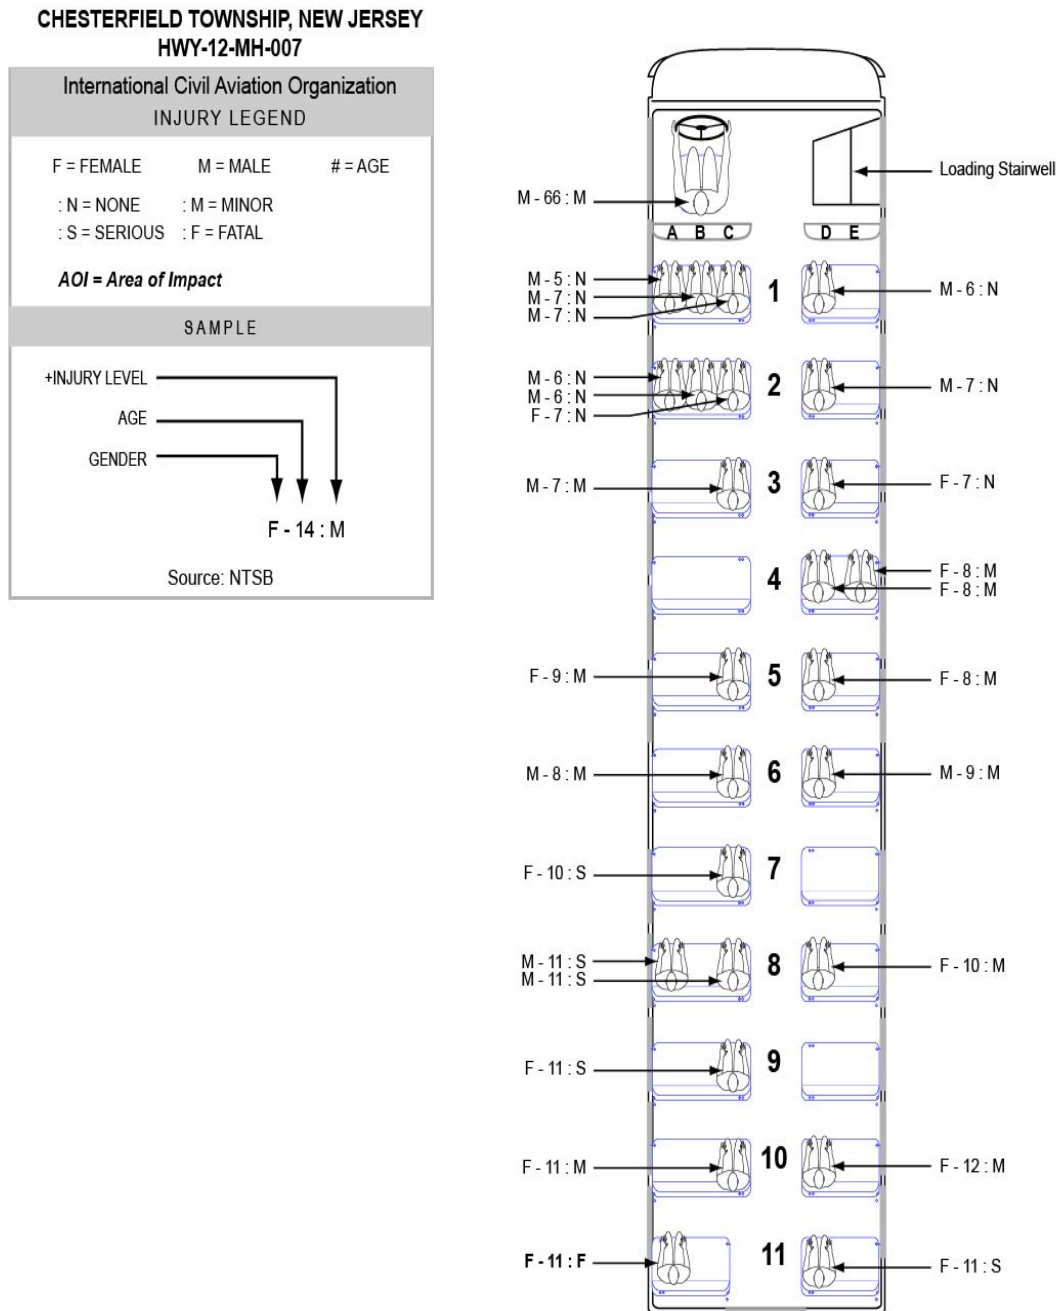
Figure 1.

Seat positions are based on passenger questionnaires, Northern Burlington County Regional School District seating chart, witness, and first responder interviews. Total weight of the driver and twenty-five passengers was 2008 pounds.
