NATIONAL TRANSPORTATION SAFETY BOARD
Office of Aviation Safety
Washington, DC 20594

SURVIVAL FACTORS SLIDE/RAFT TEARDOWN REPORT

Operator : Federal Express
Aircraft : McDonnell Douglas MD-11 [N584FE]
Location : St. Louis, MO
Date : February 24, 2015
Time : 0616 (cst)¹
NTSB # : DCA15FA073

Inspection of Fed Ex Evacuation System 60289-117 serial number 0406.

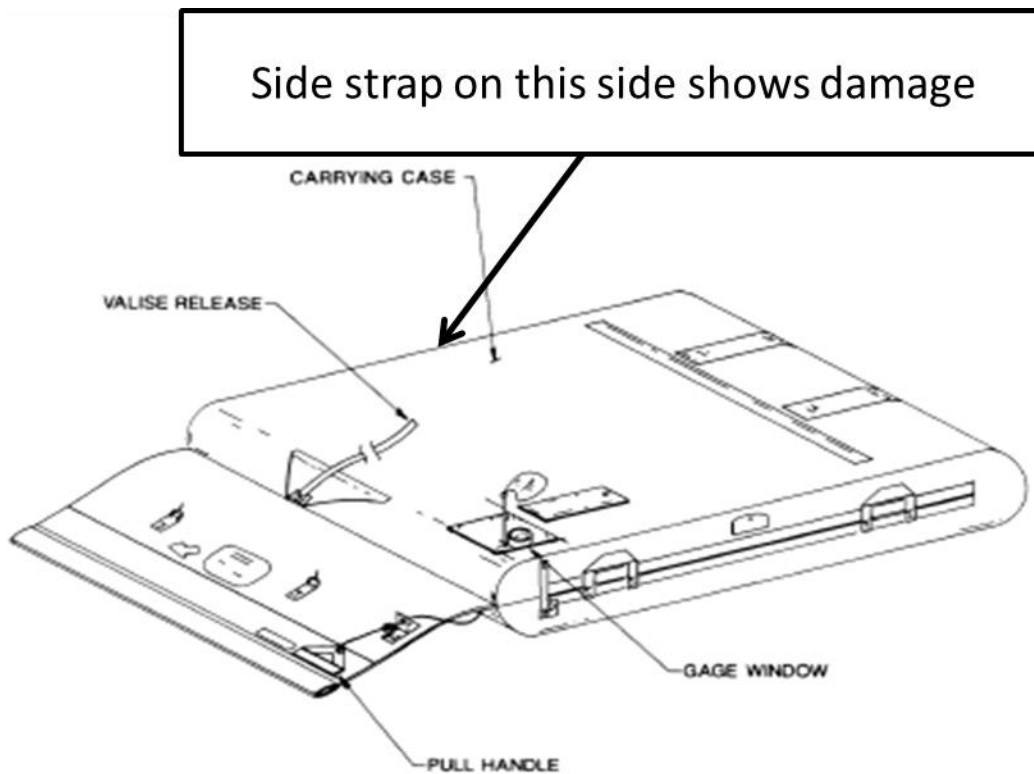
Diagram 1 - Pack slide carry case before installation.

1. Unit remained in its shipping box, in a quarantine area, unopened prior to inspection.
2. Carrying Case (part number 60522-101 dated 13 Dec 1995 (diagram 1)).
 - a. Case exterior surface overall in good condition.
 - i. Minor dirt marks

- i. Both found intact and snapped in place on top side of carrying case per installation requirement
- ii. Right (forward) side storage strap – no notable damage
- iii. Left (aft) side storage side strap
 - 1. This would be over the aspirator
 - 2. Storage strap shows visible signs of damage
 - a. Drag marks across snap top
 - b. Torn webbing sections
 - c. Friction burn marks and melted fibers at torn edge

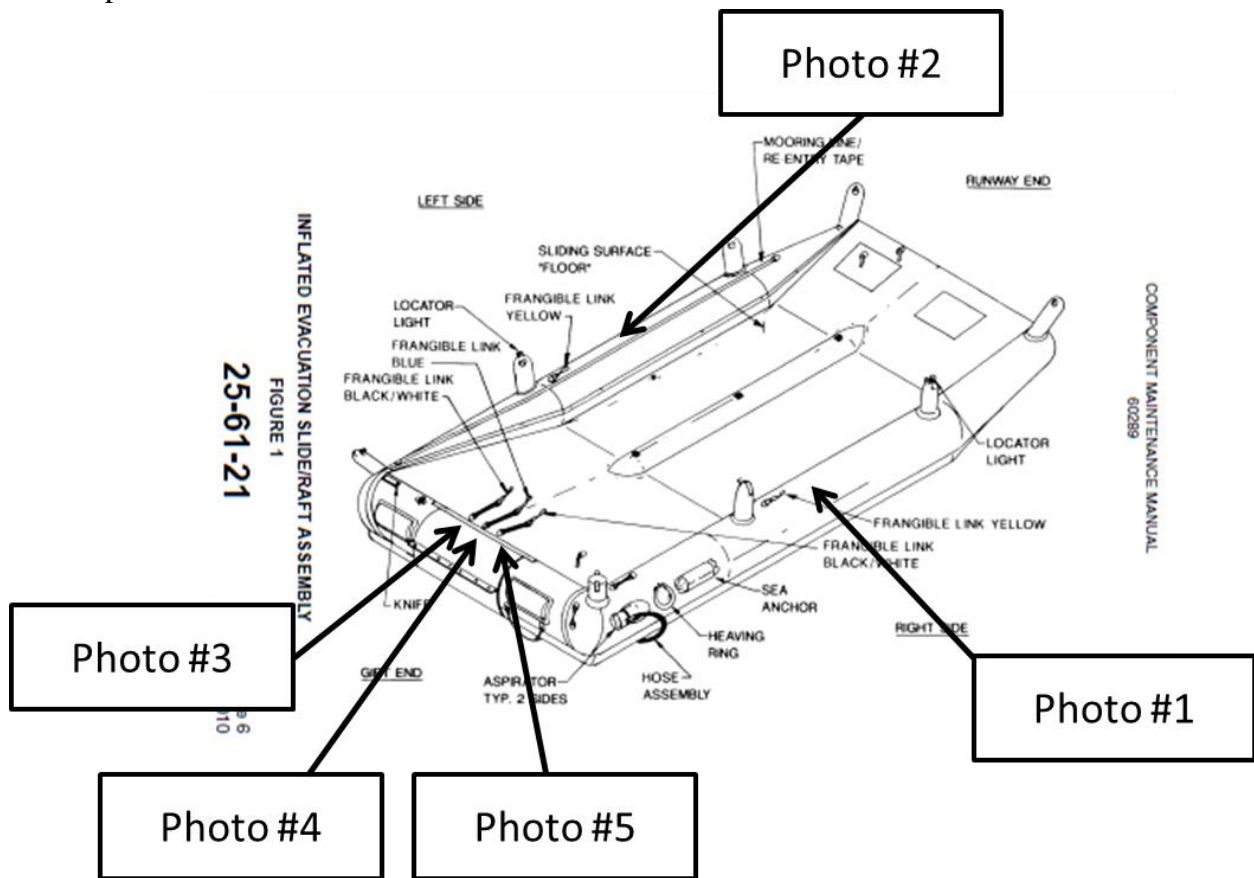
Diagram 2 - Frangible link location.

The frangible links were found separated and indicated proper color coordination per location.

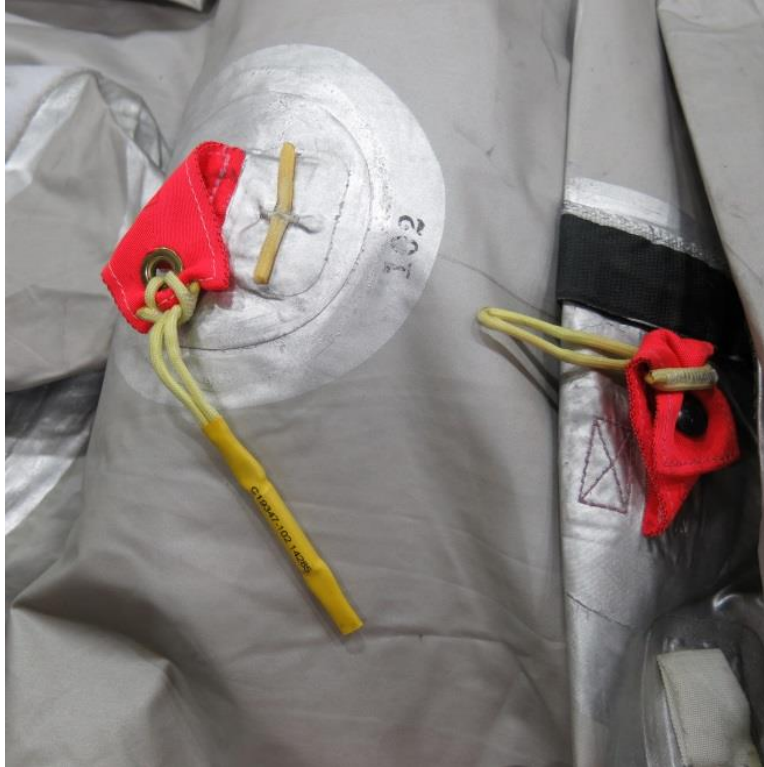
Photograph 1 - P/N C19347-102 yellow/yellow cord loops.

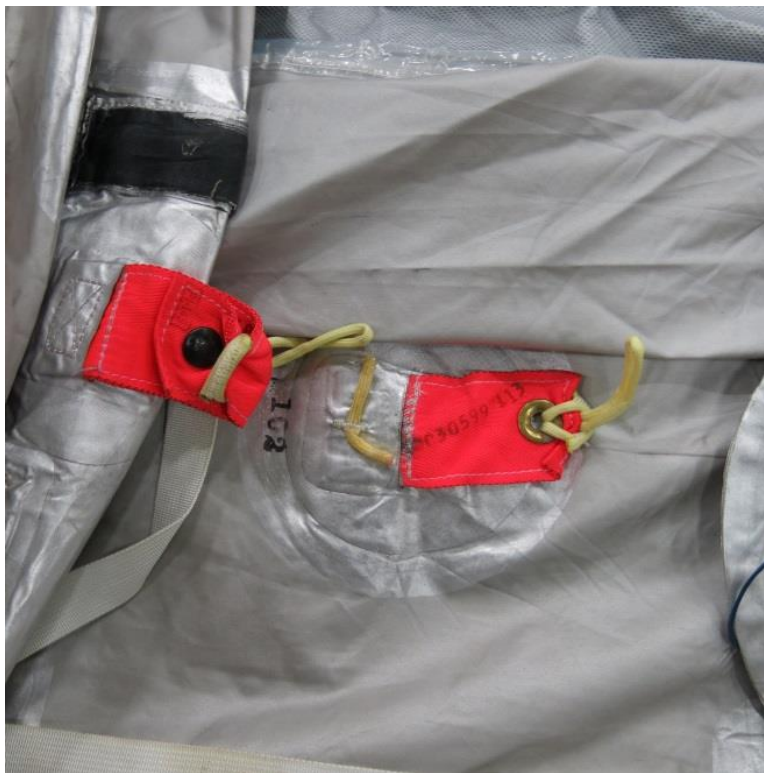
Photograph 2 - Yellow cord loops only.

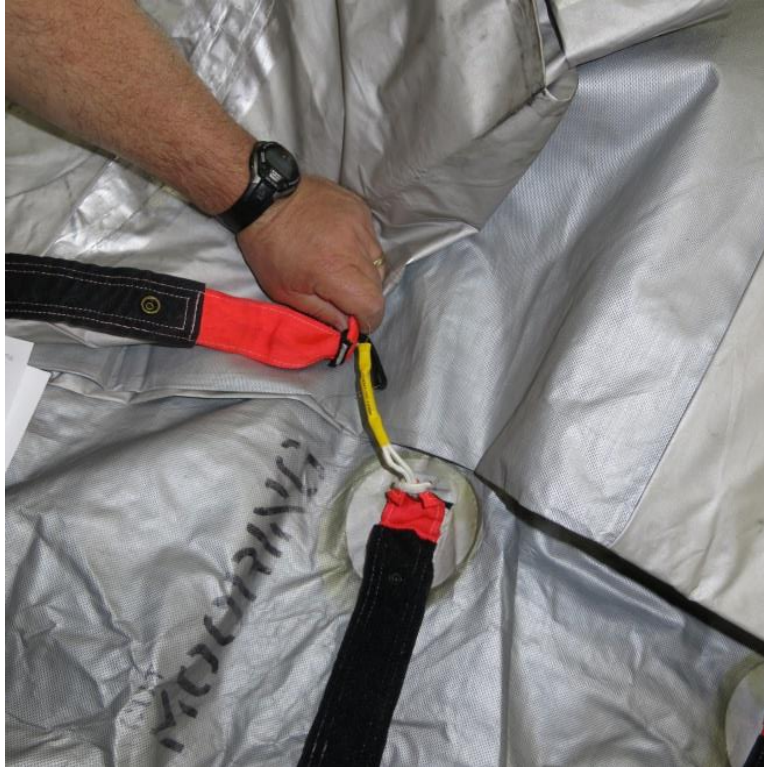
Photograph 3 - P/N C19347-107 Lot # 14358 black/white cord loops.

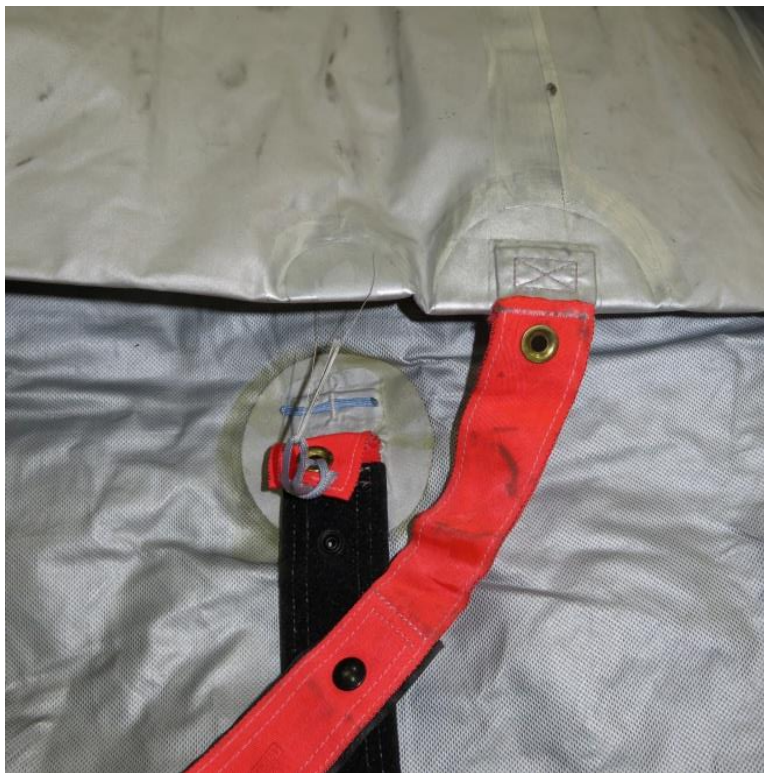
Photograph 4 - One blue cord loop.

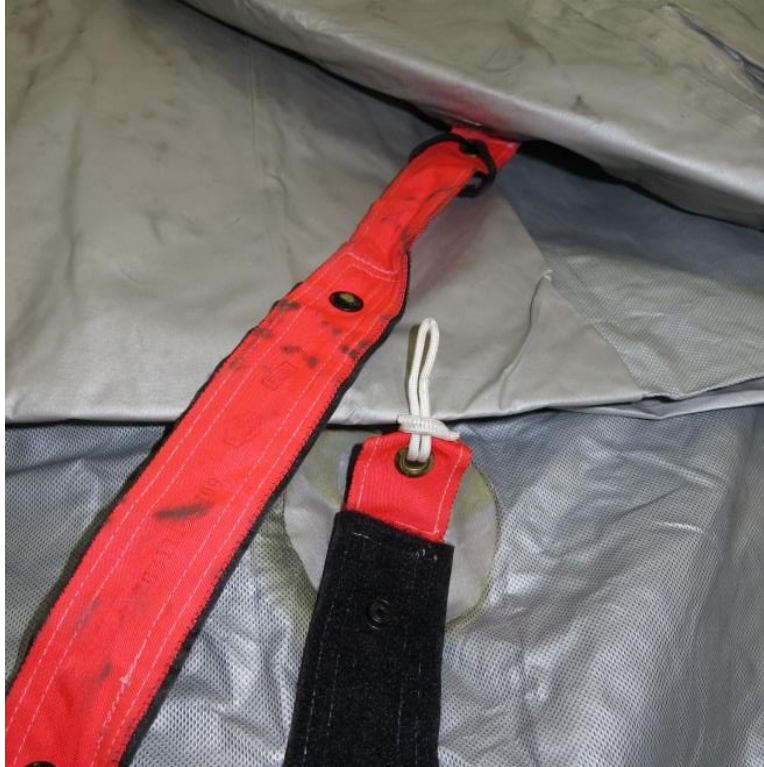
Photograph 5 -One white cord loop.

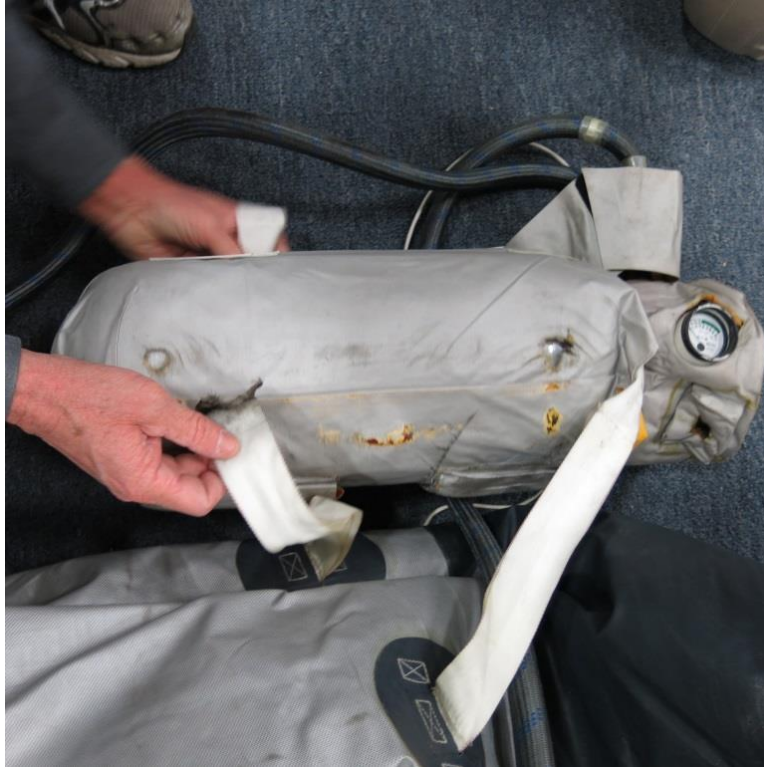
Photograph 6 - Reservoir sling sleeve.

7. Reservoir and Valve Assembly installed.
 - a. Sling webbing around sleeve – one of two torn apart.
 - b. Sling sleeve – abrasion marks, several holes torn into fabric (photograph 6).

9. Reservoir
 - a. PMA by Aethra Aviation Technologies – 635 cubic inch volume.
 - b. Carbon fiber.
 - c. Surface scuffs – match sling damage.

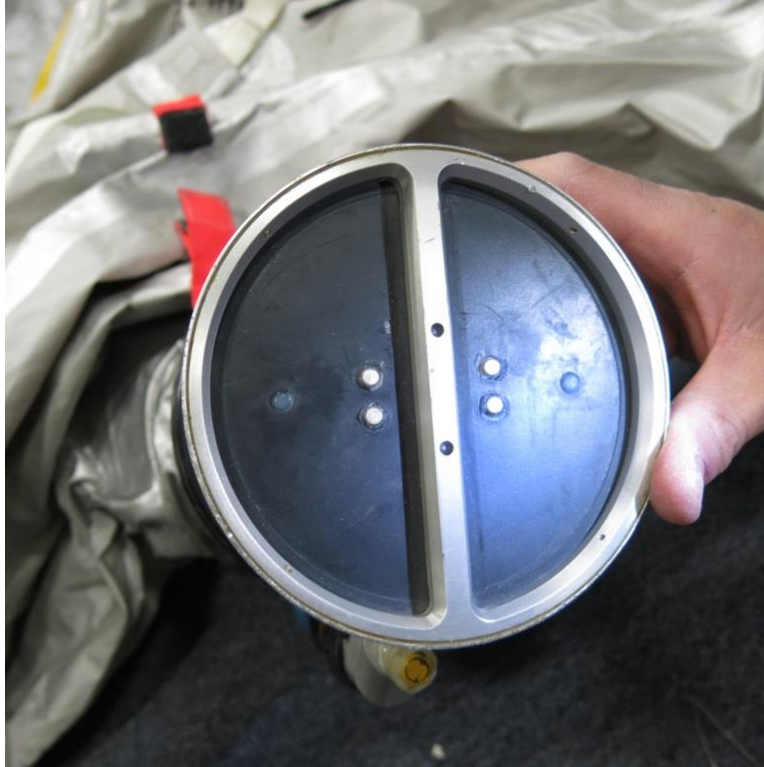
Photograph 7 - Left side aspirator.

10. Left side aspirator, (aircraft aft side) – for lower chamber of inflatable (photograph 7).

- a. P/N 61852-101 S/N C1590.
 - b. Housing P/N D17878-107.
 - c. Interior nozzle array – good condition.
 - d. Aspirator tube concentric.
 - e. Two tracks/scratches down inside of aspirator mixing tube, starting from inlet housing junction to outlet.
 - f. Inlet ring has ‘dings’.
 - g. Scuff/drag marks on inlet ring outer edge.
 - h. Elbow (tape) shows abrasion marks.
 - i. Flappers – no apparent damage.
 - i. Wired open – some wire damage noted
 - ii. Operation appears ok
 - j. Check valve flow direction correct.
11. Right side aspirator – for upper chamber of inflatable (photograph 8).

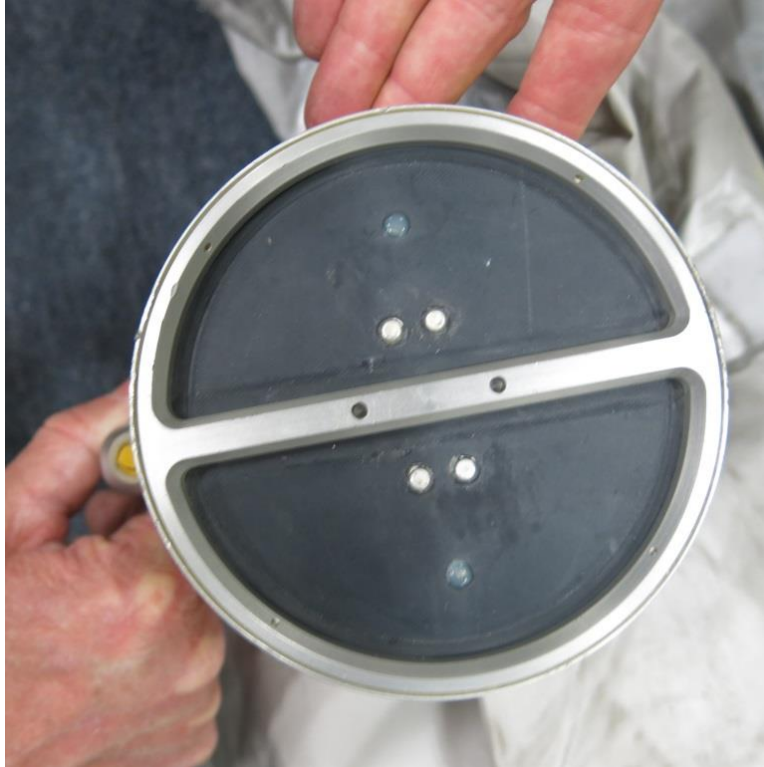
Photograph 8 - Right side aspirator.

- a. P/N 61852-101 S/N C1599 date code 524.
 - b. Interior nozzle array – good condition.
 - c. Aspirator tube concentric.
 - d. Inlet ring has ‘dings’ – not as much as the left side aspirator.
 - e. Scuff/drag marks on inlet ring outer edge – not as bad as left side aspirator.
 - f. Flappers – no apparent damage.
 - i. Wired open – some wire damage noted
 - ii. Operation appears ok
12. Pressure Relief Valves.
- a. 64154-5 Rev E 300067 on the upper tube
 - b. 64154-5 Rev E 302077 on the lower tube
 - c. Both screwed in tight
13. Power Units for slide lighting.
- a. Activation lanyard still in place on both batteries.
14. Unit partially inflated to form shape with compressed air.
- a. No apparent leaks.

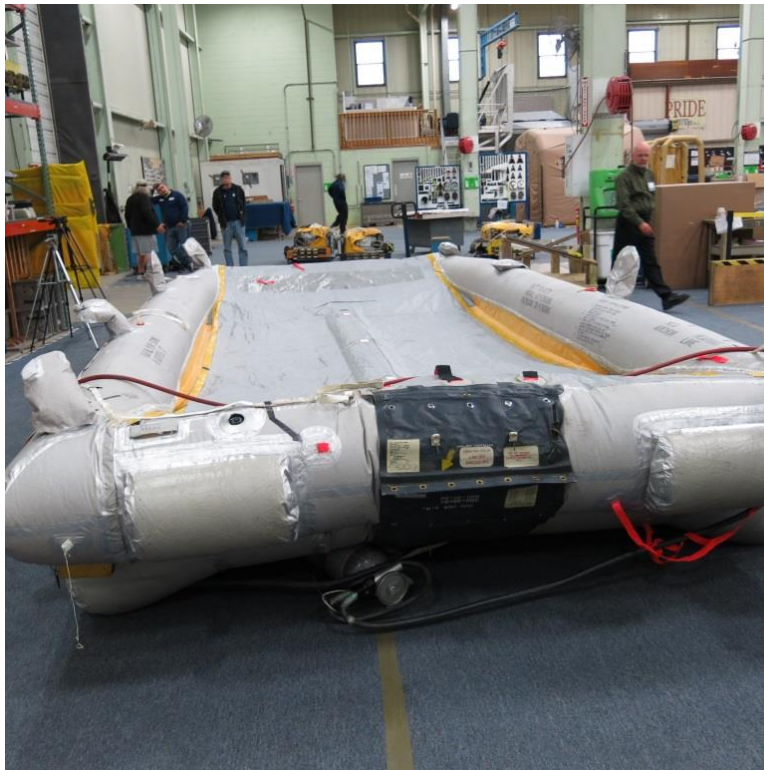
Photograph 9 -Slide/raft after flat fire test.

- b. No unusual damage found.
 - c. Lights activated upon lower chamber inflation.
 - d. Re-Entry / mooring lines not routed correctly.
 - i. Loose section in the left side middle of the inflatable
 - ii. No discoloration or marks that would indicate ingestion into aspirator
15. Reservoir and valve assembly pressurized and leak checked with leak detection fluid.
- a. Recharged per CMM.
 - b. no leakage found.
16. Reservoir and valve assembly reinstalled and flat fire inflation performed successfully (photograph 9).
- a. 2.54 psi upper tube.
 - b. 2.43 psi lower tube.
 - c. No obvious leak detected on either chamber.

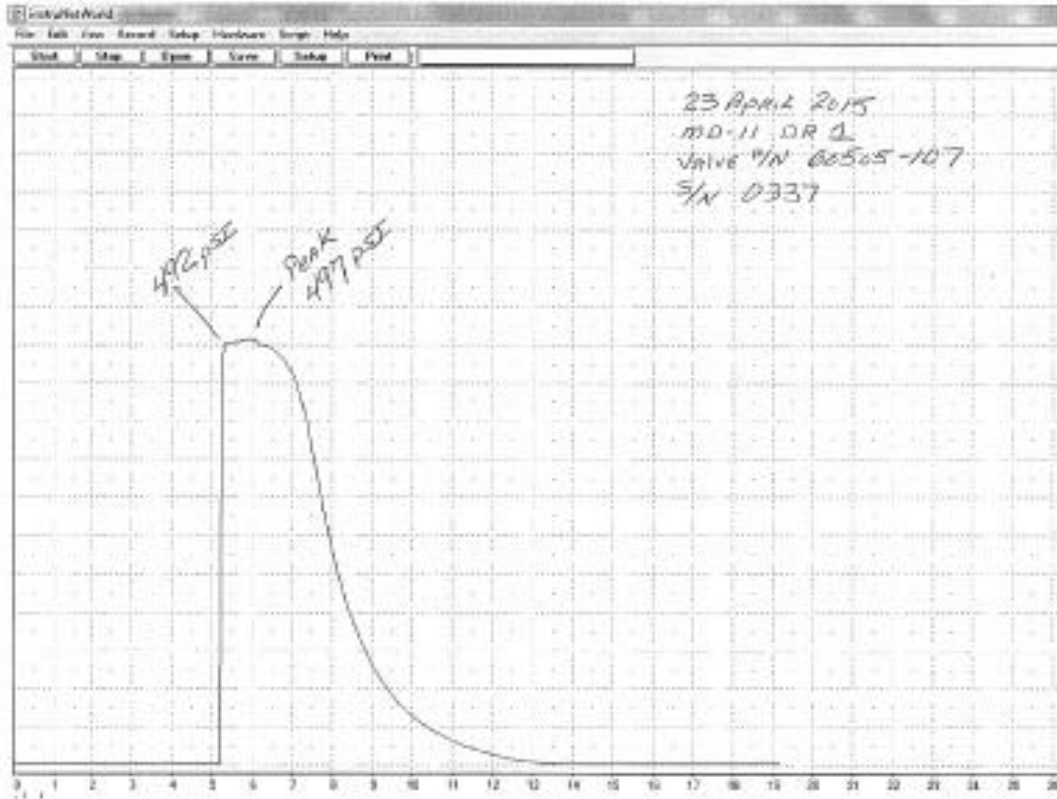
Diagram 3 - Regulator output pressure trace.

17. Valve regulator calibration check.
- a. 497 psi peak value recorded.
 - b. CMM requirement is 550 psi (+-50) (diagram 3).
