## **NATIONAL TRANSPORTATION SAFETY BOARD**

### **Group Chairman's Factual Report**

# **SURVIVAL FACTORS**

**ERA13MA139**

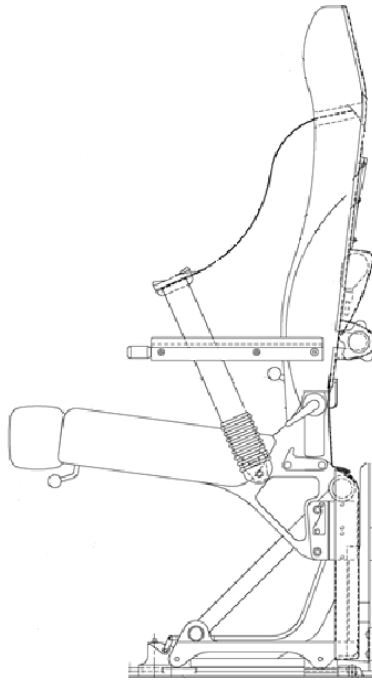
Figure 2 – Side view of the pilot seat.

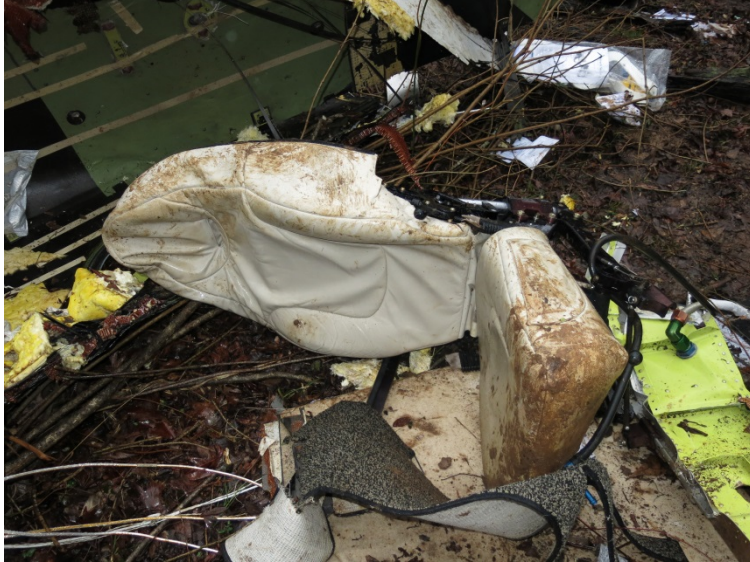
The pilot seat was found with the seatback and seat pan cushions attached to the frame. The frame was severely damaged with broken tubes in the seatback and seat bottom. The upper shoulder area of the seat was crushed forward and to the right. The seat appeared to be forcefully detached from the cockpit floor track rails with small floor track pieces attached to the seat post and was located near the remains of the cockpit (photograph 1).

Photograph 1 – Pilot seat as found at the accident site.

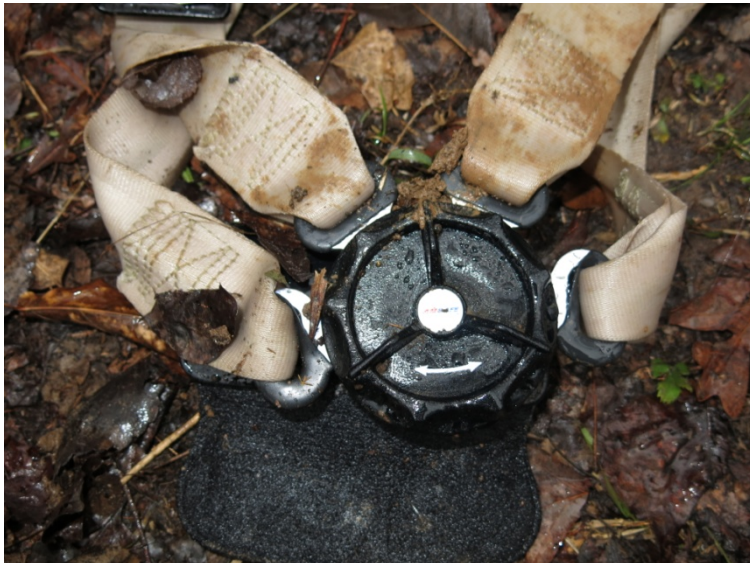
The pilot seat restraint system was manufactured by AmSafe, Inc, model 4015-1, part number 4015-1-03A. The FAA TSO number was C114. The pilot seat restraint system was a 4-point buckle system. All 4 belts were cleanly separated in a manner consistent with extrication by rescue personnel (photograph 2).

Photograph 2 – Pilot seat 4-point restraint.

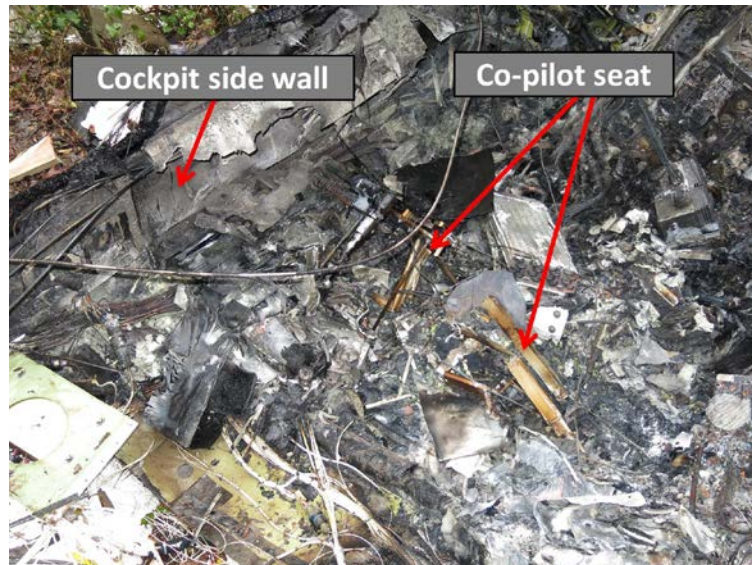
The co-pilot seat was manufactured by 4 Flight Industries, model 41001001, part number 41001001-104. The co-pilot seat was found in its original position in the cockpit. The seatback and seat pan cushions were consumed by fire. The seat frame was severely damaged with broken tubes in the seatback and seat bottom (photograph 3).

Photograph 3 – Co-pilot seat at the accident site.

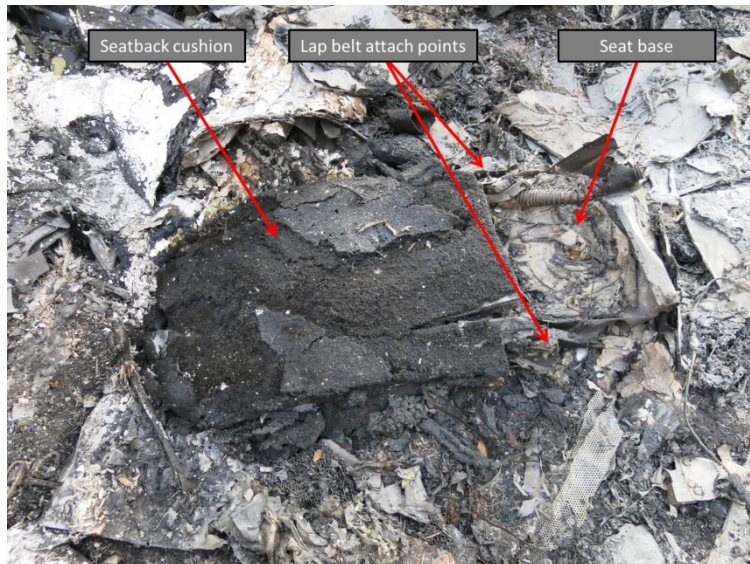
Three of the passenger cabin seats were consumed by fire with only the seat frame and partial seat cushions remaining (photograph 5). All six passenger cabin seats were severely damaged with broken tubes in the seatback and seat bottom

Photograph 5 – Passenger cabin seat consumed by fire.

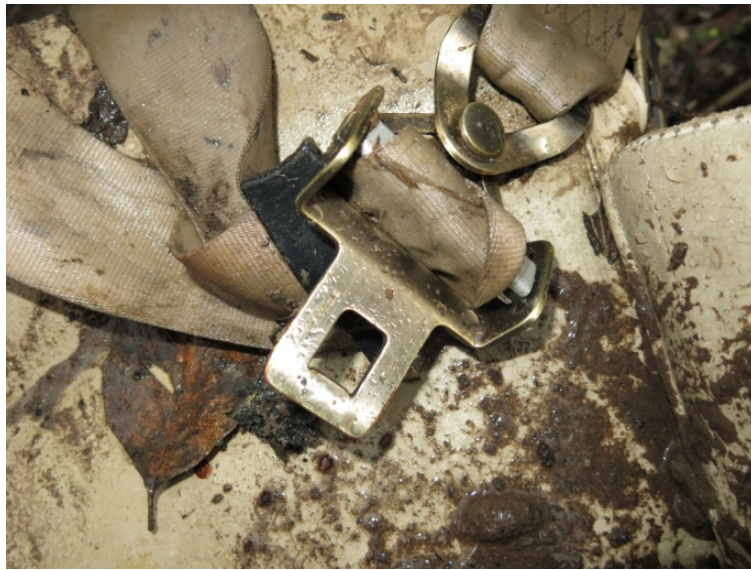
All 6 passenger seat restraint systems were found attached to their respective seat frames. For each of the 6 lap belts, the female portion of the buckle was found unattached to the male portion of the buckle. Three of the seats had belt webbing uncut. The other three seat restraints were consumed by fire. One of the 6 shoulder harness was found attached to the lap portion of the female buckle (photograph 6). The other 5 shoulder harnesses were found retracted in the seatback frame. None of the passenger seat buckles showed damage to the female or male portions.

Photograph 6 – Shoulder harness attach point.

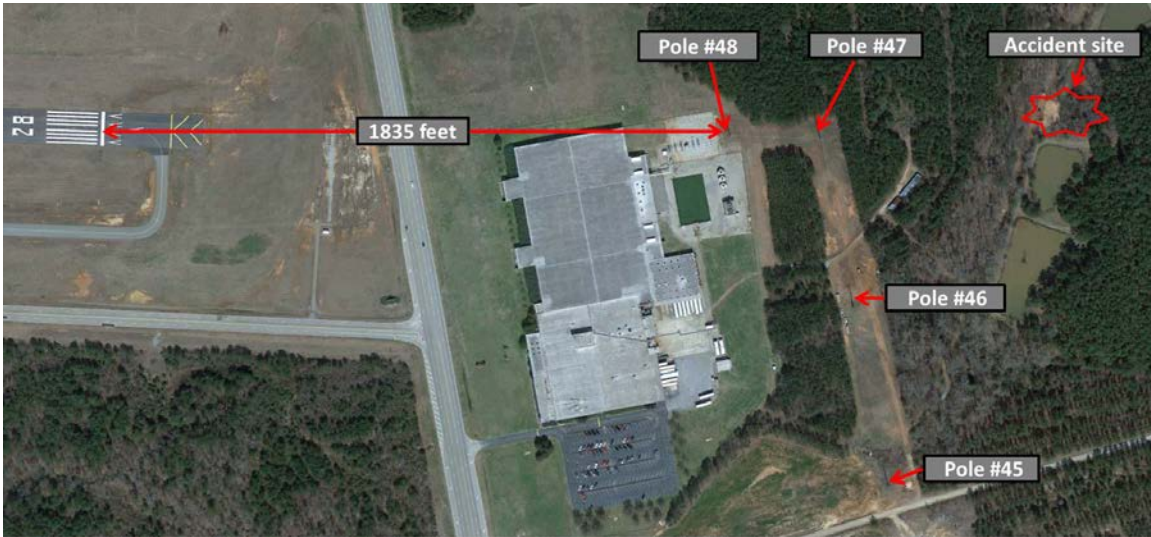
During the accident sequence, the airplane struck a concrete electrical transmission pole that was approximately 1835 feet from the runway 28 threshold, and 50 feet left of the extended runway centerline (pole 48, photograph 7). The pole was 72 feet above ground level, and the airplane struck the pole about 58 feet above the ground. The pole was owned and maintained by Georgia Power, a regional utility that supplied electric power to local businesses and residents. Pole 48 was erected on this location in 1989, along with similar poles and electrical transmission

Photograph 7: HQU runway 10 departure obstructions
