NATIONAL TRANSPORTATION SAFETY BOARD

SURVIVAL FACTORS

Specialist's Factual Report

ANC15MA041

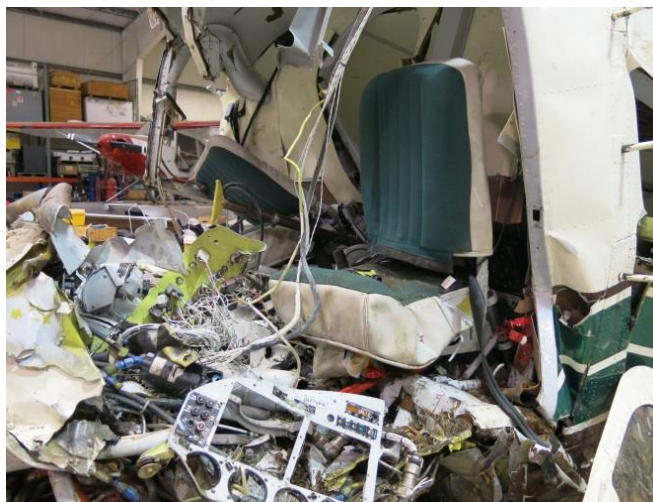
Photograph 1- Photograph of the cockpit seats during the wreckage exam.

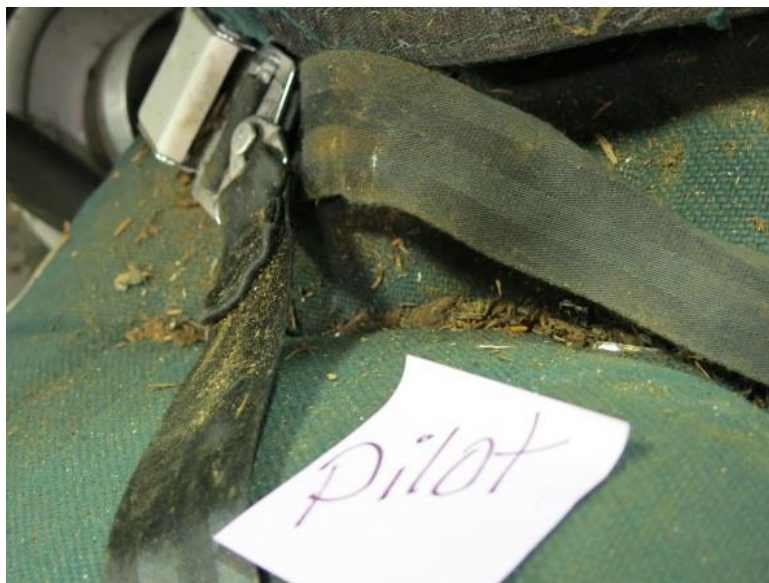
The pilot seatback was attached to the seat bottom. The seat bottom center was bent upwards. The seat bottom frame was crushed. The seat legs were bent forward. The instrument panel and cockpit floor were pushed up toward the seats.

Photograph 2- Pilot seat bottom and lap belt restraint.

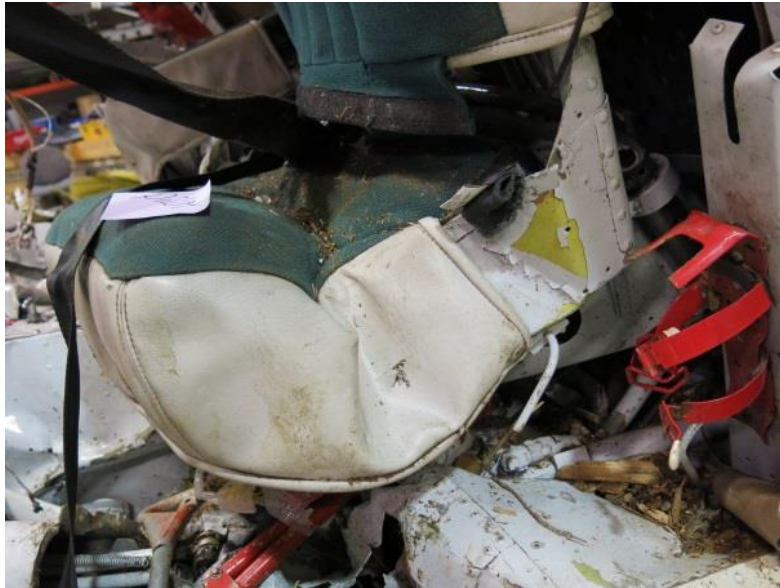
Photograph 3- Pilot seat showing deformation.

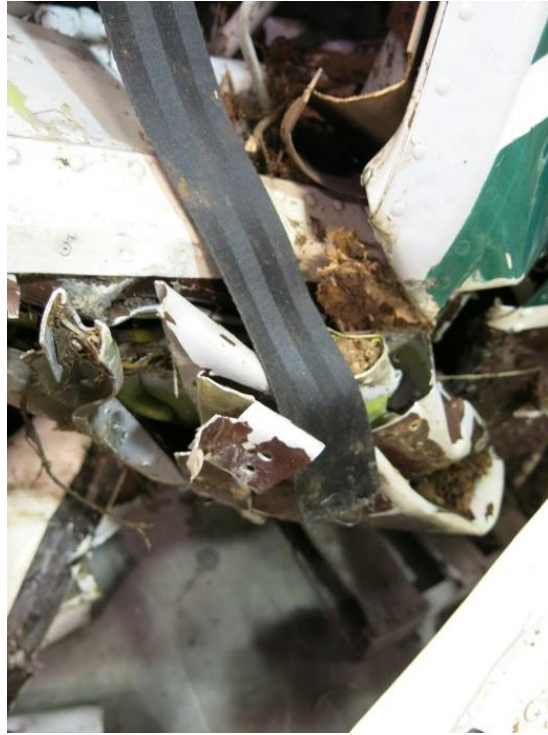
Photograph 5- Photograph of the cut seatbelt webbing at the pilot's seat.

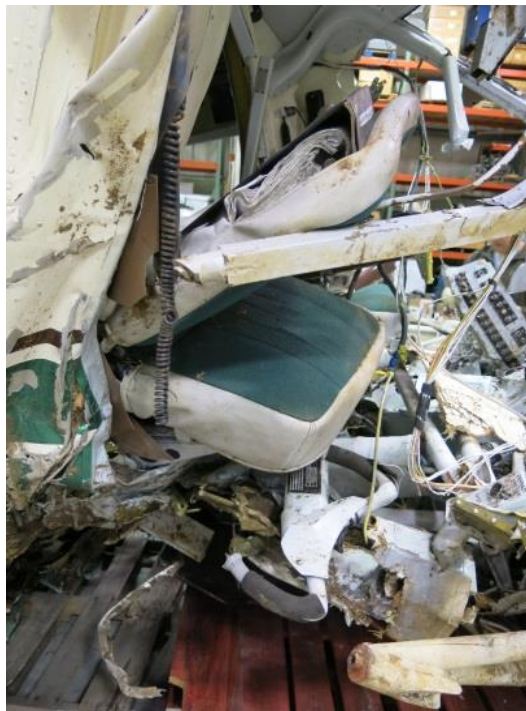
The co-pilot seatback was bent forward and not attached to the seatpan. The left side seatback fittings that connect to the seatpan were sheared off and bent to the left. The right side seatpan was slightly bent at the bottom. The seat bottom was still attached to the floor fittings. The seat bottom was bent downward toward the floor of the airplane. The steel tubes under the seat bottom were crushed.

Photograph 6- Photograph of the co-pilot seat.

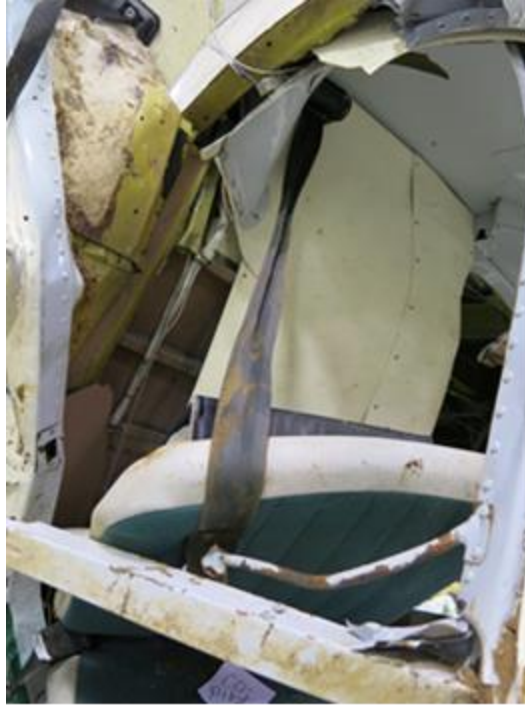
Photograph 7- Co-pilot seatback bent forward.

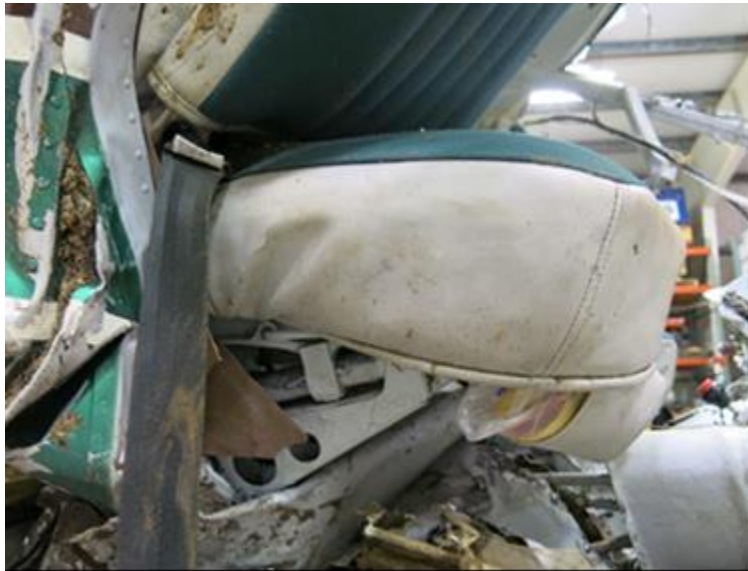
Photograph 8- Photograph of the co-pilot seat bottom.

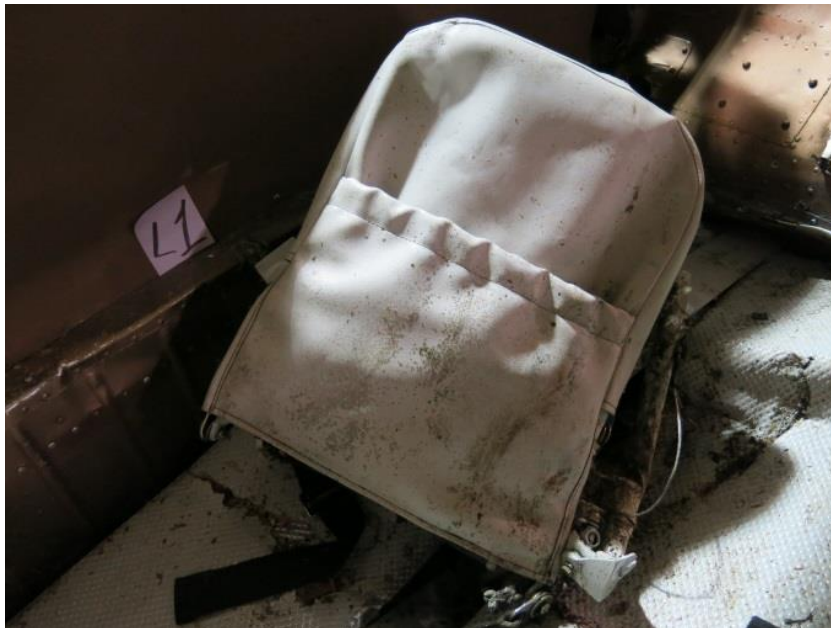
The L1 seat was inside the airplane. The seatback was present and connected by the wired cables. The wired cables were connected to both sides of the seatback. The seatback was not connected to the seatpan. The aft seatpan tube was broken from the side tubes. The tubes were held together by fabric. The right side seatpan was bent downwards. The left seatpan tube was broken. The forward left seat tube was connected to the fuselage. The floor area was bent downward under the airplane floor. The seat legs were attached to the floor fittings but pinned under the airplane flooring. The restraints attached to the seatback on both sides. The restraint fitting attachment points were broken on the right side and missing on the left. The restraints were unbuckled. The restraints were operable. The latchplate webbing was labeled with Belt Makers, Inc. in Torrance, California. The latchplate was not bent, deformed, or scarred. The information on the label was:

Photograph 9- L1 seatback.

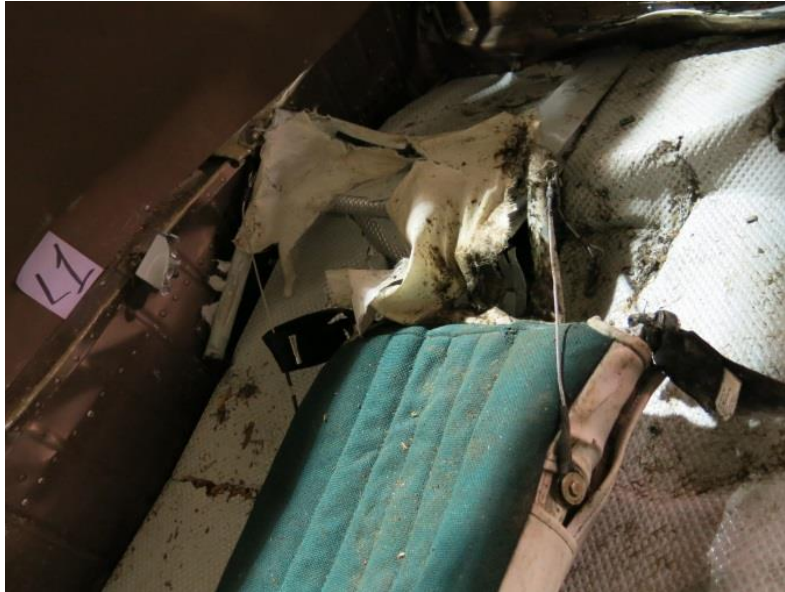
Photograph 10- Photograph of L1 seat bottom and deformation of the floor.

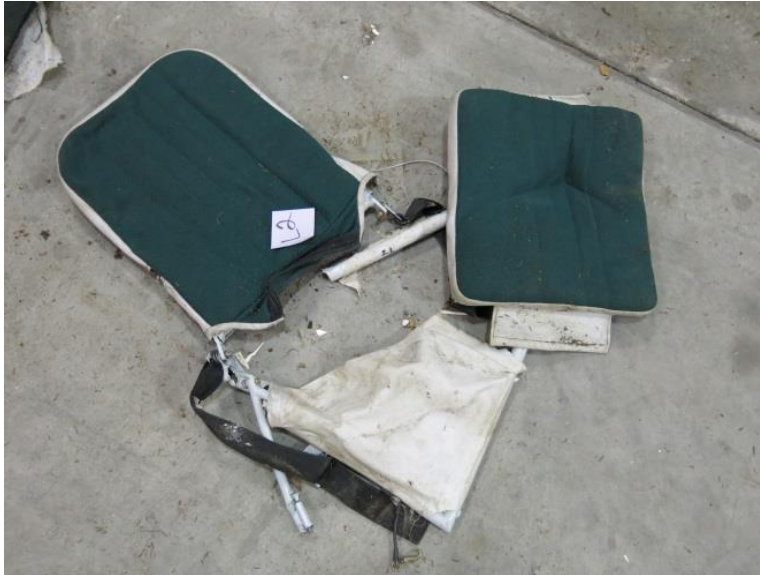
Parts of the L2 seat were found outside the airplane. The seat bottom cushion was marked “2L Bottom 270PA”. The seatpan was broken at three of the four corners. The front right was intact. It was held together by fabric. The seat legs were broken. The pin was attached to the aft seat leg. The seat leg cross tube was sheared in 2 pieces. The seatpan was broken from the fittings in the fuselage. The seatback was intact and not bent. The right lower side was attached to a portion of the seatpan. The left side was broken from the seatpan. The seatbelt was still attached.

Photograph 11- Portions of the L2 seat components.

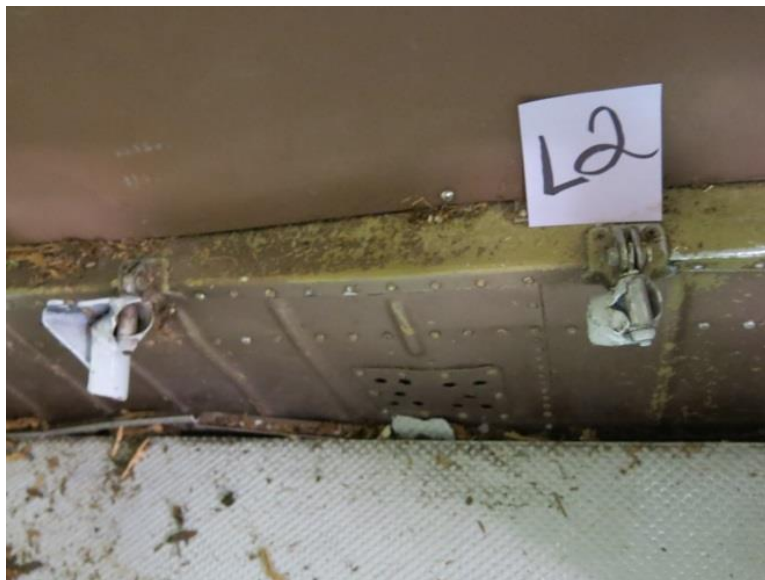
The L2 seat was not present inside the airplane. The fittings were attached to the fuselage wall. The seatpan had been broken off completely and missing. The L2 floor fittings attachment holes were deformed.

Photograph 12- Sheared L2 attachment points on the side of the fuselage.

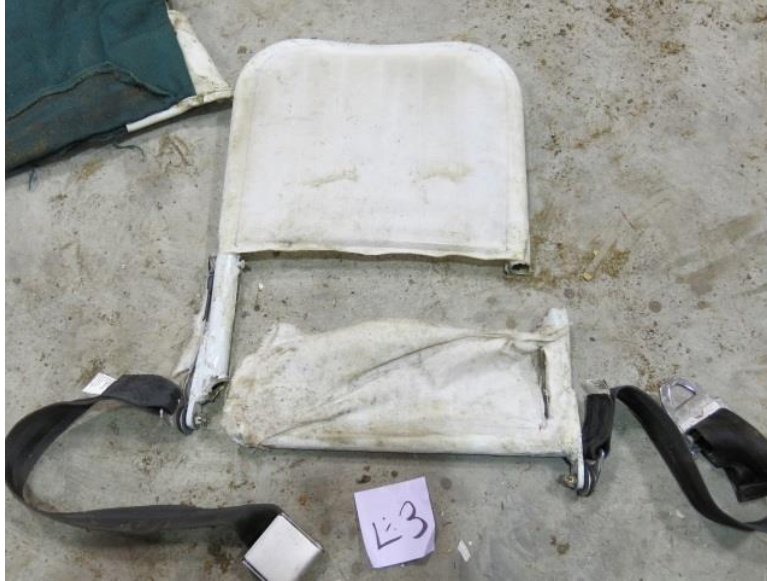
The L3 seatback cushion was found removed from the seatback frame in the aft of the airplane. The restraints were connected to the seatback. The seatback was broken in 2 parts. The bottom piece was broken from the top. The left buckle restraint was attached to the seatback portion. The bottom piece had the right latchplate restraint attached.

Photograph 13- L3 seatback and restraints.

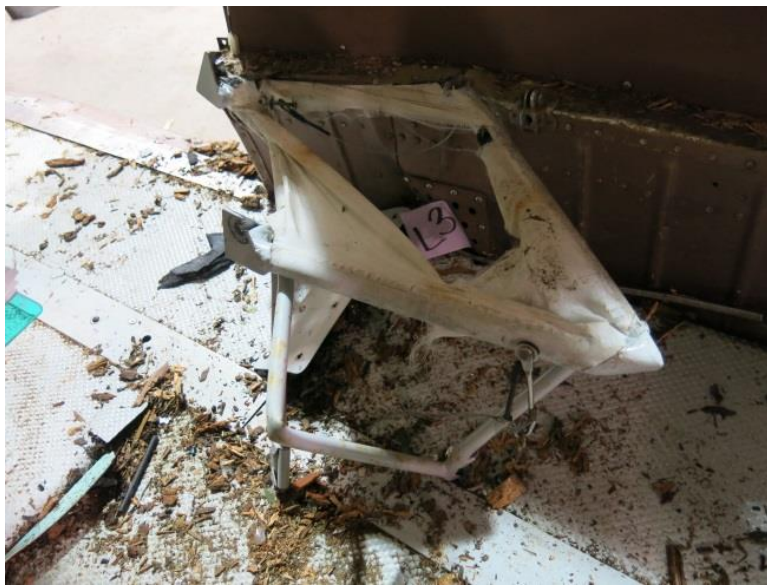
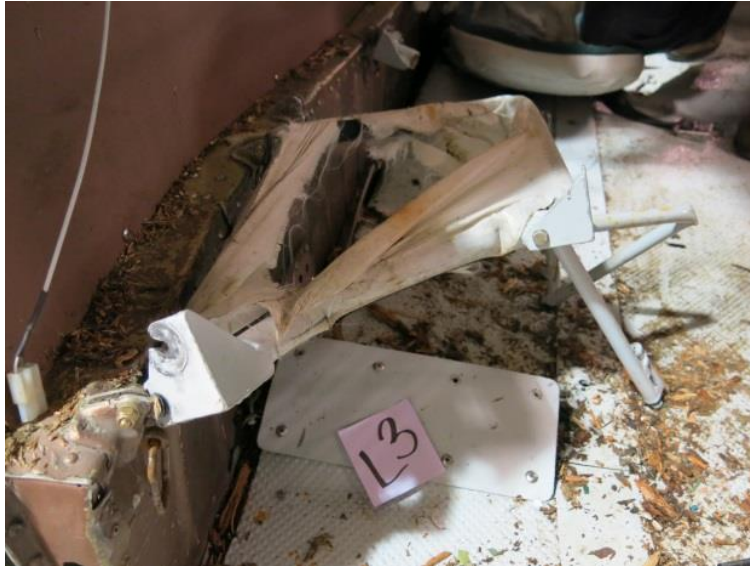
The L3 seatpan and the legs were inside the airplane. The seatback was missing. The seatpan attached to the side fuselage. The seatpan was bent forward in a 45-degree angle. The aft leg pin was attached to the aft seat leg. The pin was missing from the forward. The floor area was bent upward. The seatback attachment holes were broken. The seat leg cross tube was bent outward. The seatpan fabric had been ripped. The wired cable was attached to the seatpan but not attached to the seatback. The seatpan could be folded upward adjacent to the fuselage wall. There was no restraint present. The restraint attachment points were broken.

Photograph 14- L3 seat bottom.

Photograph 15- L3 Seat bottom and seat legs.

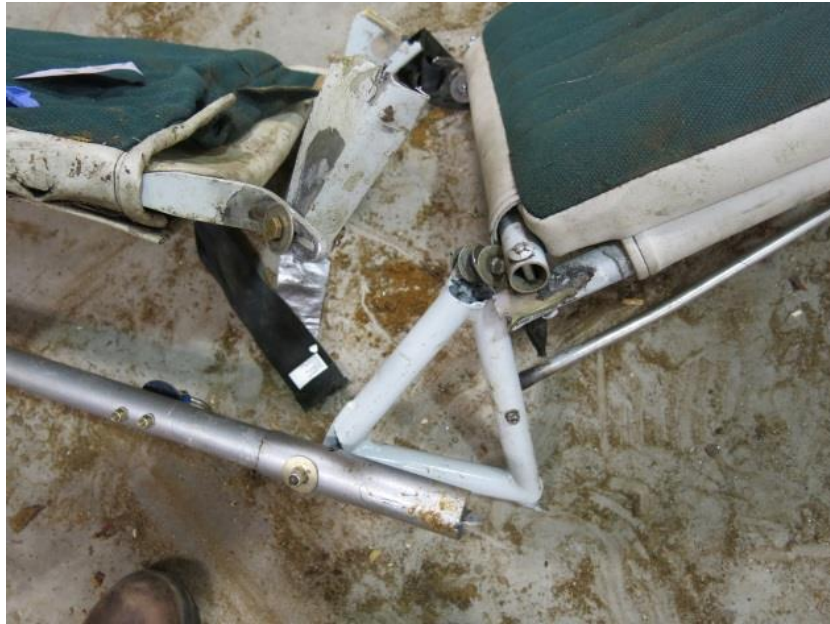
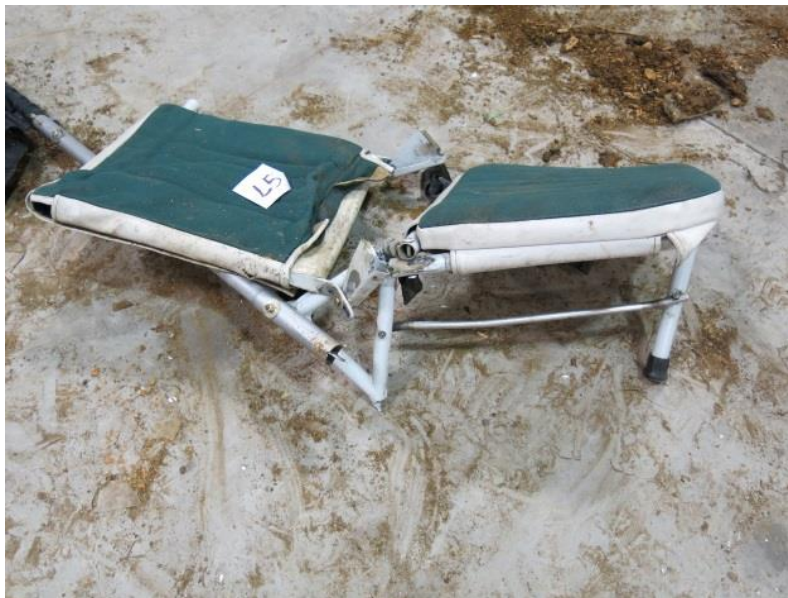
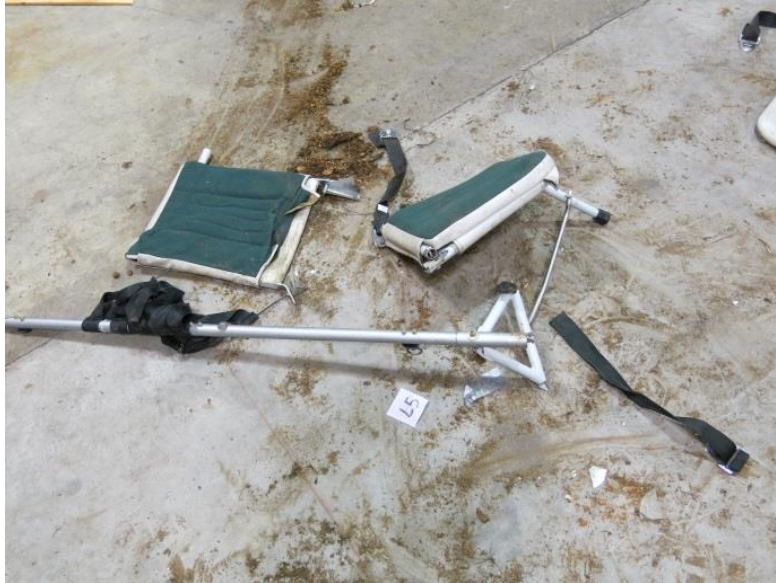
The L5 seat was found outside of the airplane. The center pole was intact and the cargo netting was still attached. The triangular support was bent and twisted. The seat legs were bent. The lower two back seatback fittings points broken. One seatback fitting was attached to the fuselage wall and broken. No wired cables were present. The ceiling fitting hole was deformed.

Photograph 16- Photograph showing L5 seat deformation.

Photograph 17- L5 seatback and seat bottom.

Photograph 18- L5 seatback and bottom with the connecting pole.

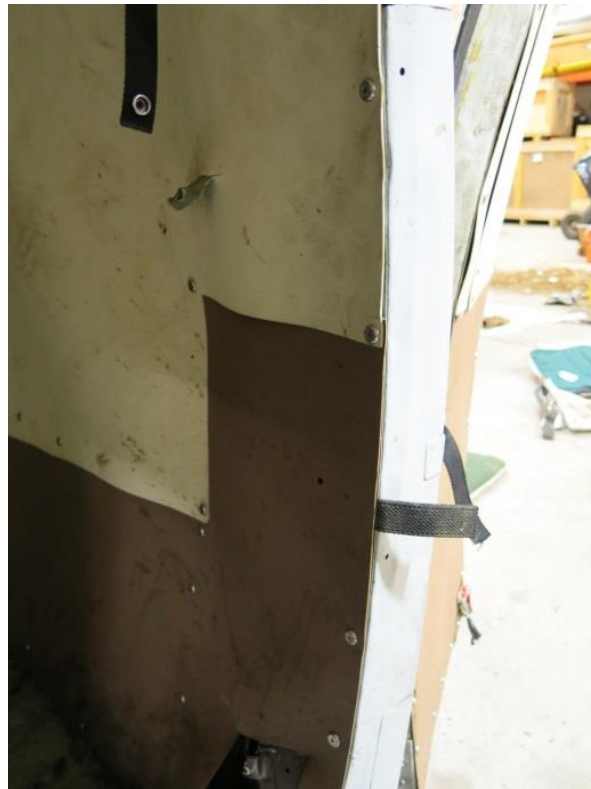
Photograph 19- Photograph of the sheared L5 seat side attachment point.

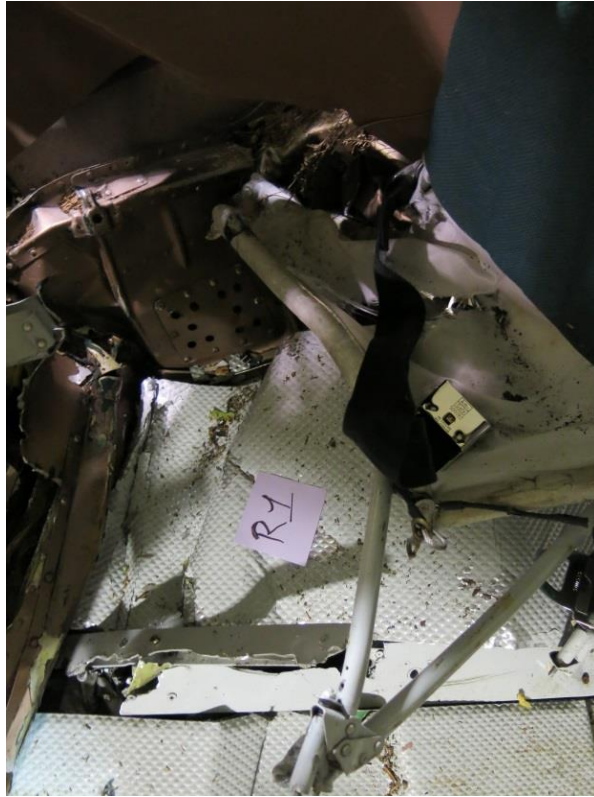
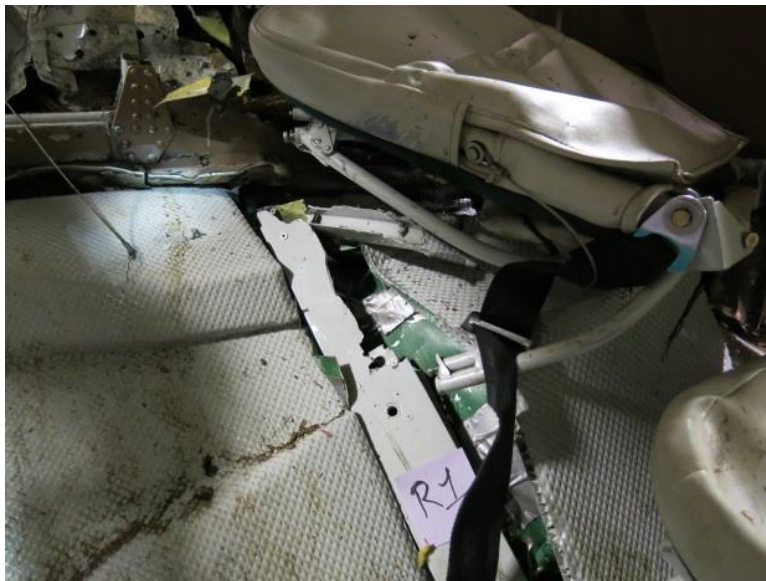
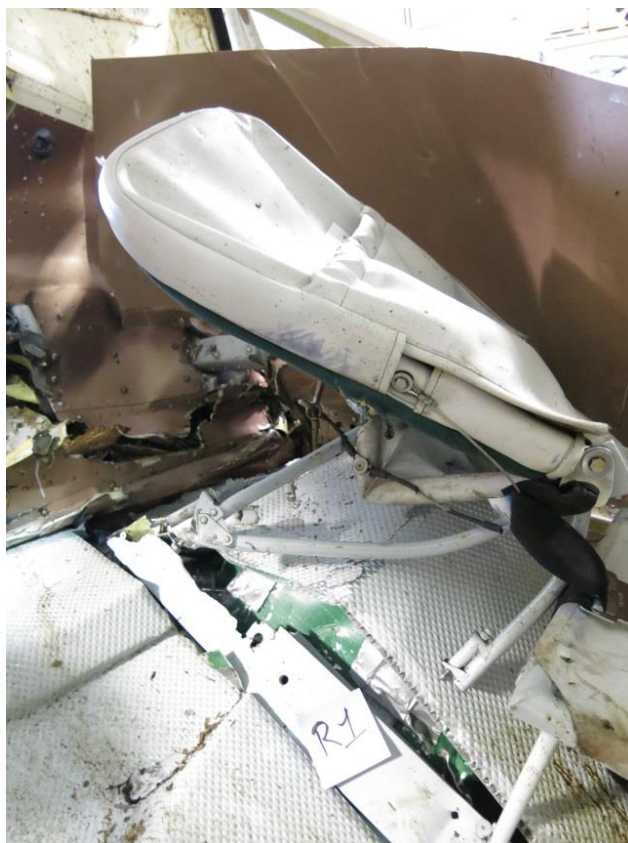
The seat was present. The seatpan cushion was missing. The seatpan was buckled on the left. The seatpan was broken on the right side. It was not attached to the floor fittings. The floor was buckled upward. The seatbelt was attached to the left and right side. It was unbuckled. The buckle was operable. The seat legs were broken. The seat legs were broken from the floor fittings. The seat legs were bent. The seatpan was bent upward and to the right. The right aft seatpan attached to the fuselage. The fuselage wall lining was bent outward. The pin that attached the seat legs to the floor was attached to both the forward and aft legs. A wire braided cable was attached from the seatpan to the seatback on both sides. Seatback folded forward.

Photograph 20- *Photograph of R1 floor deformation and seat legs.*

Photograph 21- *Photograph of R1 floor deformation and seatback and seat legs.*

Photograph 22- Photograph showing R1 floor deformation, seatback, and seat legs.

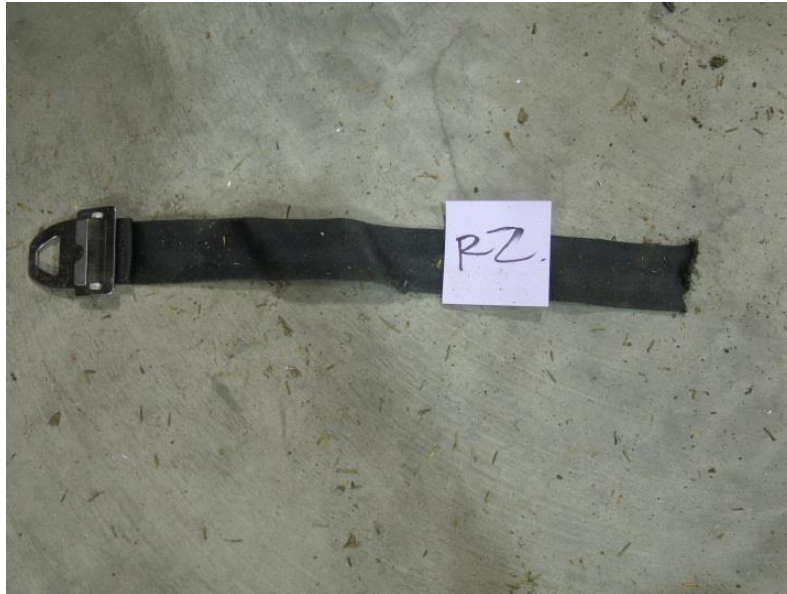
Half of the R2 restraint (latchplate restraint) was found in the aft of the airplane. The webbing was cut. The latchplate was not bent, deformed, or scarred.

Photograph 23- R2 seat latchplate restraint. The restraint had been cut.

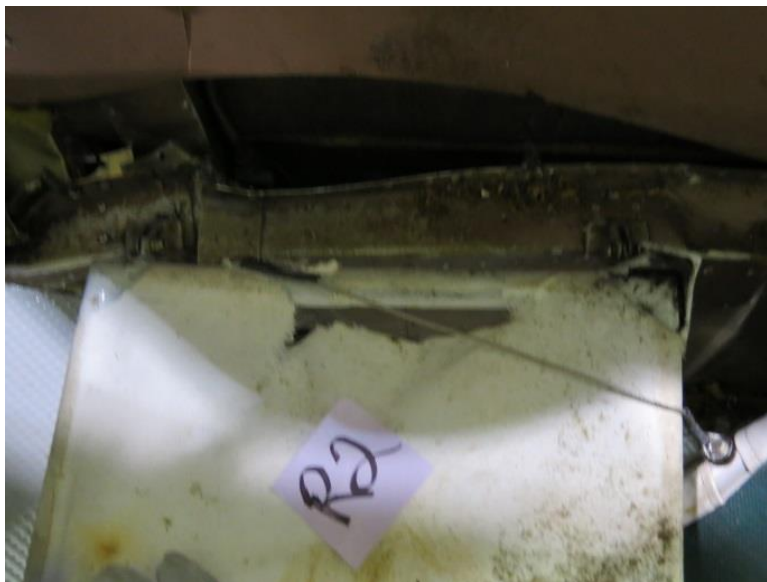
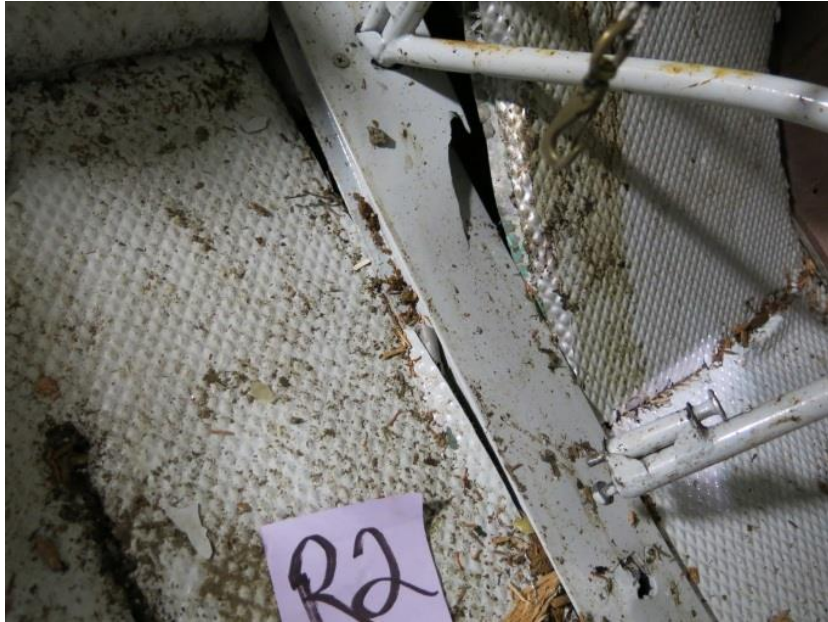
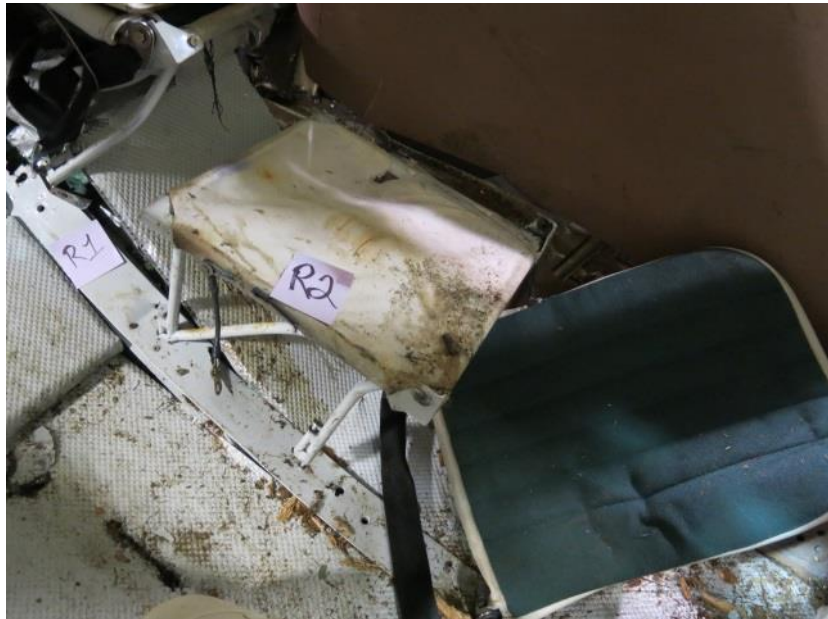
The seat was present inside the airplane. The seatback was not attached to the seatpan. The wired cable was attached from the seatpan to the seat on the right side back holding it together. The wired cable was attached to the seatpan on the left side however was not attached to the seatback. The front seat leg was attached to the fittings. The aft seat leg was not attached to the fittings. The hole in the floor for the fitting was broken. The seat pins moved upward and were operable. The back seat leg bent forward. The seat leg cross tube was bent upward. The seatpan was not bent. The fittings on both sides where the seatback attaches were broken. It was also broken where the restraints attach. The right side seatpan was attached to the fuselage. The restraints were connected to the seatback. The buckle restraint was attached to the bottom seatback. The floor area was bent upward. The seat legs were buckled upward with a 3-inch tear in the middle section of the seats.

Photograph 24- R2 seatpan.

Photograph 25- Photograph of R2 seat legs and floor deformation.

Photograph 26- R2 seatpan and seatback.

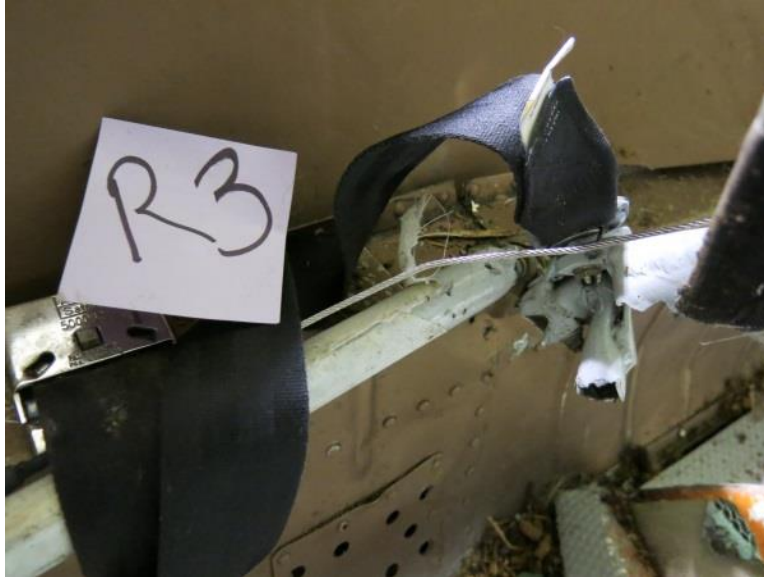
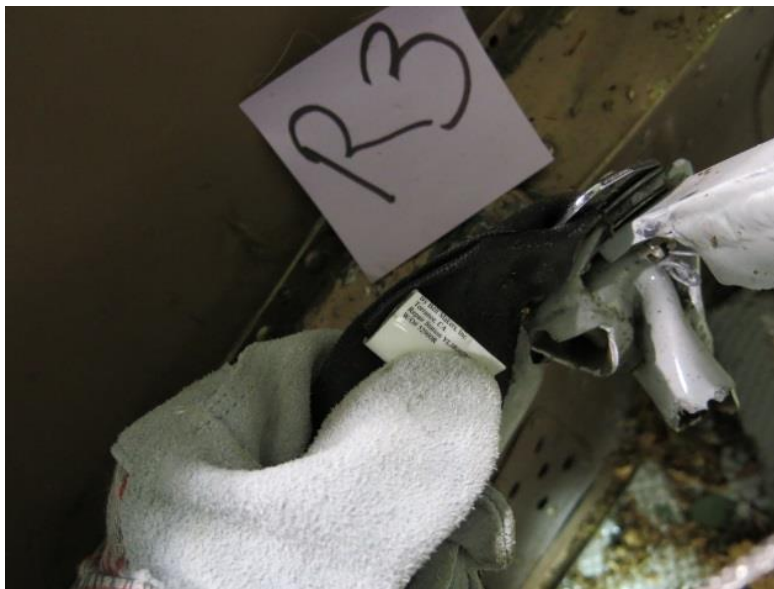
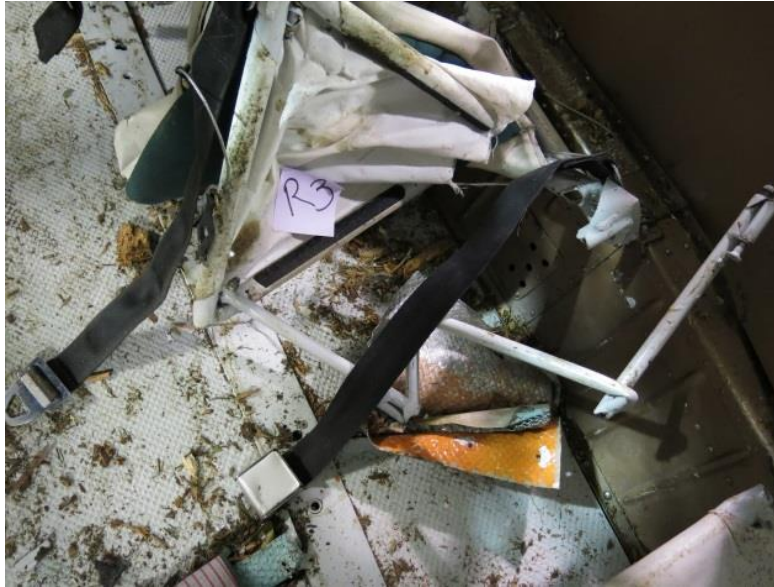
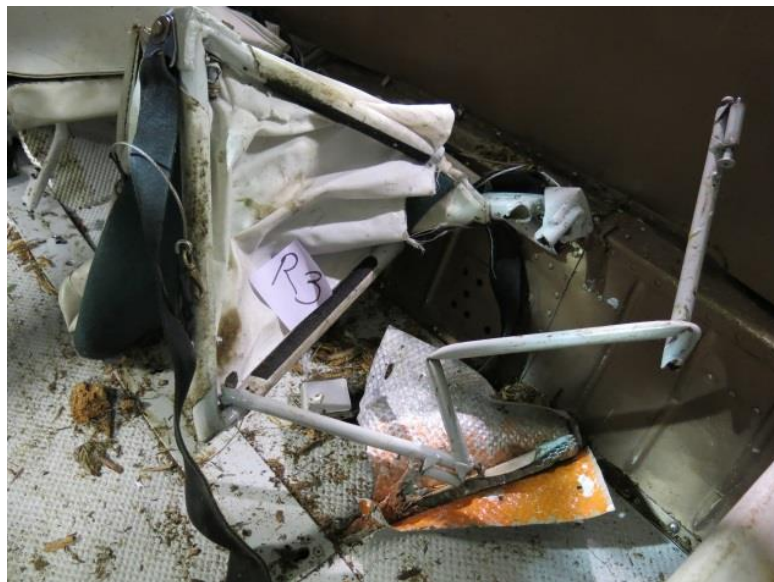
broken at the connection to the seatpan. The seatback was bent aft. The forward seatpan tube was broken at the fuselage attachment. The fuselage fittings were still attached to fuselage. The wire cables were attached to the right part of the seatpan tube and the seatback. The wired cables were also attached to the left side seatpan and seatback. The floor area at R3 was buckled upward. The aft corner tubes of the seatpan were broken. The seatpan was attached to the fuselage. The forward and aft seatpan was broken at the corners.

Photograph 27- Photograph of sheared R3 seatpan tube and restraint.

Photograph 28 - R3 seatpan tube.

Photograph 29- Photograph of deformed R3 seat components and seat restraints.

Photograph 30 - Photograph of deformed R3 seat.

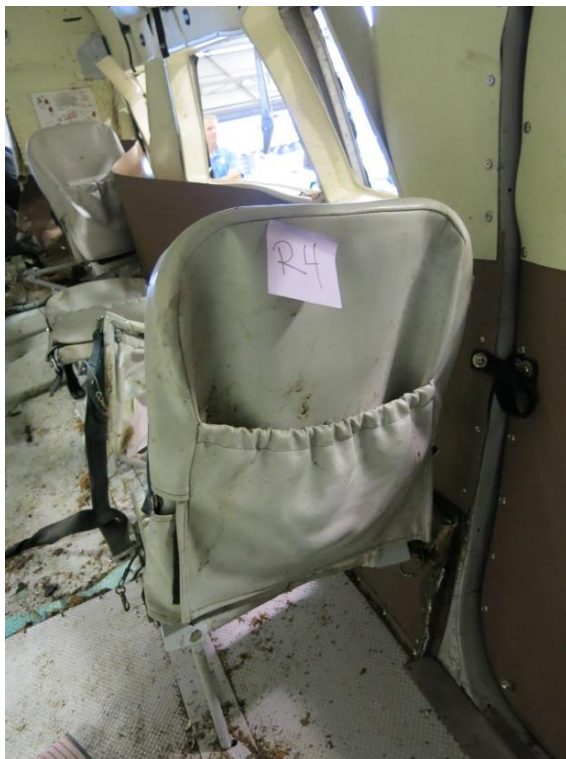
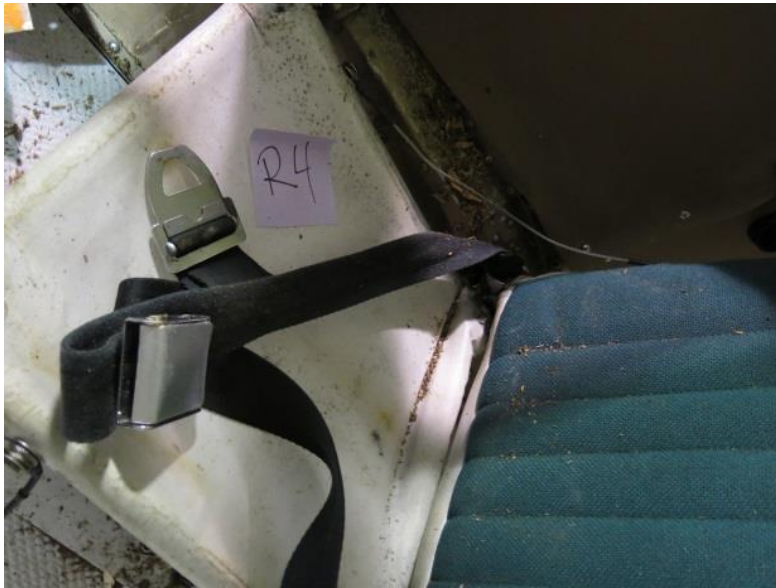
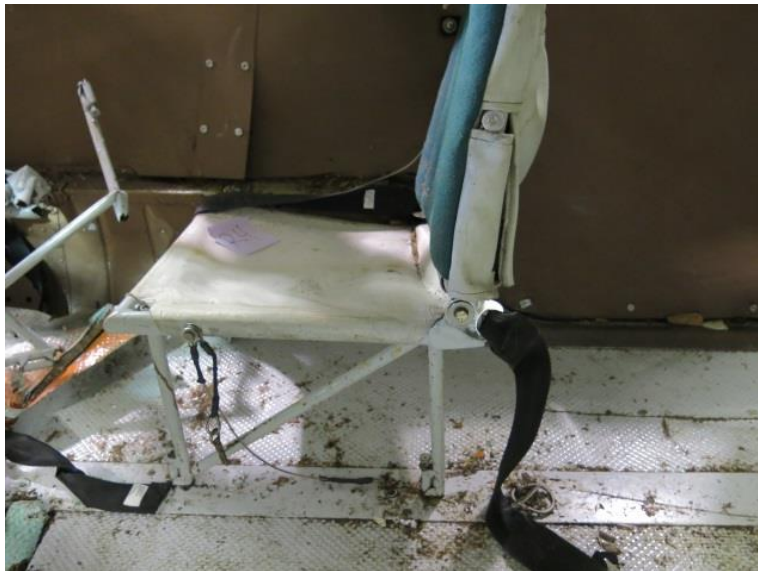
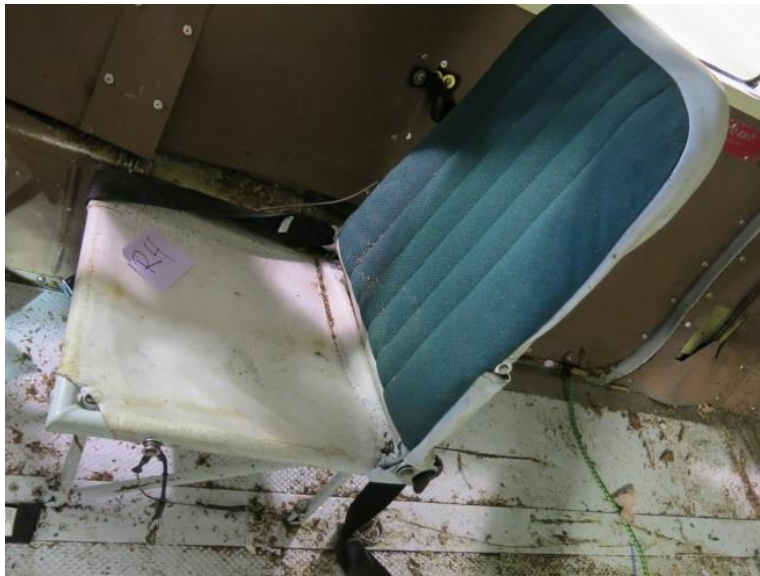
The seat was present inside the airplane. It was attached to the floor fittings. The seat bottom cushion was missing. The seat legs appeared to be undamaged. The back right seatpan was attached to the fuselage wall. The fuselage wall was bent inward. The back seatpan rod was bent slightly. The floor area surround R4 was relatively flat, not deformed. The wire cable from the seatpan to the seatback was attached on both sides. The seatback folded forward. The leg pins were attached to the floor fittings. They did not move to unlock.

Photograph 31- R4 seatback.

Photograph 32 - R4 seatpan, seatback, and restraints.

Photograph 33- Photograph of R4 seat components.

Photograph 34 - R4 seat.

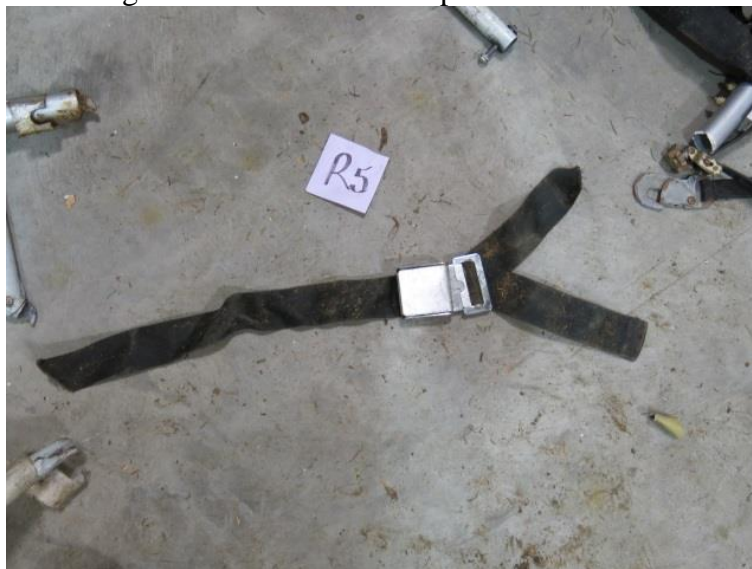
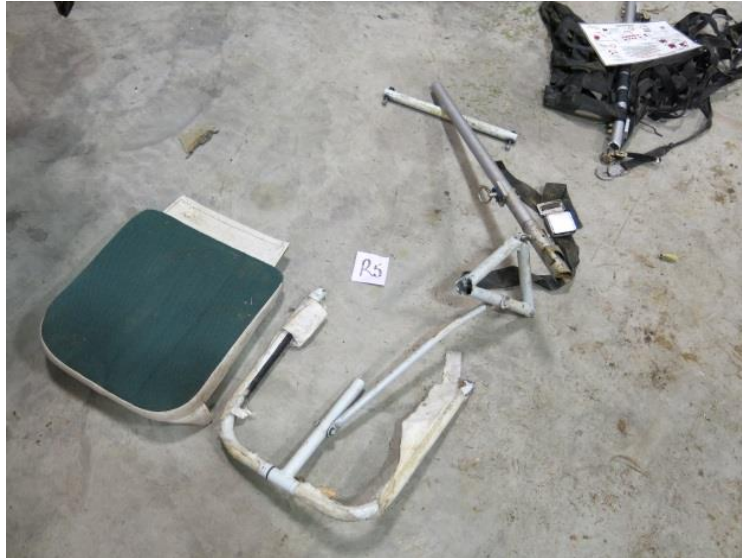
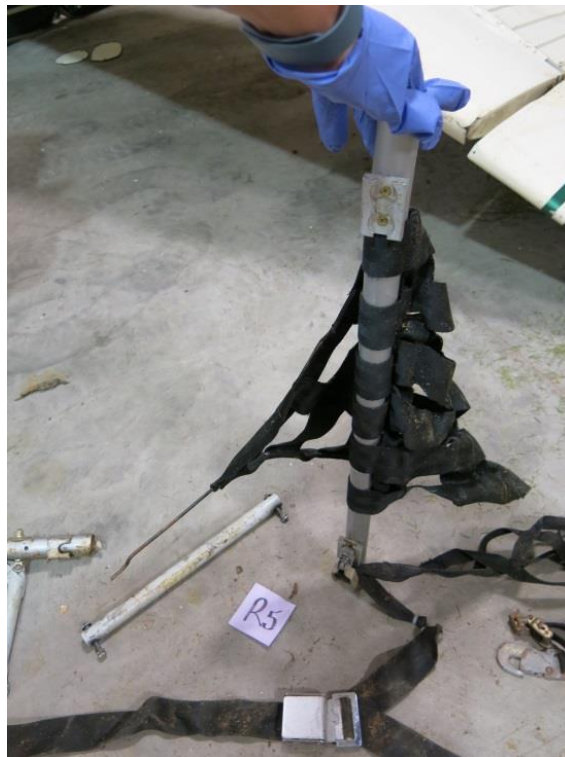
The R5 seat was found outside of the airplane. The center pole that connected to the floor fitting and the center ceiling was broken in half. The left seatpan was bent upward. The triangular support floor fitting was twisted to the right. The seat cushion was present. The seatback was missing. The cargo netting was still attached to the pole. The restraints were found cut on both sides but still buckled together and operable. There were no labels present. The cuts to the restraints were made prior to where the labels would have been affixed. The aft tube was missing that would have held the restraint fittings. The ceiling hole did not appear to be deformed in any way. There was a gash in the floor immediately in front of the R5 seat approximately 13 inches long. No wired cables were present.

Photograph 35- Photograph of the cut R5 restraint straps.

Photograph 36 - R5 seat components.

Photograph 37- R5 pole attachment.

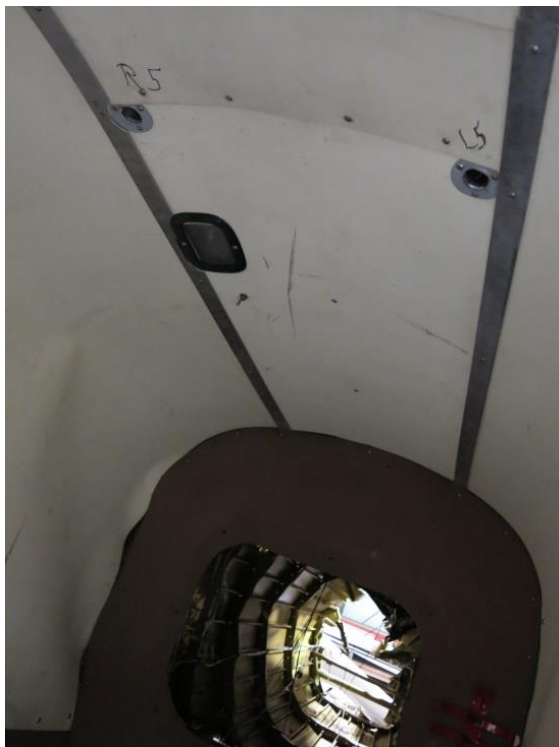
Photograph 38 –L5 and R5 ceiling attachment point.

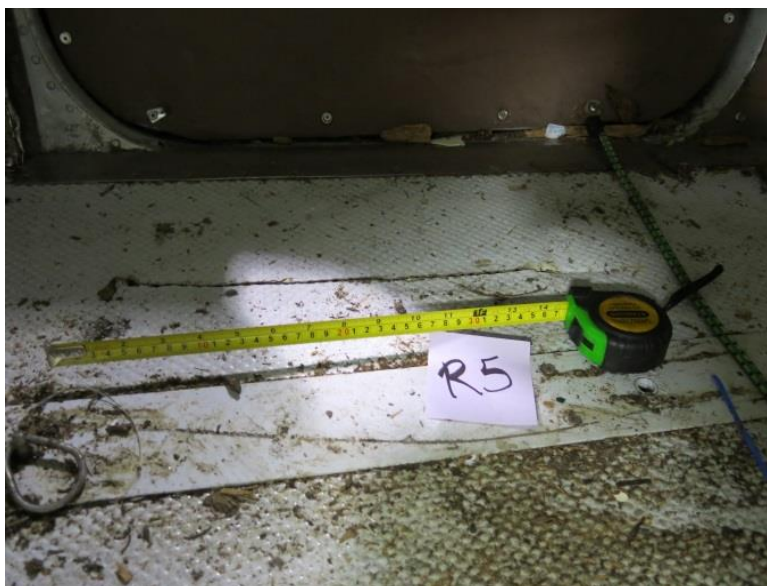
Photograph 39- Photograph of 13inch gash in the floor in front of R5 seat.

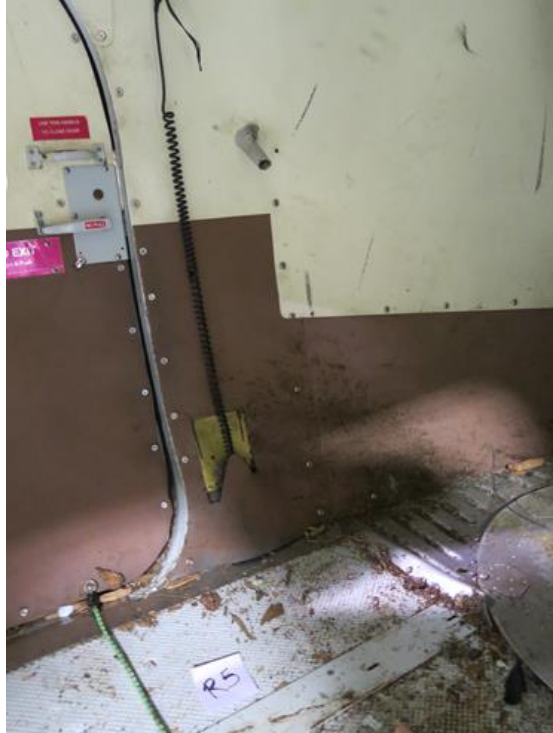
Photograph 40 – Sheared pole on right side fuselage wall that attached R5.

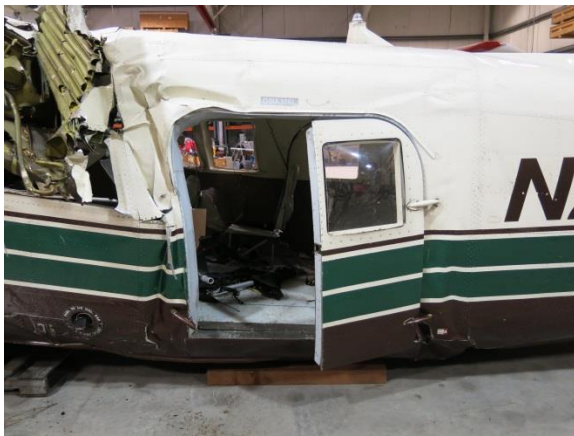
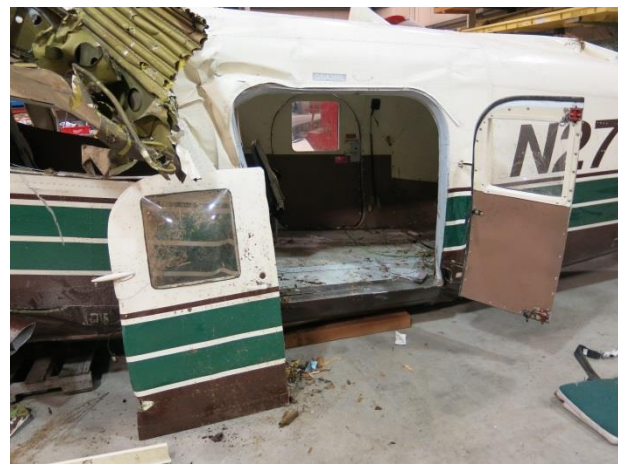
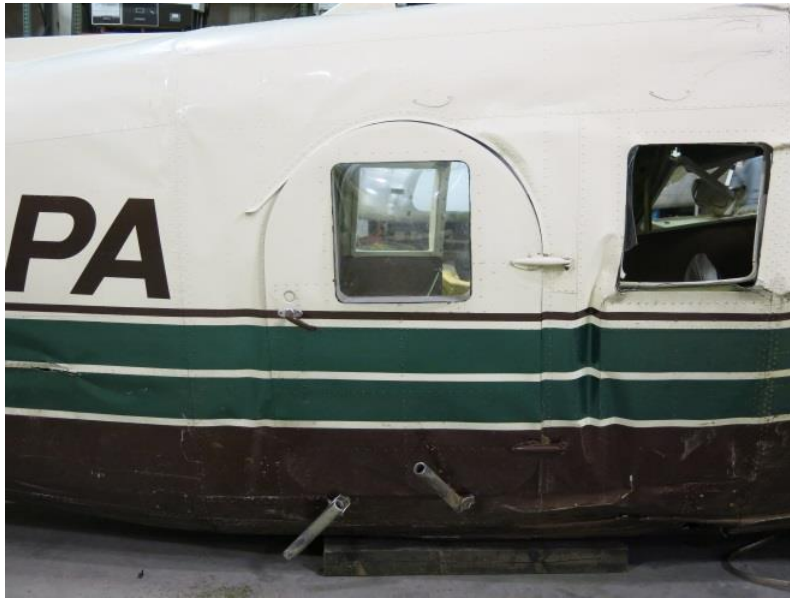
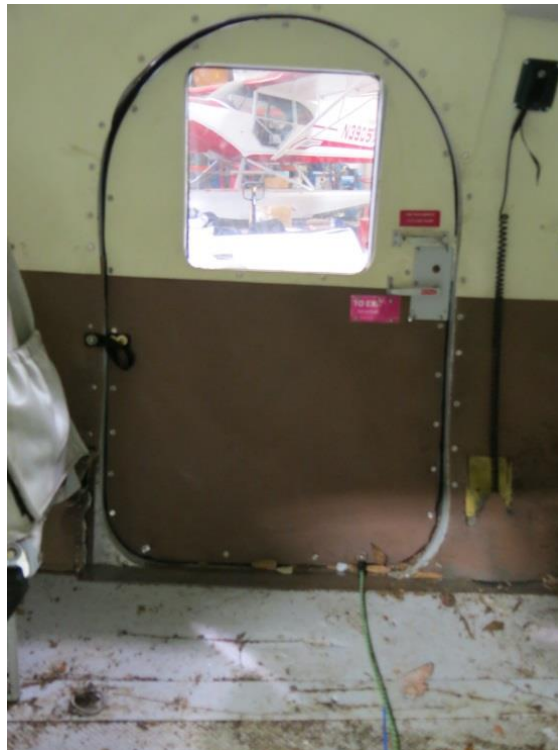
The cabin was equipped with 2 doors, a double passenger door on the left side of the airplane and a single entry door on the right side. The right side door was located behind the R4 seat. It was intact and present. The left side door was located behind the L3 seat. The left side door was a double door. The right side door was attached at the hinges and the left side door was broken off the hinges. The upper hinge on the left side was attached to the door. The bottom hinge was broken off of the door and still attached to the fuselage.

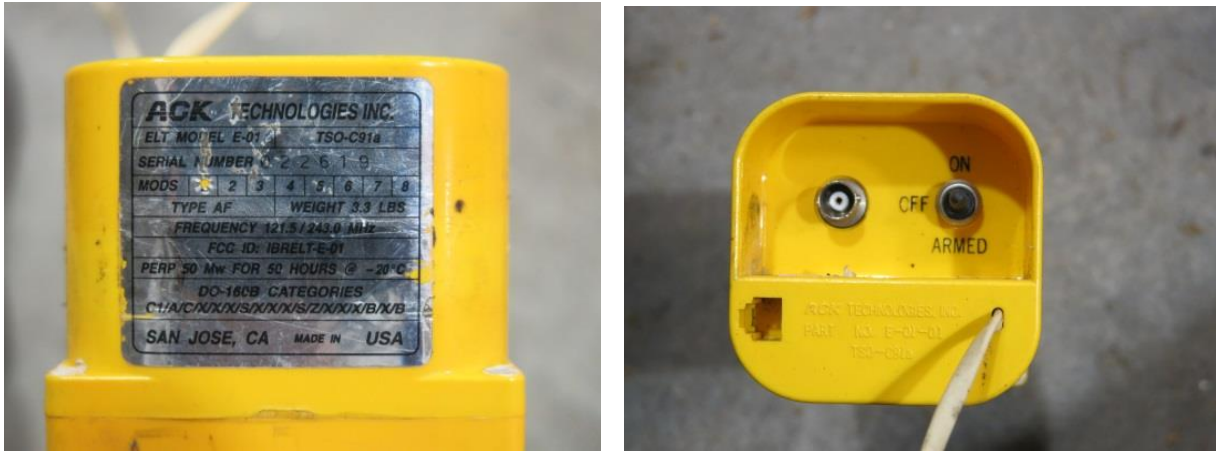
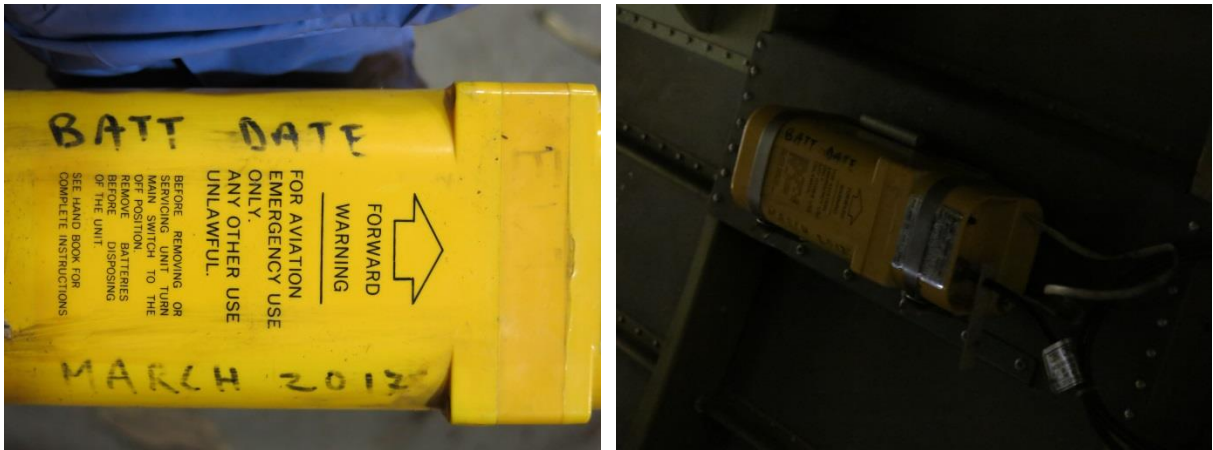
The ELT was found in the aft of the airplane. It was secured and in a bracket. The toggle switch was in the OFF position³. A placard was located near the toggle switch with ACK Technologies, Inc. Part No: E-01-01, TSO-C91A. The battery date was labeled March 2017. A placard on the ELT was present. The information on the label was:
