Gulfstream Aerospace  
Roswell, NM  
April 2, 2011  
DCA011MA076

**NATIONAL TRANSPORTATION SAFETY BOARD  
WASHINGTON, D.C.**

ATTACHMENT 1

PHOTOGRAPHS

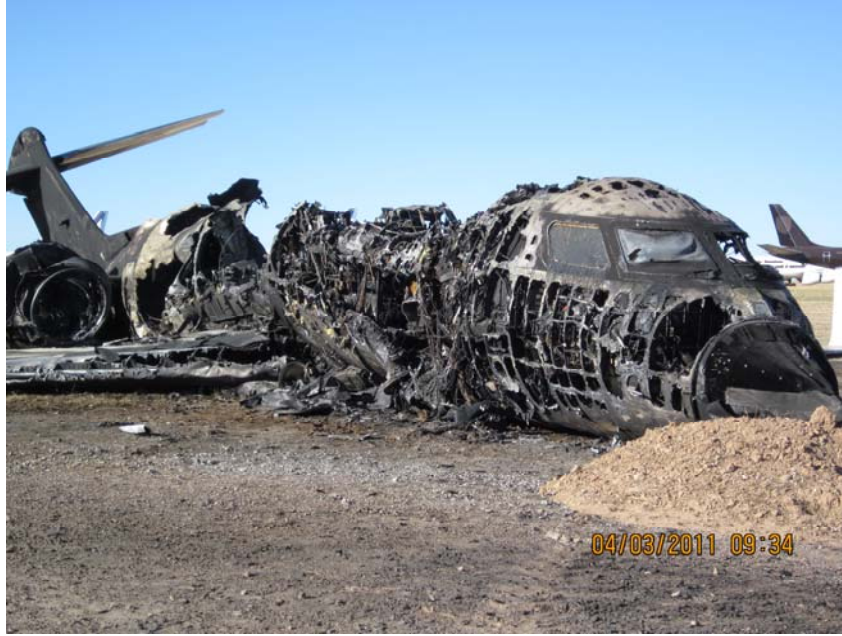
Photograph 3: Airplane damage (Roswell, NM).

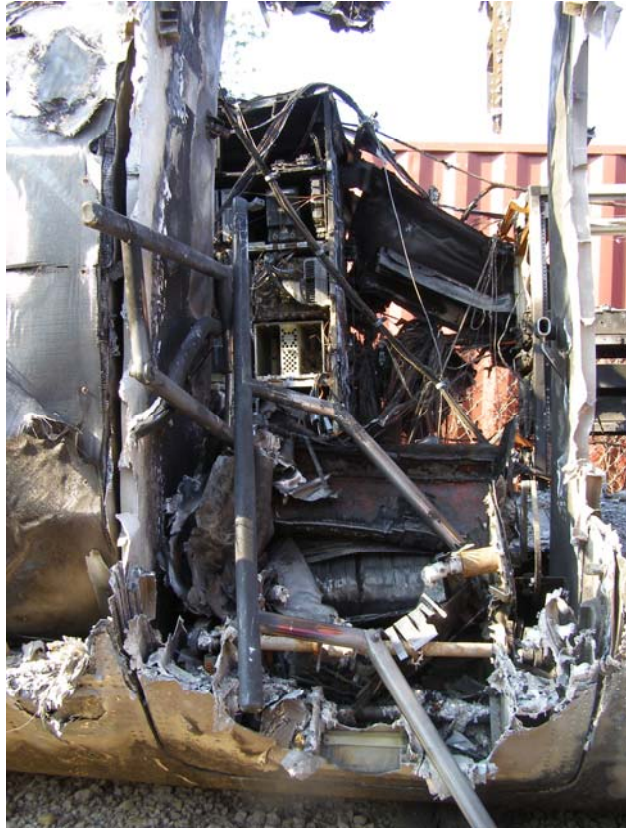
Photograph 9: Remains of MED after accident (Lancaster, TX).

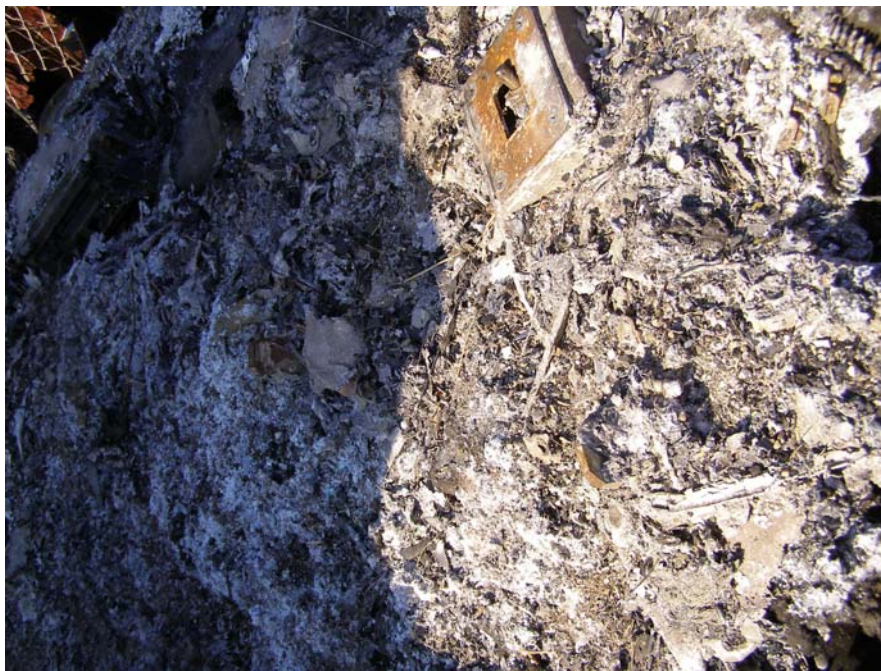
Photograph 10: MED components fused together in molten metal (Lancaster, TX).

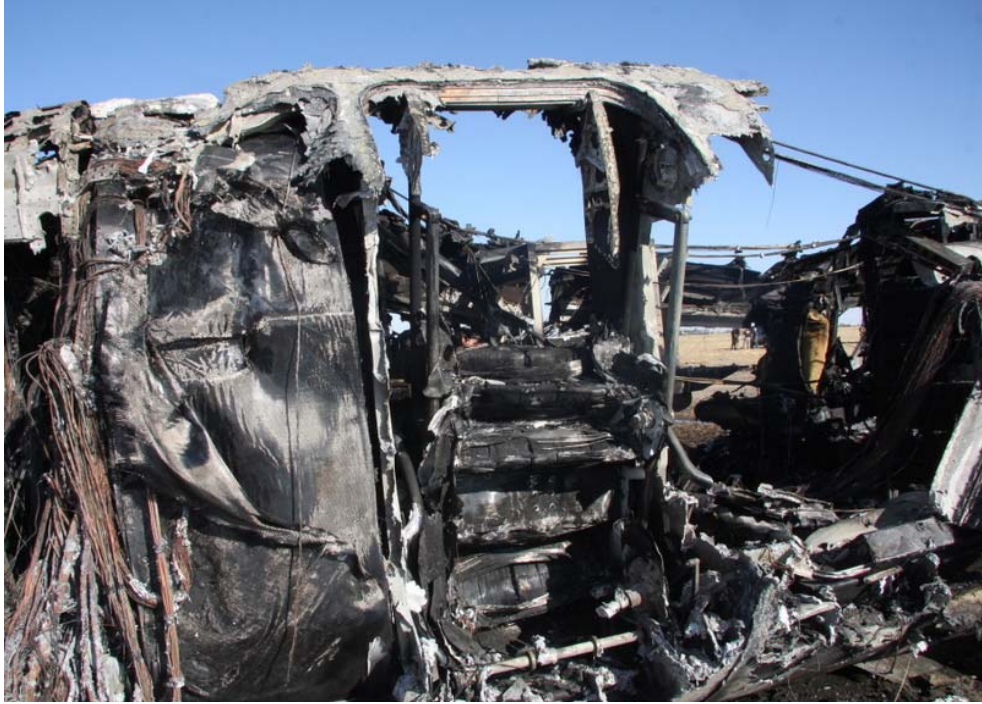
Photograph 11: MED upper door hooks in place (Roswell, NM).

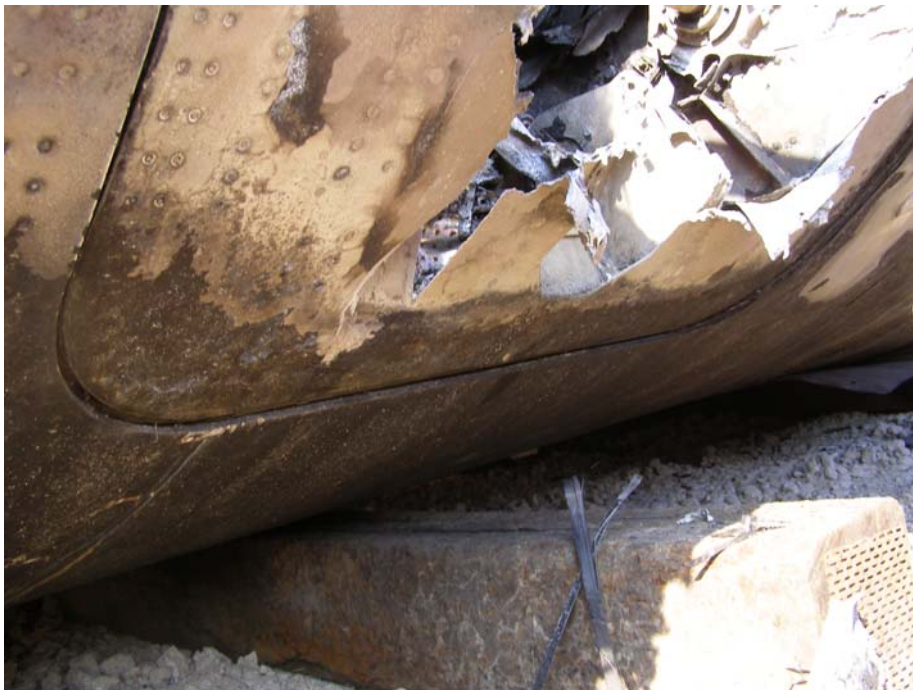
Photograph 12: Gap in lower portion of MED (Lancaster, TX).

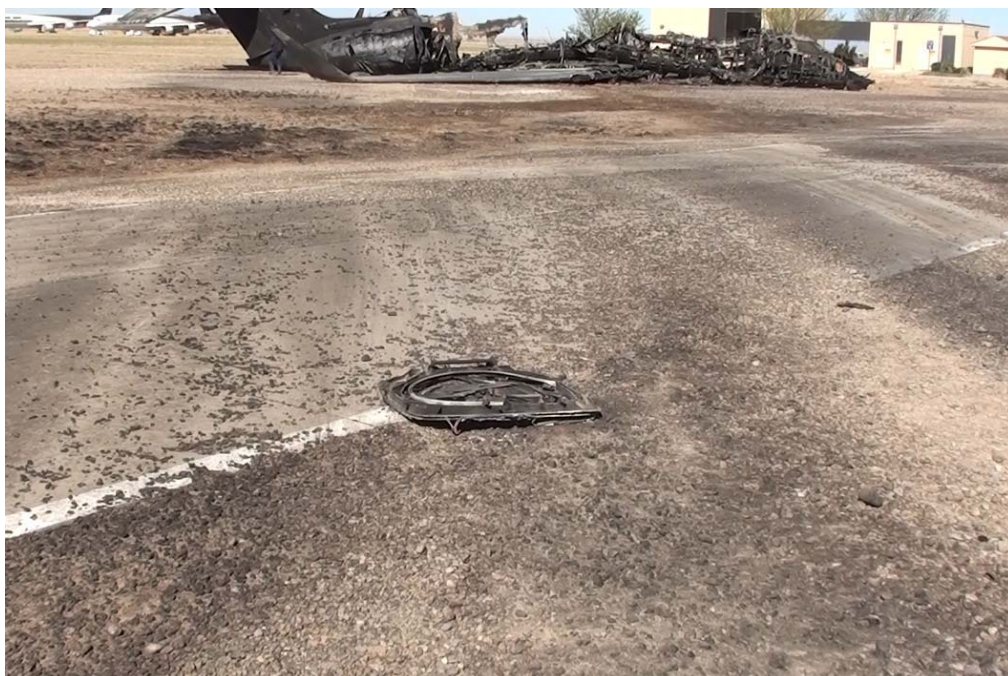
Photograph 13: Aft left overwing emergency exit position on-scene (Roswell, NM).

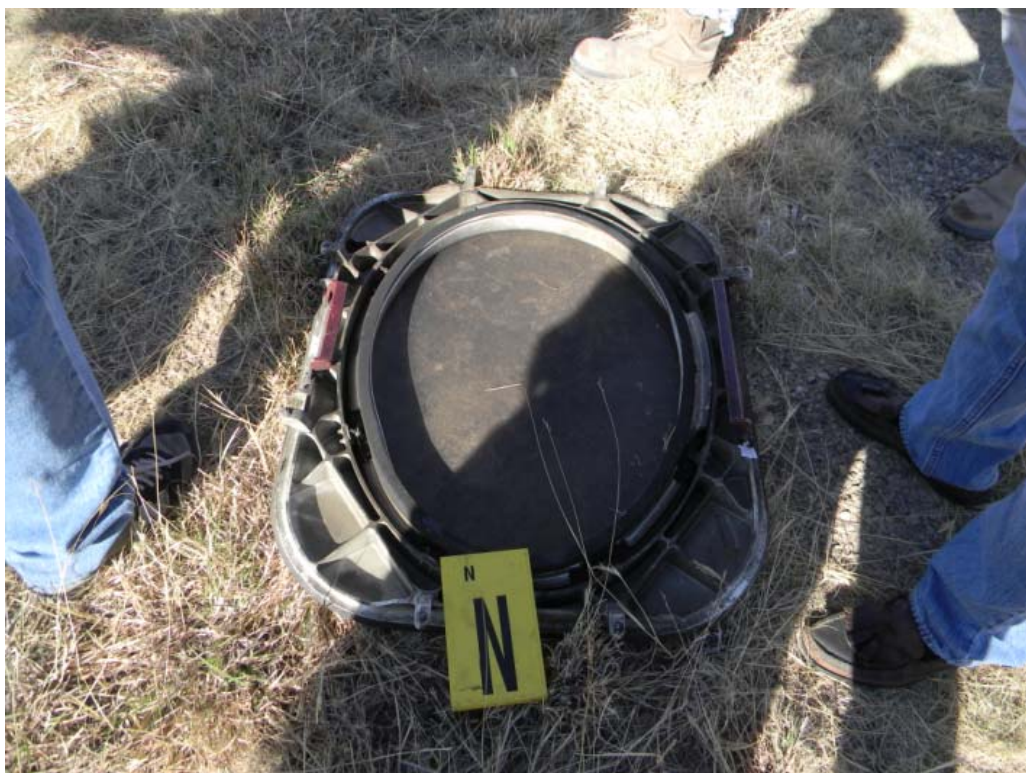
Photograph 14: Forward left overwing emergency exit position on-scene (Roswell, NM).

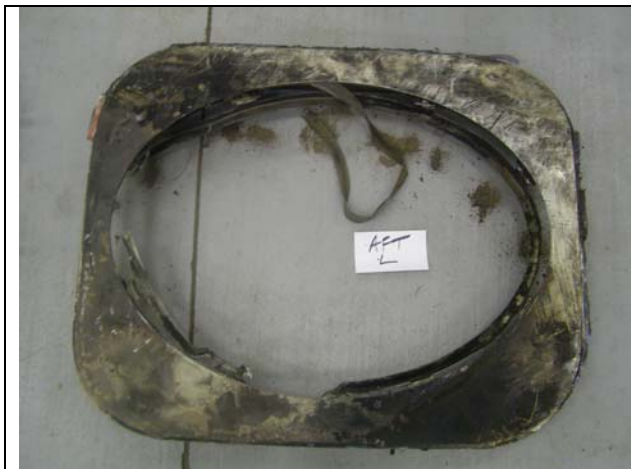
Photograph 19: Aft left overwing emergency exit door after accident (Lancaster, TX).

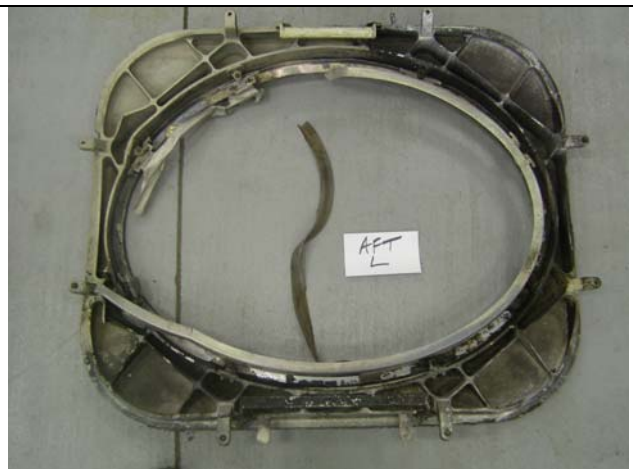
Photograph 20: Aft left overwing emergency exit door after accident (Lancaster, TX).

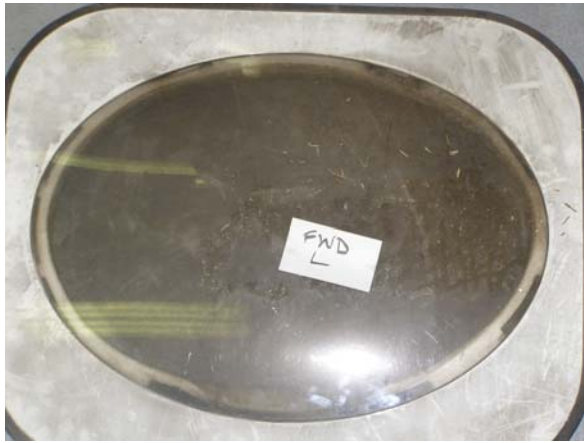
Photograph 21: Forward left overwing emergency exit door after accident (Lancaster, TX).

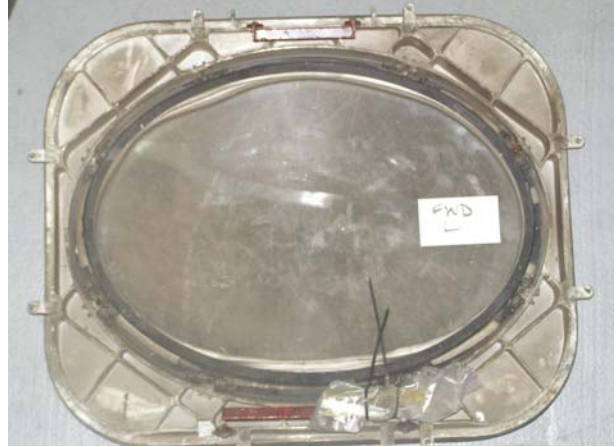
Photograph 22: Forward left overwing emergency exit door after accident (Lancaster, TX).

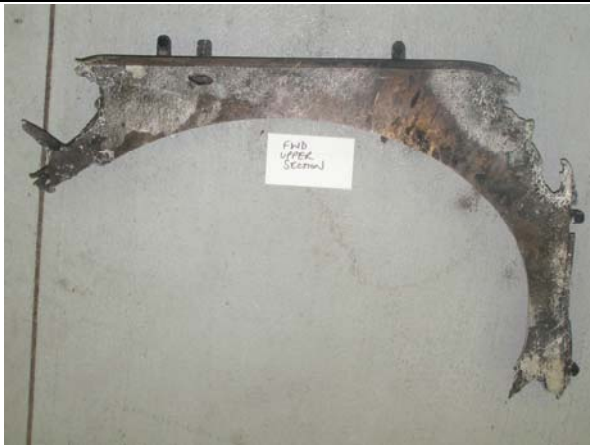
Photograph 23: Right side #1 after accident (Lancaster, TX).

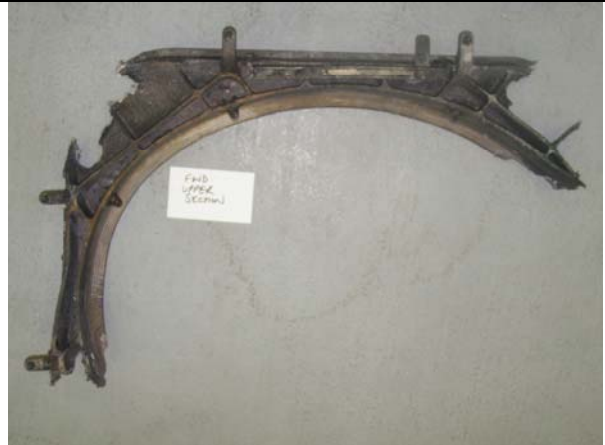
Photograph 24: Right side #1 after accident (Lancaster, TX).

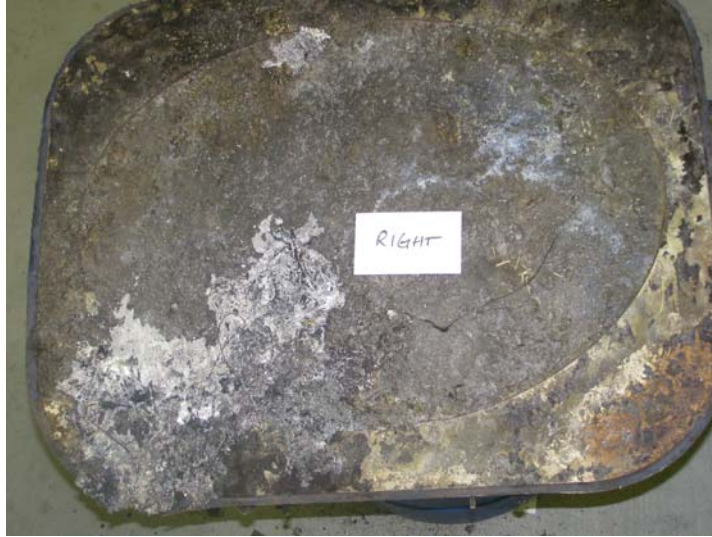
Photograph 25: Right side #2 after accident (Lancaster, TX).
