United Airlines
New Orleans, LA
April 4, 2011
DCA11IA040

National Transportation Safety Board
Washington, D.C.

Attachment 1

Photographs of UAL 497

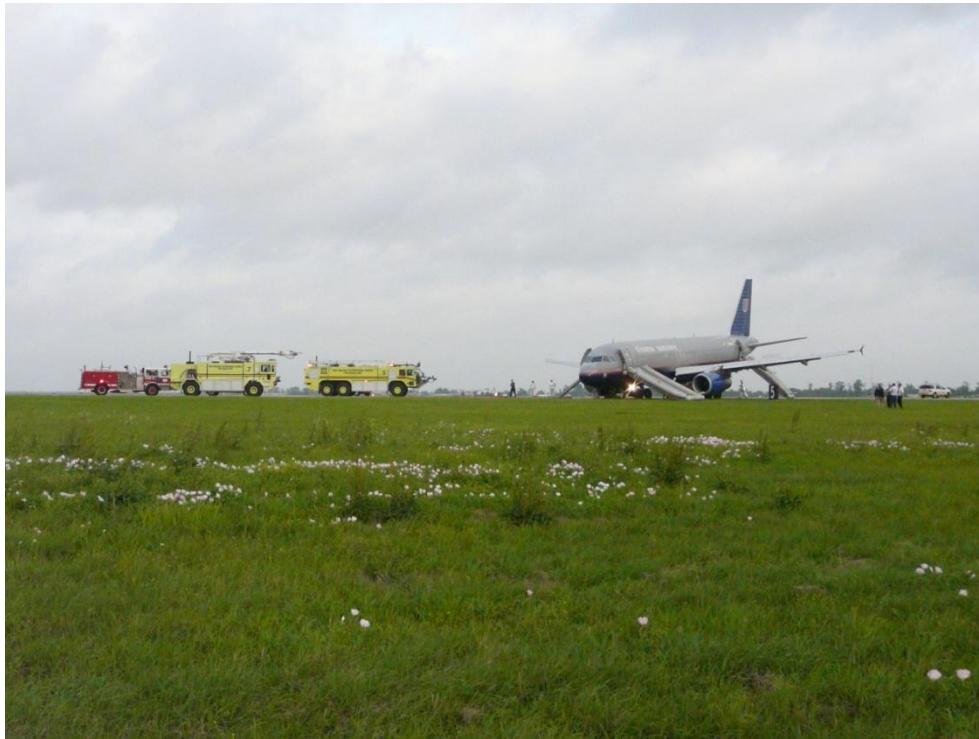
1. Photograph of UAL flight 497 in the grass on the left side of MSY Runway 19.
Note: Slide/rafts 1L and 2L are deployed.
(Photograph provided by MSY ARFF)

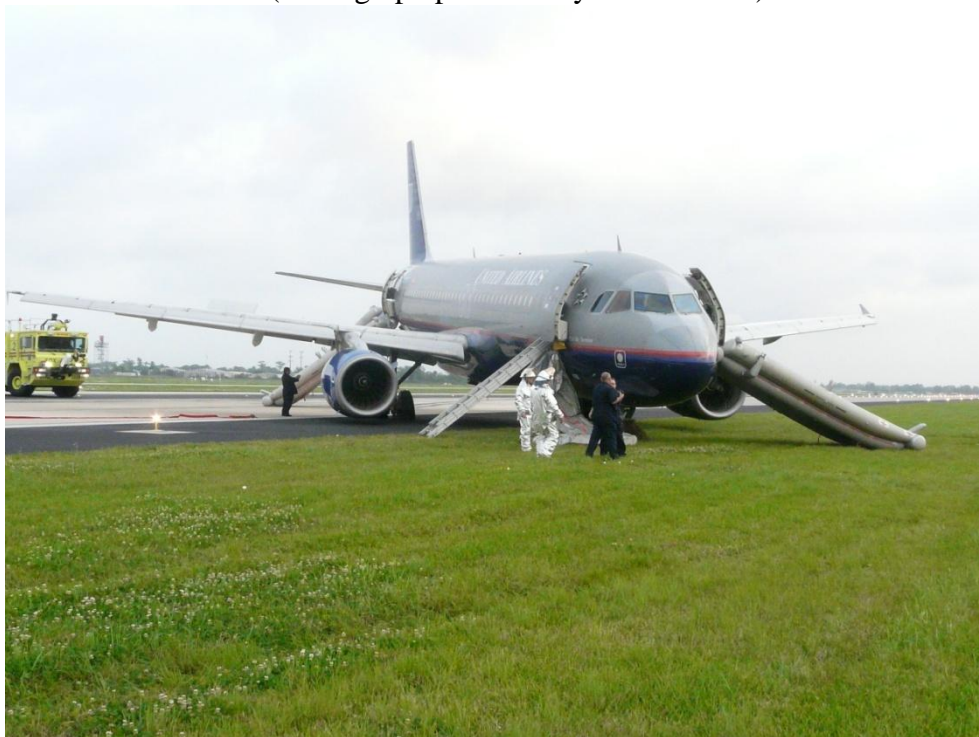
2. Photograph looking at the right side of N409UA.
Note: The 1R slide/raft is hanging limp at the 1R exit, and an ARFF ladder is placed at the exit
to provide access to the airplane.
(Photograph provided by MSY ARFF)

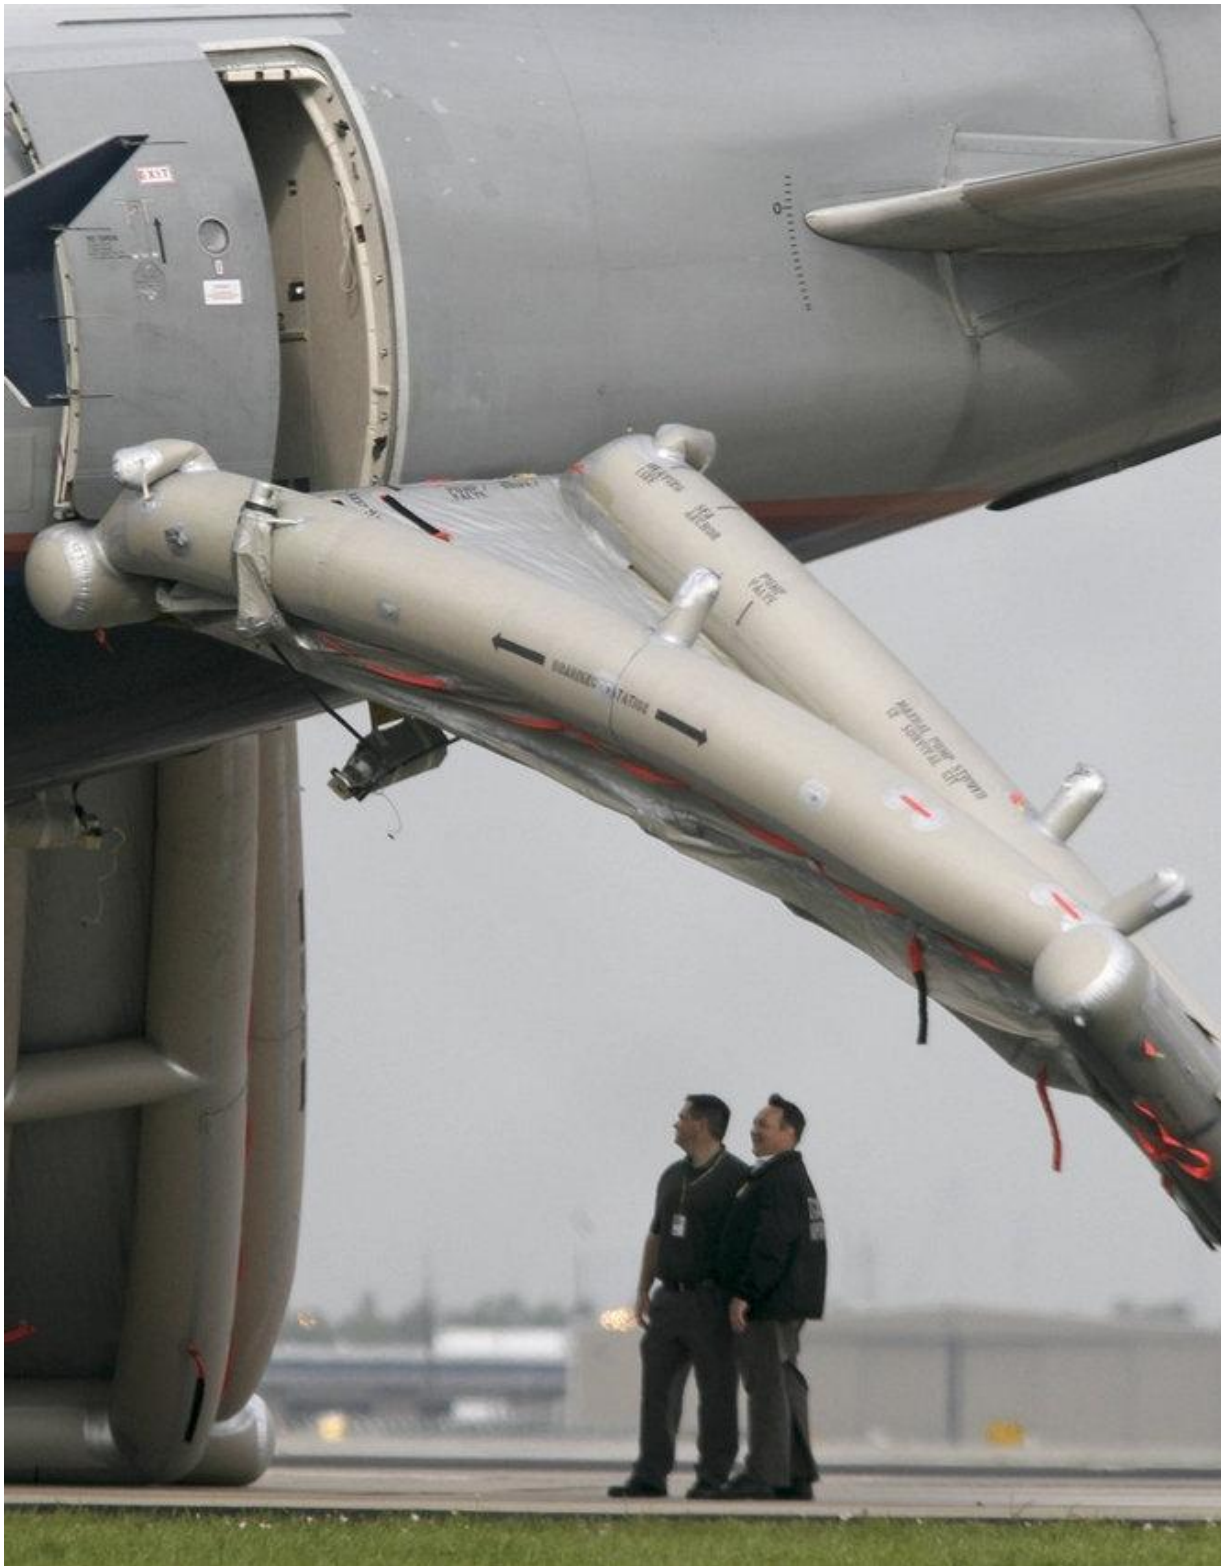
3. View of the 2L slide/raft taken after the evacuation.
Note: the slide/raft's lower tube is deflated.
(Photograph provided by UAL)

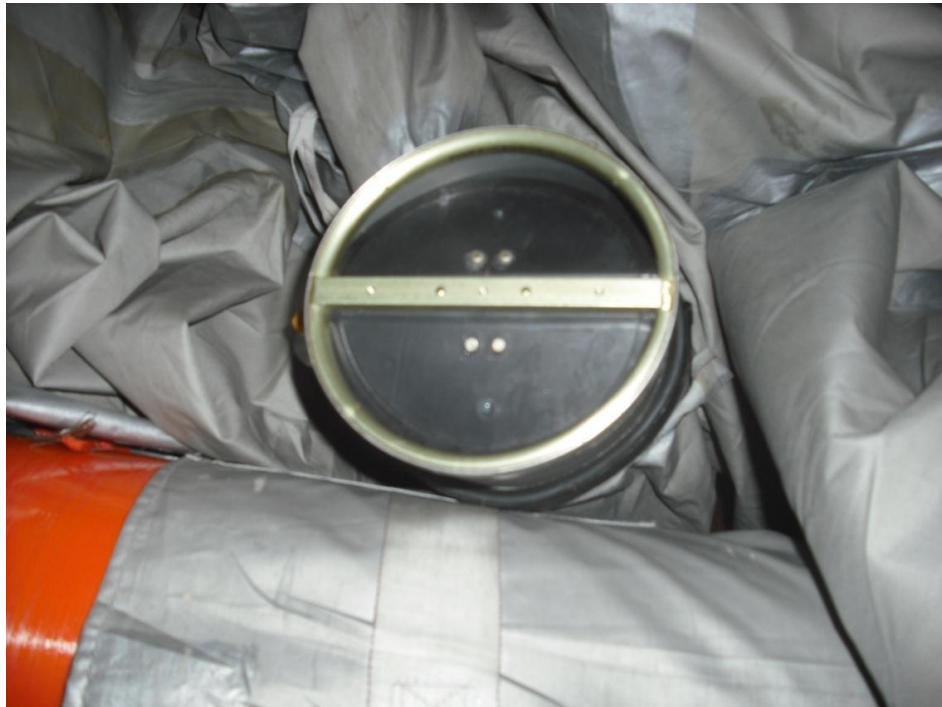
4. Close up view of the 2L slide/raft's forward aspirator.
Note: the flapper is not completely seated.
(Photograph provided by UAL.)

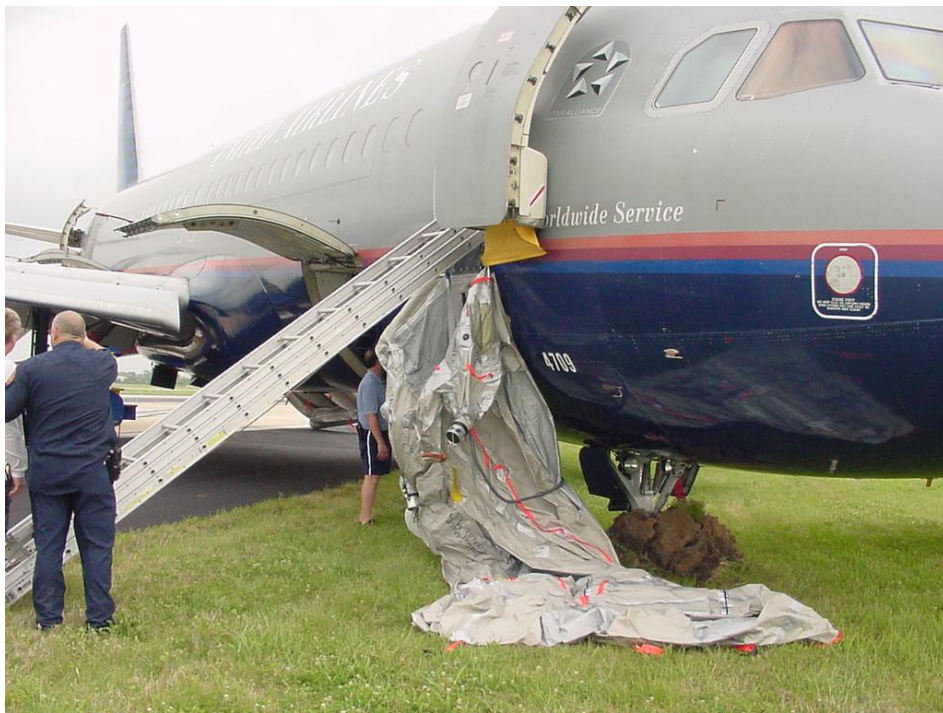
5. View of the 1R evacuation slide/raft.
(Photograph provided by UAL.)

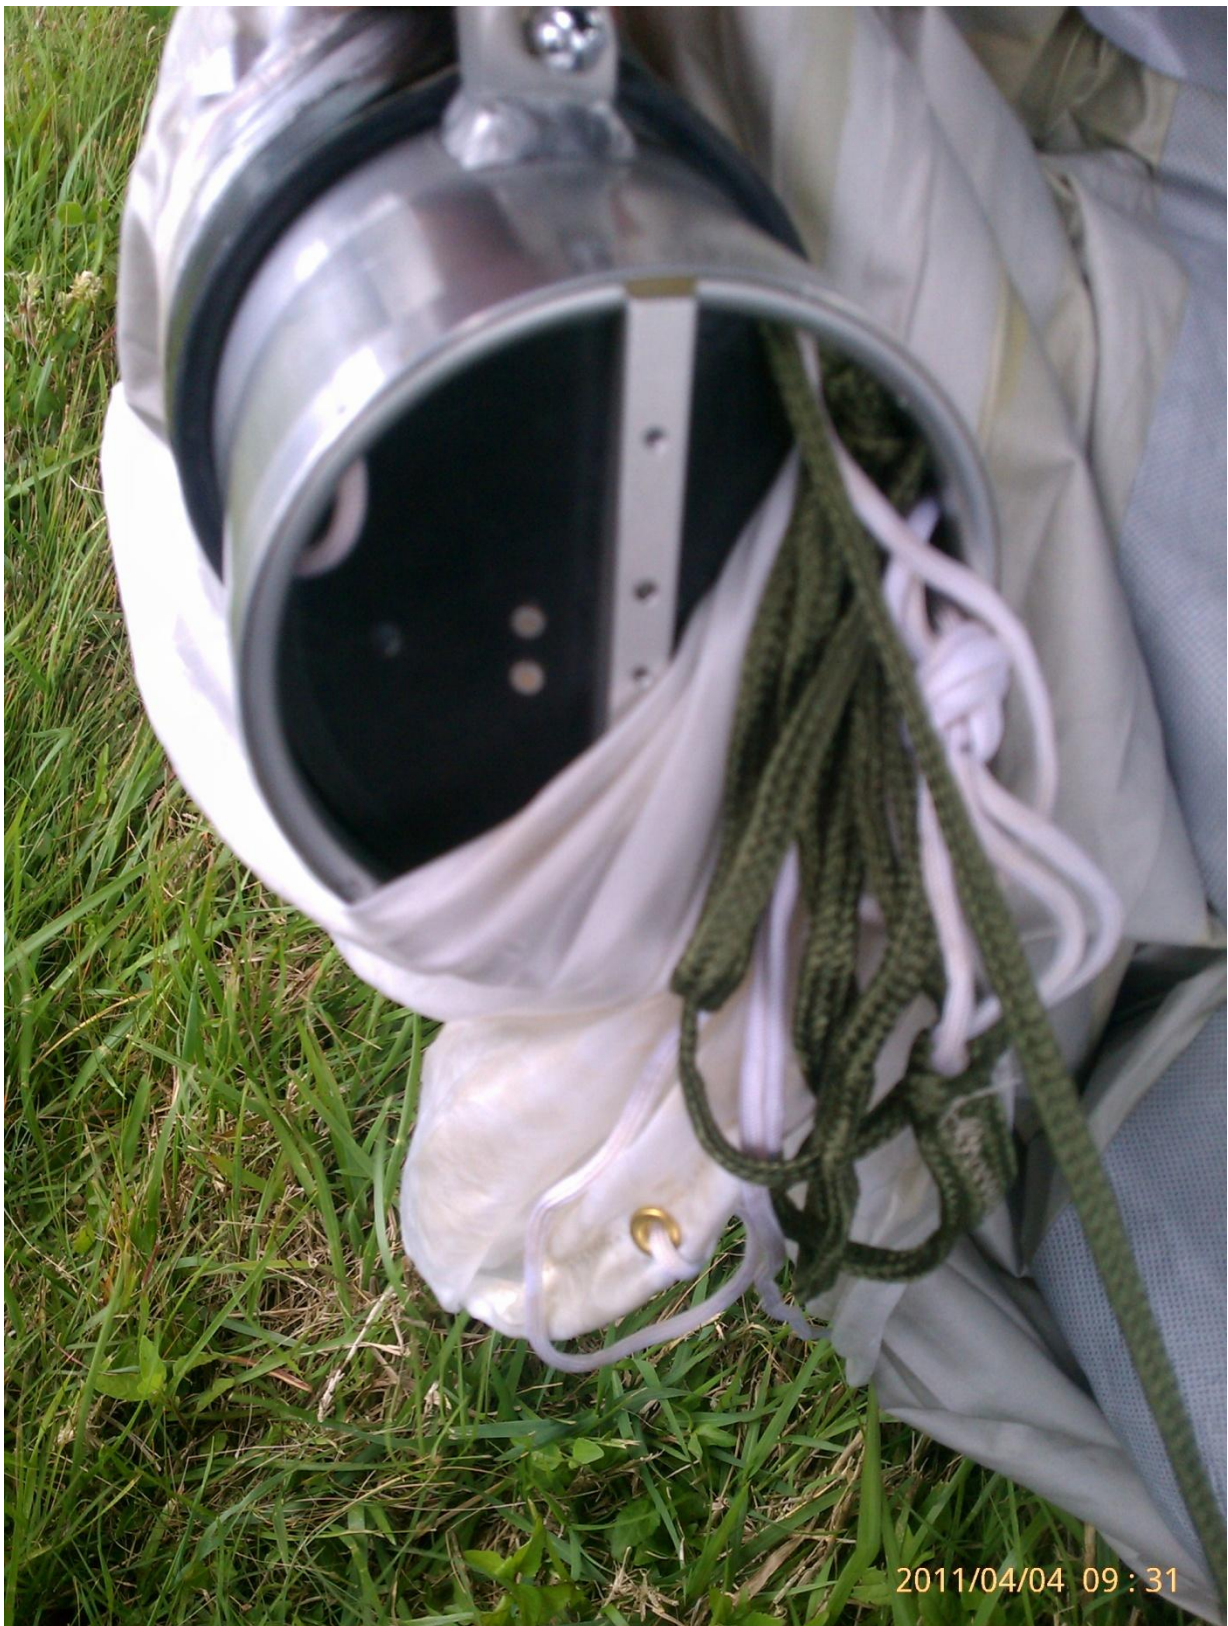
6. View of the 1R slide/raft's aft aspirator with the ingested sea anchor and sea anchor line
(Photograph provided by UAL.)

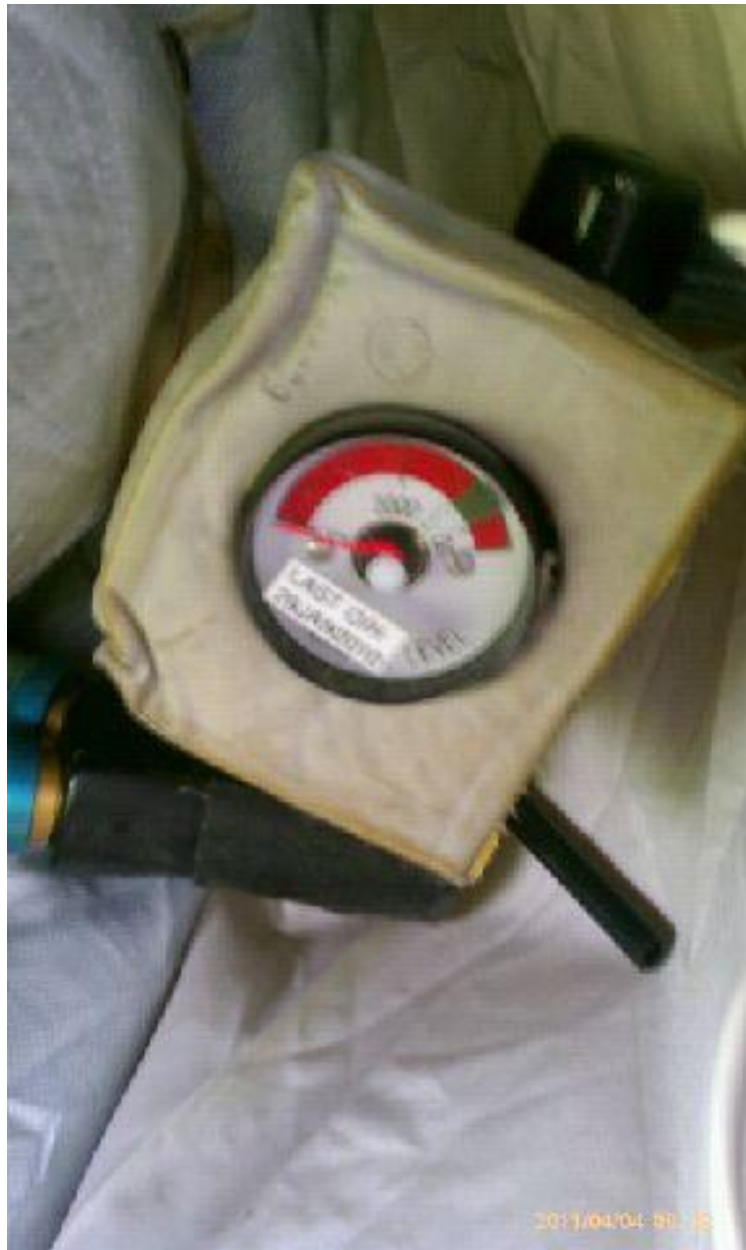
7. View of the 1R evacuation slide/raft inflation bottle pressure gauge.
(Photograph provided by UAL.)

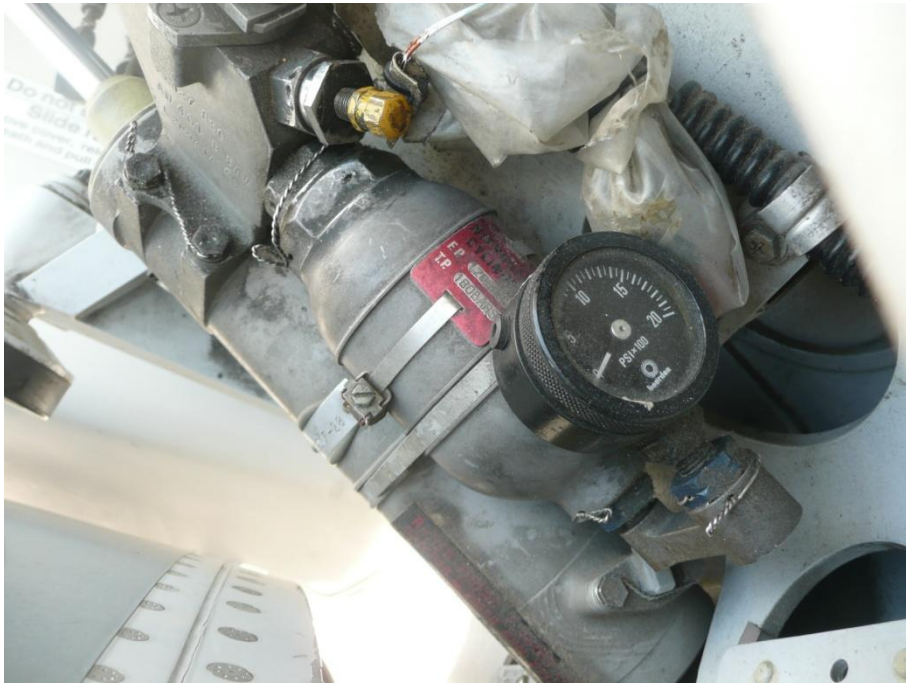
8. Photograph of the 1R power assist actuator gauge.

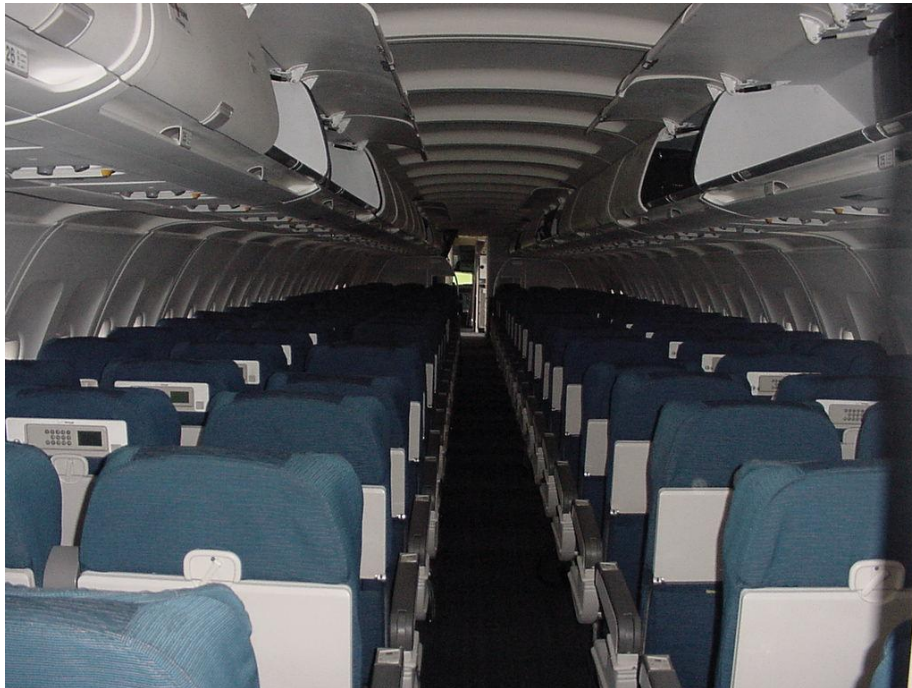
9. View of N409UA's cabin from the aft cabin looking forward.
(Photograph provided by UAL.)

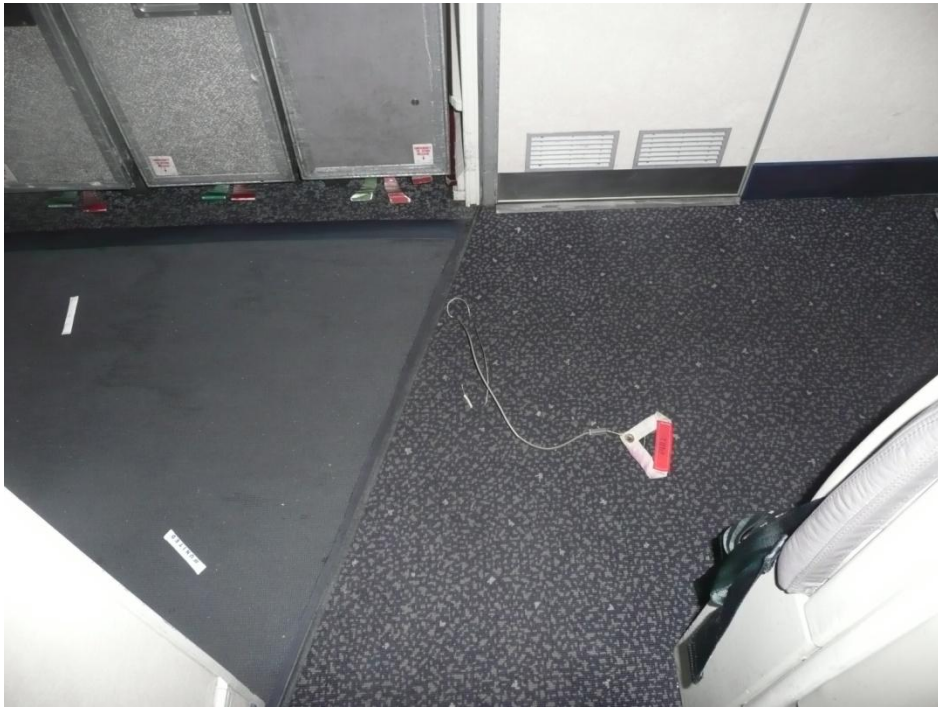
10. View of the manual inflation handle (from the 2R slide/raft) found near the 2R exit.

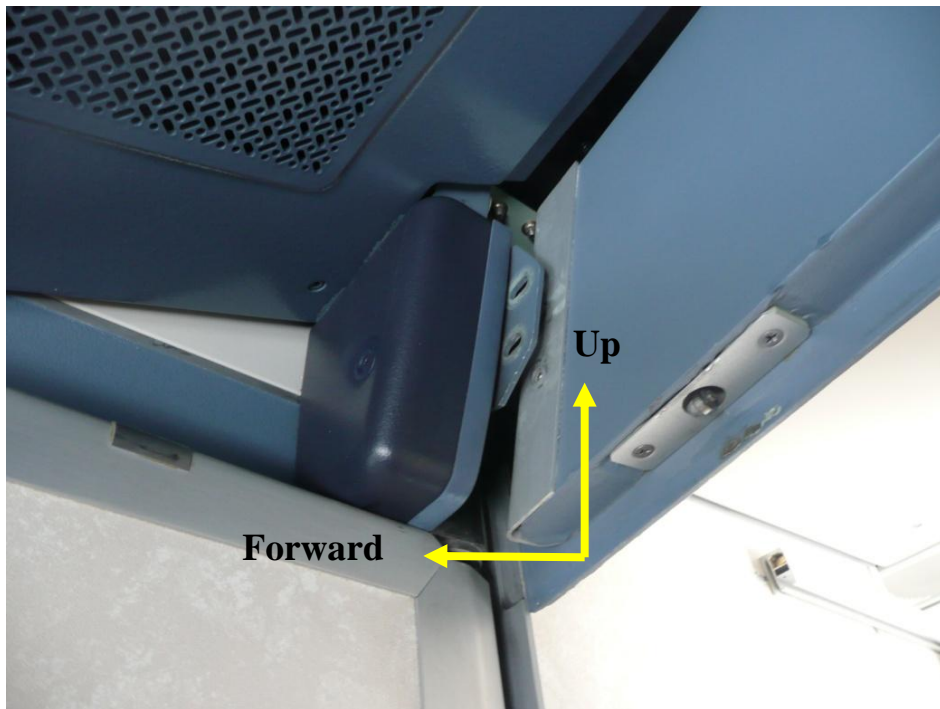
11. View looking at the upper cockpit door hinge from the inside cockpit.
The door standoff bracket was found separated from the bulkhead.
