Carson Helicopter Services
Weaverville, California
August 5, 2008
LAX08PA259

National Transportation Safety Board
Washington, D.C.

Attachment 2

Wreckage Photographs

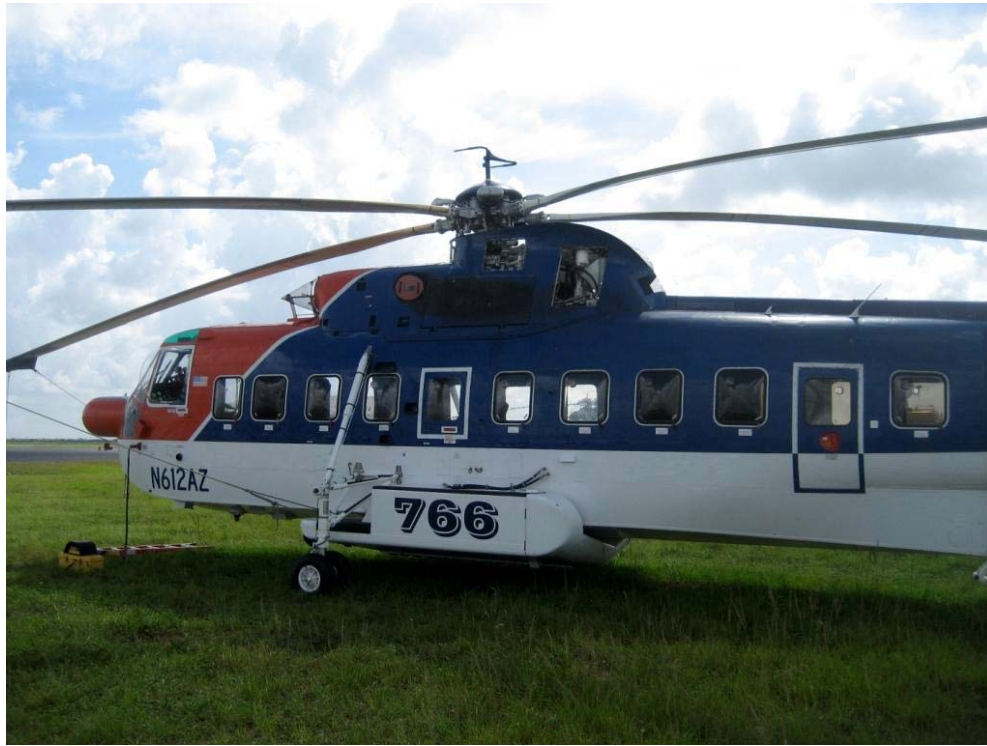
1. Photograph (courtesy Carson Helicopters Services, Inc.) of the left side of N612AZ taken prior to the accident.

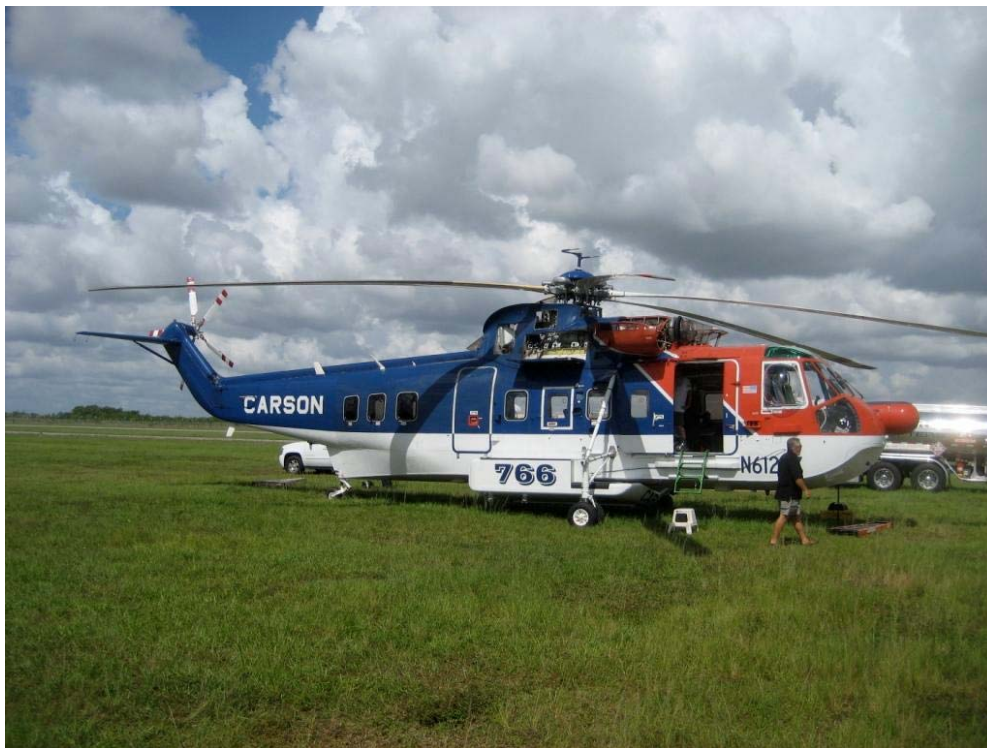
2. Photograph (courtesy Carson Helicopters Services, Inc.) of the right side of N612AZ.
Note: A removable rubber seal surrounds each window to be used as an emergency exit during an emergency evacuation.

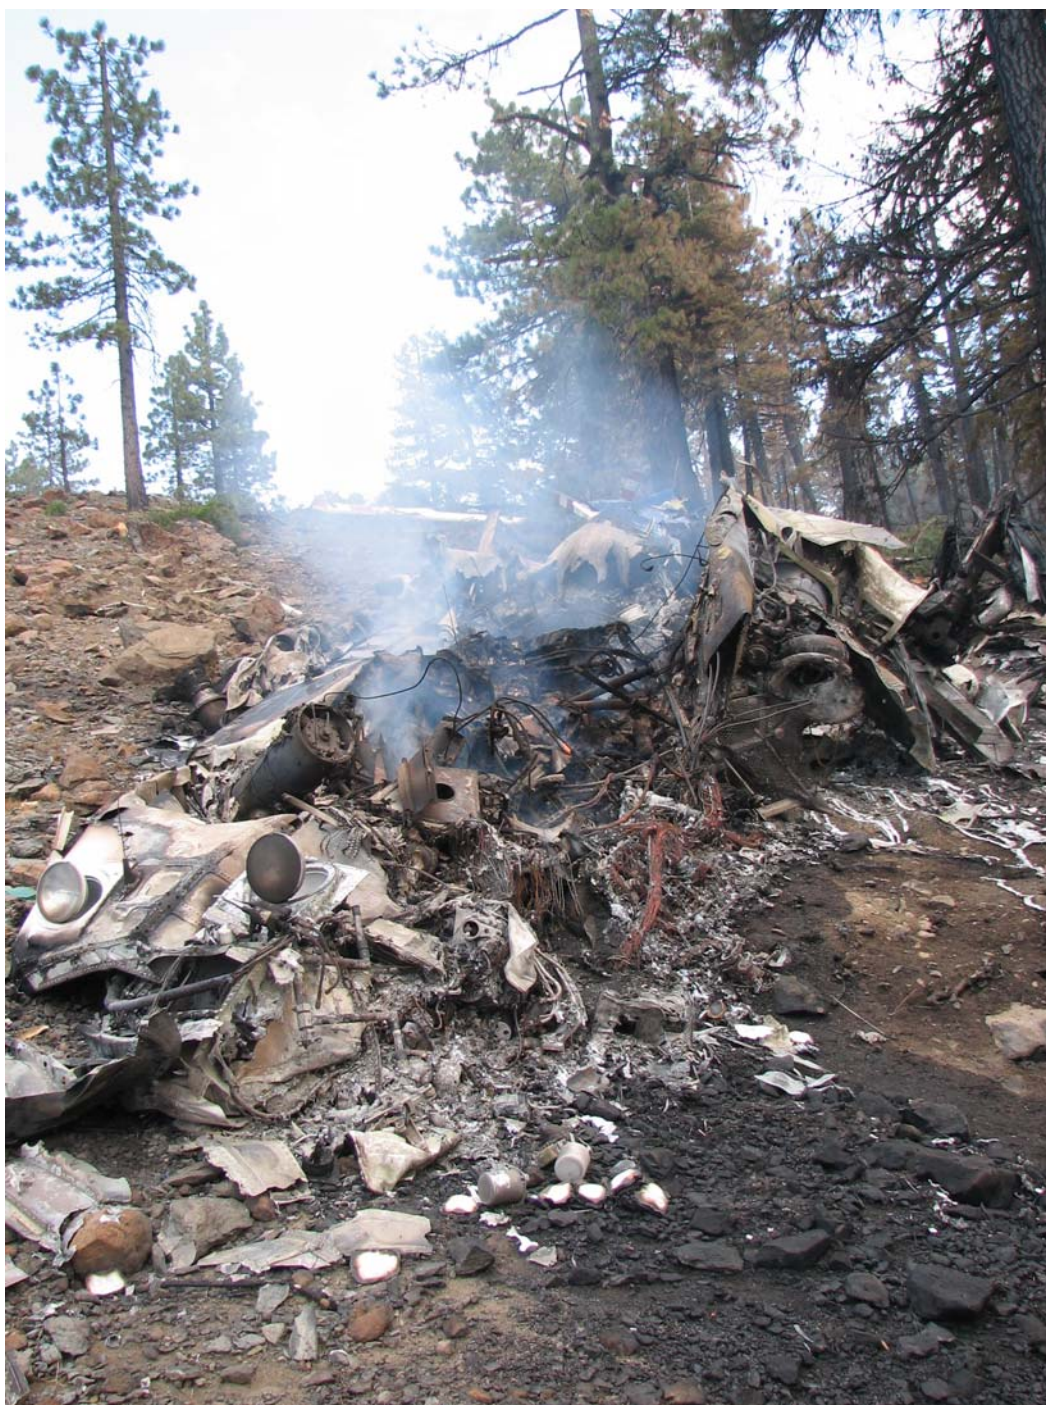
3. View of the wreckage. The nose of the helicopter is in the foreground and the tail of N612AZ in the background.

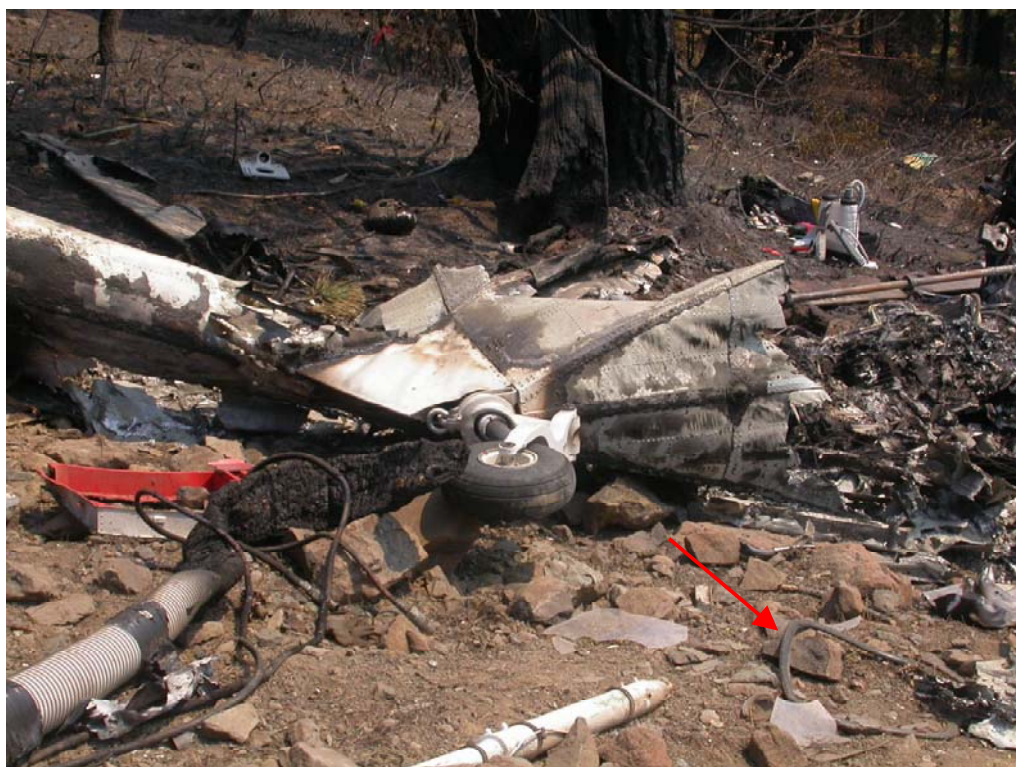
4. Red arrow points to a rubber window seal near the main wreckage.

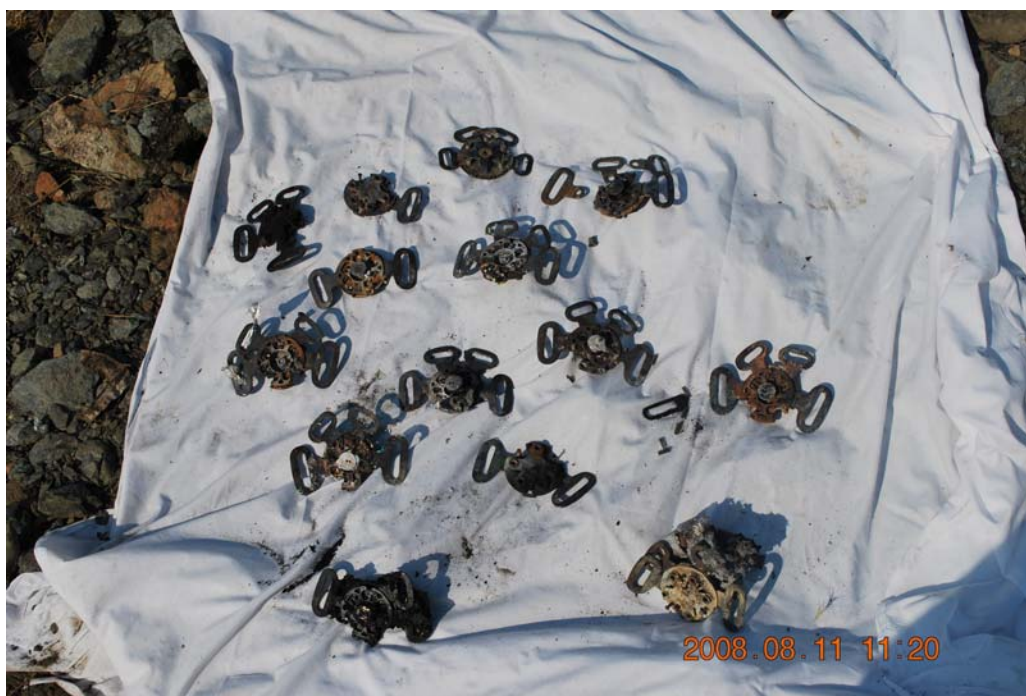
5. Photograph of the charred remains of restraint buckles removed from the wreckage.

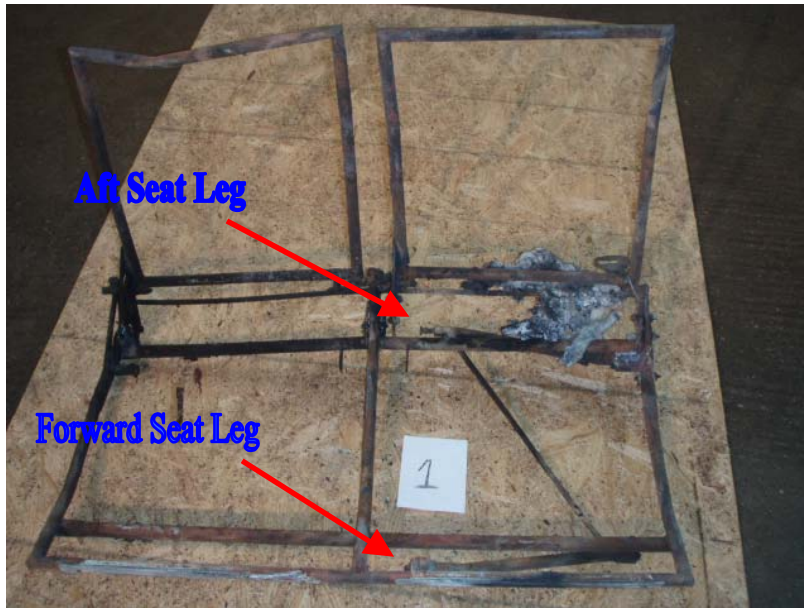
6. View of a double seat frame from N612AZ's wreckage.
Note: The seat legs are folded under the seat and the pan fittings separated from the seat legs. The forward single stud hold down fitting remained attached, and the aft seat leg hold down fitting separated.

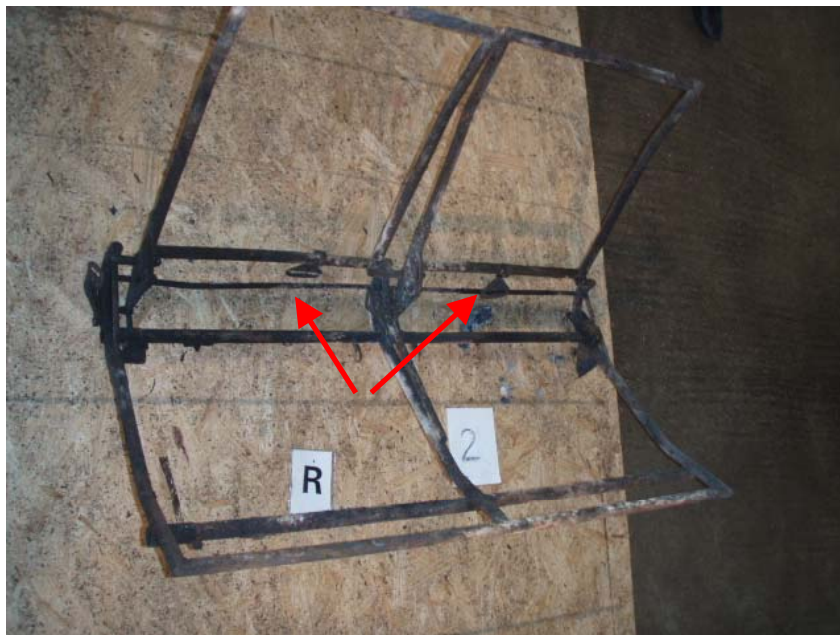
7. View of a double seat frame. The seat legs separated and were found in the wreckage. Note: The red arrows point to the shoulder restraint end fittings that remained attached to the aft crosstube.

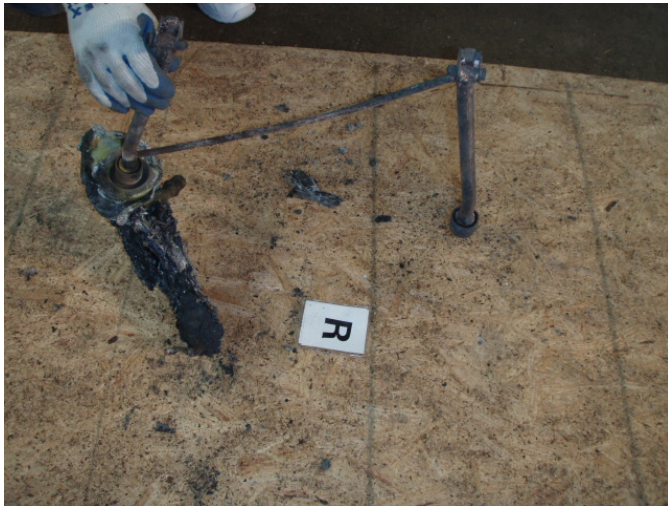
8. View of the seat legs that had separated from the seat and were cataloged as R above.

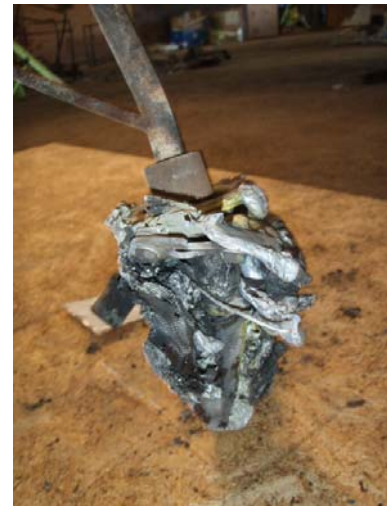
9. Close up of the fuel probe that melted to the aft seat leg, revealing that the double seat was from row 4 seats C and D on the right side of the cabin.

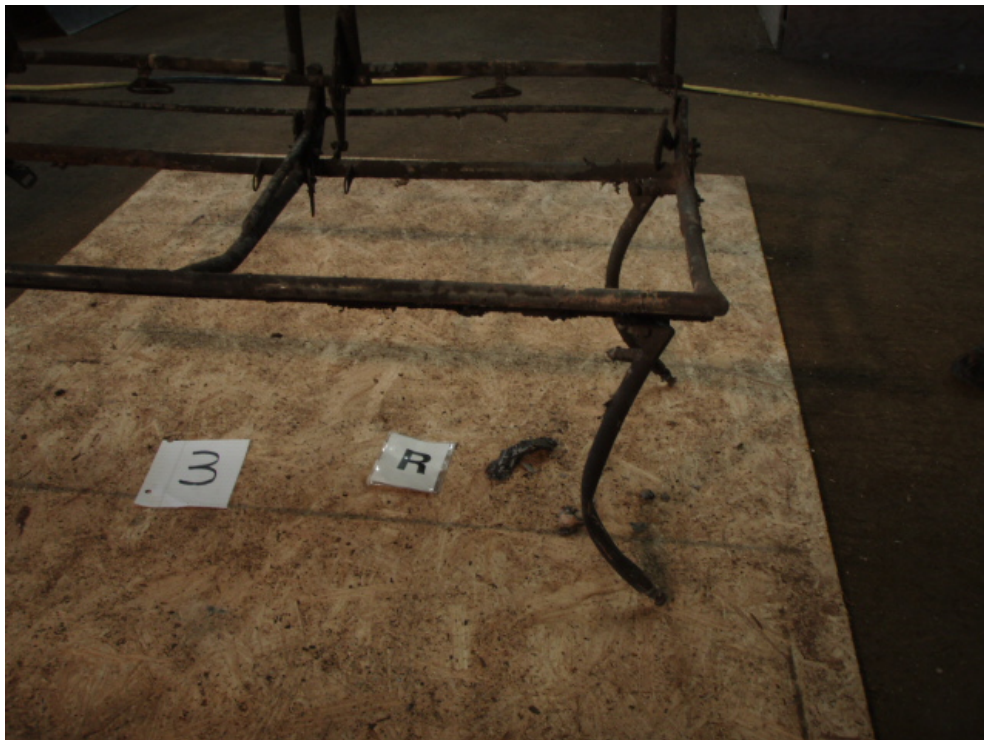
10. Photograph of the 3rd double seat found in the wreckage.
Note: The inboard seat legs exhibited compression bending and both hold down stud fittings separated from the seat legs.

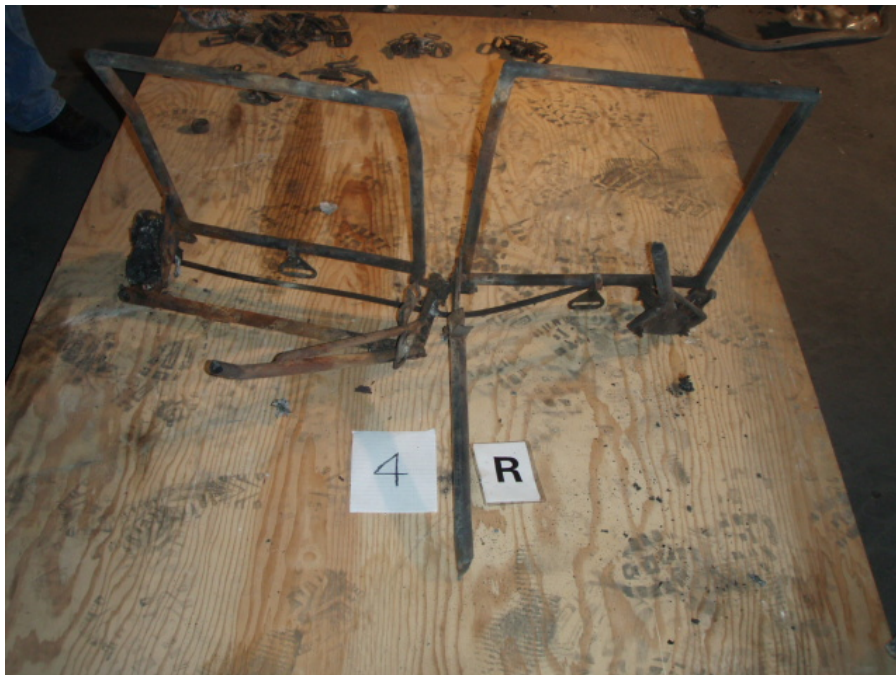
11. Photograph of a forward facing double seat.

Note: the lower seat frame separated from the seat back, and the shoulder restraint end fittings remained attached to the aft cross tube.

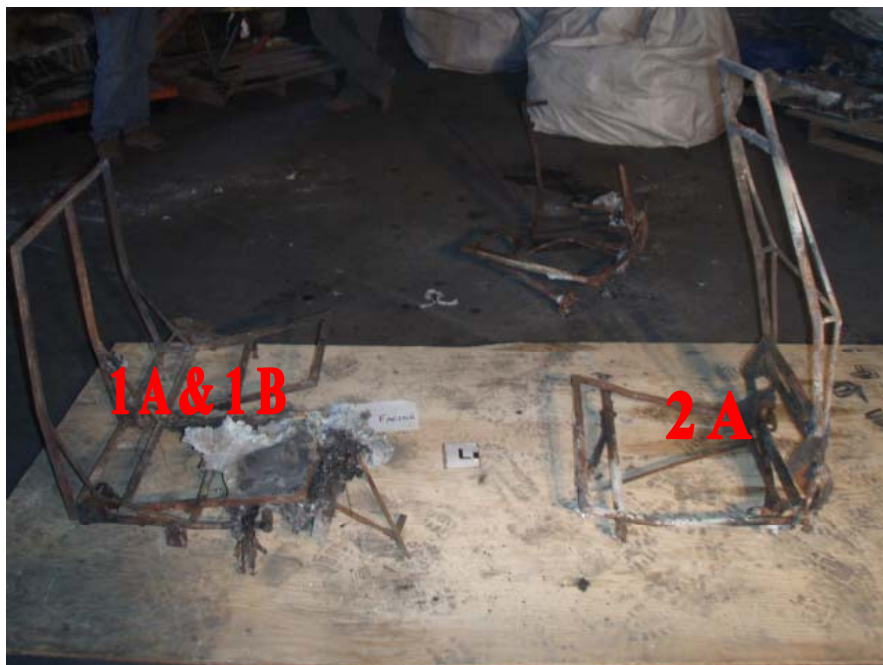
12. Photograph showing the aft facing double seat and a single high back single seat (for seat positions 1A and B and 2A.)

Note: Seats 1A and B are designed with short standoffs instead of seat legs, and seat 2A is designed with an extended seatback.

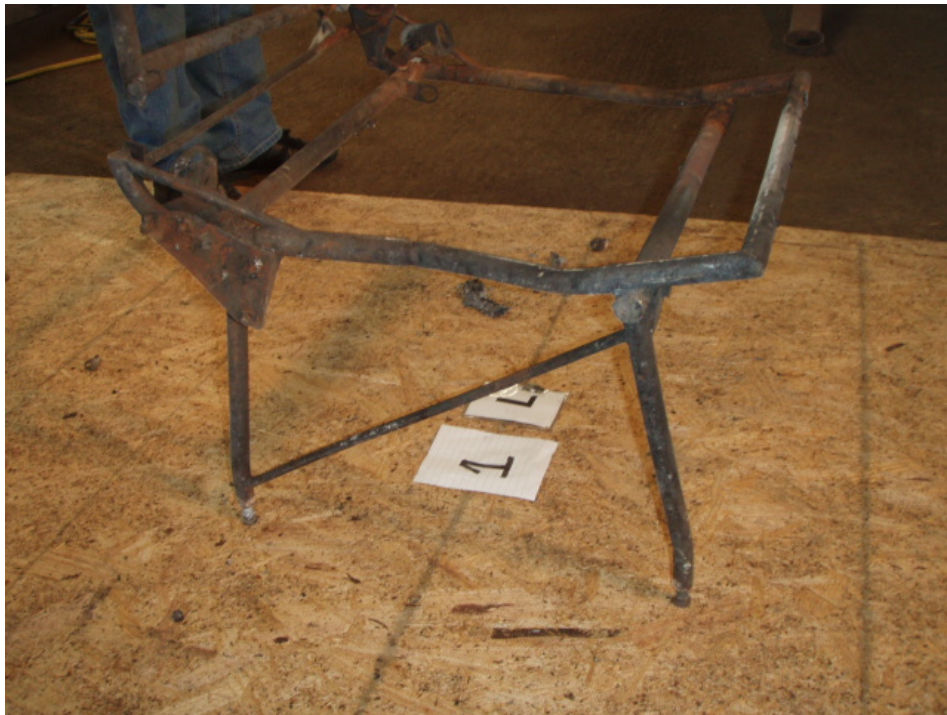
13. View of the inboard seat legs from a forward facing single seat.
Note: The single stud hold-down fittings separated from the seat legs.

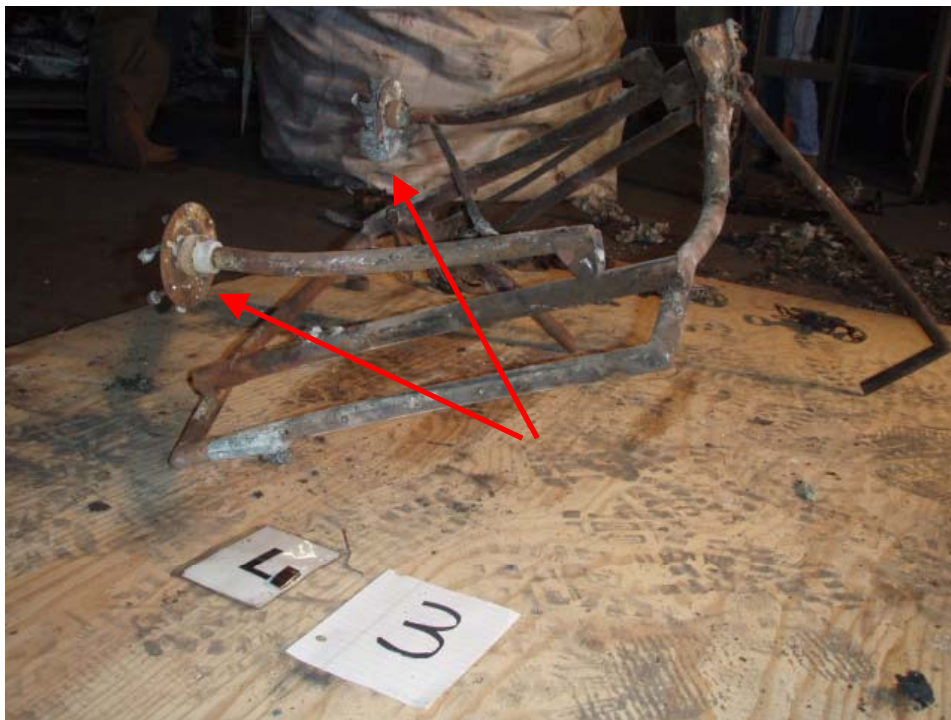
14. View of a forward facing single seat.
Note: Red arrows point to the single stud hold down fittings and floor mounted pan fittings that remained attached to the seat legs.

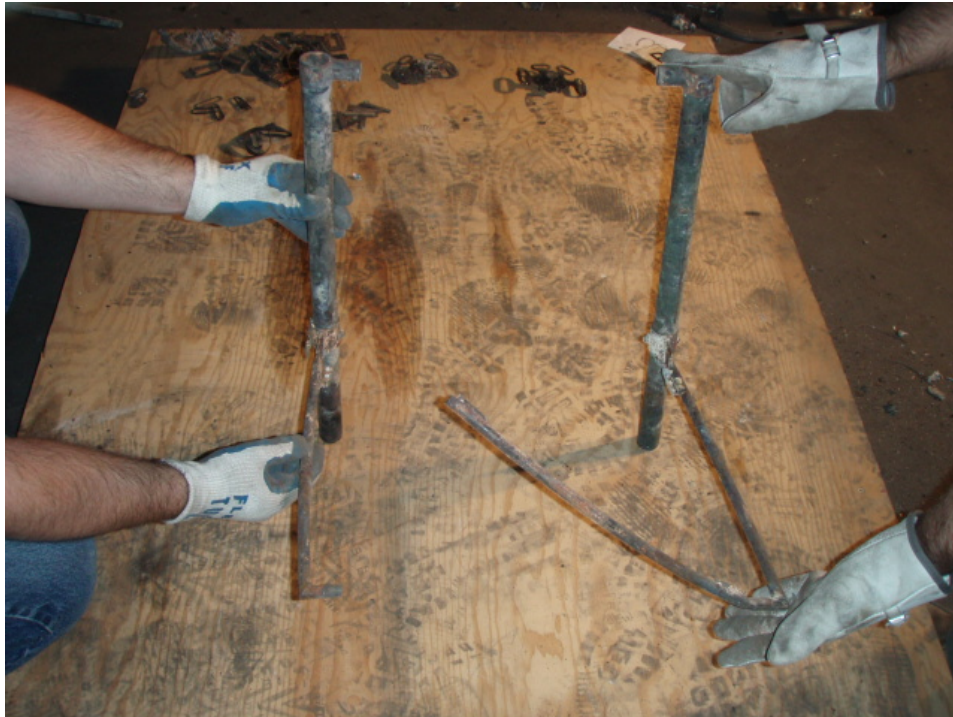
15. View of the remains of a flight crewmember seat frame.

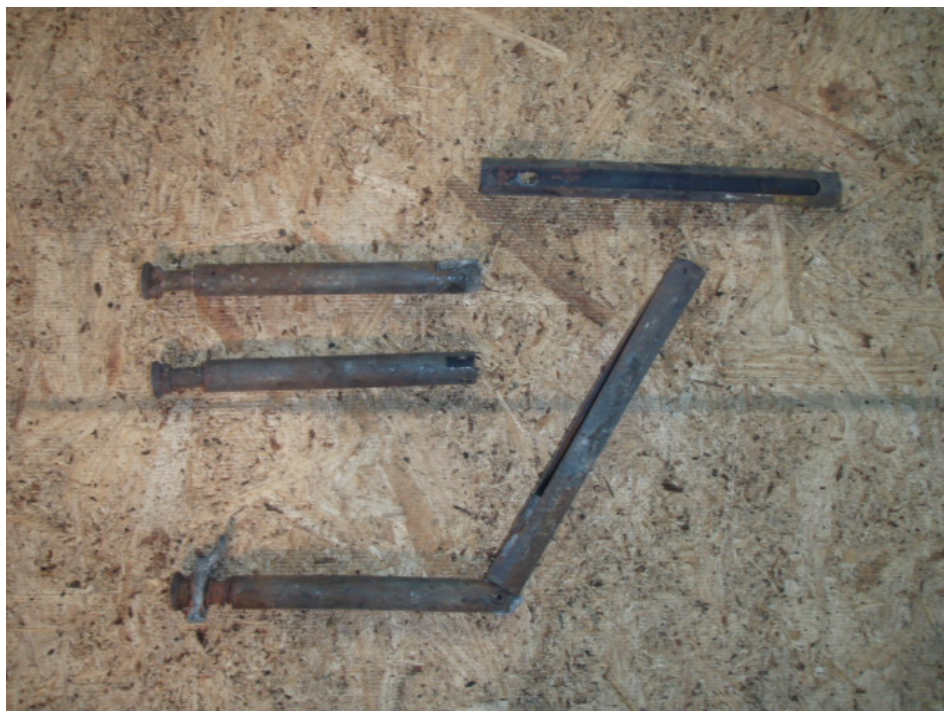
16. Photograph of single pin hold down fittings that were found in the wreckage.

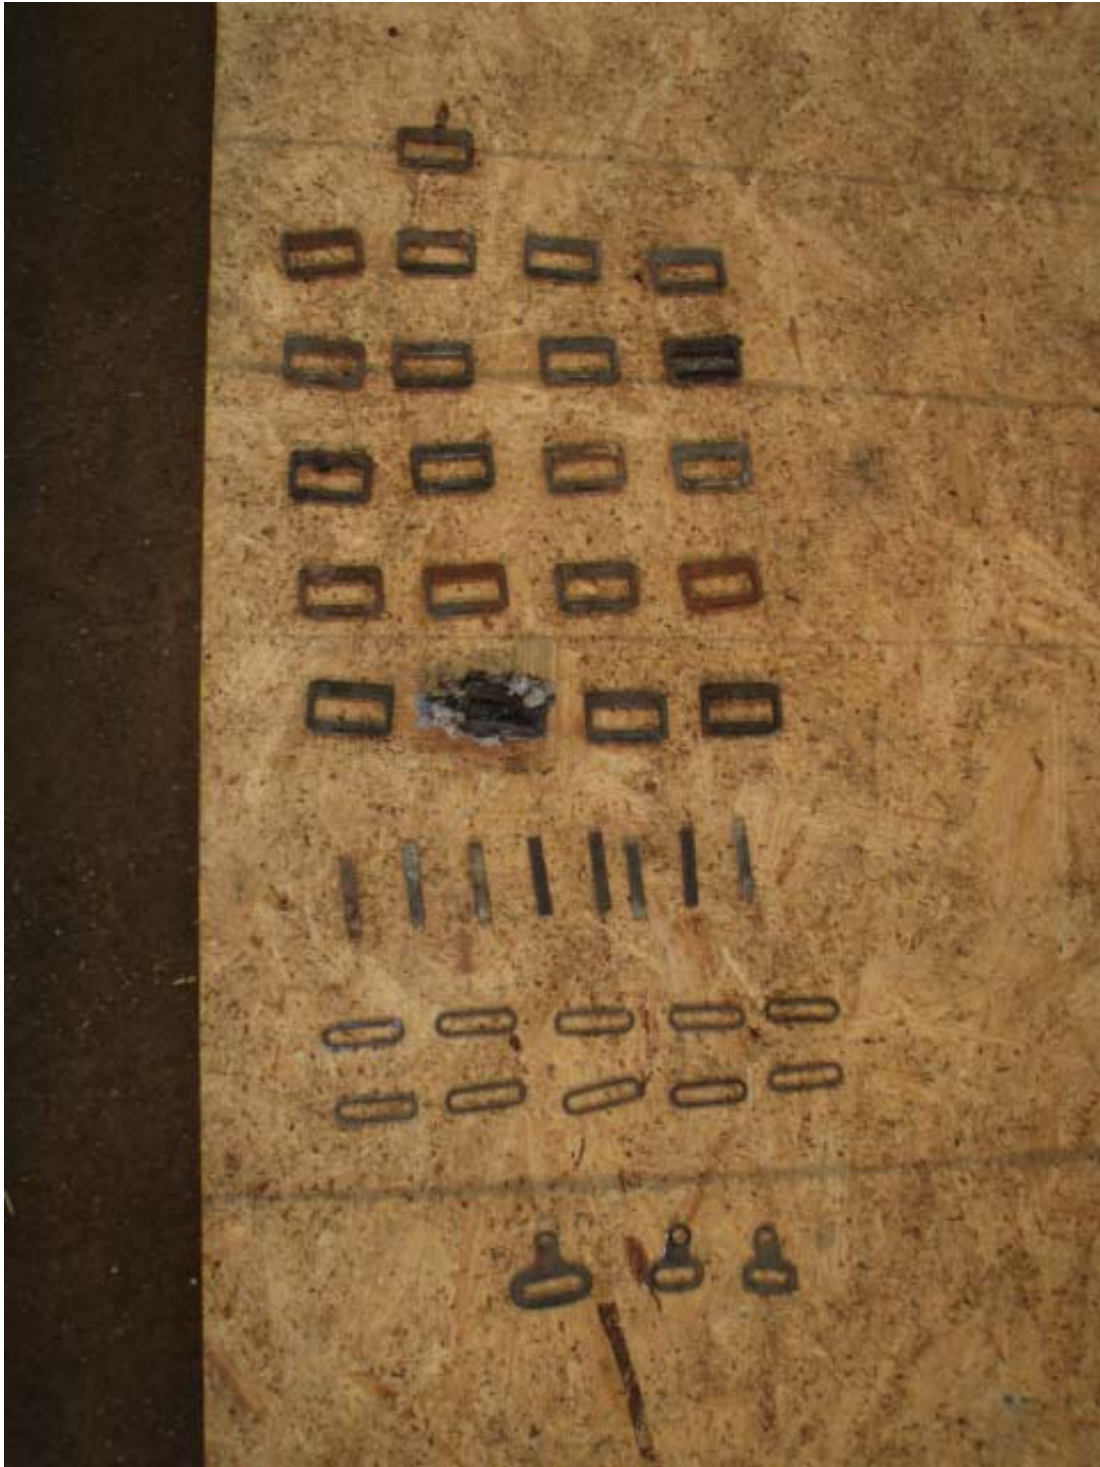
17. View of restraint steel hardware pieces that were found in the wreckage.
Note: One lap-latch fitting and 2 shoulder restraint fittings are shown at the bottom of this photograph.

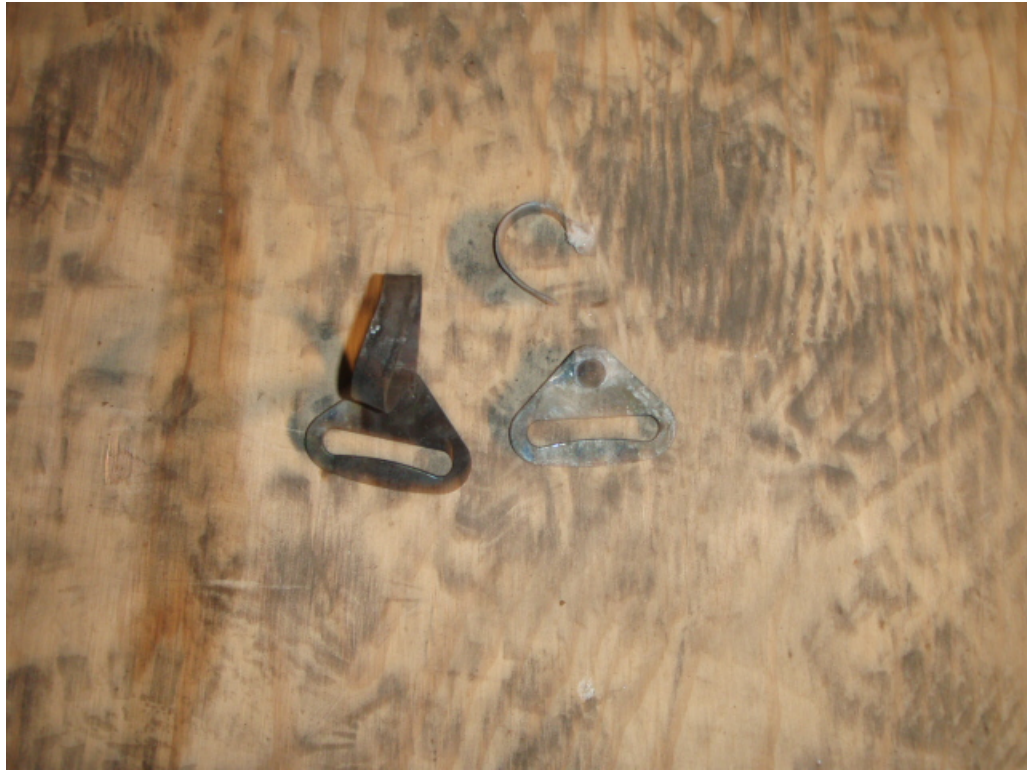
18. View of two shoulder restraint end fittings. The end fitting on the right became separated from the aidel clamp.

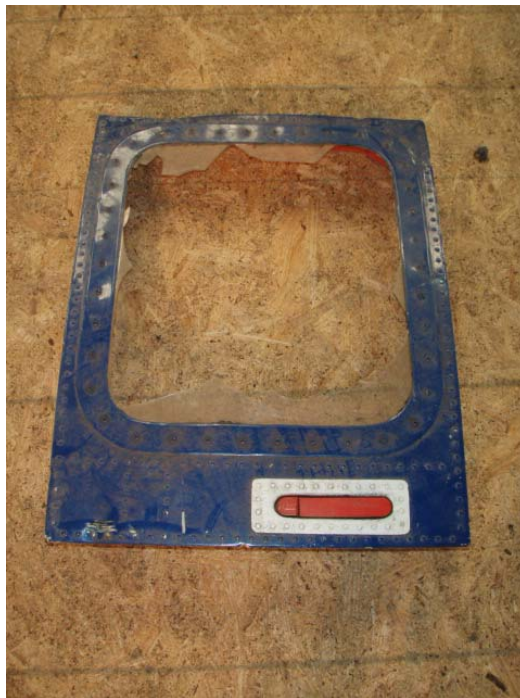
19. View of the left emergency exit hatch from N612AZ.
