United Airlines
New Orleans, LA
April 4, 2011
DCA11IA040

National Transportation Safety Board
Washington, D.C.

Attachment 3

Photographs of 1R and 2L Slide/Raft Examinations

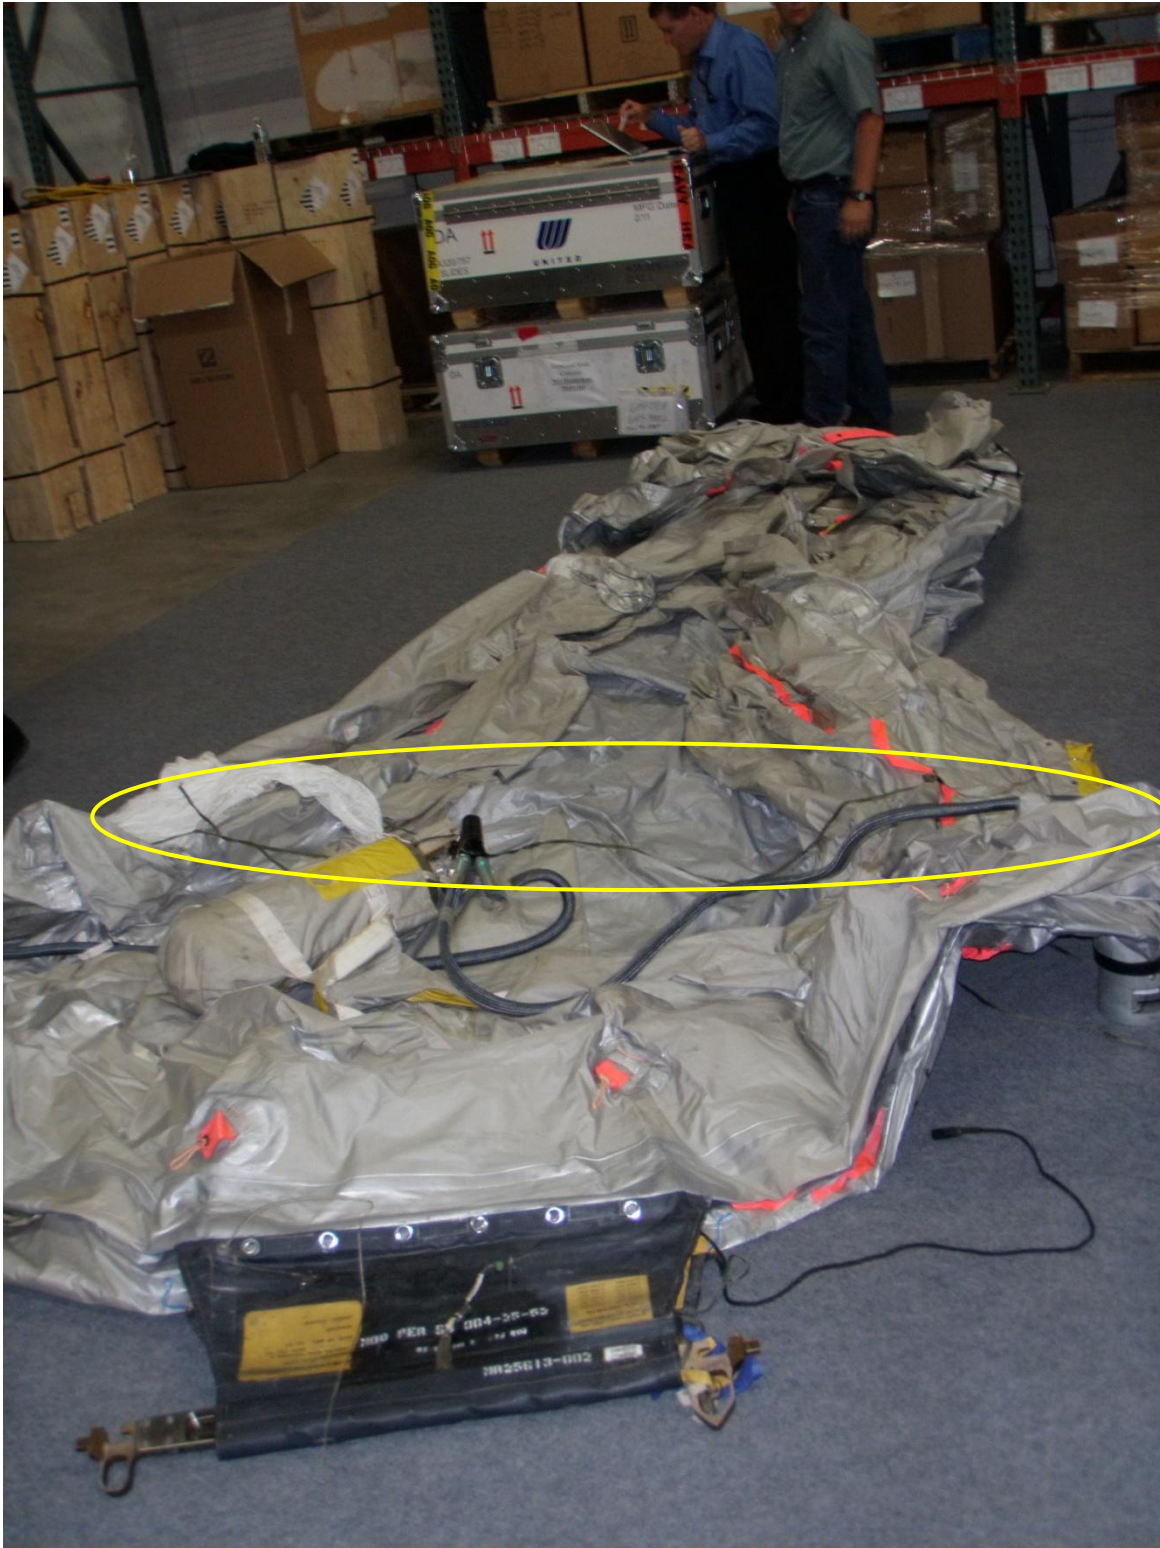
1. Photograph of inverted 1R slide/raft (bottom facing up)
Note: Yellow oval shows the thin sea anchor line between the pouch and aft aspirator.

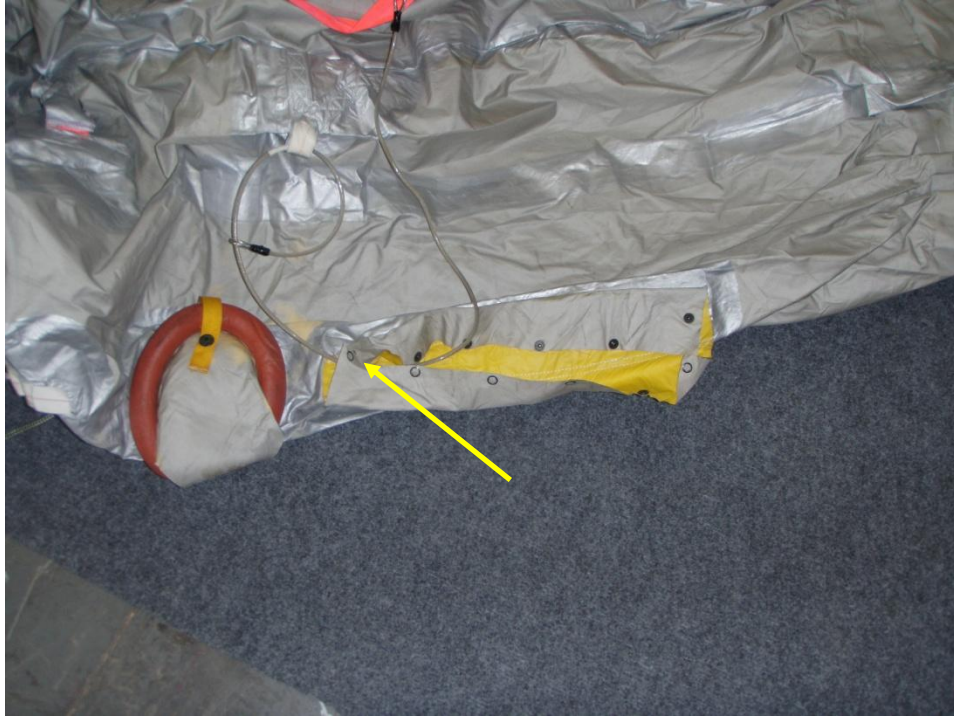
2. Photograph showing the sea anchor pouch as it was found with the stainless steel cable routed through the sill end of the pouch.

Note: The yellow arrow points to the single snap that remained snapped

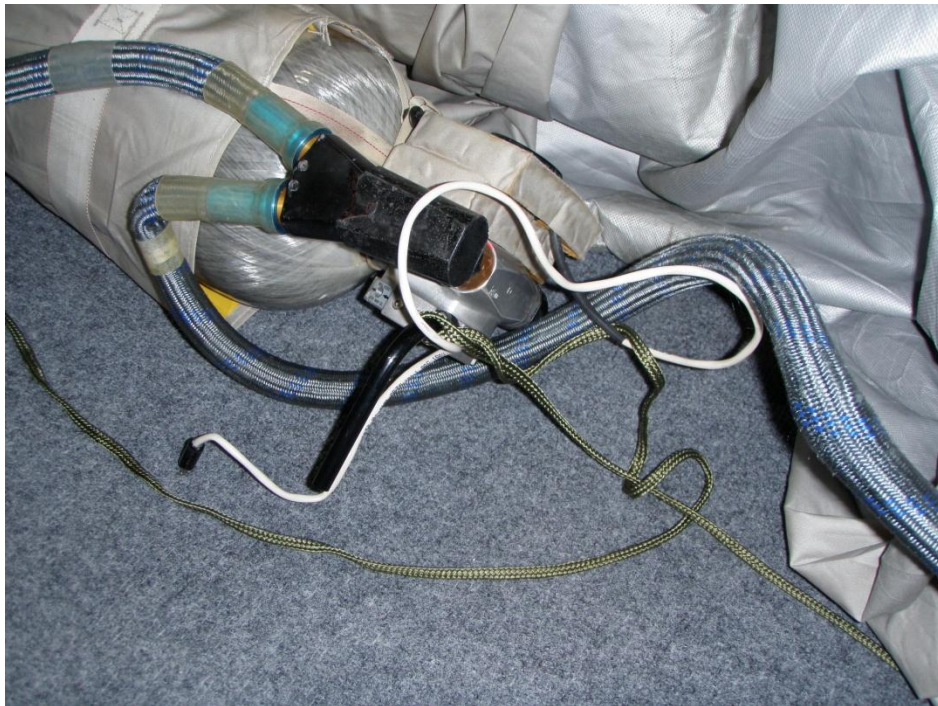
3. View of the sea anchor line wrapped around inflation bottle lead.

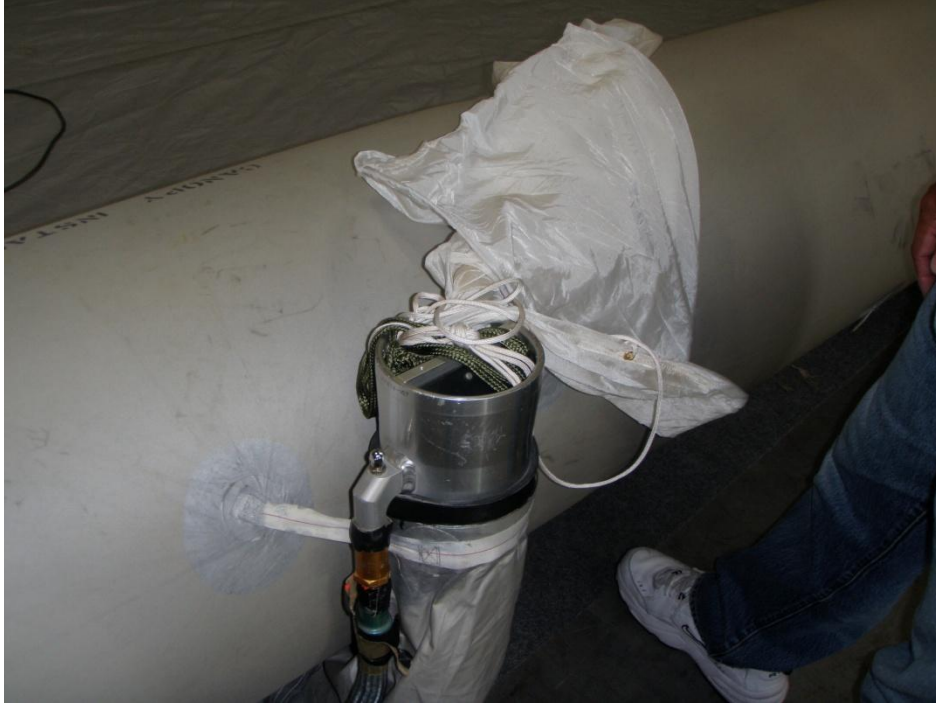
4. Close up view of the sea anchor and sea anchor line ingested in 1R aft aspirator.

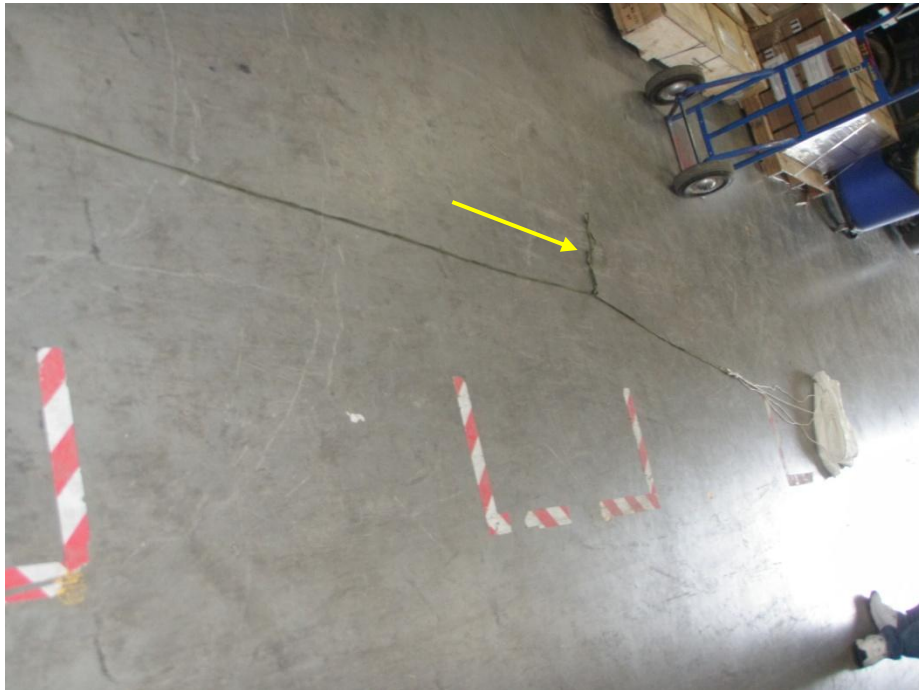
5. Photograph of the sea anchor and sea anchor line stretched out on the shop floor.
Note: The yellow arrow points to the knot in the sea anchor line.

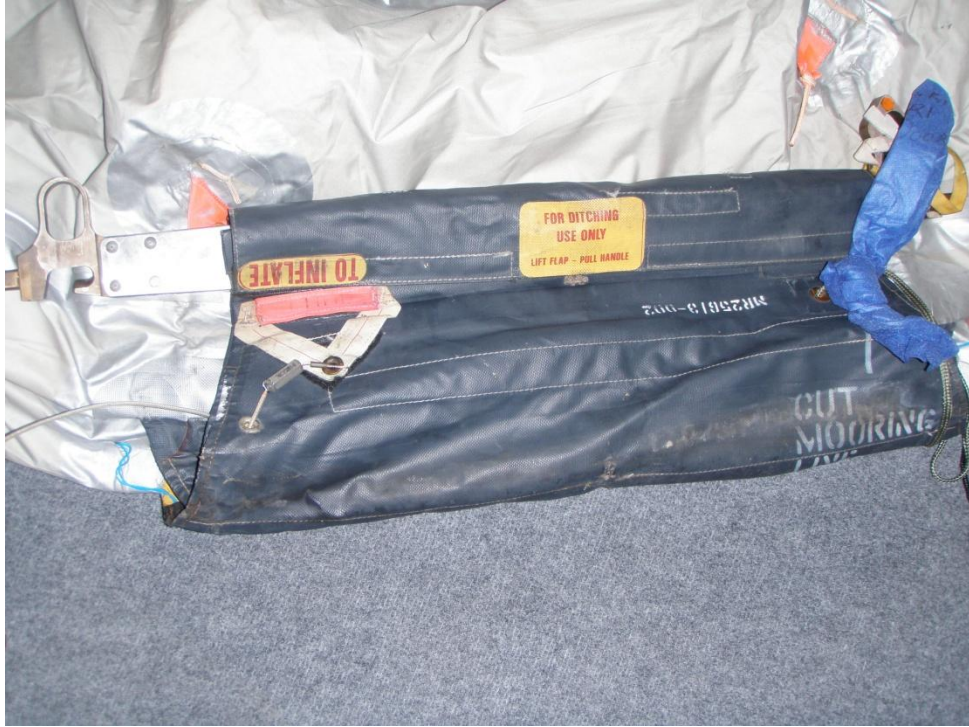
6. Photograph of the manual inflation handle found attached to the 1R girt.

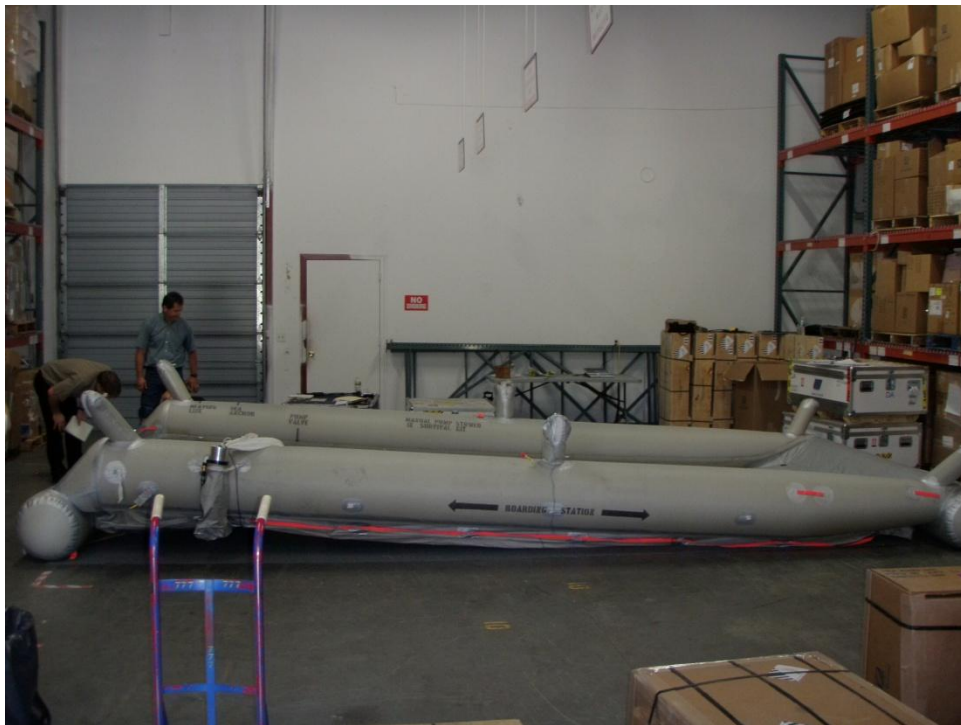
7. Photograph of the 1R slide/raft inflated with the sea anchor ingested in the aft aspirator.

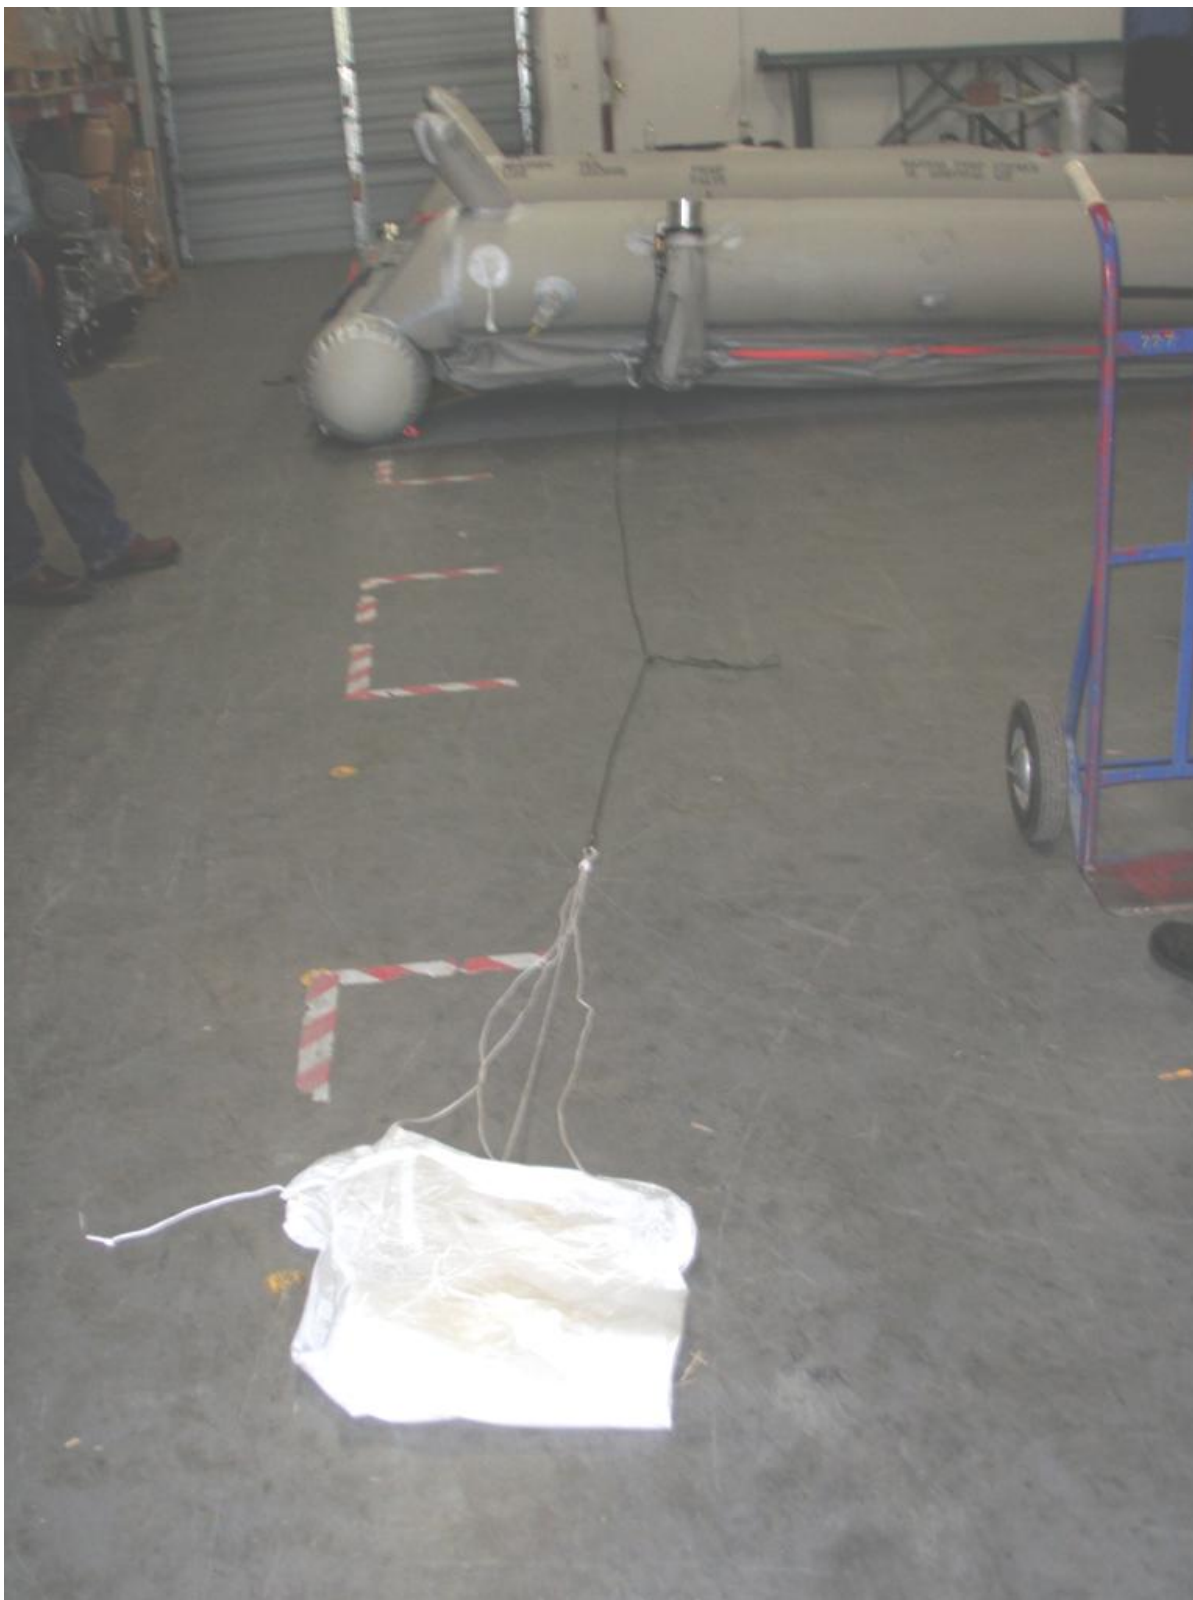
8. Photograph of the 1R slide/raft with the sea anchor removed from the aspirator
Note: The slide/raft lower tube partially deflated.

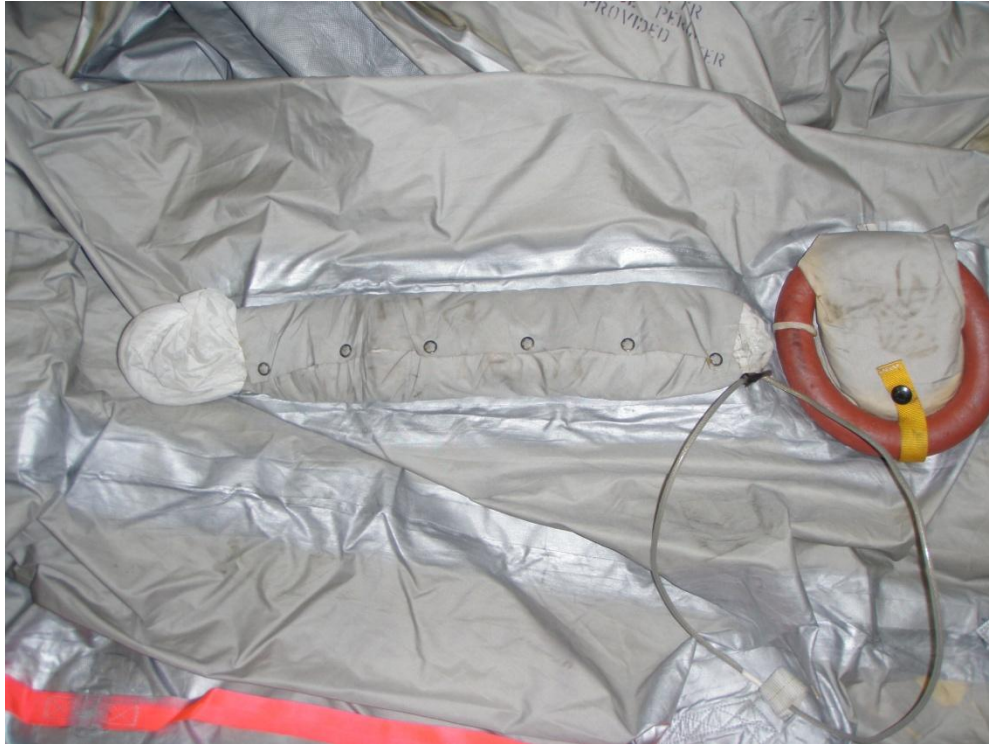
9. Photograph of the 2L slide/raft sea anchor pouch and stainless steel cable secured to the slide.

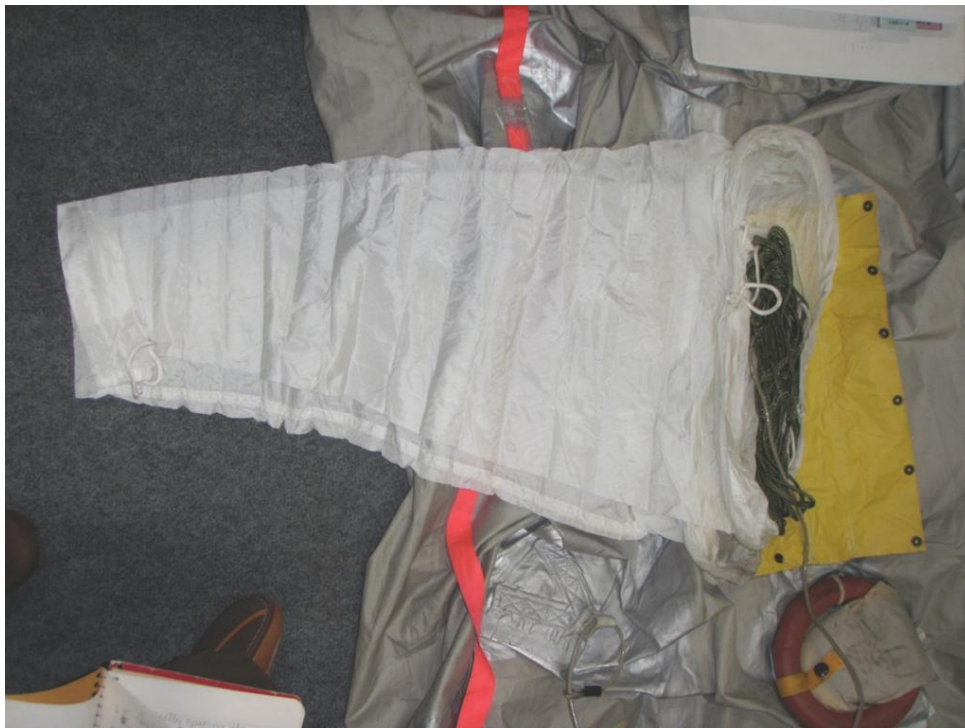
10. View of the unpacked 2L slide/raft sea anchor.

Note: The sea anchor was found stowed in accordance with OEM vendor packing requirements.

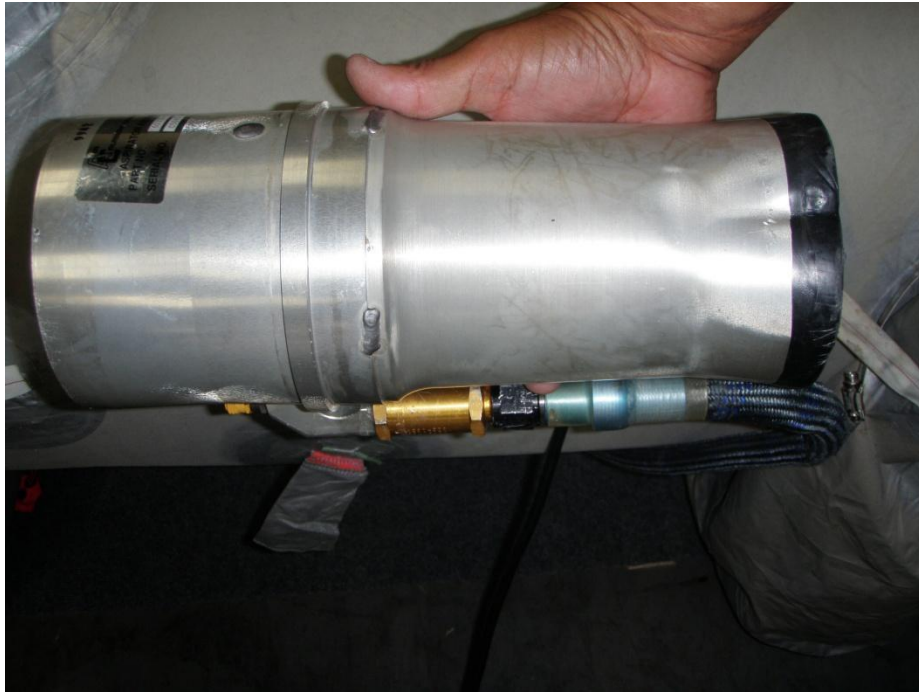
11. Side view of the disassembled forward aspirator chamber
Note: The damaged and dented chamber.
