Gulfstream G-150, N480JJ  
Key West, Florida  
October 31, 2011  
ERA12FA056

National Transportation Safety Board  
Washington, D.C.

Attachment 3

Photographs

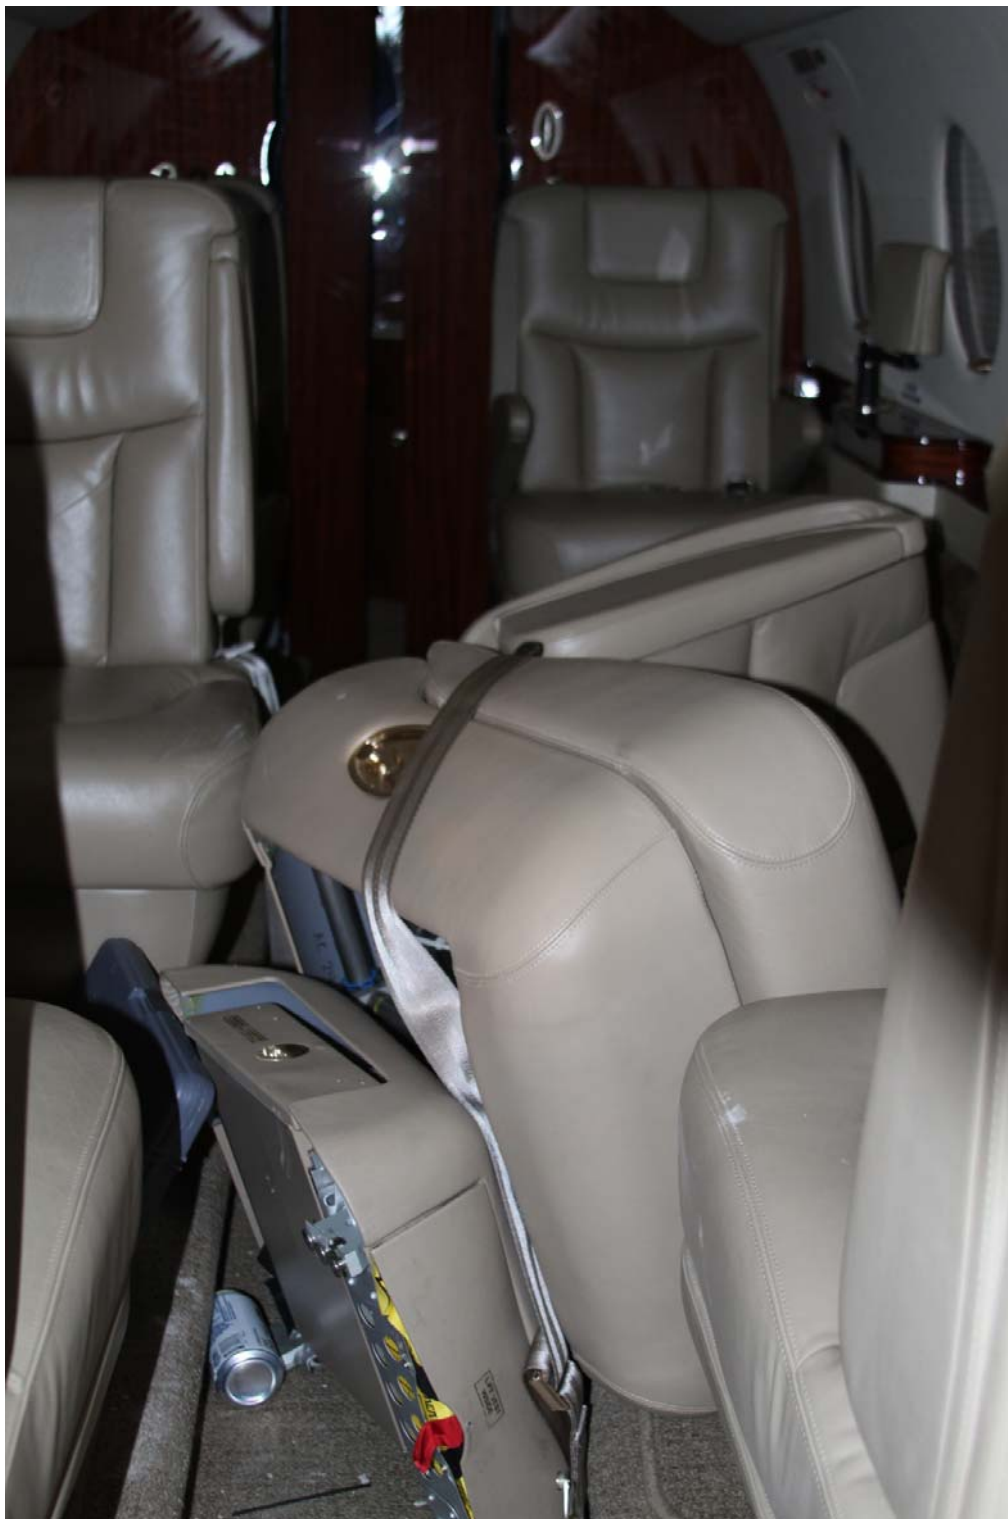
Photo No. 1: Seat L/H#2 (taken by NTSB investigator on scene).

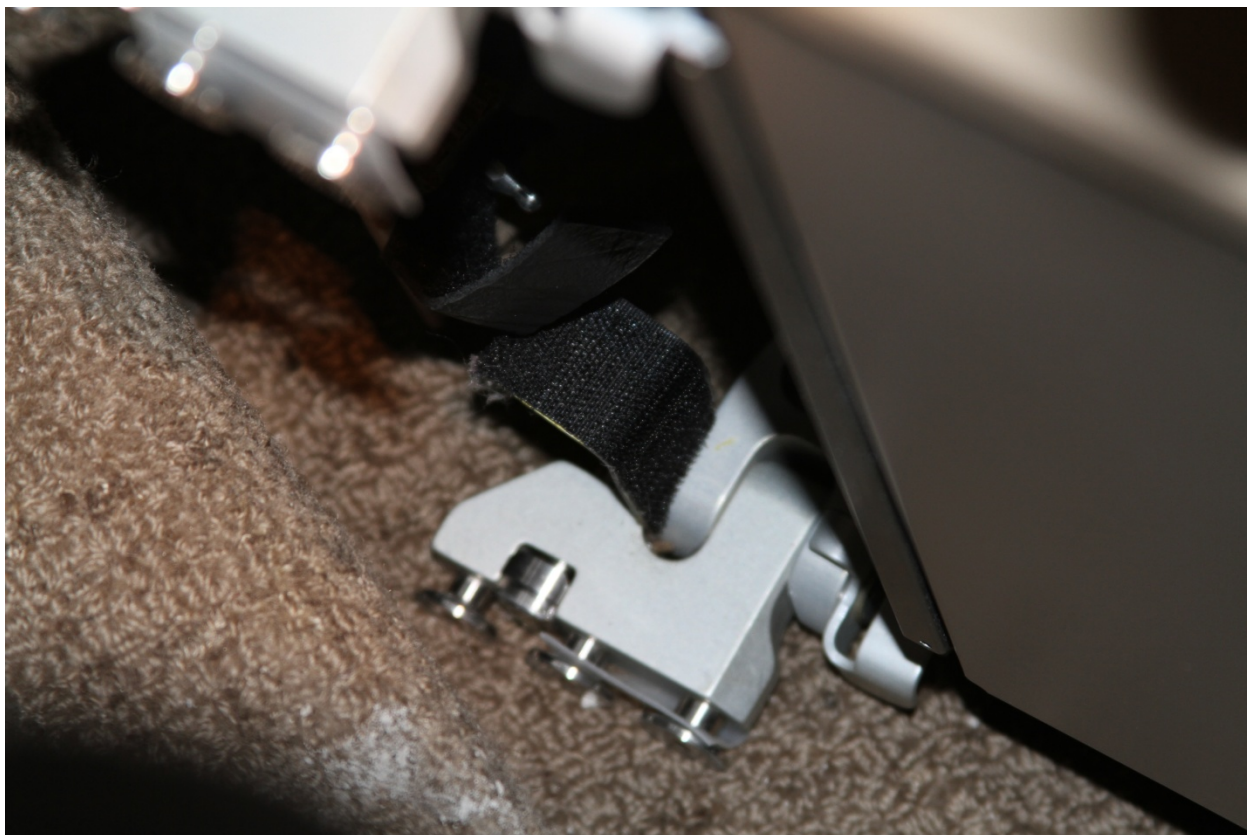
Photo 2: L/H #2 seat fitting (photo taken by NTSB investigator during on scene investigation).

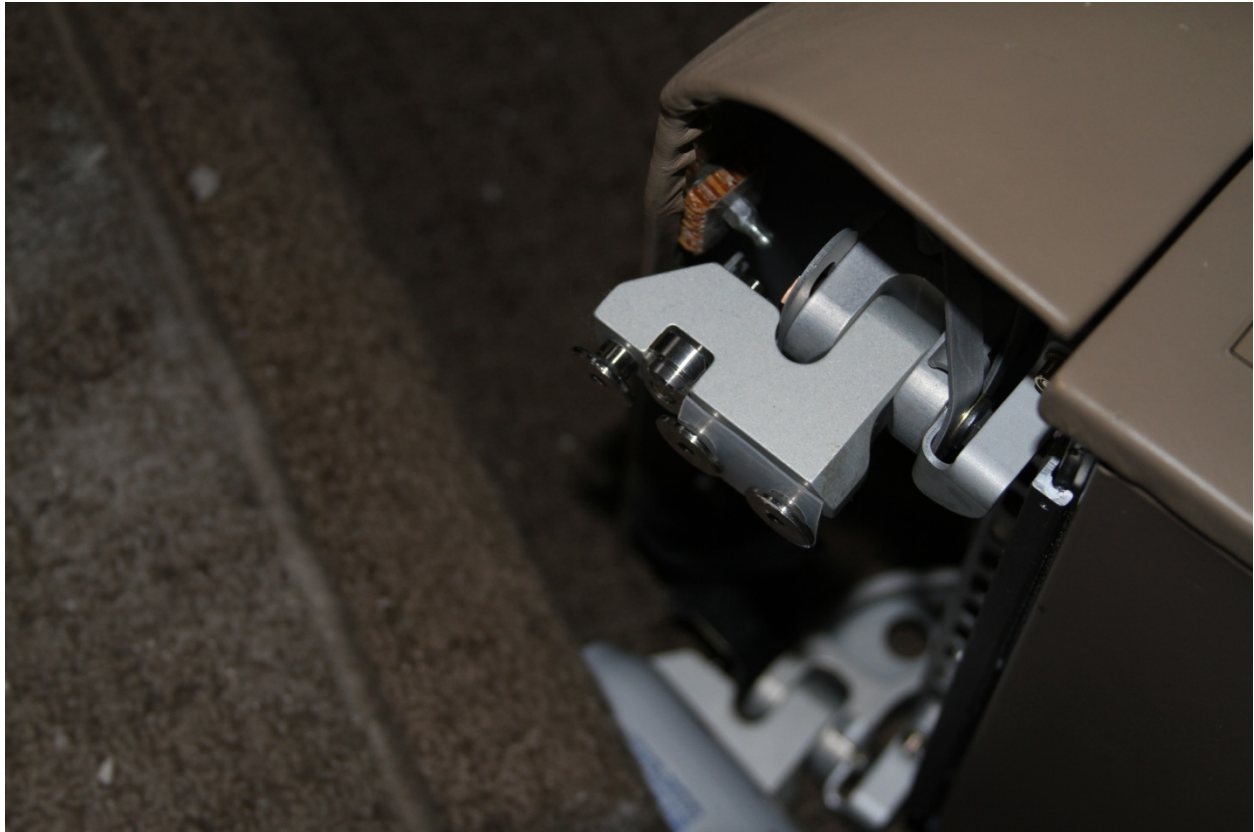
Photo 3: L/H #2 seat fitting (photo taken by NTSB Investigator during on scene investigation).

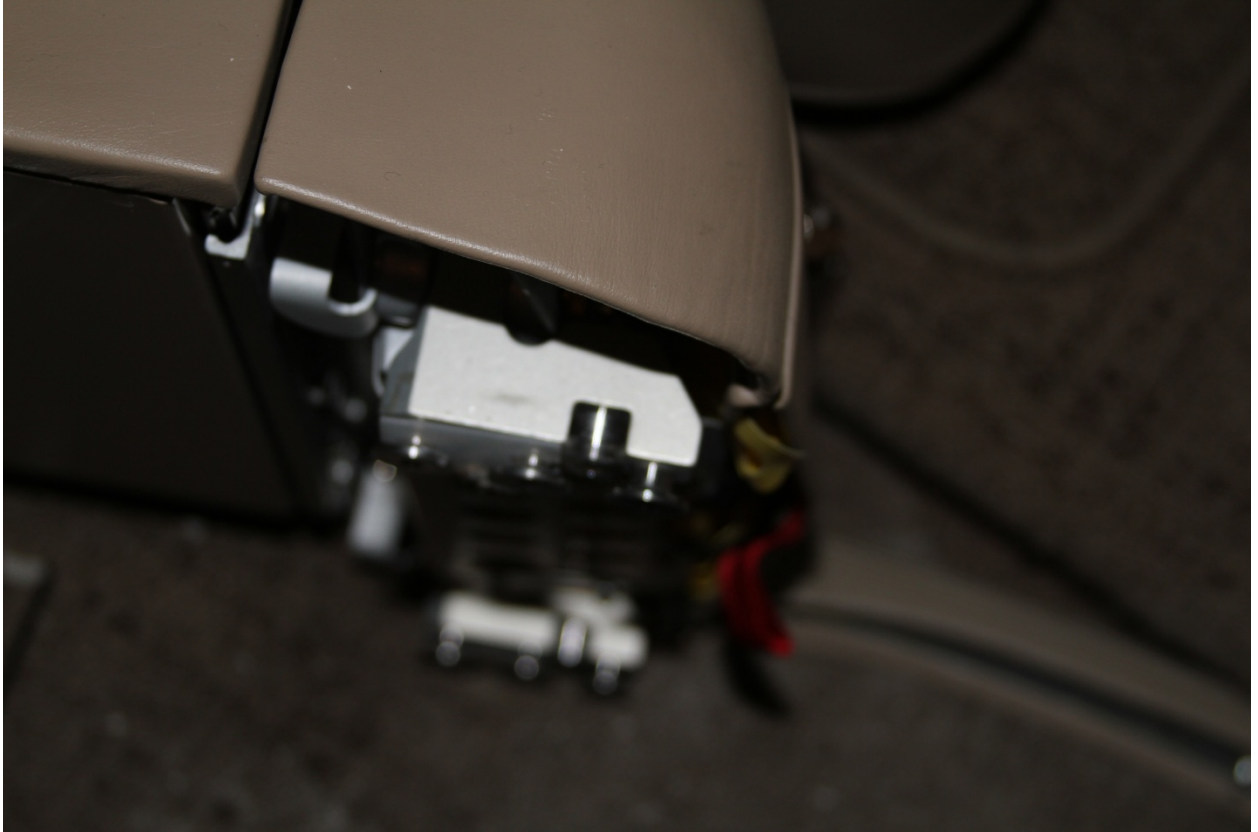
Photo 4: L/H #2 seat fitting (photo taken by NTSB investigator during on scene investigation).

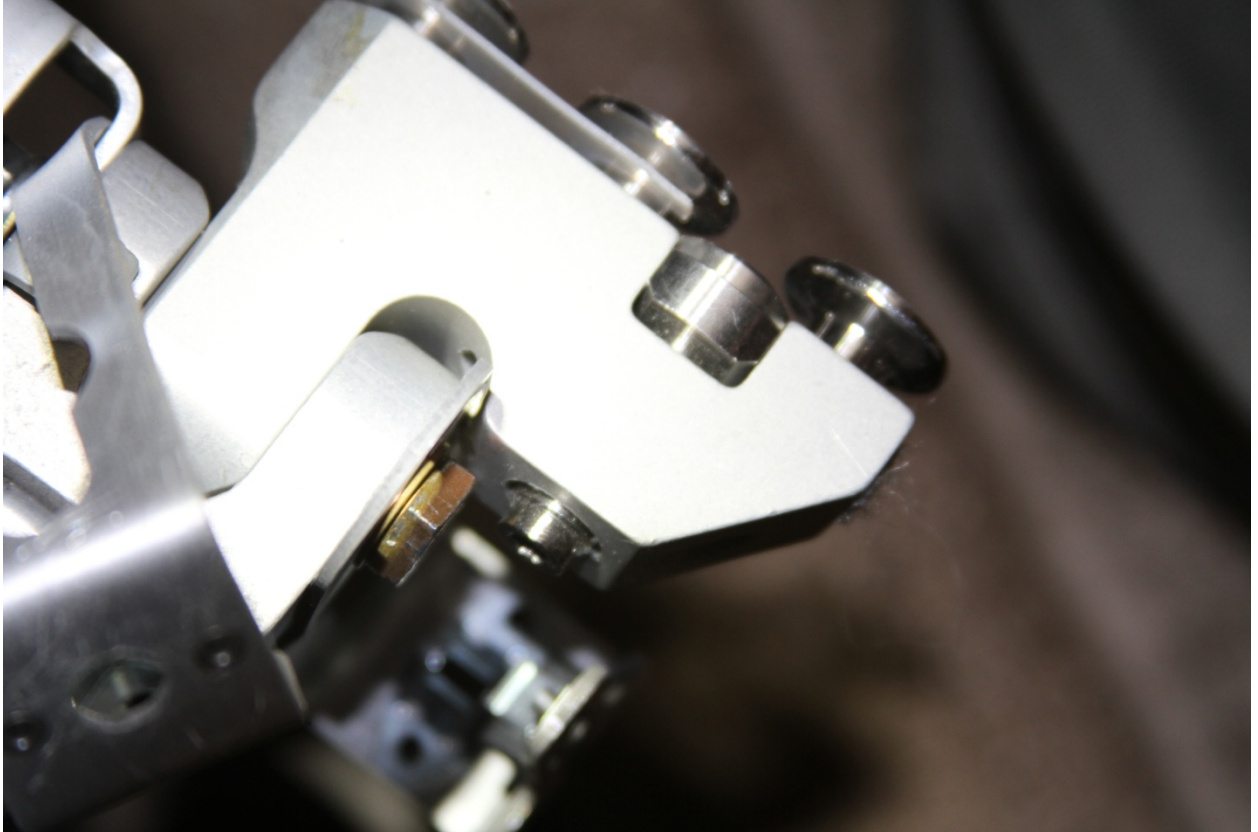
Photo 5: L/H #2 seat fitting (photo taken by NTSB investigator during on scene investigation).

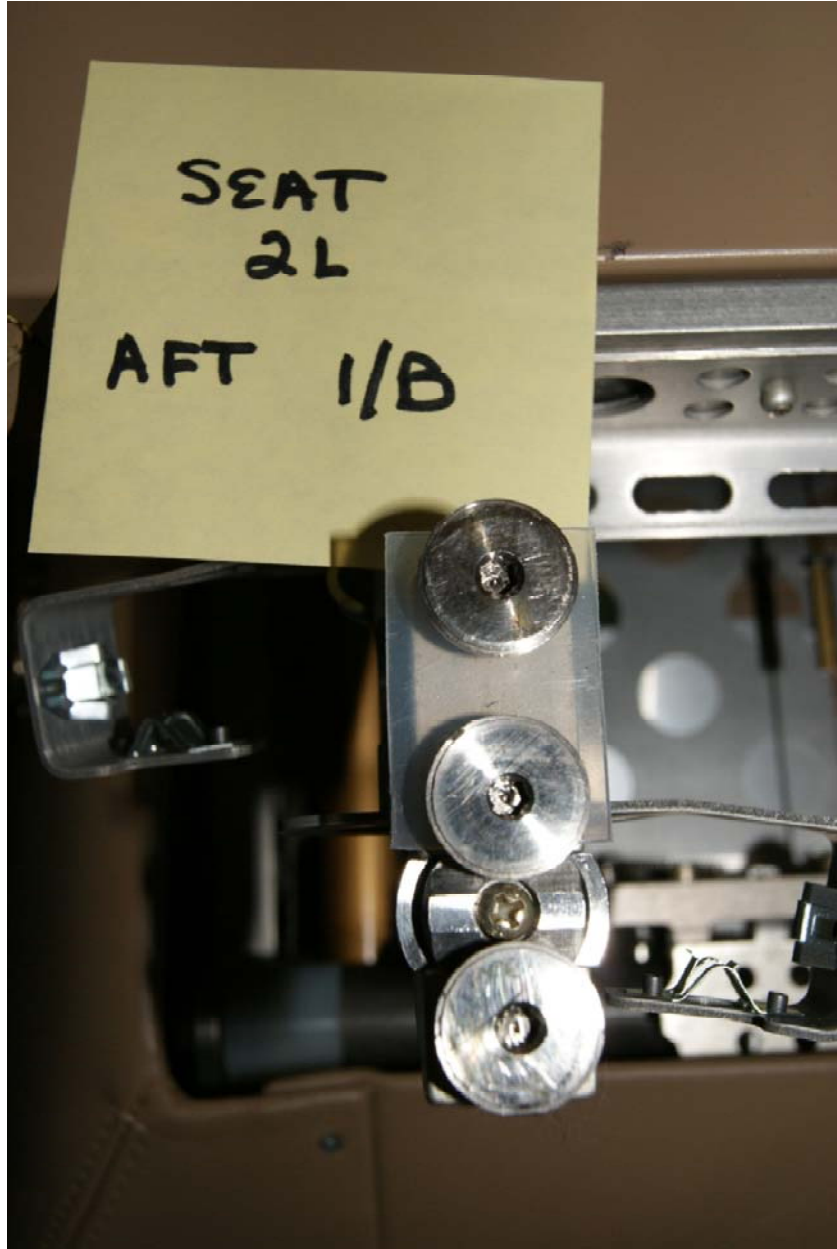
Photo 6: Seat L/H #2 aft inboard fitting plunger.

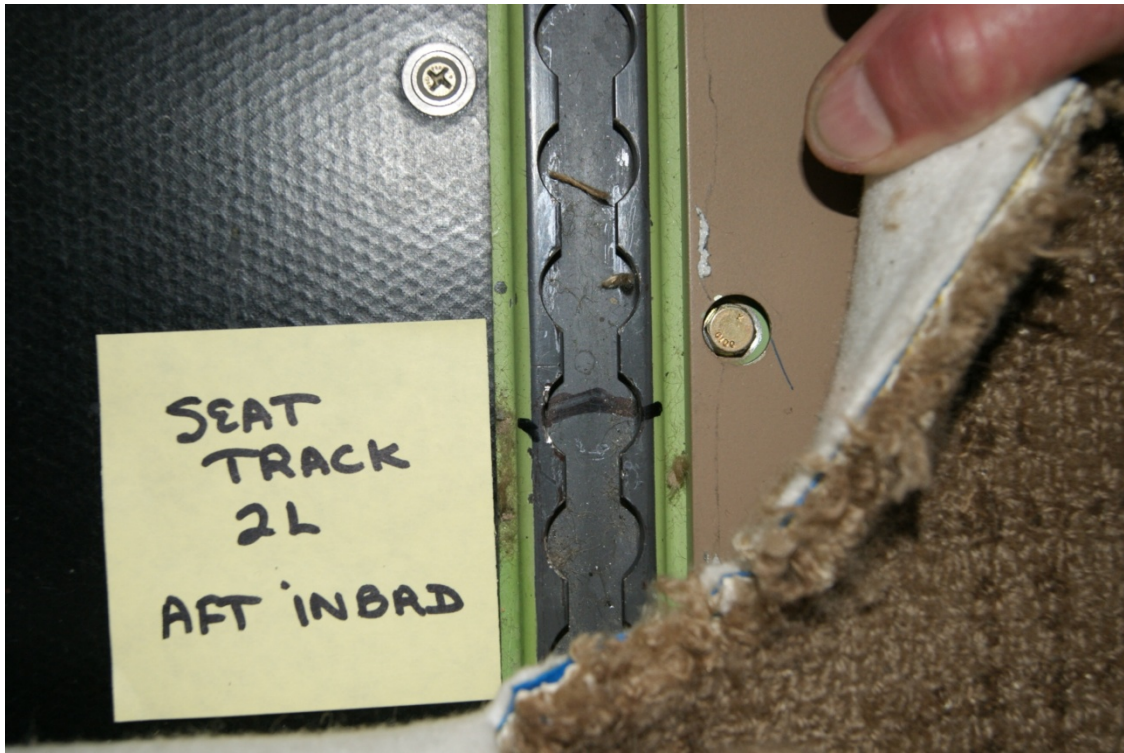
Photo 7: Seat L/H #2 aft inboard seat track.

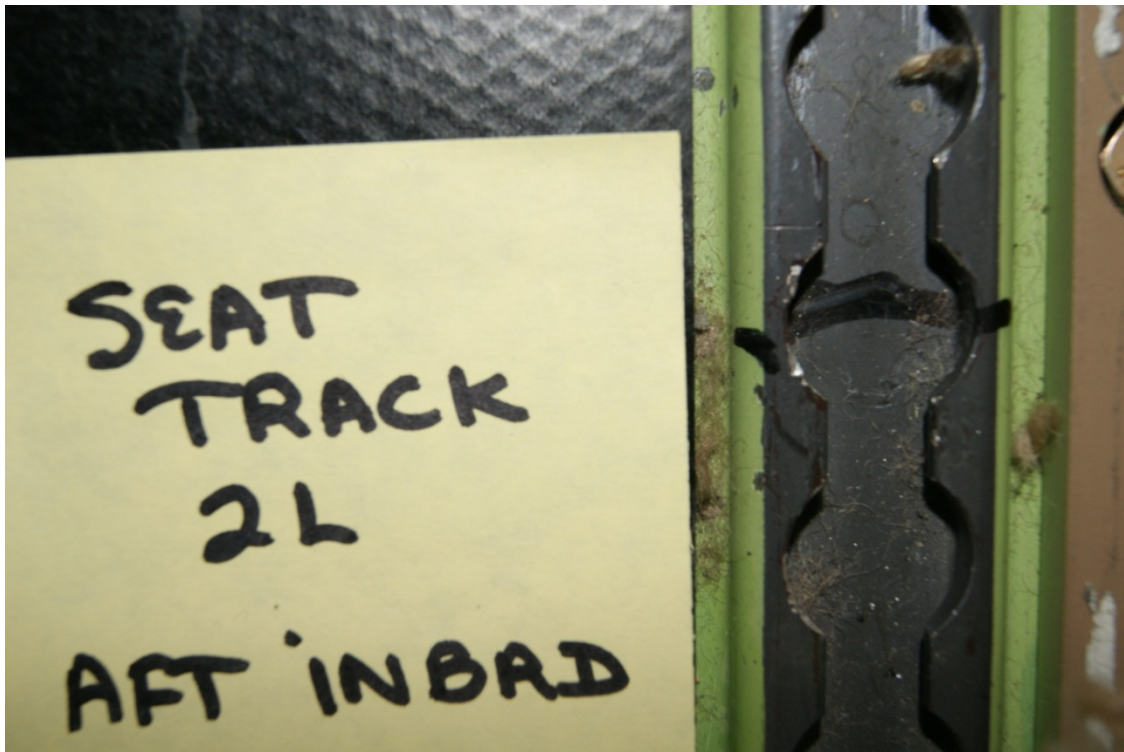
Photo No. 8: Seat L/H #2 aft inboard seat track.

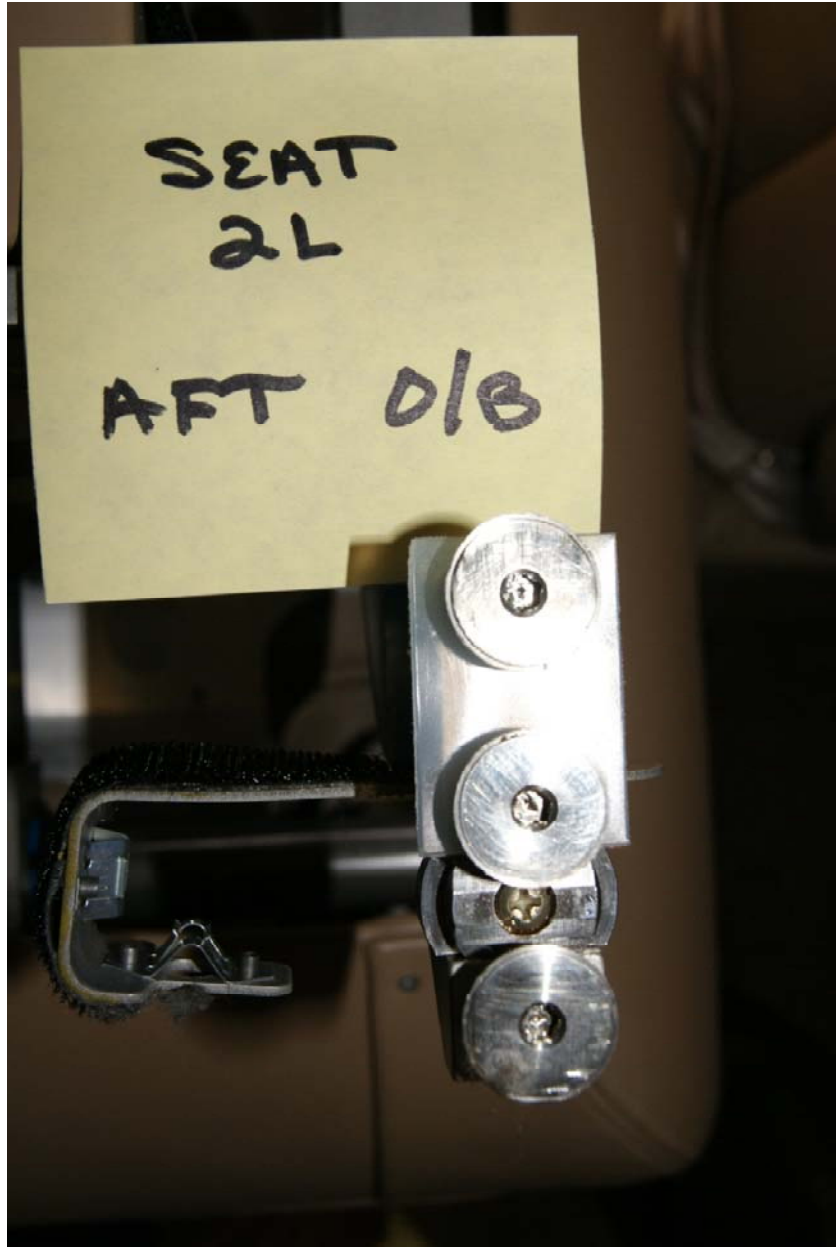
Photo 9: Seat L/H #2 aft outboard seat fitting plunger.

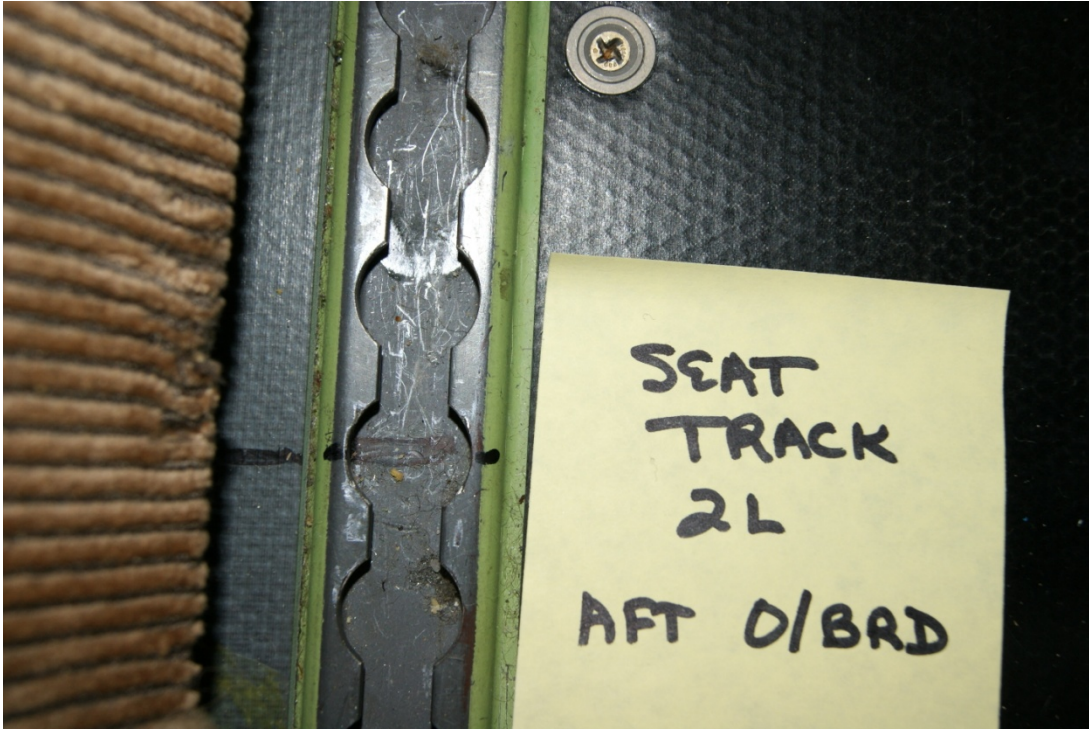
Photo 10: Seat L/H #2 aft outboard seat track.

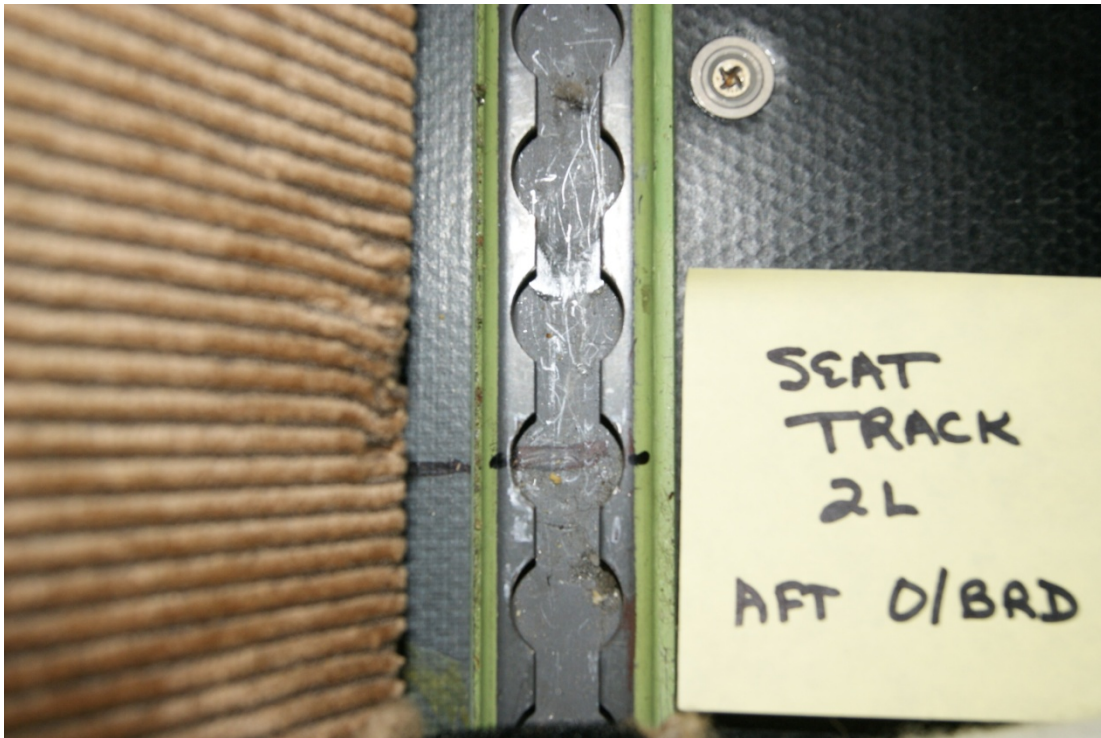
Photo 11: Seat L/H #2 aft outboard seat track.

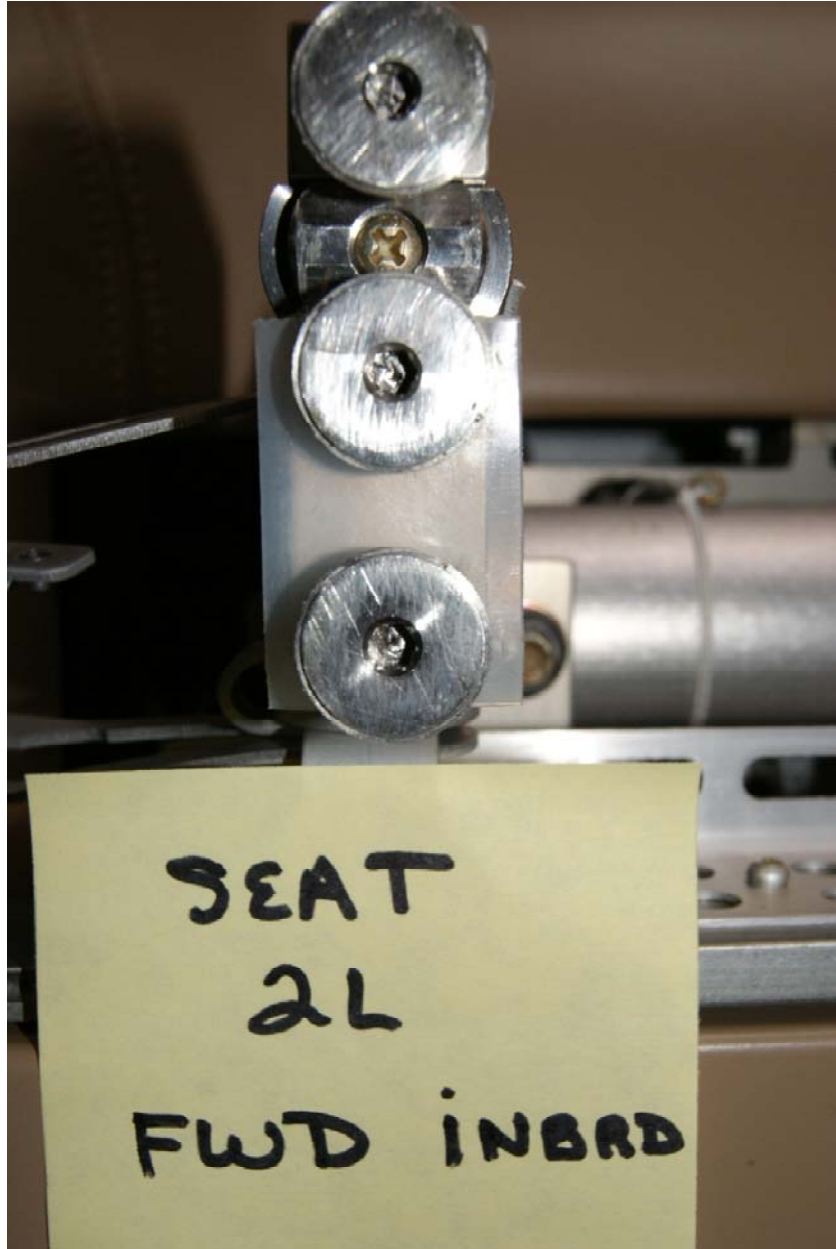
SEAT  
2L  
FWD INBRD

Photo 12: Seat L/H#2 forward inboard seat fitting plunger.

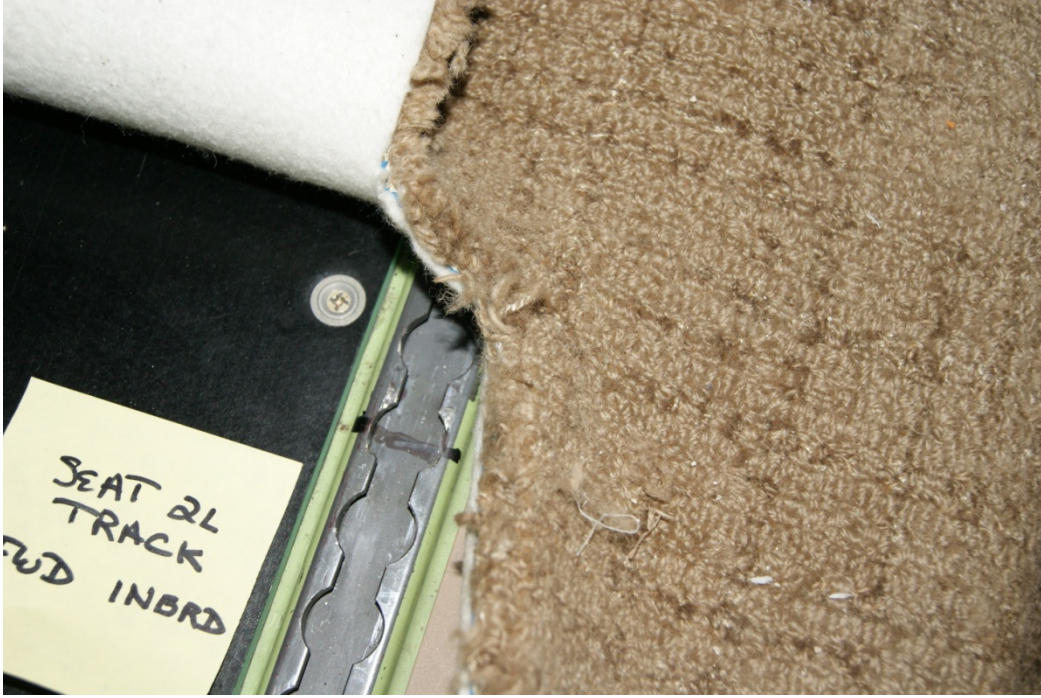
Photo 13: Seat L/H #2 forward inboard seat track.

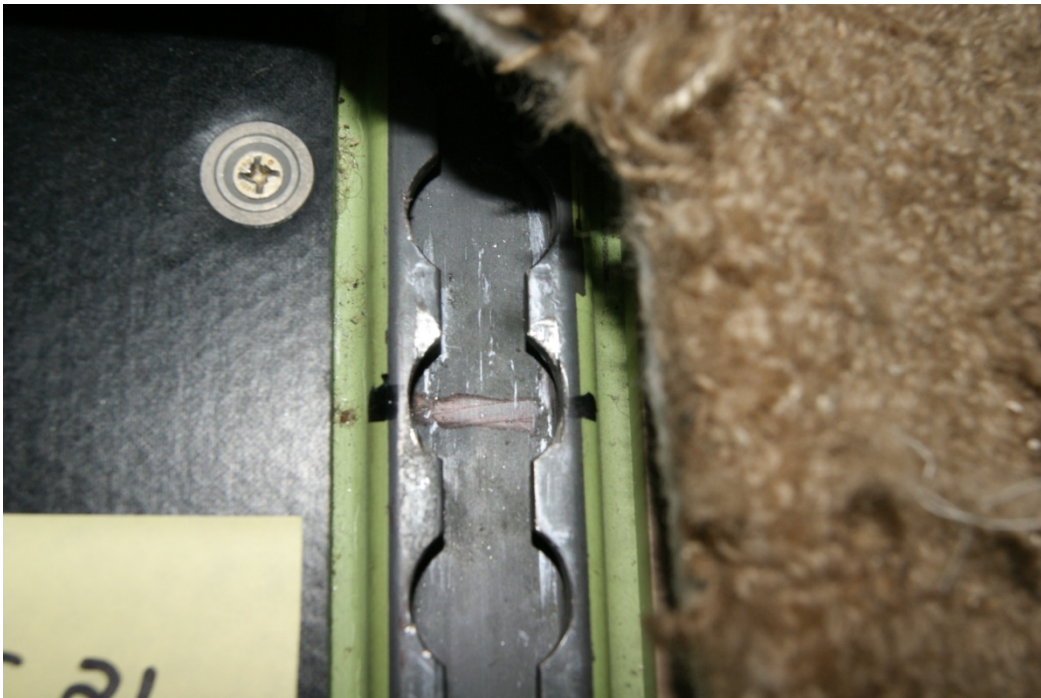
Photo 14: Seat L/H #2 forward inboard seat track.

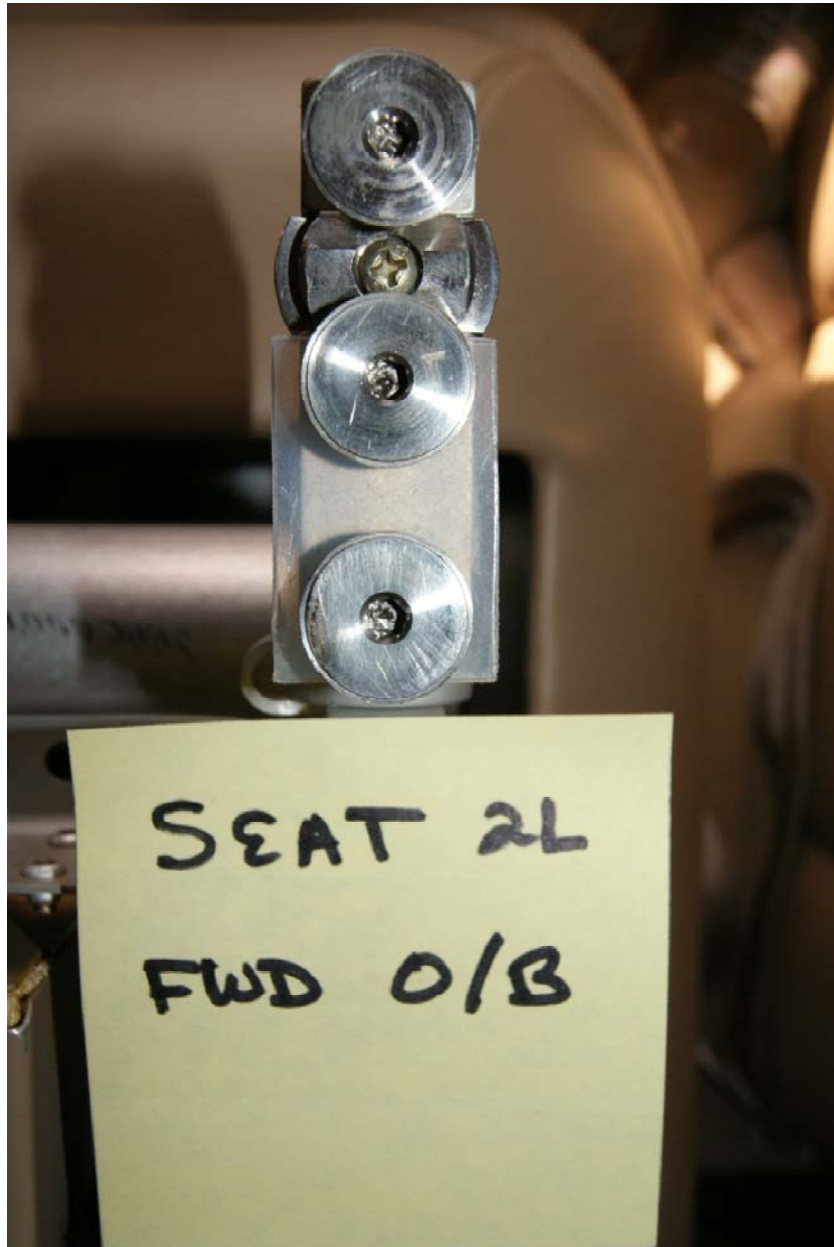
Photo 15: Seat L/H #2 forward outboard fitting plunger.

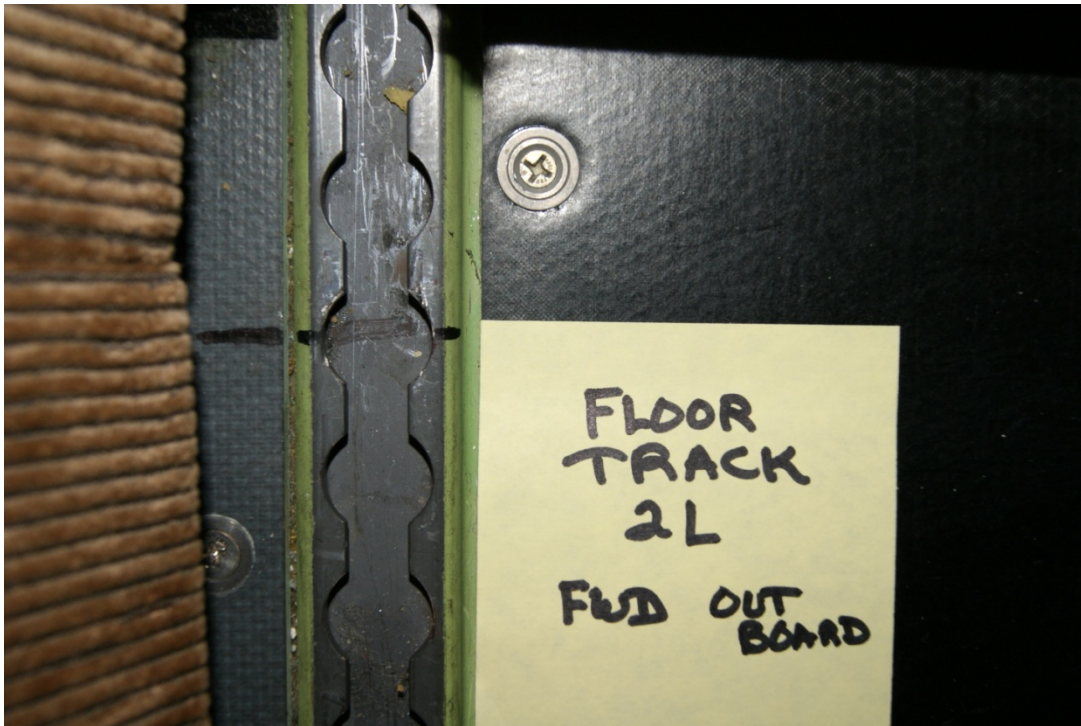
Photo 16: Seat L/H #2 forward outboard seat track.

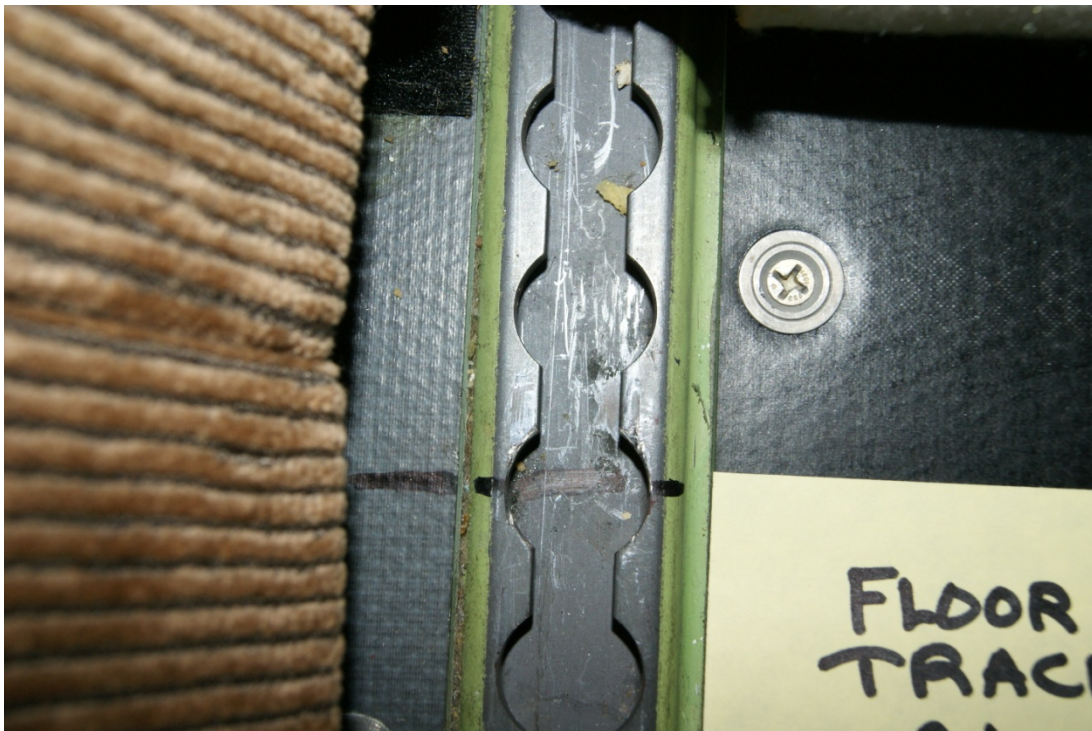
Photo 17: Seat L/H #2 forward outboard seat track.

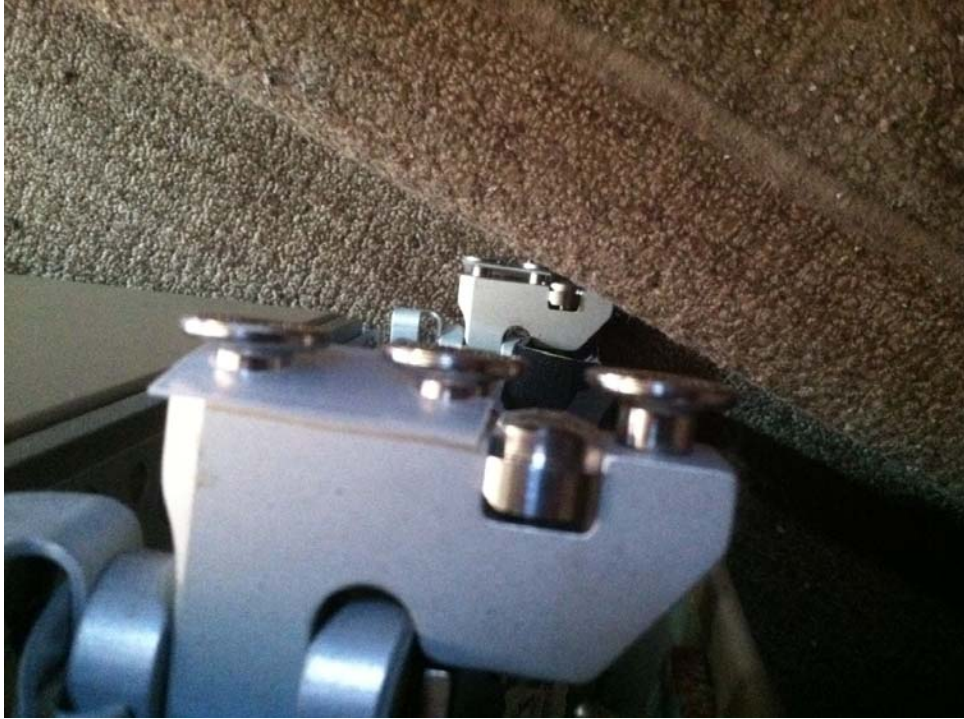
Photo 18: Seat L/H #2 seat fitting (photo taken by Hendrick Motorsports (HMS) staff during on scene investigation).

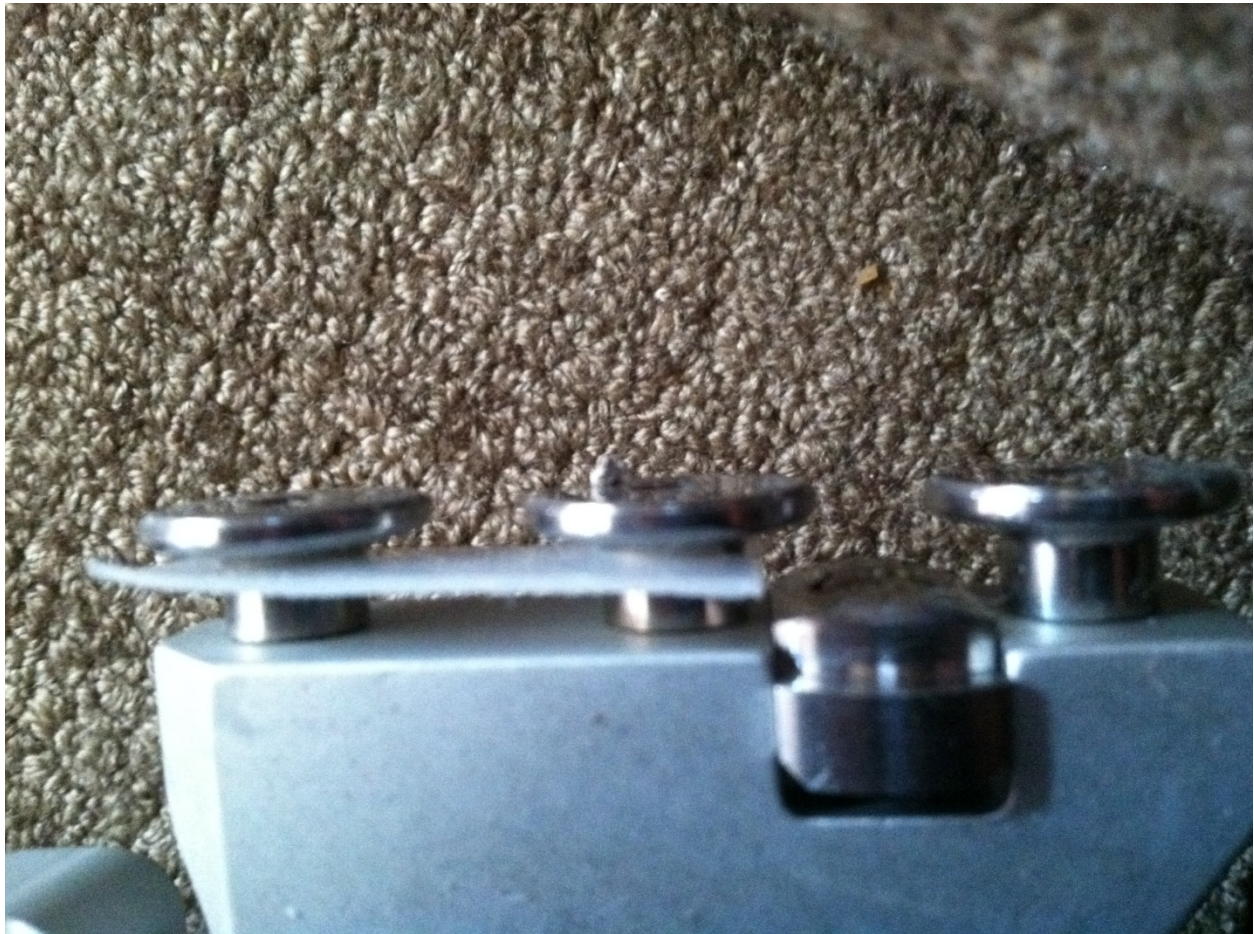
Photo 19: Seat L/H #2 seat fitting (photo taken by HMS staff during on scene investigation).

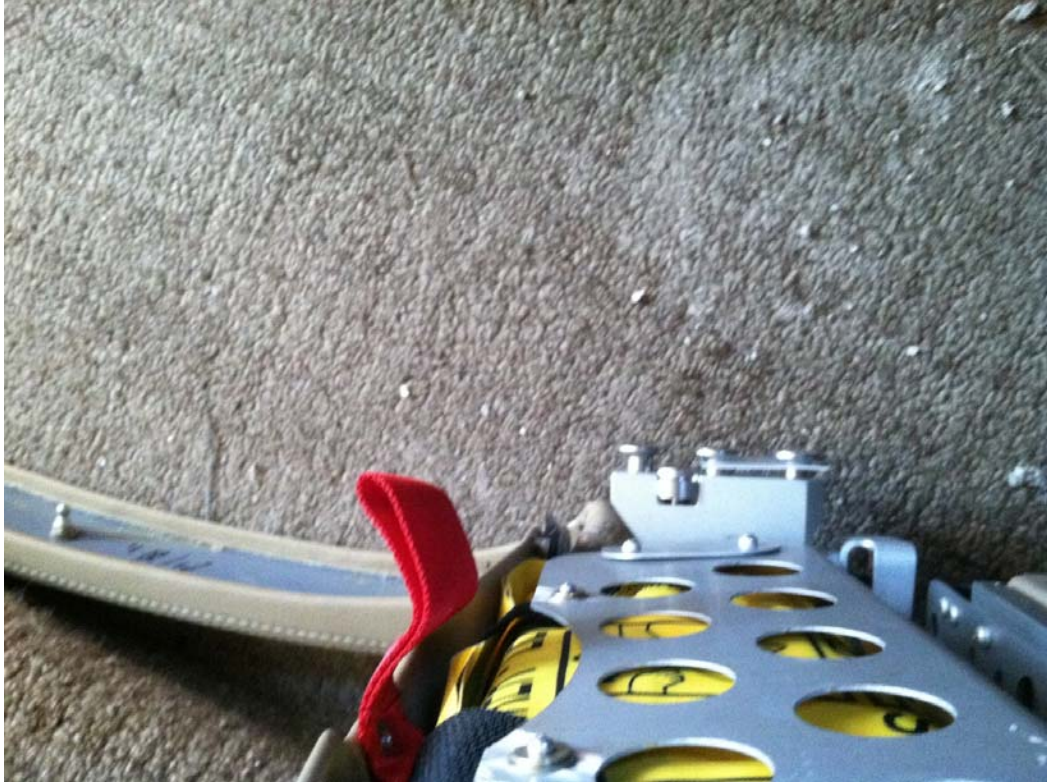
Photo 20: Seat L/H #2 seat fitting (photo taken by HMS staff during on scene investigation).

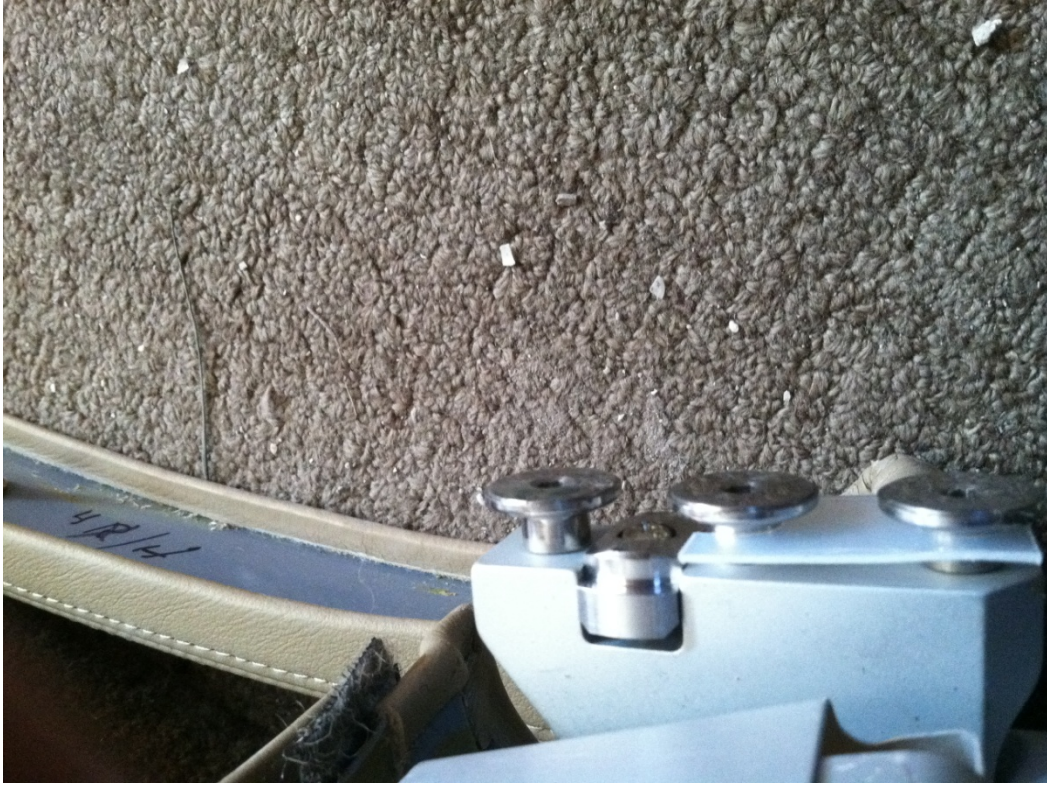
Photo 21: Seat L/H #2 seat fitting (photo taken by HMS staff during on scene investigation).

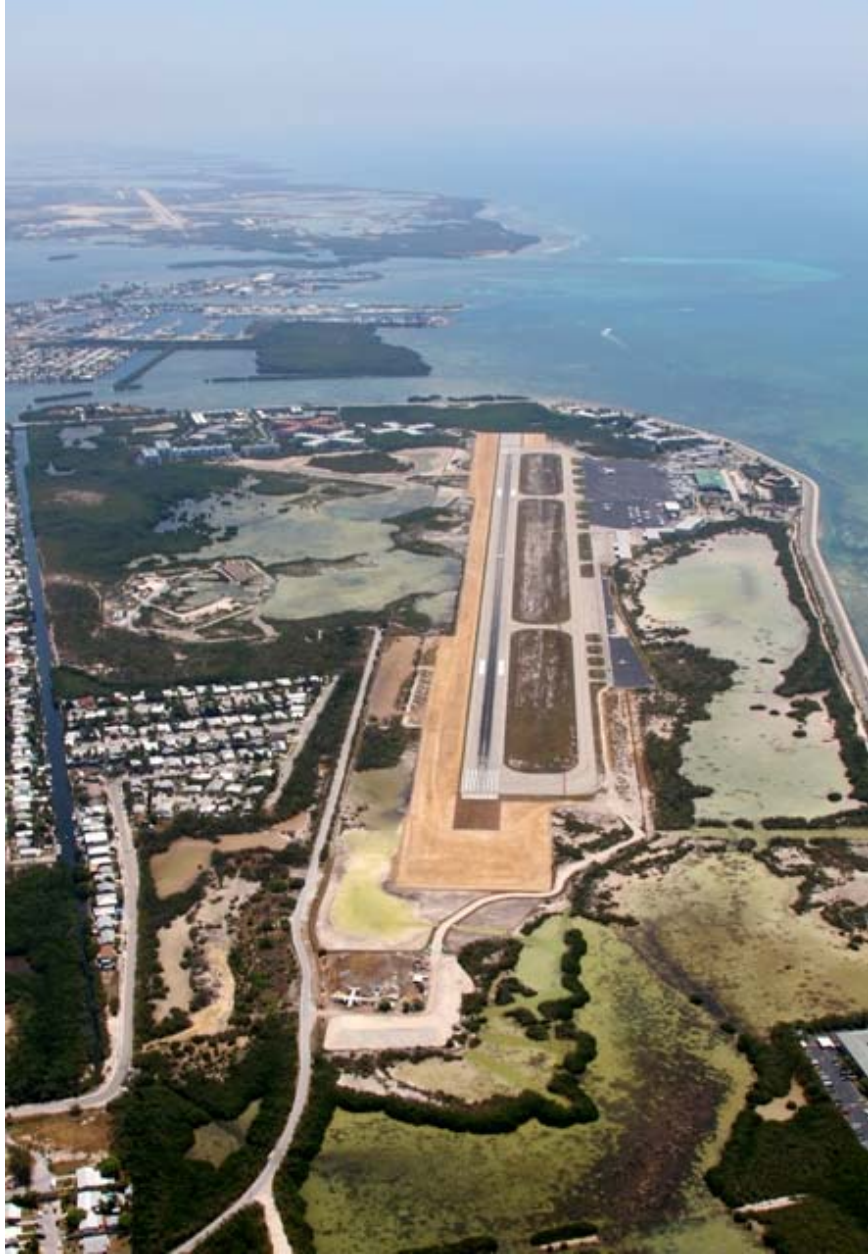
Photo 22: Aerial view of completed RSA reconfiguration.

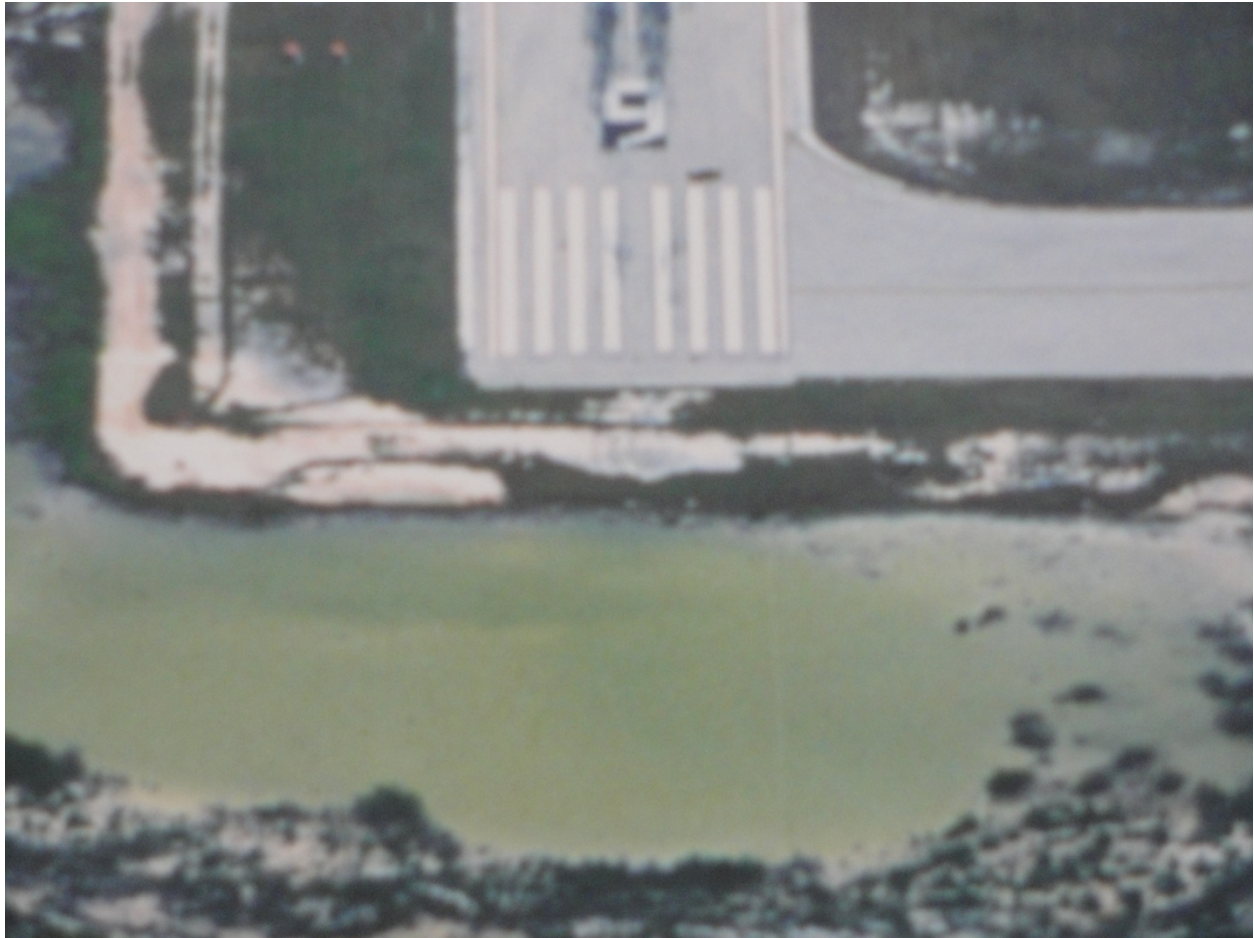
Photo 23: West end of EYW runway 9/27 before RSA improvements.
