Gulfstream G-150, N480JJ  
Key West, Florida  
October 31, 2011  
ERA12FA056

National Transportation Safety Board  
Washington, D.C.

Attachment 3

Photographs

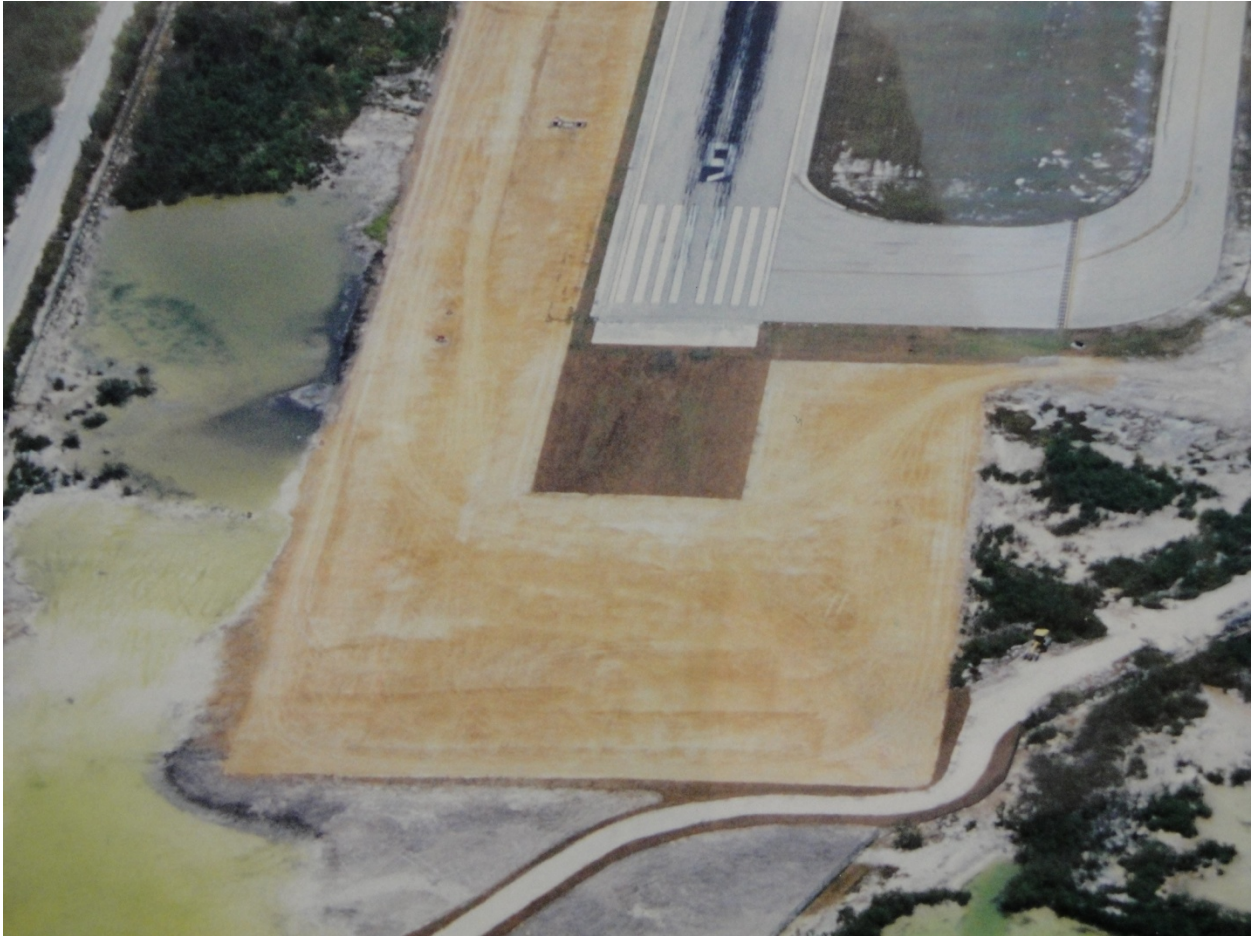
Photo No. 24

West end of runway 9/27 after RSA Improvement.
