DCA98MA015  
December 28, 1997  
Over Pacific Ocean

Chime Amplifier Tear-Down Report

**Subject:** DCA98MA015

**EXAM OF THE "AIRCRAFT PASSENGER ADDRESS AMPLIFIER" COMPONENT, IN FOLLOW-UP TO THE 12/28/97 ACCIDENT INVOLVING N4723U.**

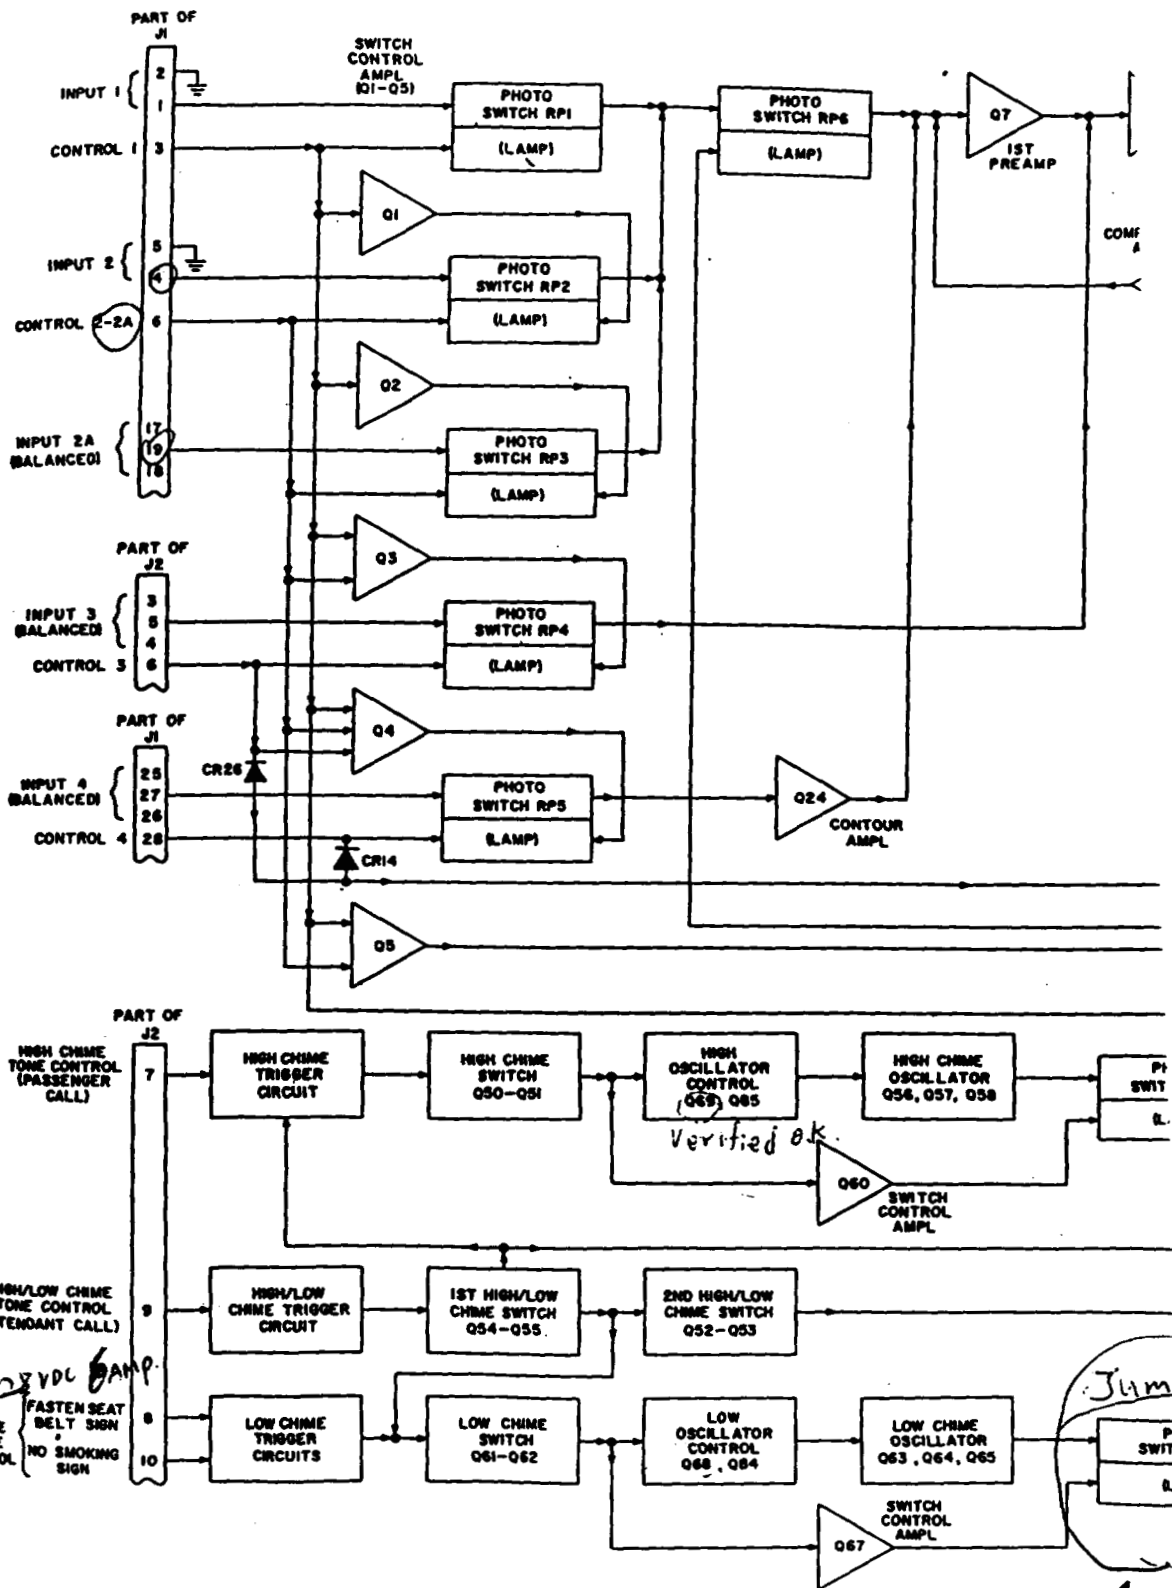
346D-1B Block Diagram  
Figure 10

Photo switches RP10 and RP11 are controlled by the high chime switch, photo switch control amplifier Q67, and photo switch RP11.

Photo switches and photo switch control amplifier. When the photo switches are triggered, the high chime oscillator, and the output of the photo switch RP11 is from the photo switch control amplifier.
