Southwest Airlines
Burbank, CA
March 5, 2000
DCA00MA030

NTSB Materials Laboratory Factual Report

MATERIALS LABORATORY FACTUAL REPORT

Report No. 00-118

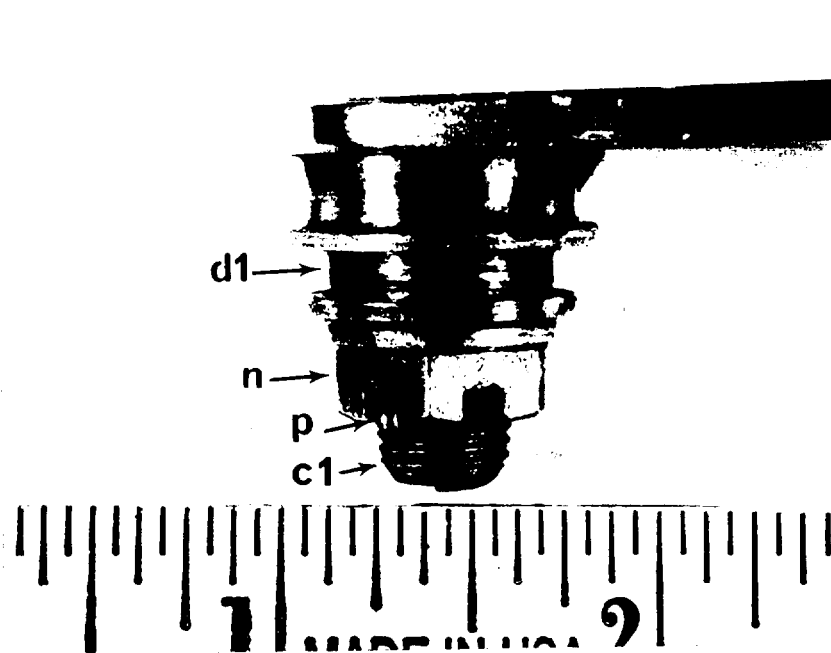
Figure 3. A close up view of the attachment end on the inboard arm showing the bushing by arrow "d1".
