Carson Helicopter Services  
Weaverville, California  
August 5, 2008  
LAX08PA259

**National Transportation Safety Board**  
Washington, D.C.

**Attachment 5**

N612AZ Restraint Photographs

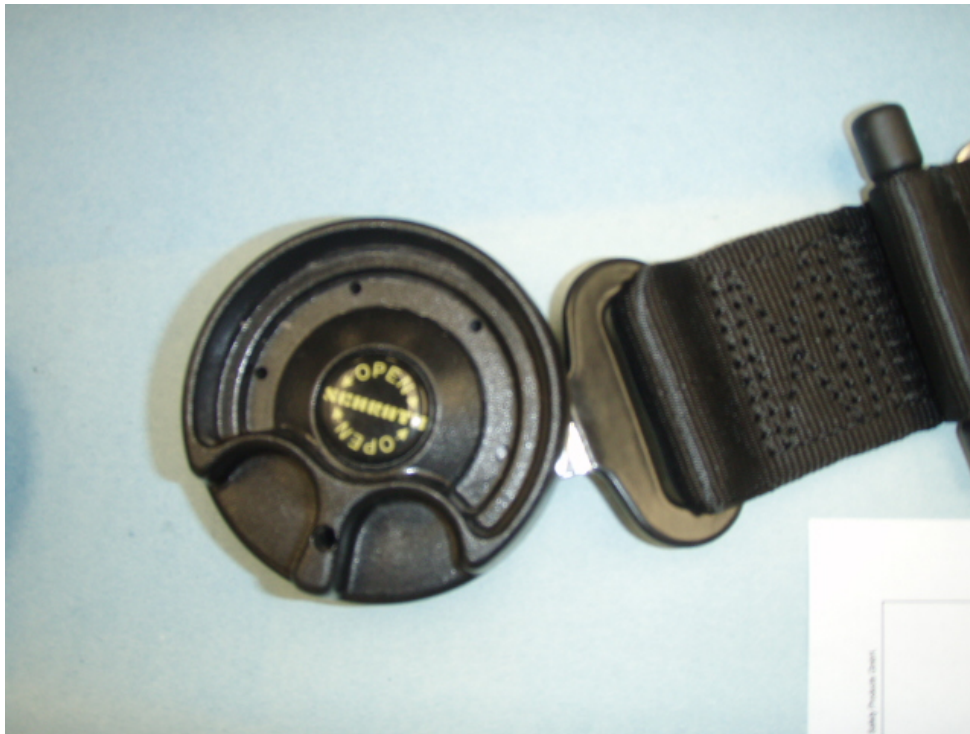
1. Photograph of a Schroth (SL 12.5) restraint unbuckled with the (occupant's left) fixed restraint installed in the buckle.

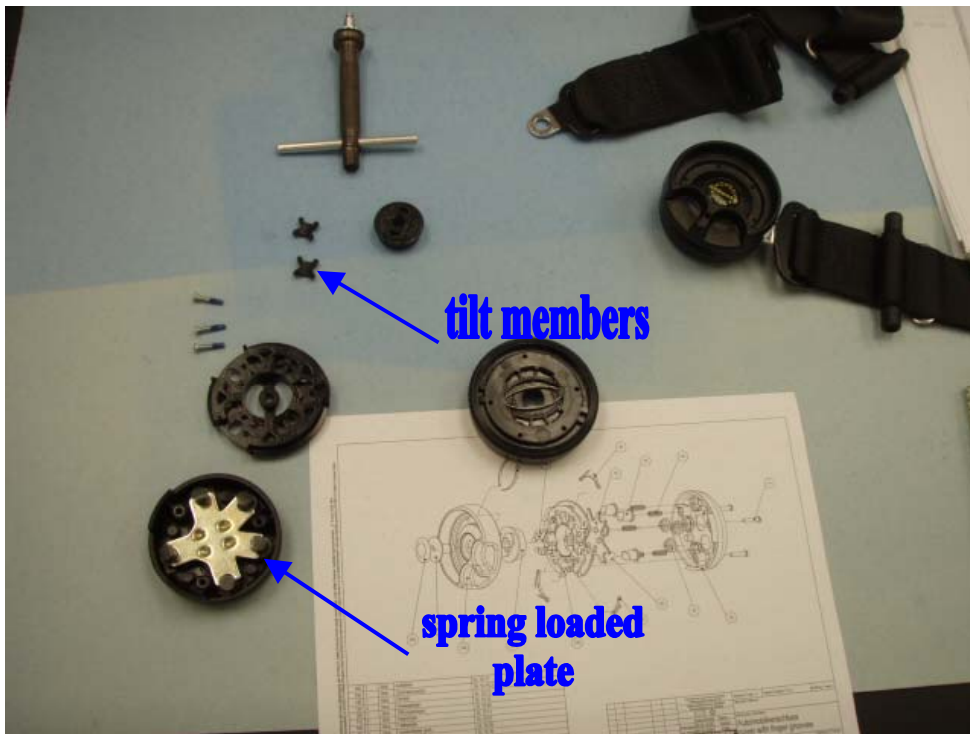
2. View of a disassembled Schroth SL12.5 buckle, showing its internal components.

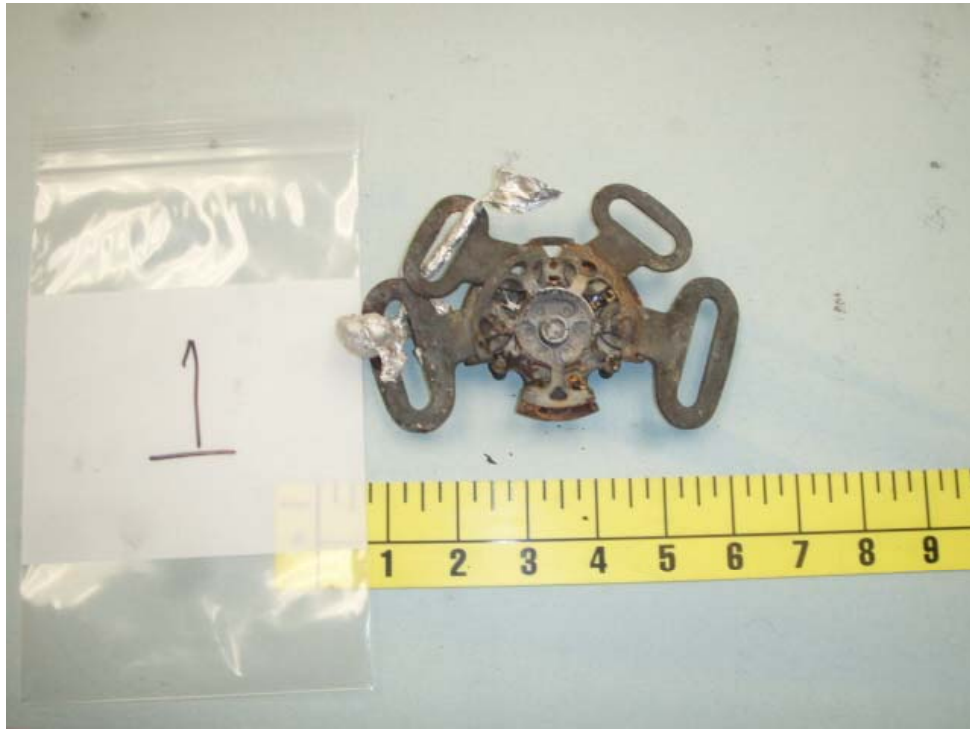
3. Photograph of the restraint cataloged as #1.  
Note: All latches are engaged.

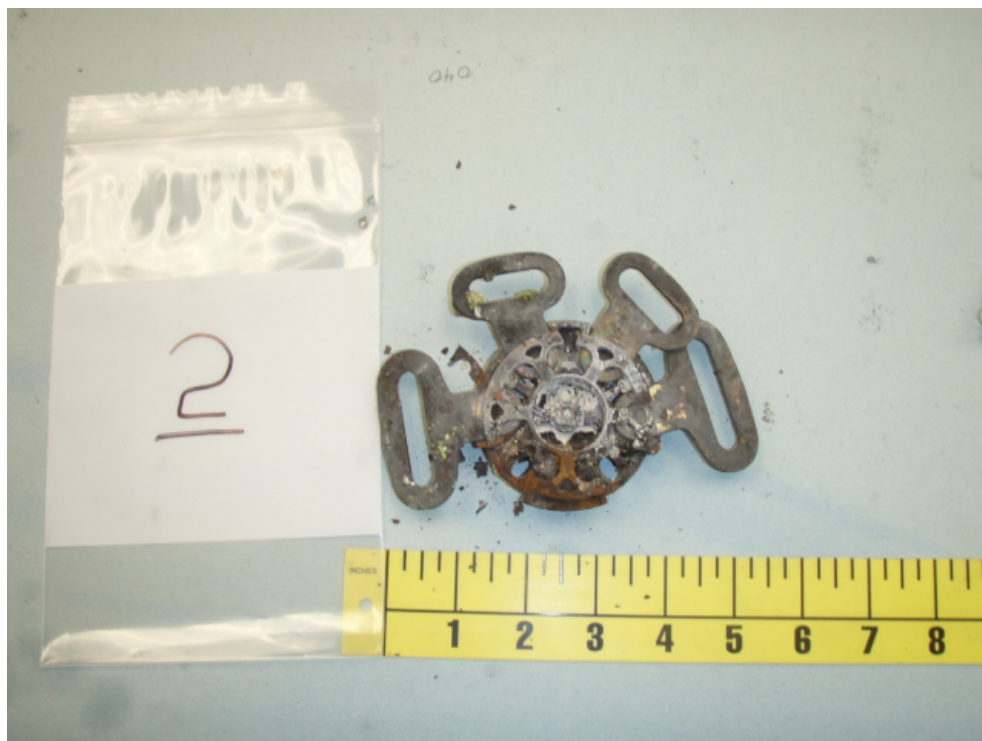
4. Photograph of the restraint cataloged as #2.  
Note: All latches are engaged.

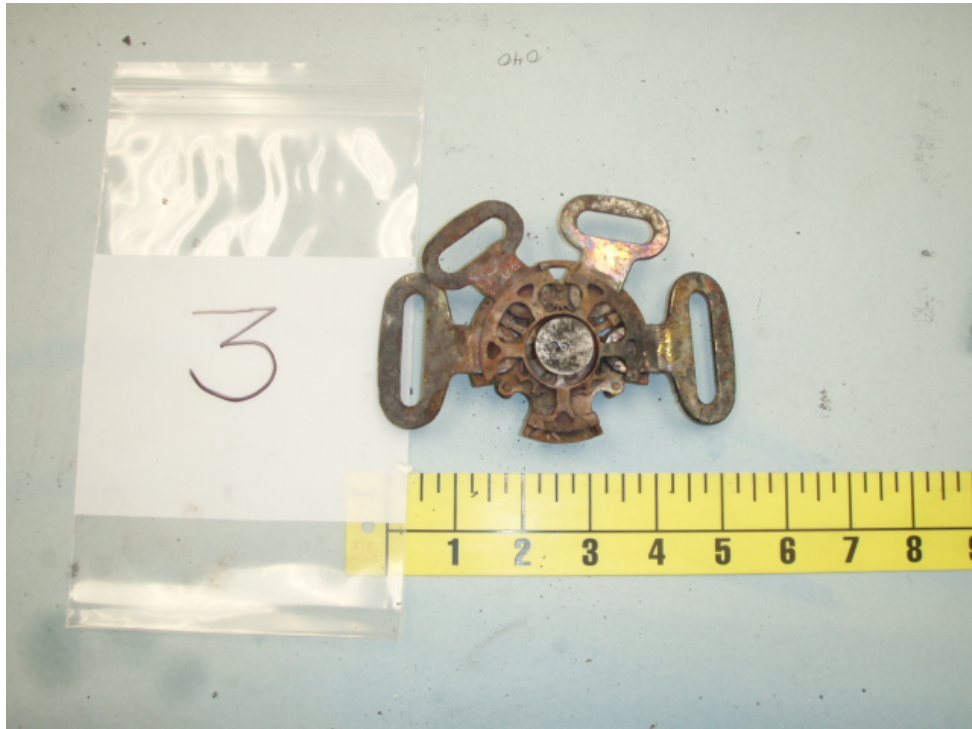
5. Photograph of the restraint cataloged as #3.  
Note: All latches are engaged.

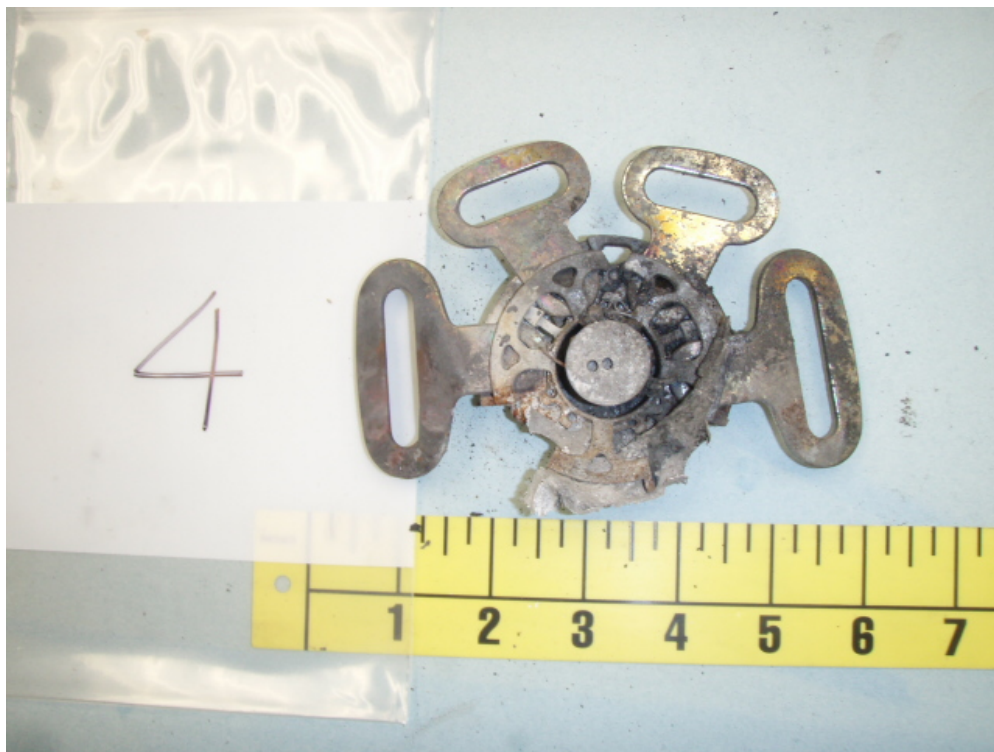
6. Photograph of the restraint cataloged as #4 buckle.  
Note: All latches are engaged.

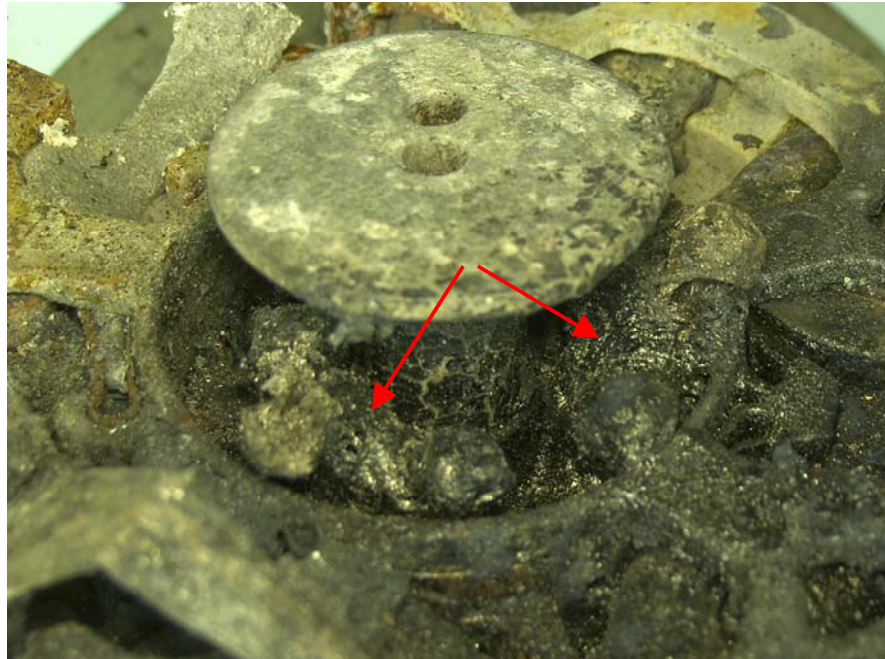
7. Close up photograph of the restraint cataloged as #4.  
Note: The red arrows point to two of the three tilt members.

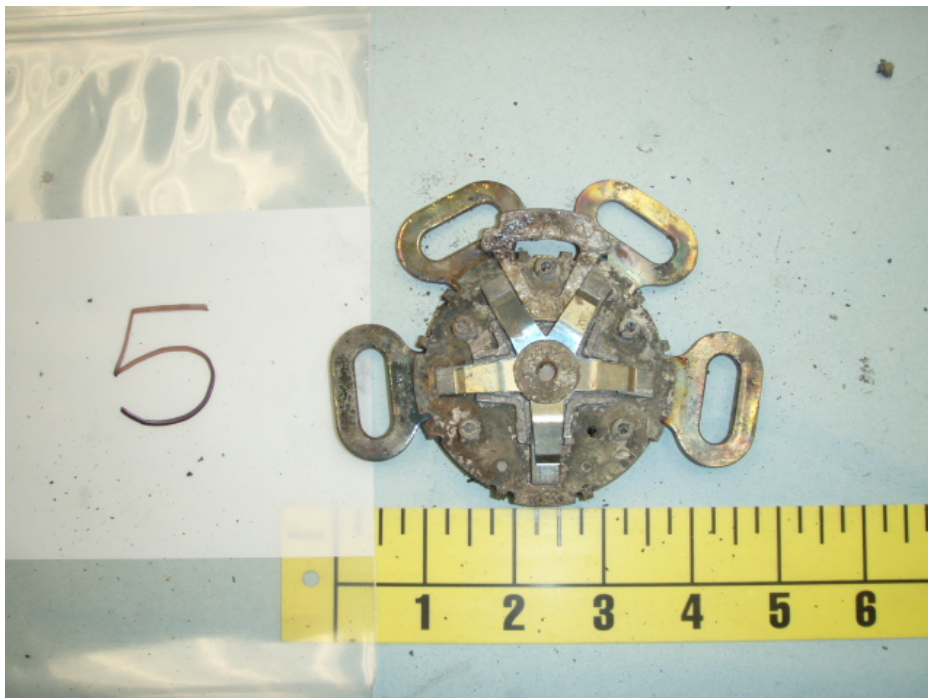
8. Photograph of a flight crewmember (Pacific Scientific) restraint cataloged as #5.  
Note: All latches were found engaged in the correct positions.

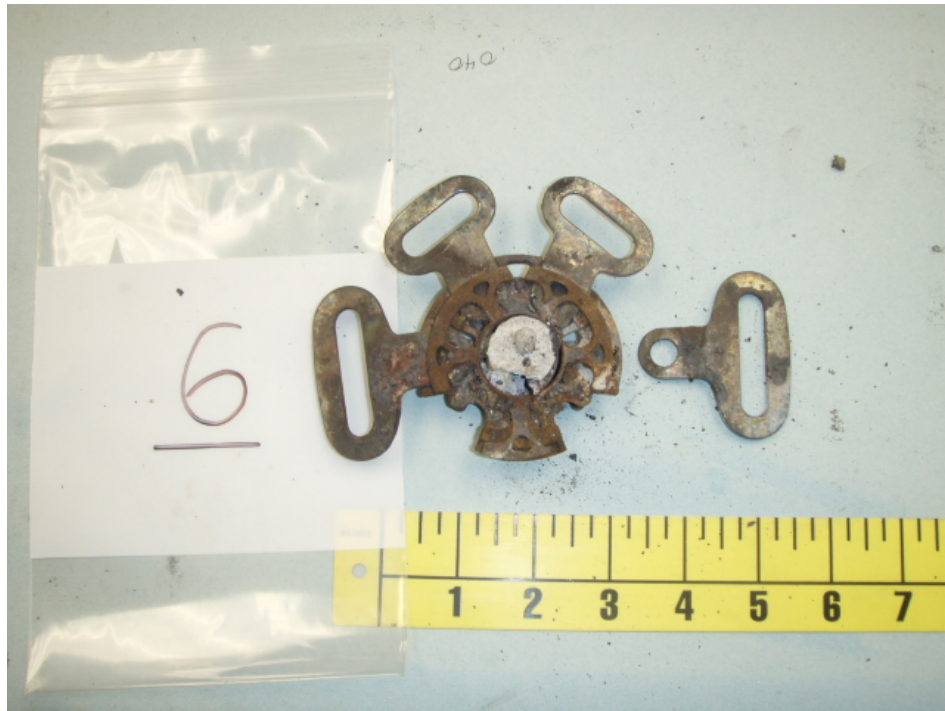
9. Photograph of the restraint cataloged as #6.  
Note: All latches engaged except the left (fixed) latch, which exhibited a shiny unscorched area where the latch would have engaged into the buckle.

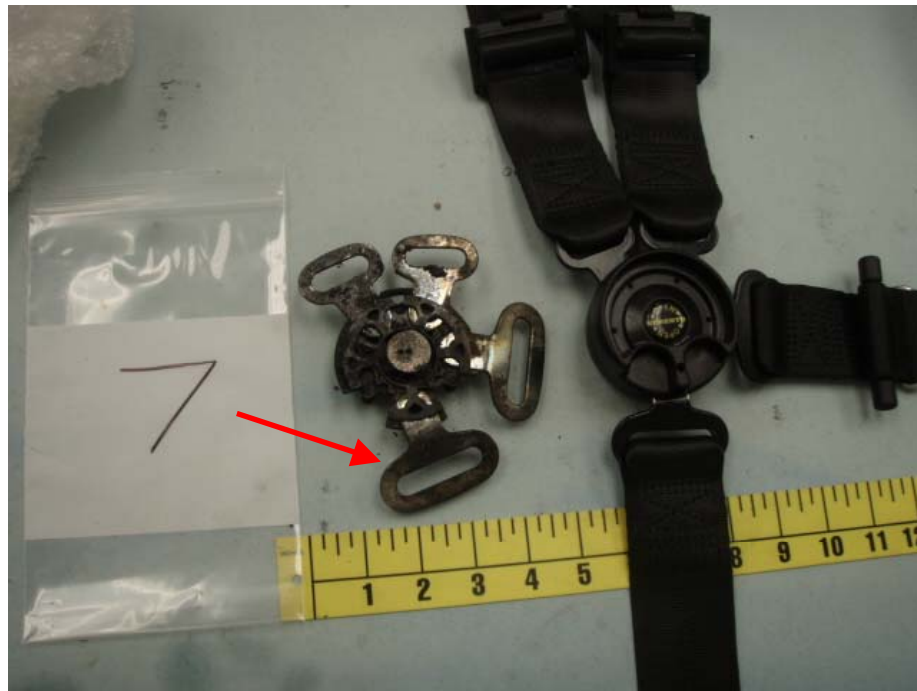
10. Photograph of restraint cataloged as restraint #7.  
Note: Red arrow points to the right lap restraint latched in the crotch engagement position.

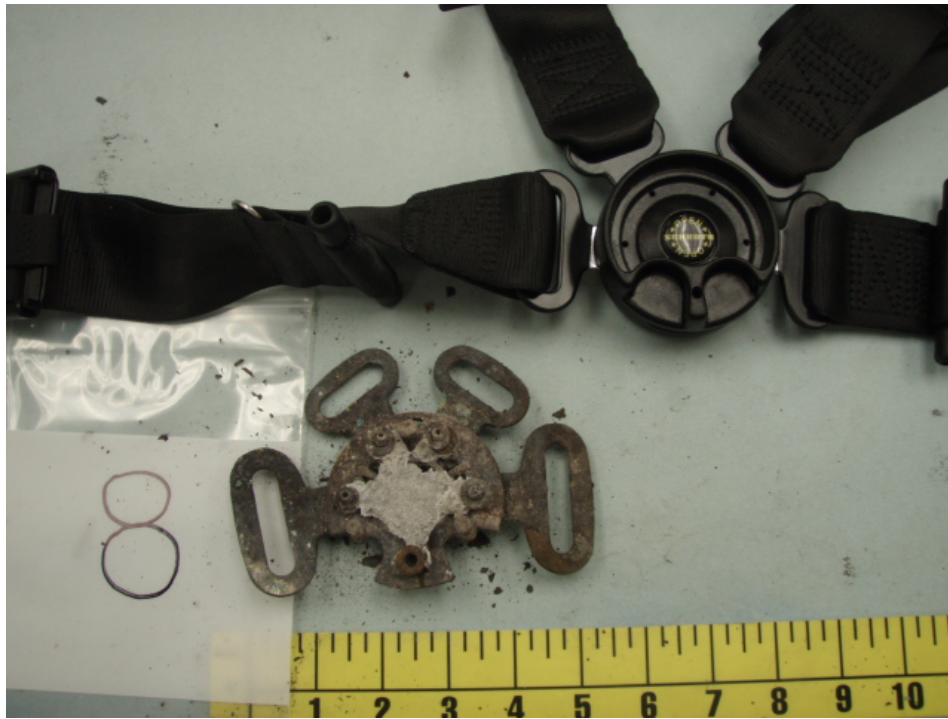
11. Photograph of restraint buckled cataloged as #8.

Note: The accident buckle is facing opposite that of the exemplar buckle, and its right lap latch is latched 180 degrees opposite its correct engagement position thereby twisting the lap belt as shown with the Schroth restraint above.

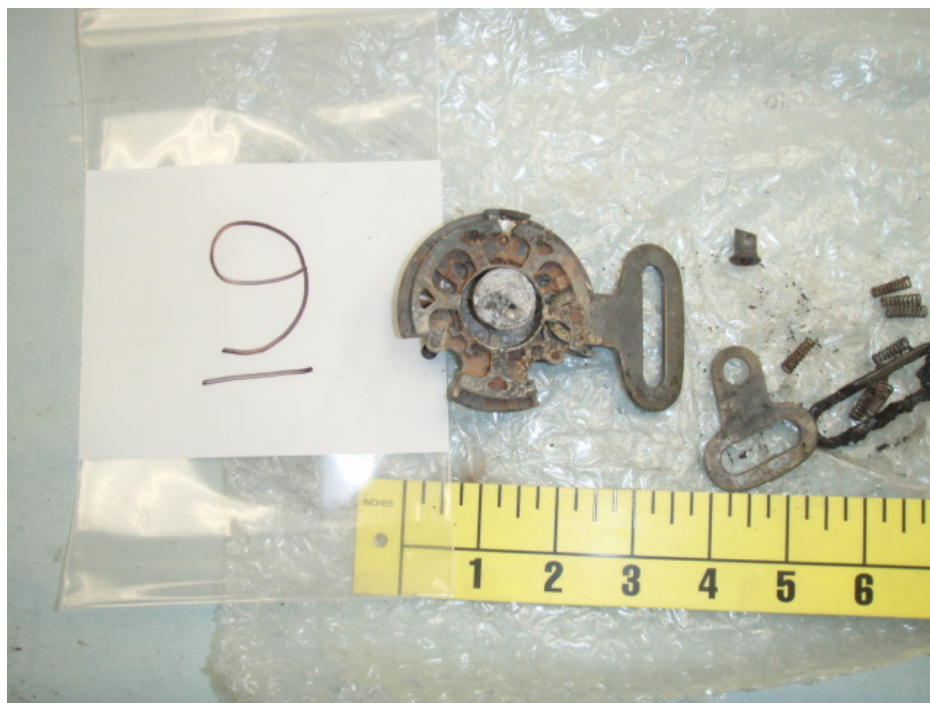
12. Photograph of buckle cataloged as #9.

Note: The left (fixed) latch is engaged and all other latches are not engaged.

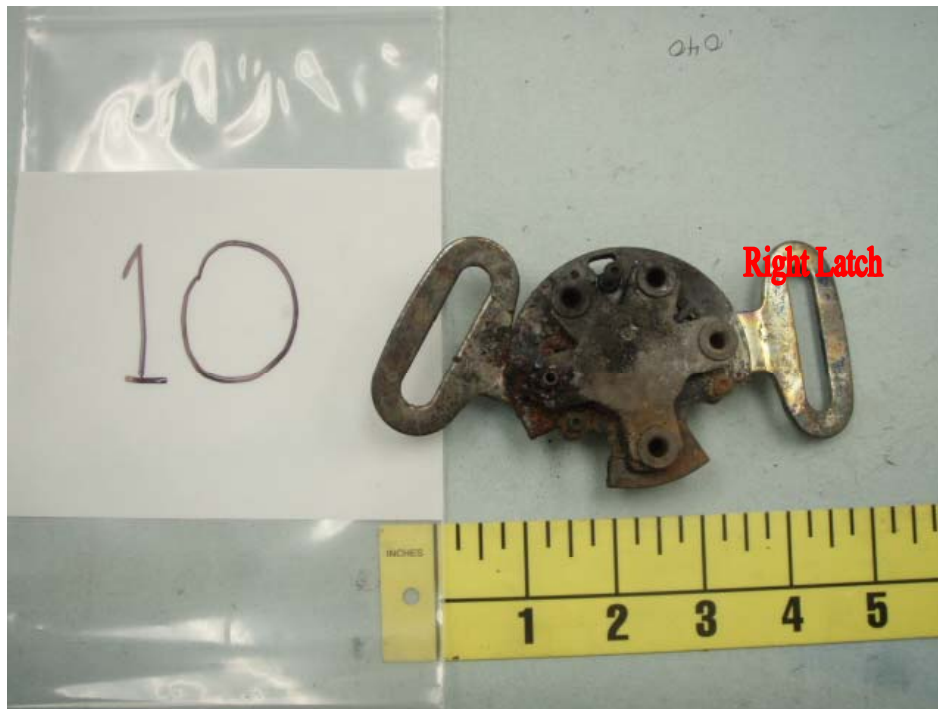
13. View of the restraint cataloged as #10.  
Note: The buckle is face down, and its right lap latch is latched 180 degrees opposite its correct engagement position.

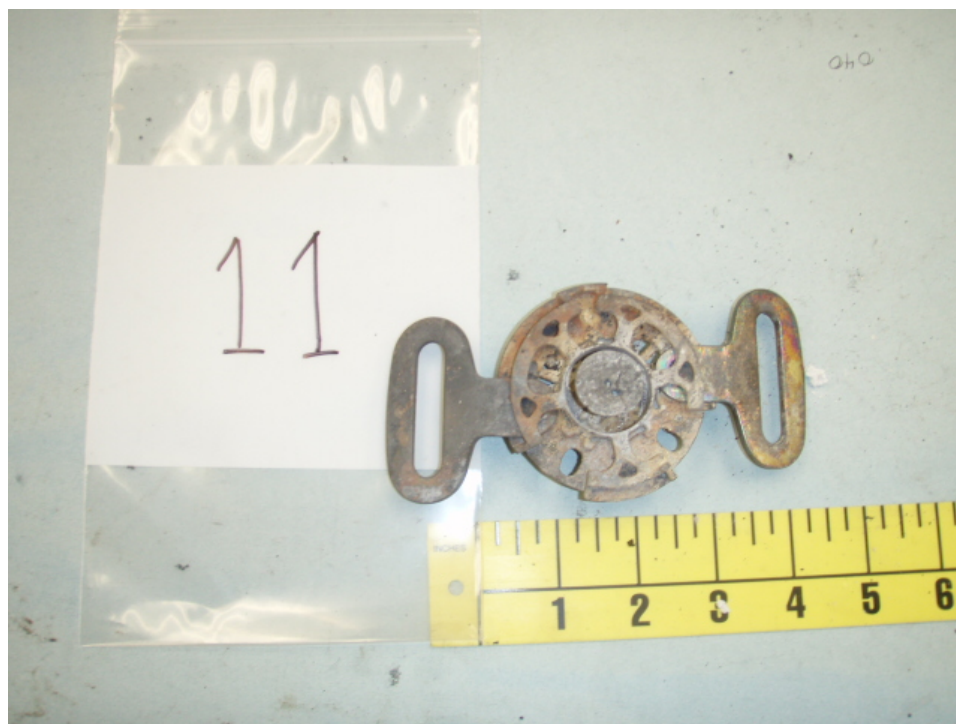
14. Photograph of buckle cataloged as #11.  
Note: The lap latch is engaged and the shoulder latches are not engaged.

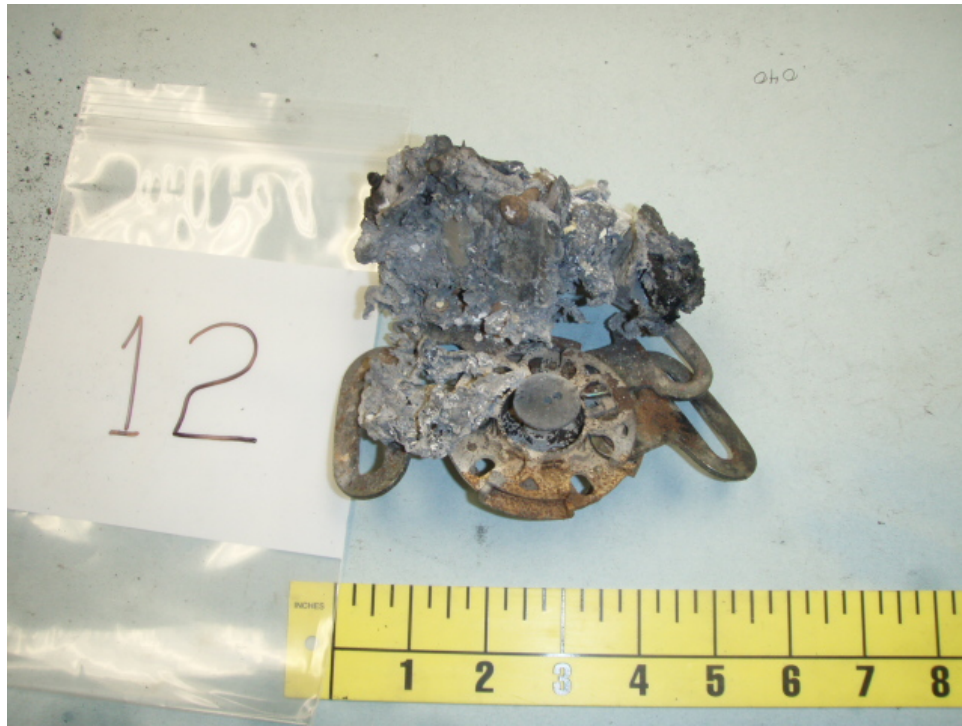
15. Photograph of buckle cataloged as #12.  
Note: All latches engaged in correct positions.

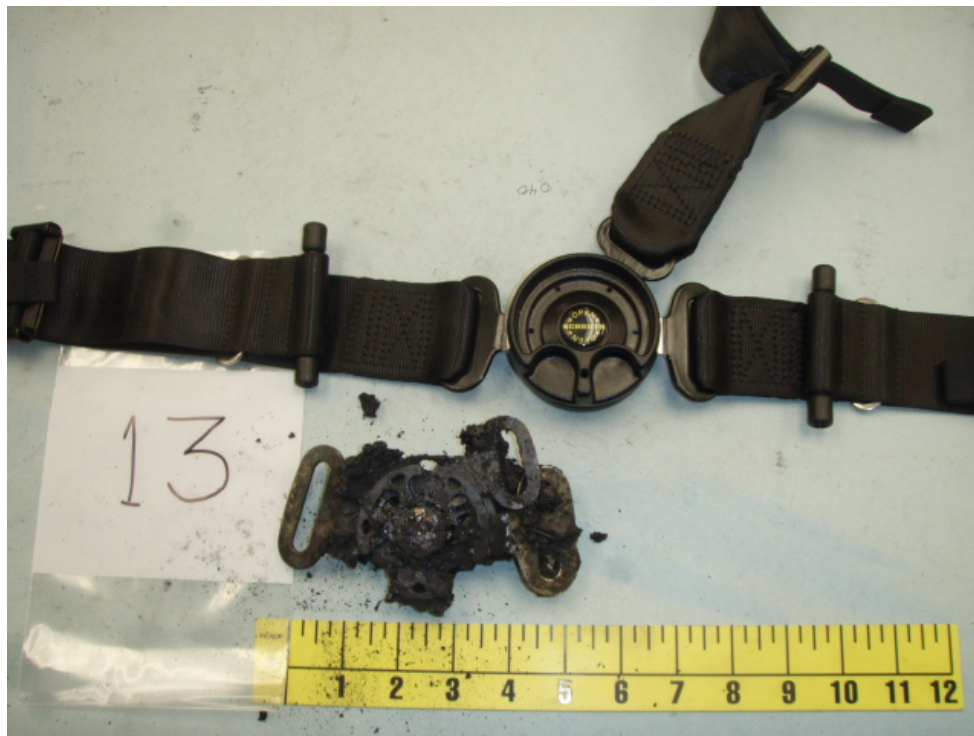
16. View of the restraint cataloged as #13.  
Note: Right shoulder harness is unlatched, and the left shoulder harness is latched 180 degrees opposite its correct engagement position.

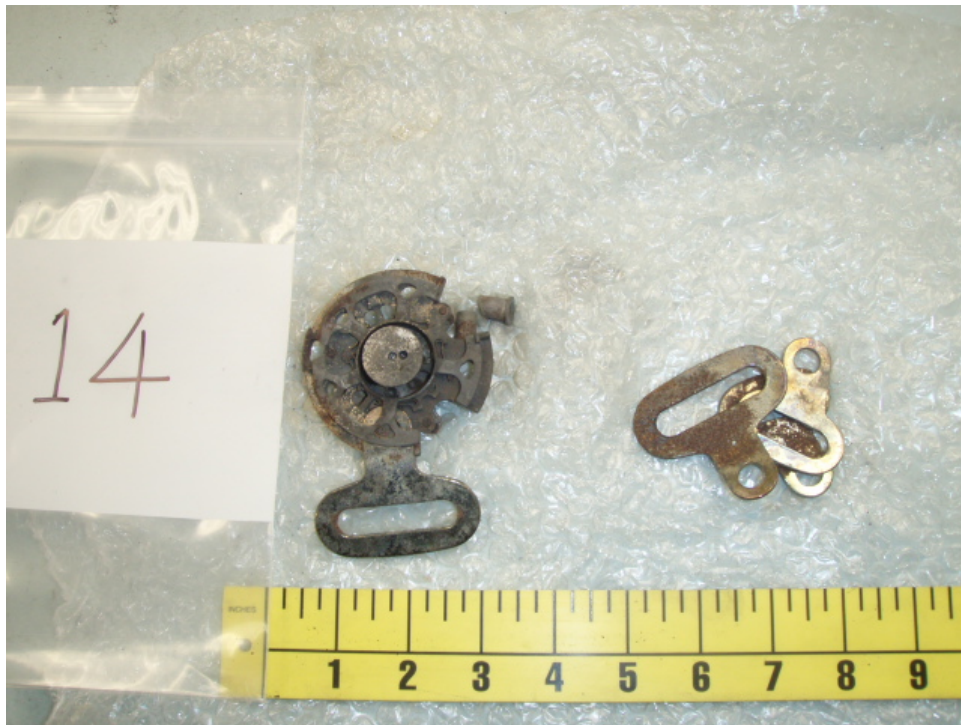
17. Restraint cataloged as #14.

Note: The right lap latch is engaged and the left (fixed) lap and shoulder restraints were not latched.

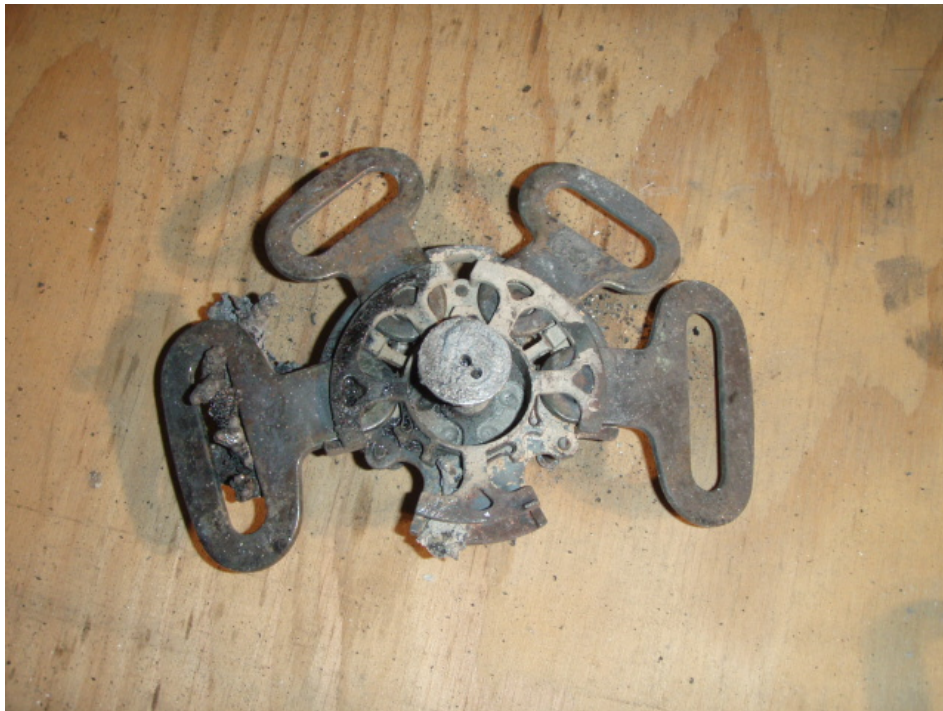
18. Photo of the restraint cataloged as #15 found during the October 28, 2008 wreckage exam. The buckle's lap and shoulder restraints are latched.

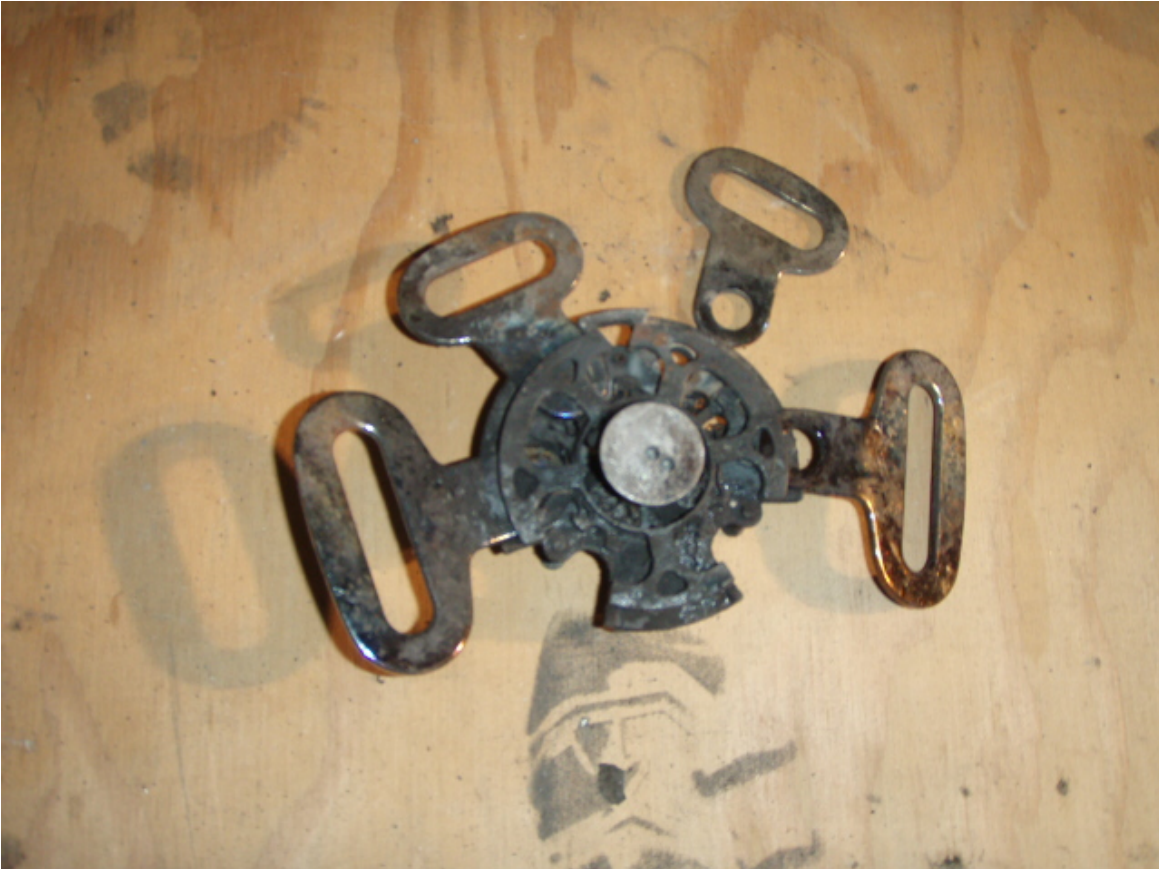
19. Photograph of the restraint cataloged #16 found during the October 28, 2008 wreckage exam. Note: The right lap latch was found latched 180 degrees opposite its correct engagement position, left shoulder restraint was not engaged but exhibited a shiny un-scorched area where the latch would have engaged into the buckle, and the left (fixed) lap latch pin fell out of the buckle and the left lap latch separated from the buckle.
