DOCKET NO. SA-515

**NATIONAL TRANSPORTATION SAFETY BOARD
WASHINGTON, D.C.**

ATTACHMENT C

**PHOTOGRAPHIC SUPPLEMENT
(5 PAGES)**

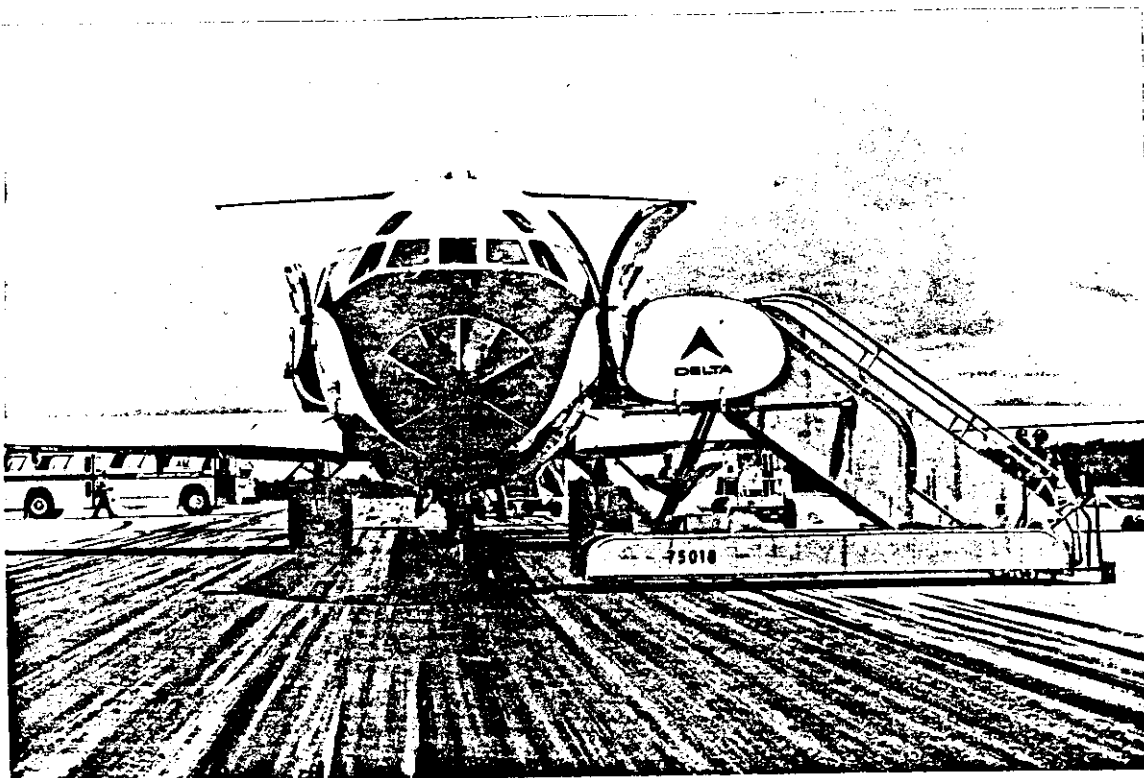
Photo 1.
View of front of airplane note airstairs.

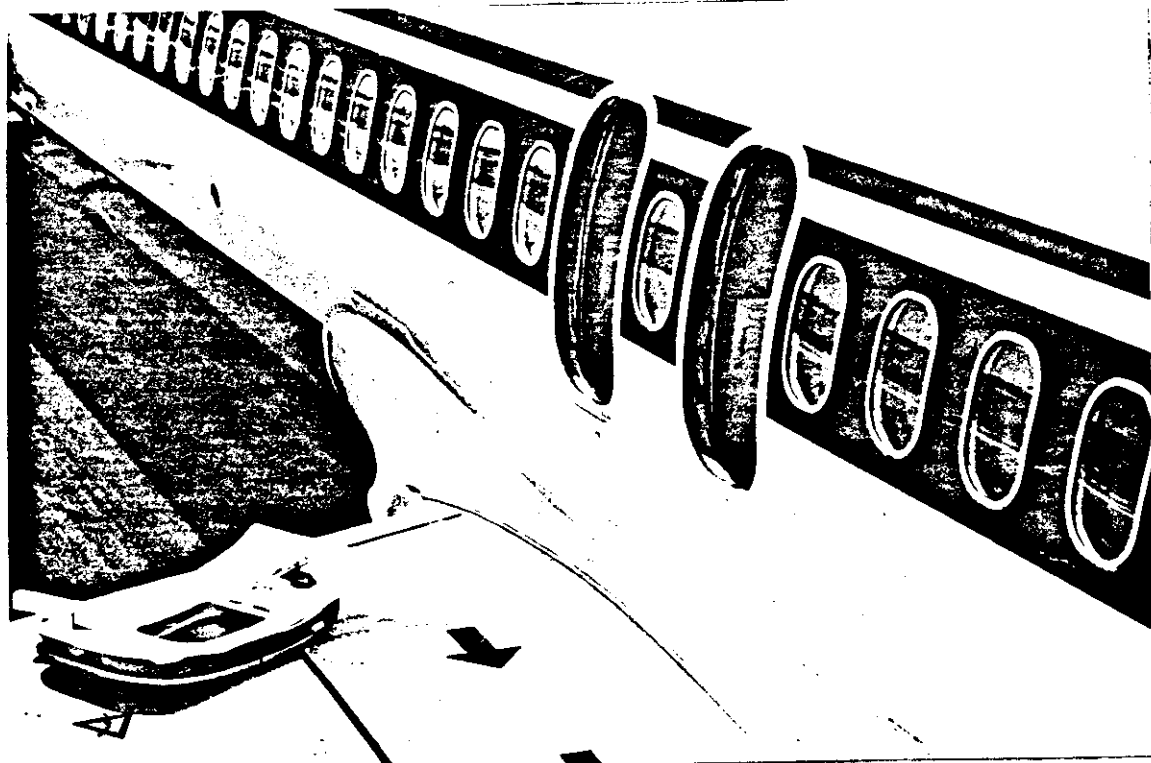
Photo. 2.
Left side overwing emergency
window exits, all 4 overwing
exits were used.

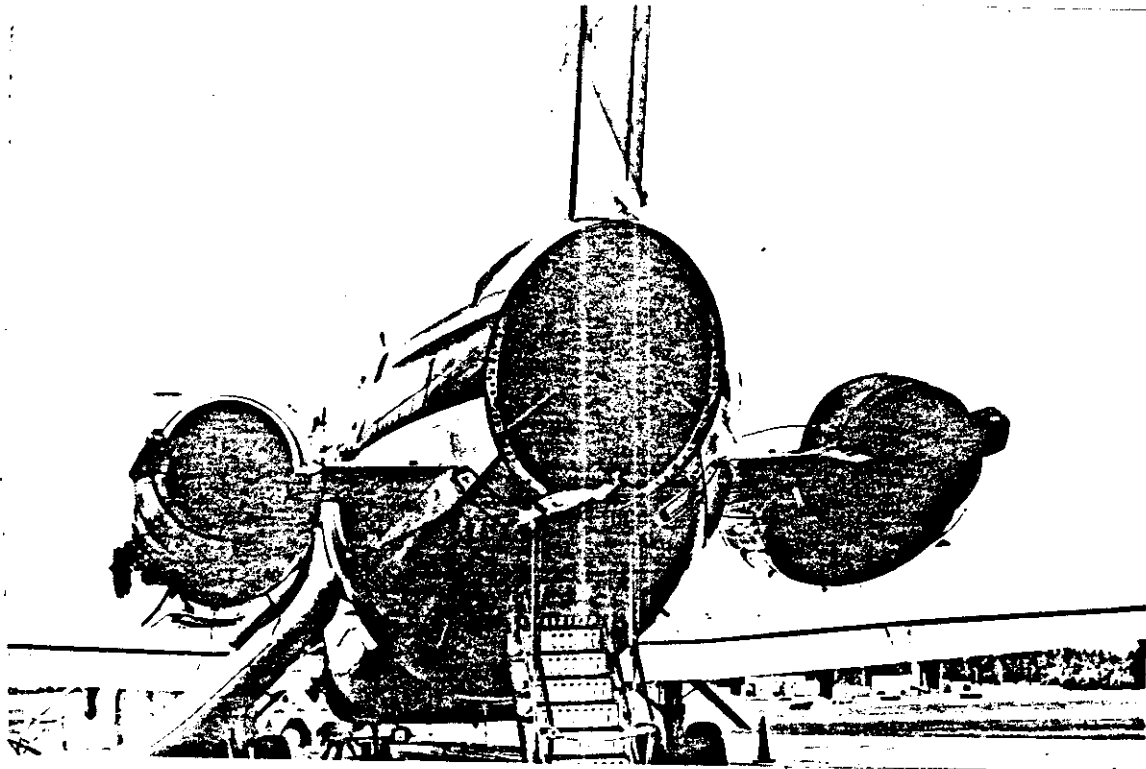
Photo. 3.
View of tailcone area and airstairs.

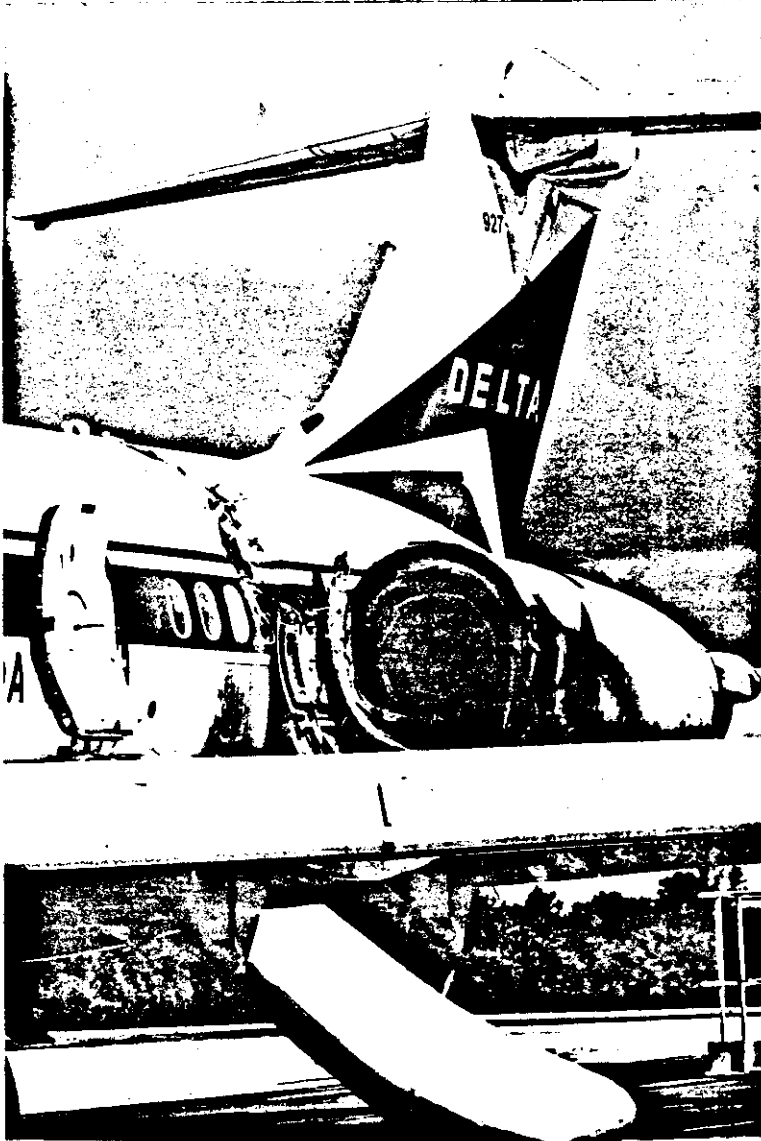
Photo. 4.
Damaged area on left
side of airplane.

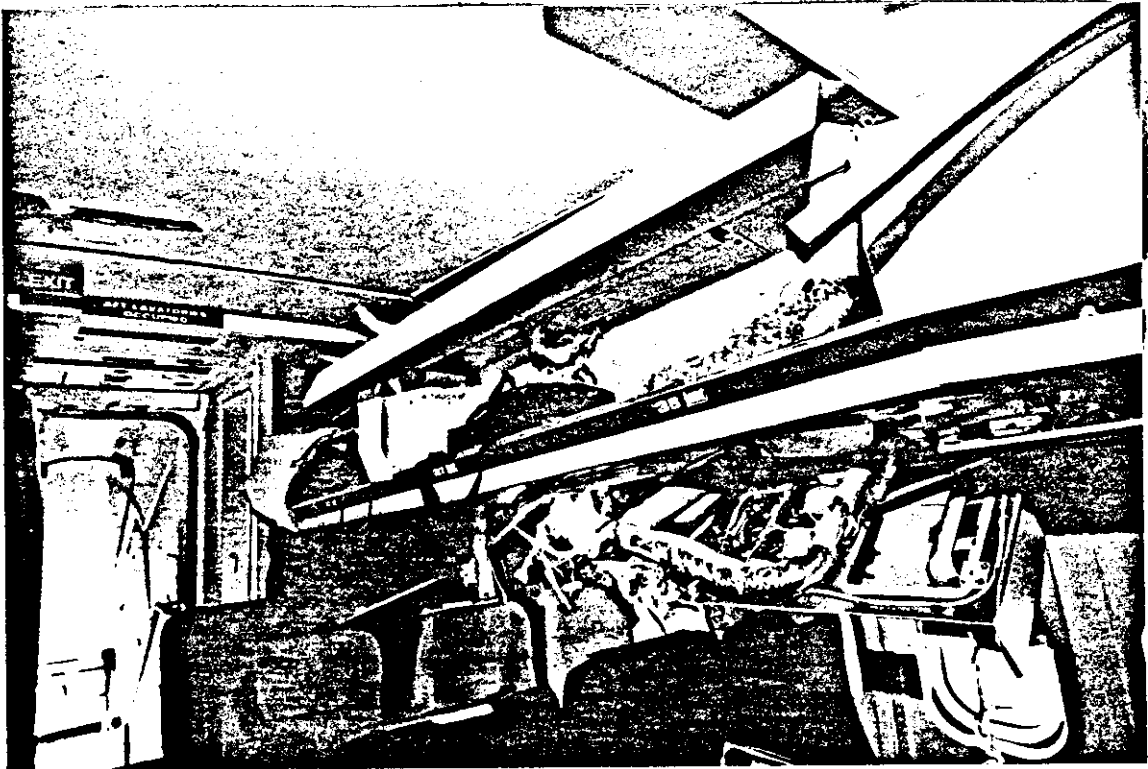
Photo. 7.
Overall view of left side of aft cabin.

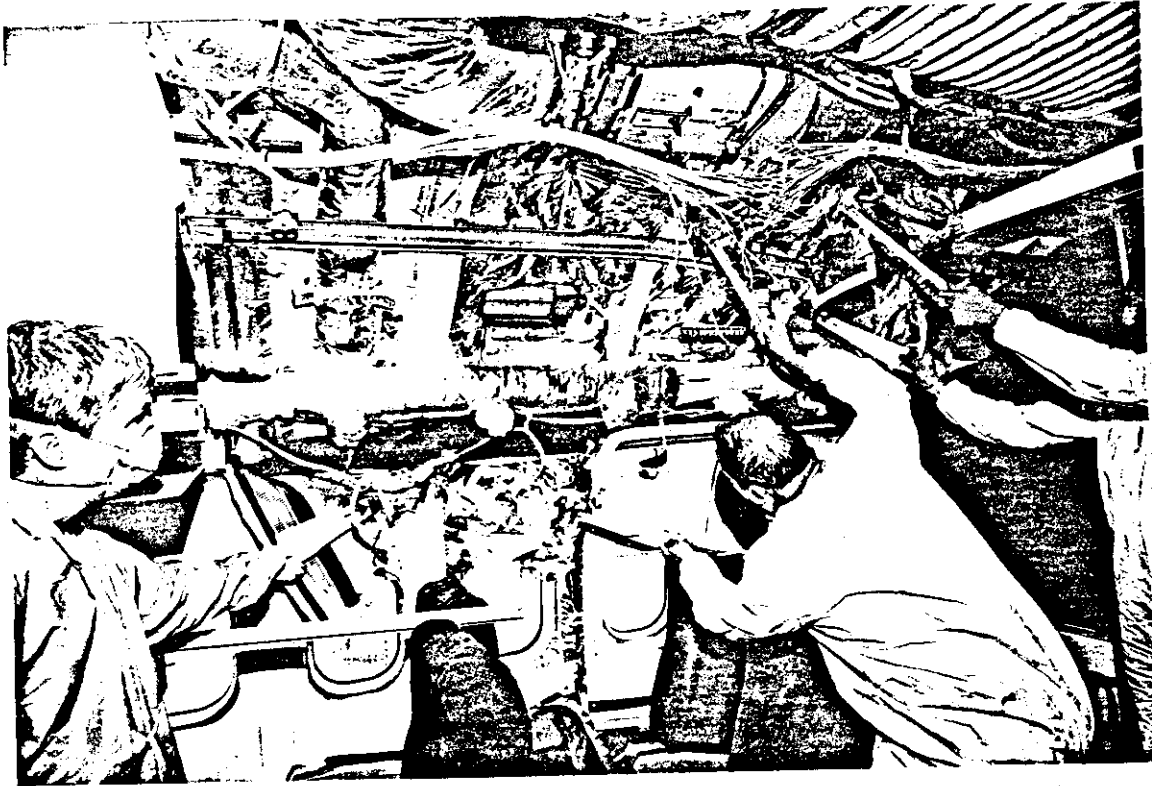
Photo. 9.
Right side of cabin at row 37.
Note 5 exit holes.
