**National Transportation Safety Board
Washington, DC**

Attachment 17

Photographs

(taken July 26-27, 2002, during accident investigation in field)

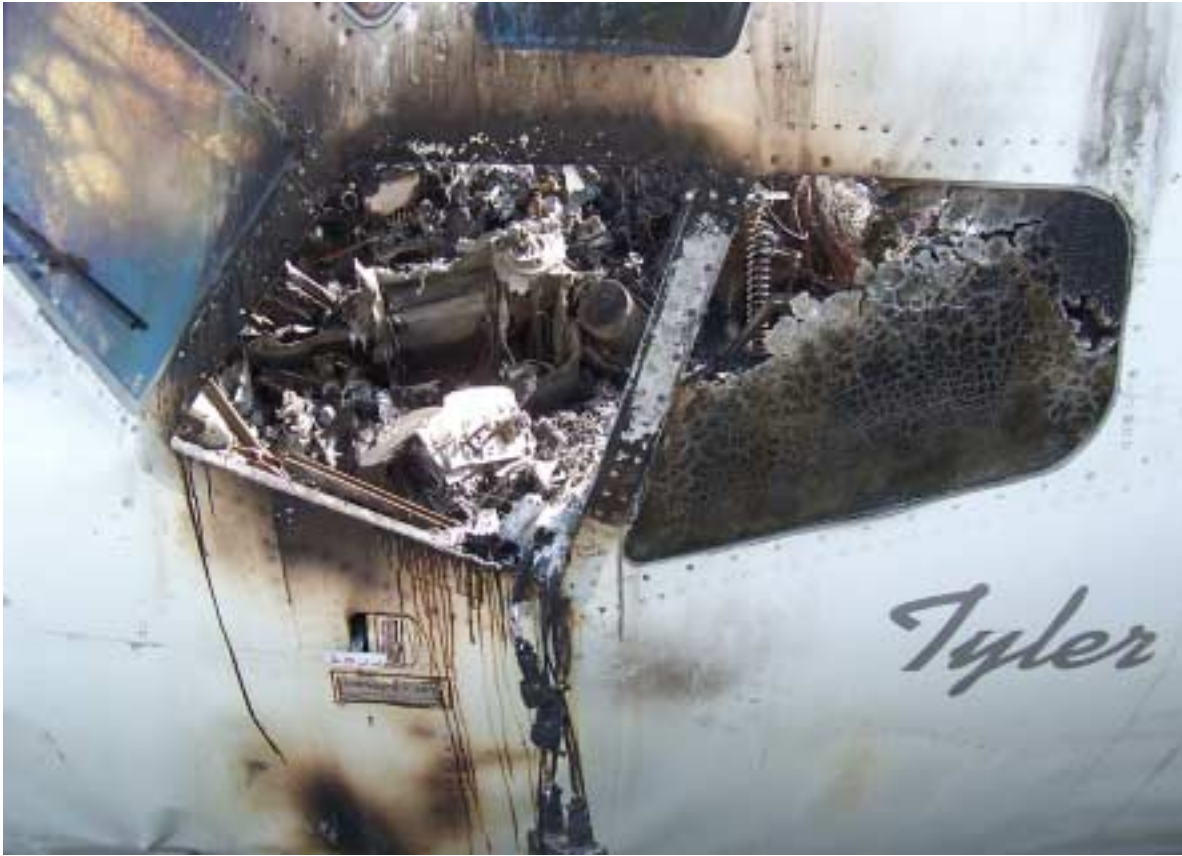
Photo 1: Left cockpit sliding window and exterior operation handle.

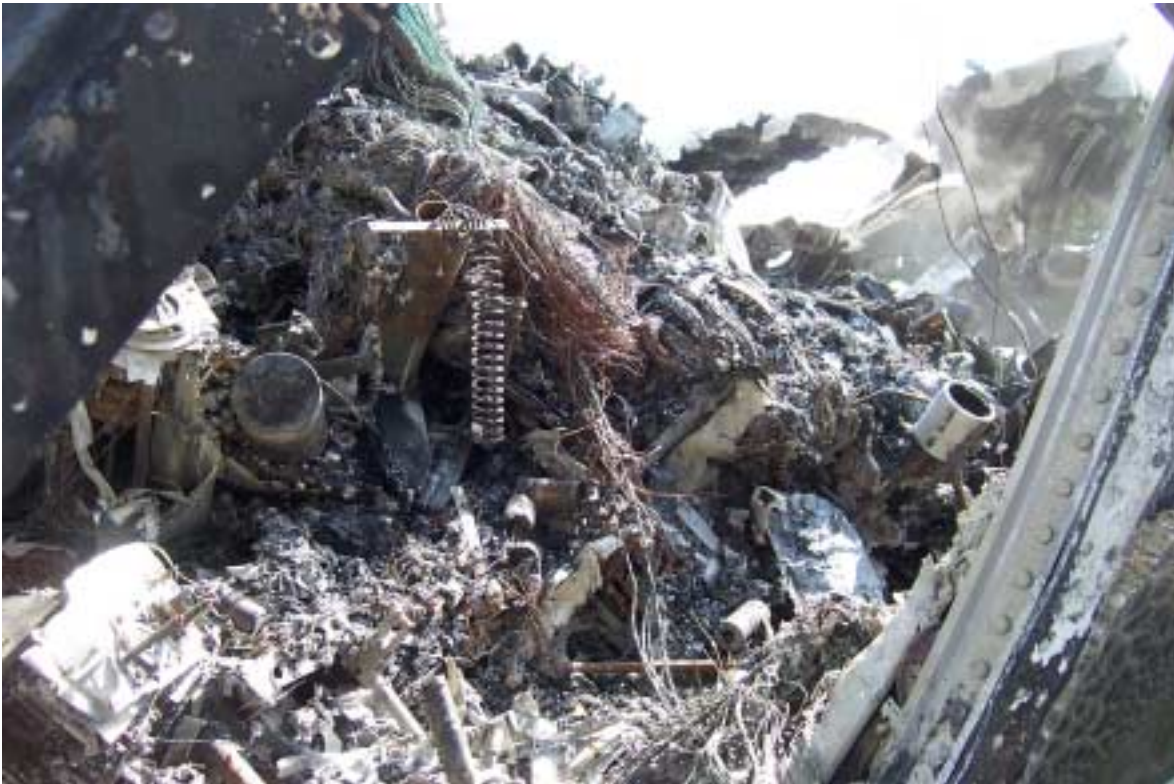
Photo 2: Interior of cockpit as viewed through the left cockpit sliding window.

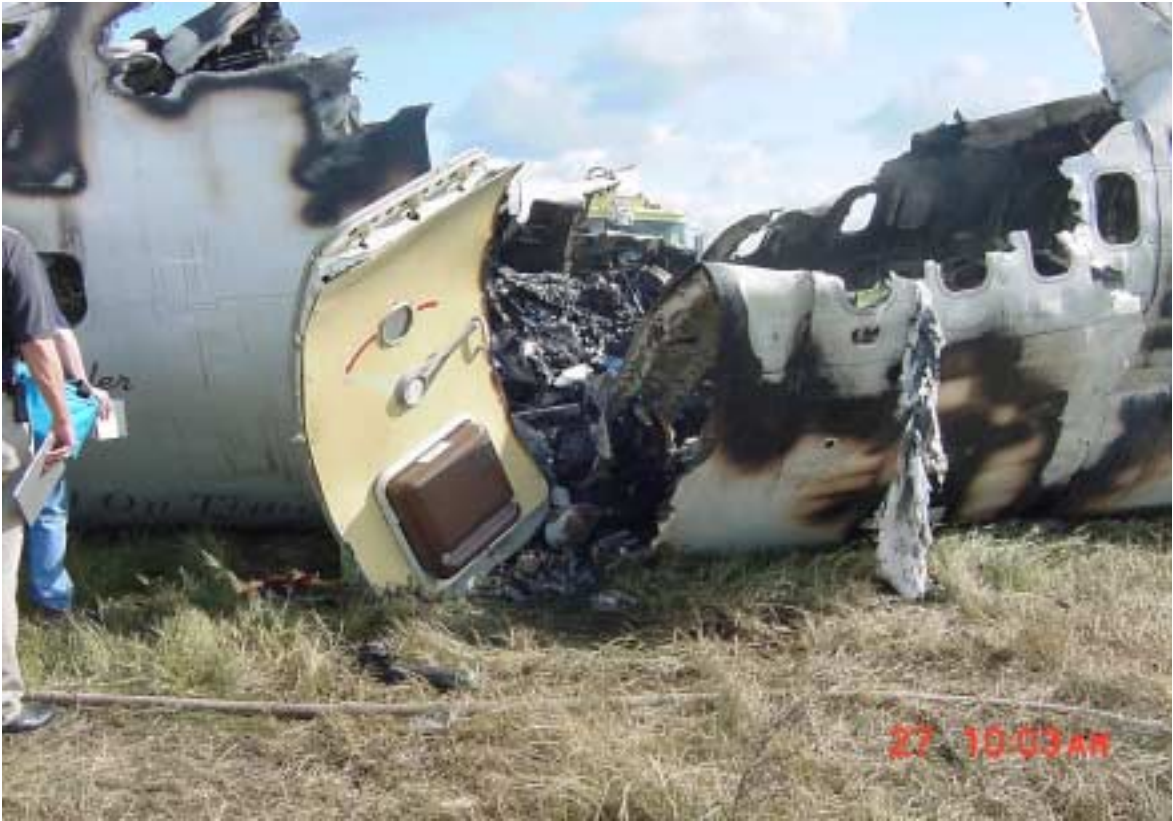
Photo 3: 1L boarding door.

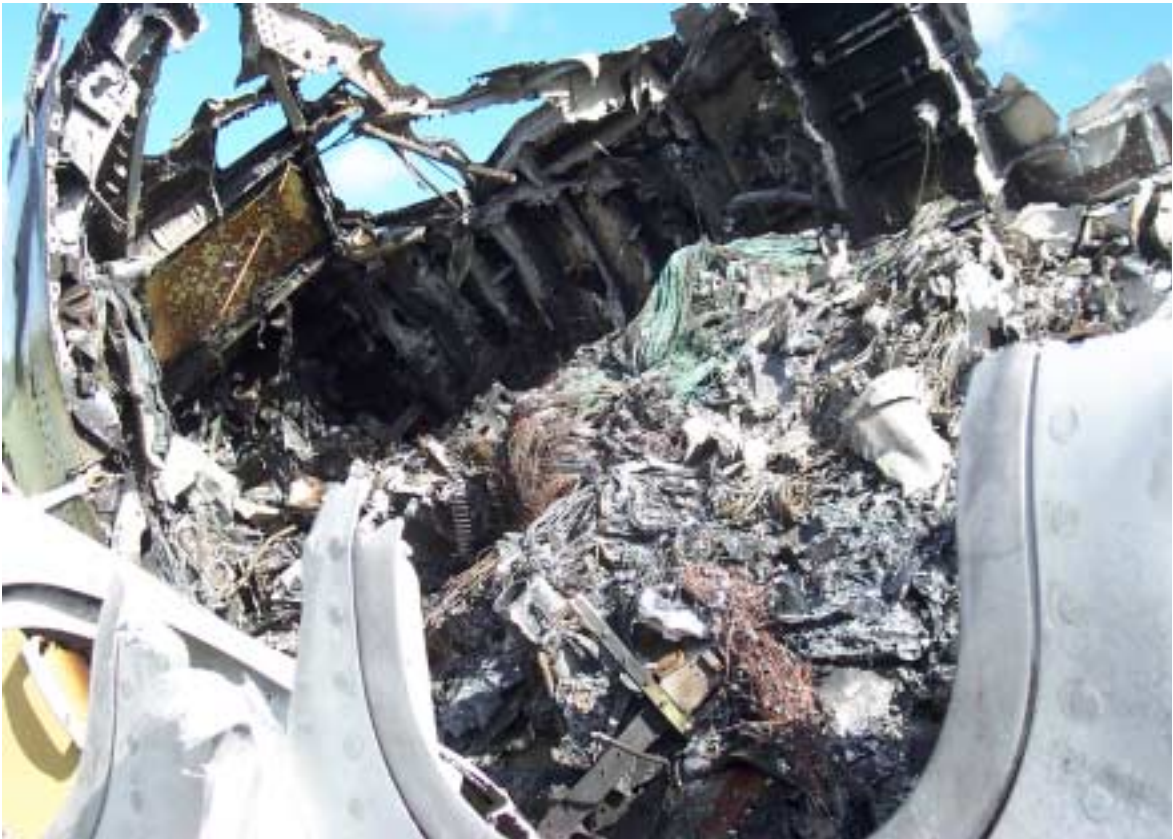
Photo 4: Interior of cockpit as viewed from outside window behind 1L boarding door.

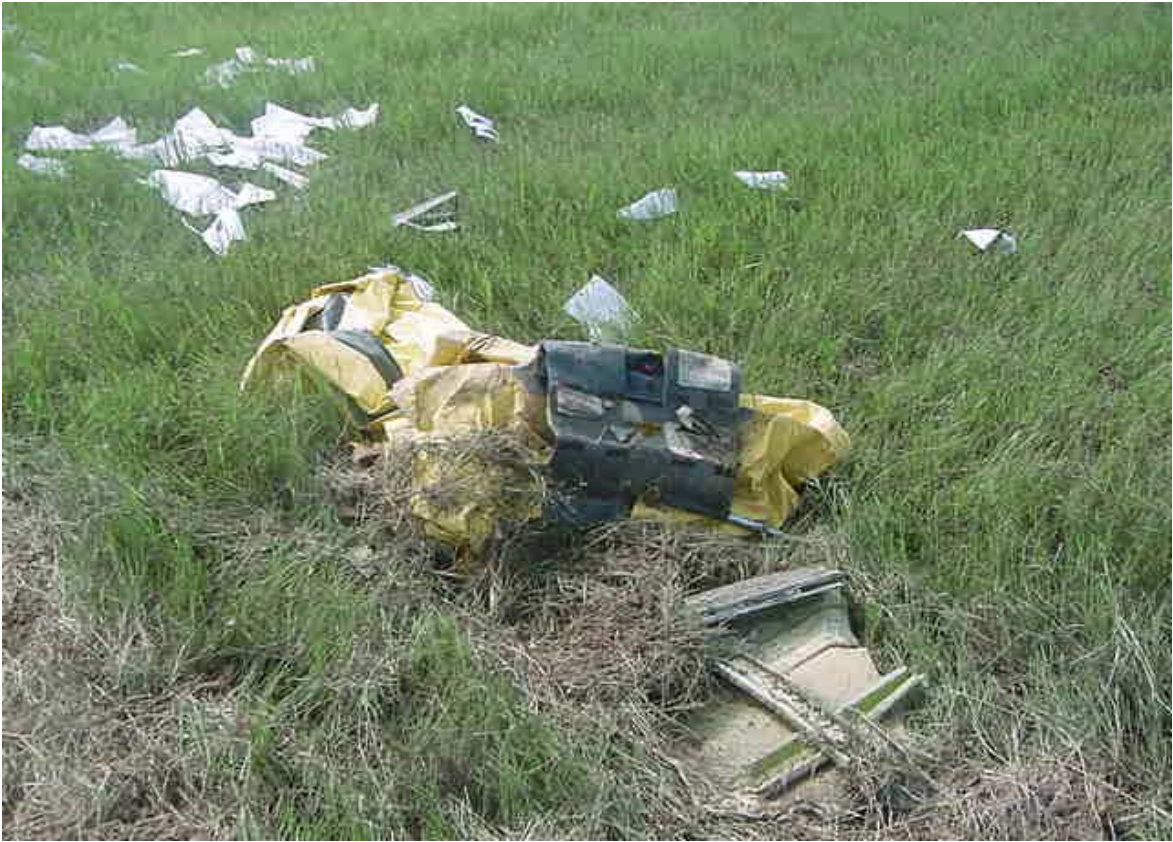
Photo 5: Evacuation slide from the 1L door, in the wreckage path.

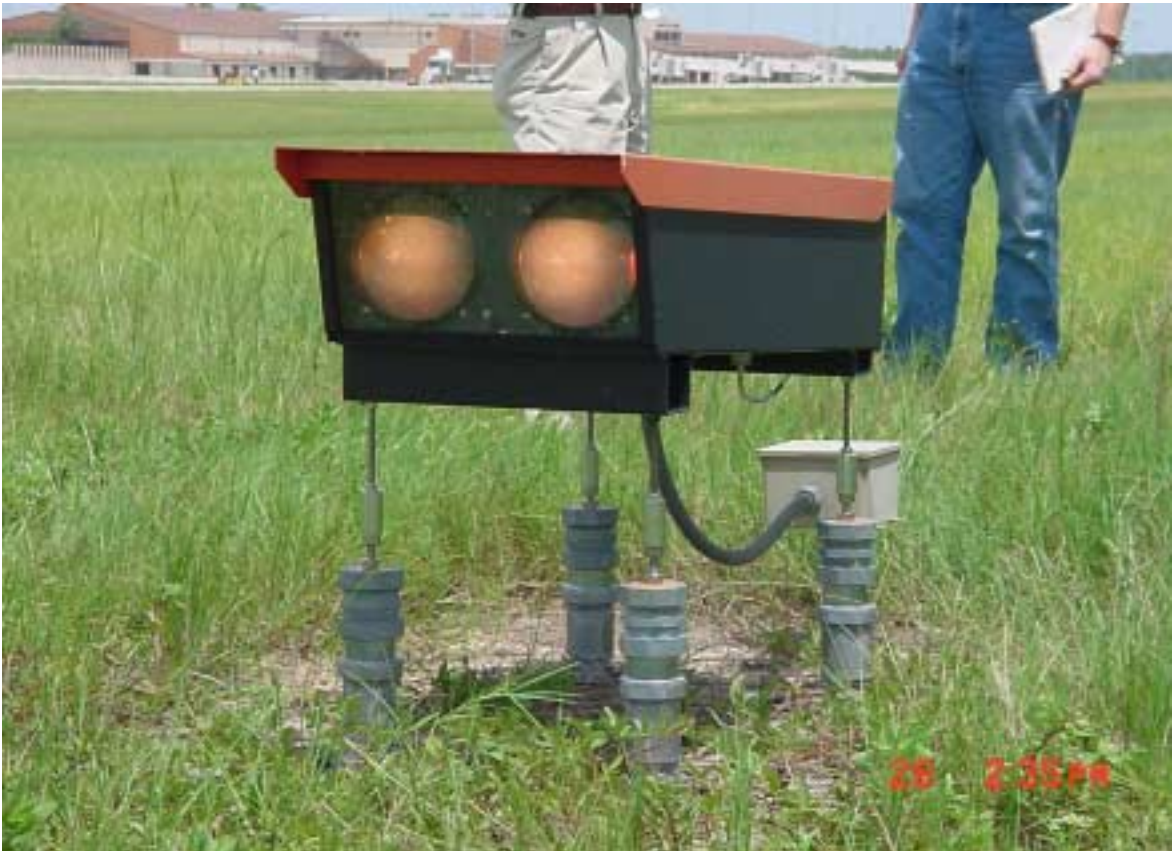
Photo 6: ADB Precision Approach Path Indicator (PAPI) Lighting Unit.

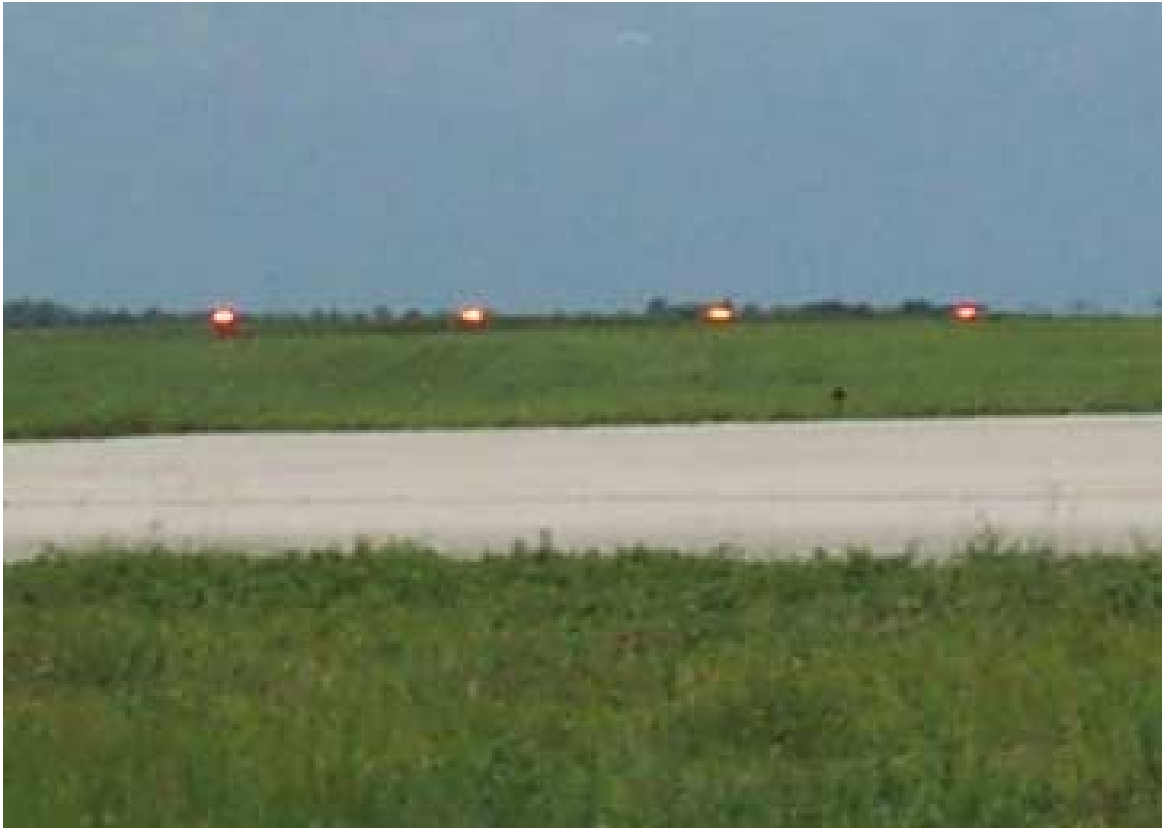
Photo 7: Four-unit ADB PAPI lighting system for runway 9, as viewed from taxiway 'M', looking east.

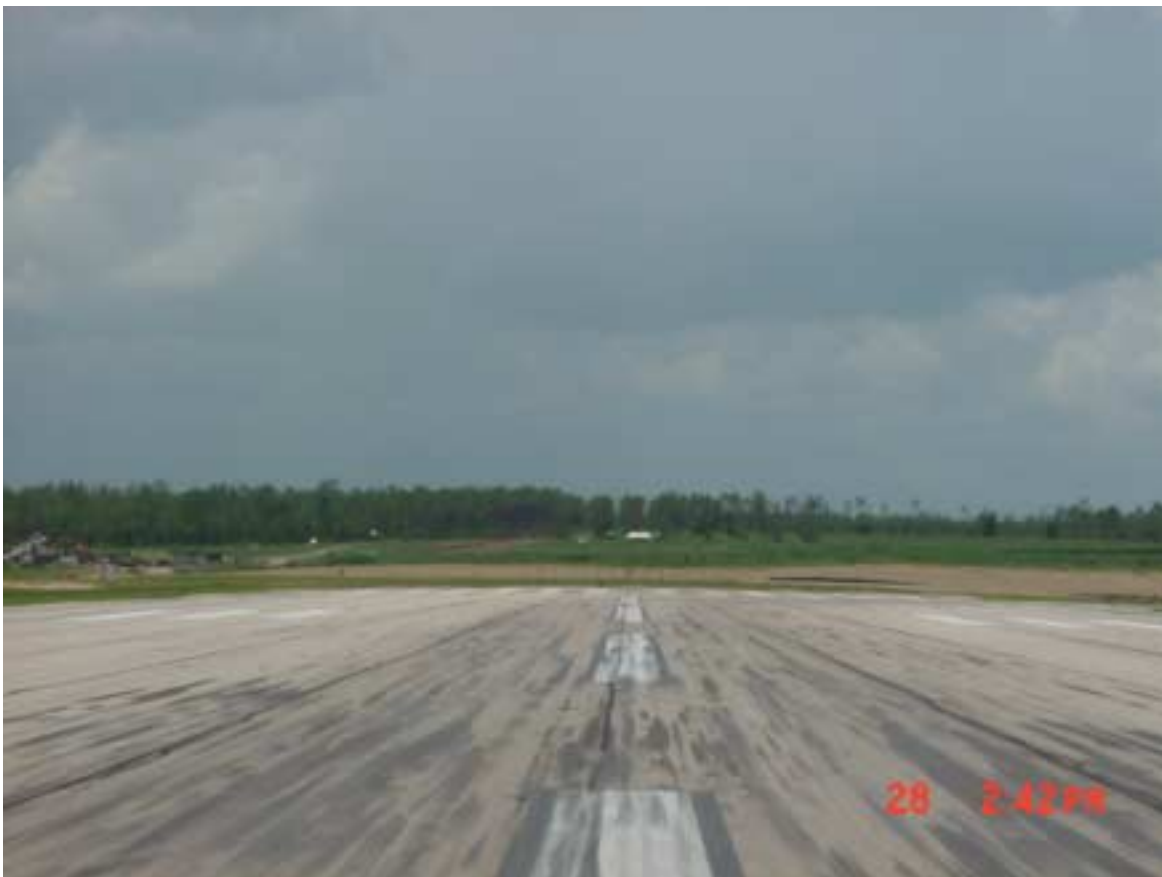
Photo 8: Approach to runway 9, as viewed from intersection point of runway 9 centerline and PAPI lighting system, looking east (accident wreckage at left-center of picture).

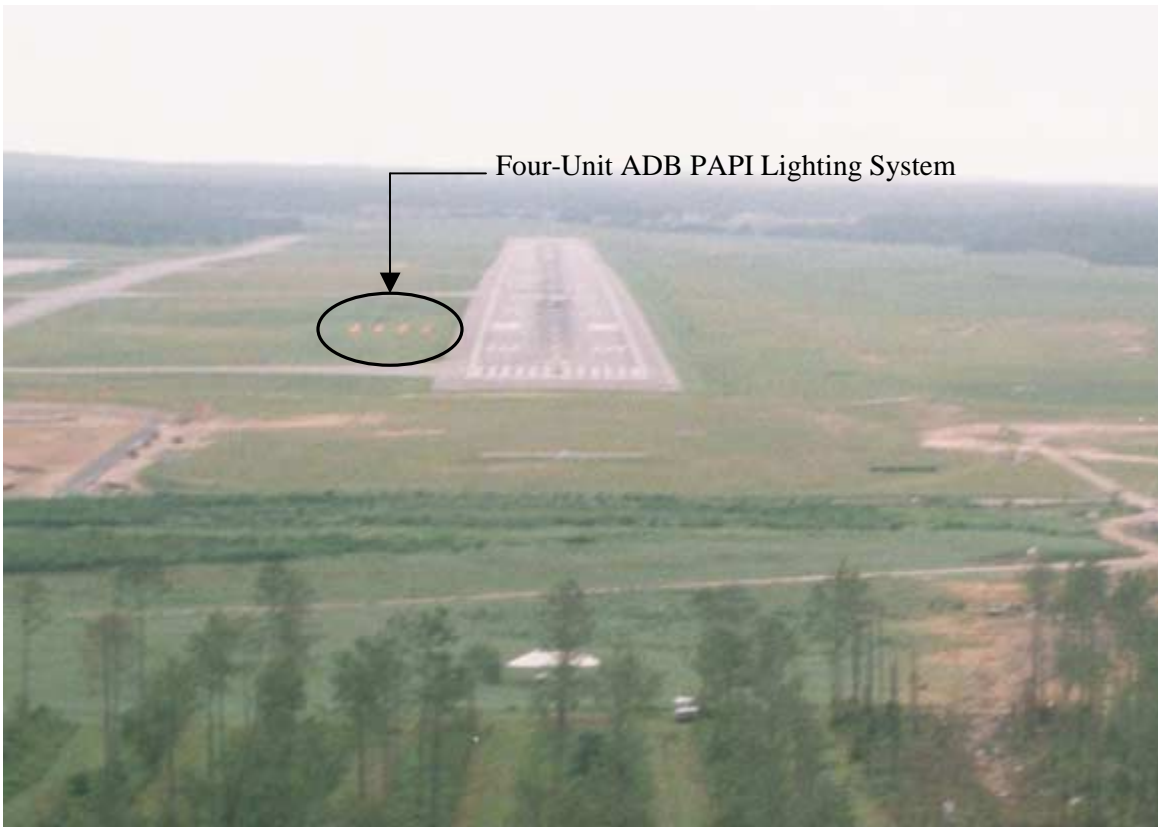
Photo 9: Aerial view of runway 9 approach.
