**NATIONAL TRANSPORTATION SAFETY BOARD
Office of Aviation Safety
Washington, D.C. 20594**

SURVIVAL FACTORS GROUP FACTUAL REPORT OF INVESTIGATION

- I. ACCIDENT :** **DCA11IA040**
- Location :** New Orleans, Louisiana,
Louis Armstrong International Airport (MSY)
- Date :** April 4, 2011
- Time :** 07:15 Central Daylight Time
- Aircraft :** Airbus A320-200
- Operator :** United Airlines, Flight 497, Registration N409UA
- II. SURVIVAL FACTORS GROUP**
- Group Chairman : Cynthia Keegan
National Transportation Safety Board
Washington, D.C.
- Member : Bob Newman
United Airlines
Chicago, IL
- Member : Vicki Jurgens
Association of Flight Attendants (AFA)
Chicago, IL
- Member : Bruce Peleschak
International Brotherhood of Teamsters Flight Safety
(IBTFS)
Chicago, IL

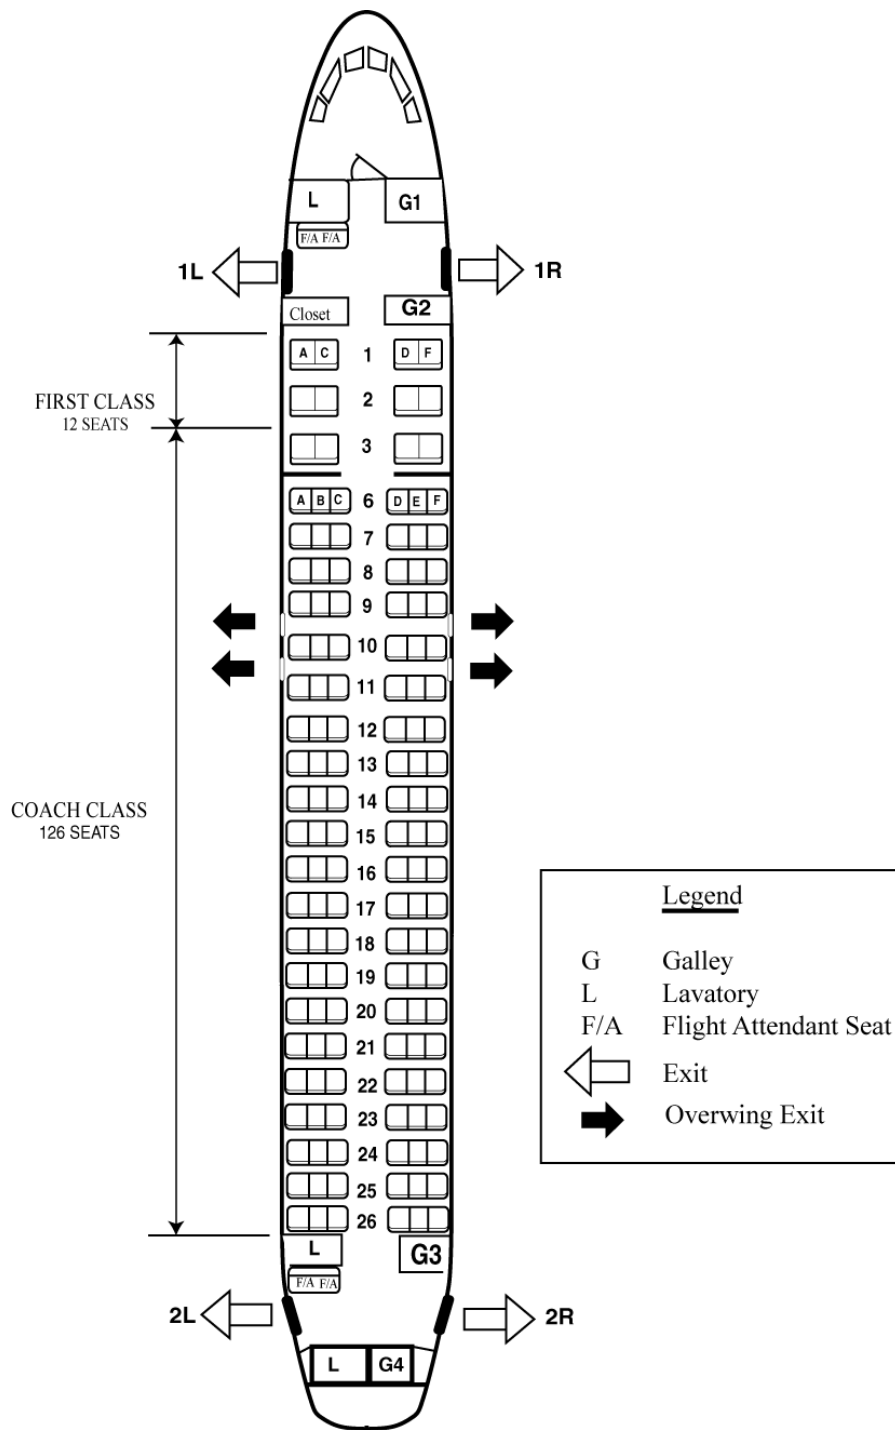
Figure 1. UAL 497 Cabin Diagram

The Airbus A320 cockpit was configured with captain and first officer seats and two cockpit jumpseats. The cabin was divided into two sections: first class and economy class with a total of 138 seats. There were 12 first class passenger seats divided into two rows of double seats longitudinally separated by one aisle. There were 126 economy class passenger seats, divided into two rows of three seats longitudinally separated by an aisle. There was a rear facing double occupancy flight attendant (F/A) jumpseat in the forward cabin, and a rear facing double occupancy F/A jumpseat in the rear cabin. See Figure 1, shows a cabin diagram of UAL flight 497.

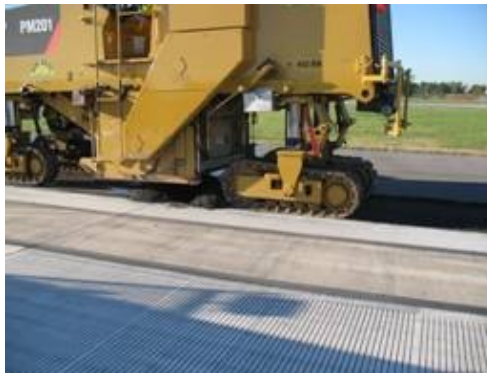
Photograph 1. Milling Machine on MSY Runway 10

After the incident, MSY Airport Operations closed runway 1/19 with NOTAM 04/008, and canceled NOTAM 04/002, advising all MSY Operators that runway 10/28 reopened. In addition, MSY Airport Operations informed the ATC Tower that runway 10/28 was clear, after the maintenance crew and equipment were off runway 10/28.
