**NATIONAL TRANSPORTATION SAFETY BOARD  
OFFICE OF AVIATION SAFETY  
WASHINGTON, D.C.**

**SURVIVAL FACTORS GROUP CHAIRMAN FACTUAL REPORT**

A.    **ACCIDENT**                :    DCA08MA076  
      **LOCATION**                :    San Francisco International Airport  
      **DATE**                    :    June 28, 2008  
      **TIME**                    :    2215 Pacific Daylight Time (PDT)  
      **AIRCRAFT**               :    Boeing B-767-200 (N799AX)  
      **OPERATOR**              :    ABX Air, Inc.

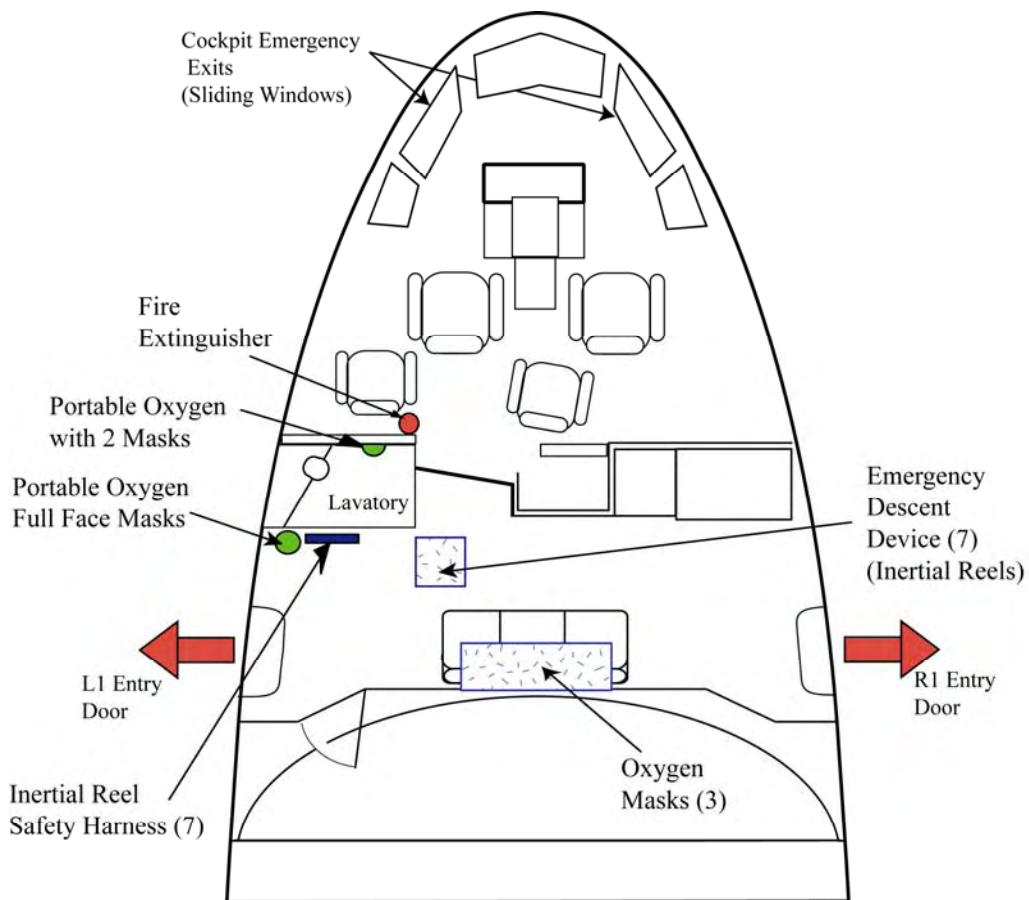
FIGURE 1 (Not to scale)

The cockpit contained a captain, first officer and two observer's seats, and there were three seats in the supernumerary compartment with oxygen masks located adjacent to each seat. There was one portable oxygen bottle with a full face mask near the L1 door and a second portable oxygen bottle was located on the fuselage inside the lavatory (located forward of the L1 door). See Figure 1 for a diagram of exits and emergency equipment location.

ABX Air Boeing 767 Cockpit and Forward Cabin Diagram
