D. Details of the Investigation

1.0 Airplane Configuration

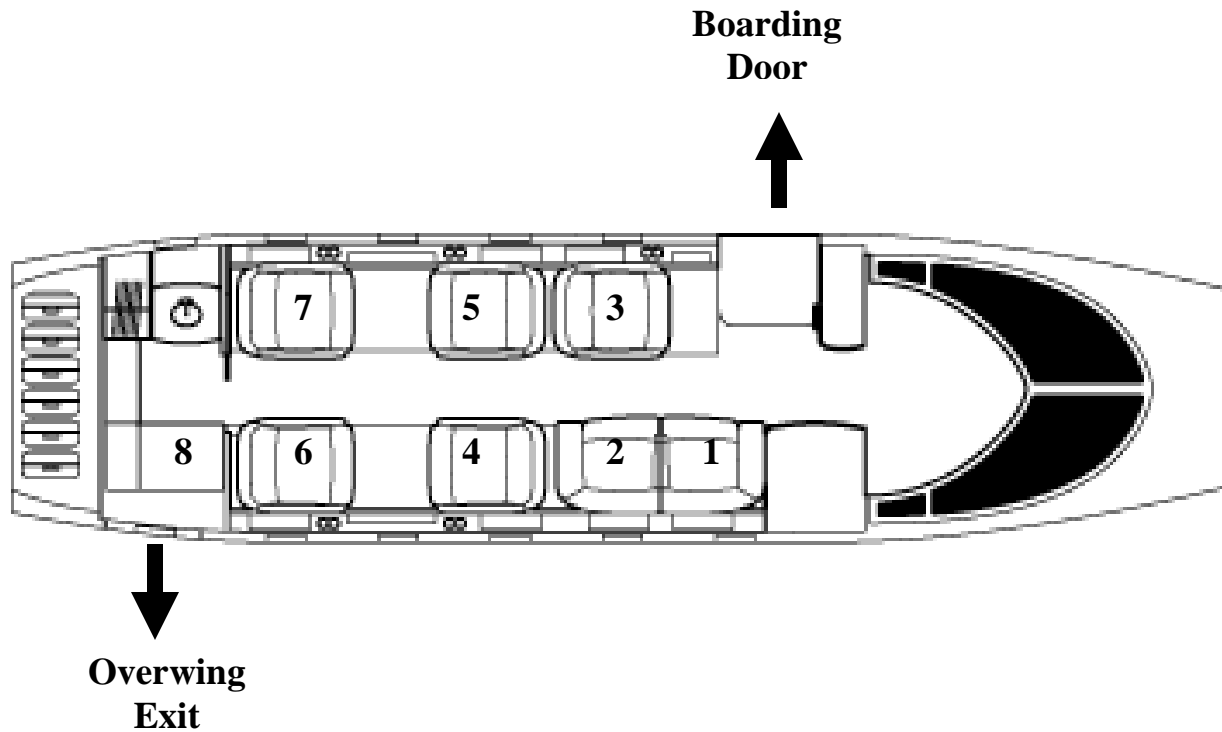
Figure 1. Learjet 60 cabin configuration

The airplane was configured with 8 passenger seating locations and 2 cockpit crew seats. (Figure 1). Seats 1 and 2 were part of a side-facing divan; seat 3 was forward-facing; seats 4 and 5 were aft-facing, seats 6 and 7 were forward-facing, and seat 8 was a side-facing seat located in the lavatory. There was a Type I floor-level passenger boarding door on the left, forward portion of the cabin, and a Type III escape hatch located in the lavatory at the right rear portion of the cabin. Note: Figure 1 shows the front of airplane to the right, and cockpit seats are not shown.

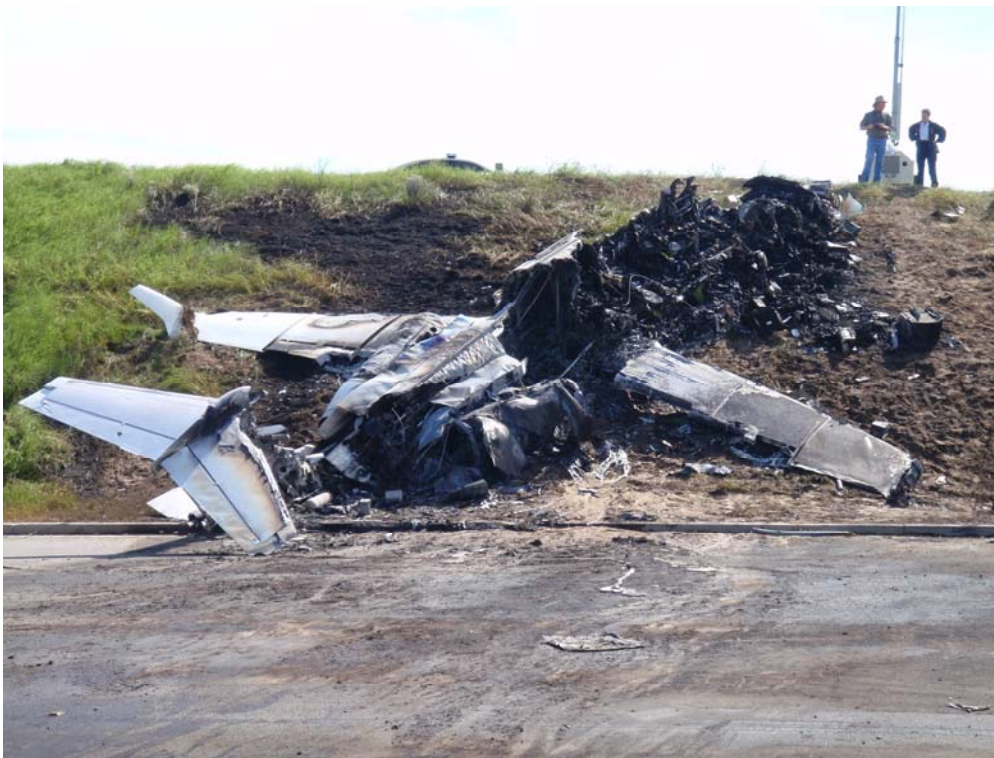
Photo 1. Airplane wreckage

The airplane was severely damaged by the post-crash fire. All interior furnishings including seats and restraints were destroyed. Charred remains of the pocket door separating the lavatory (and aft emergency exit) area from the cabin were found in the open (stowed) position. Remnants of the seats and exits were identified, and are summarized below.

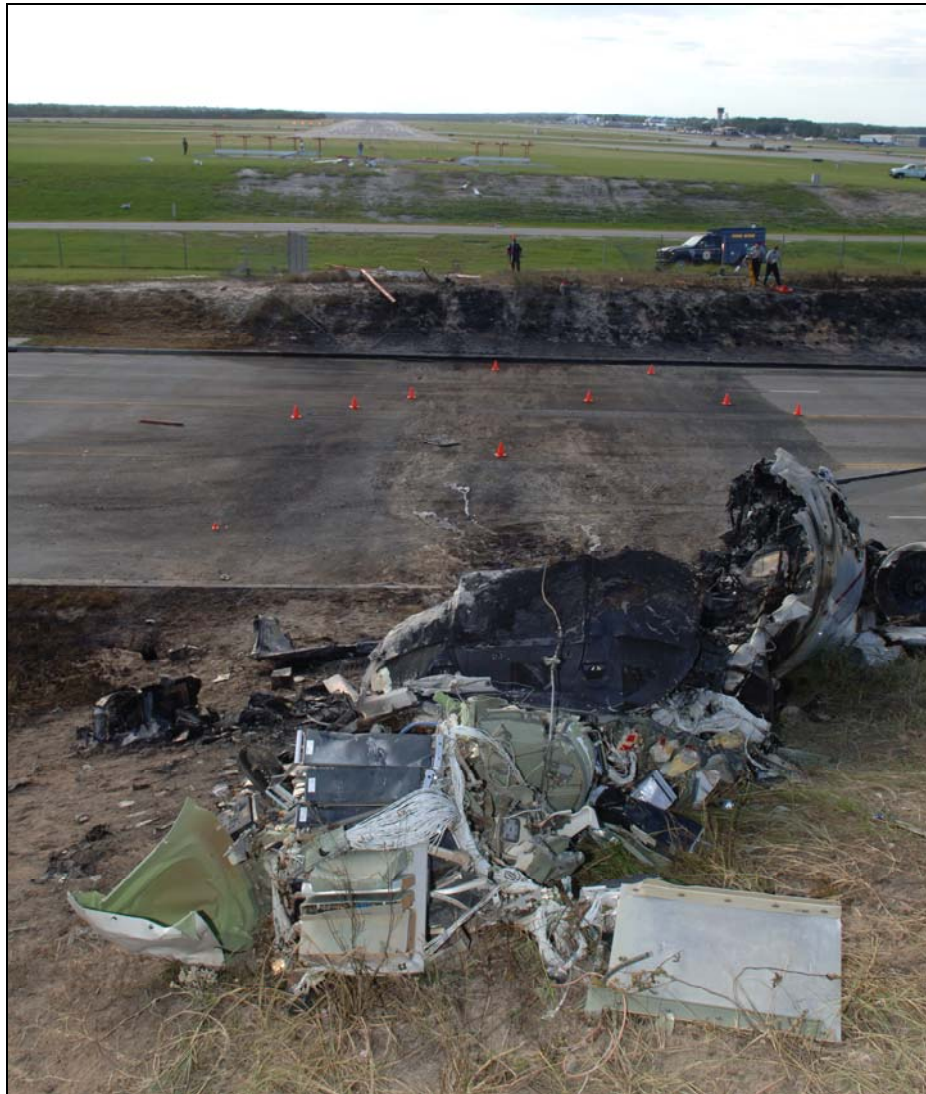
Photo 2. Airplane wreckage in foreground, Highway 302 in center, with airport and departure runway at the top of the photo.
