C. SUMMARY

On August 5, 2008, about 1941 Pacific daylight time,² a Sikorsky S-61N helicopter, N612AZ, impacted trees and terrain during the initial climb after takeoff from Helispot 44, located at an elevation of about 6,000 feet in mountainous terrain near Weaverville, California. The airline transport pilot, the safety crewmember and seven firefighters were killed; the commercial copilot and three firefighters were seriously injured.³ Impact forces and a postcrash fire destroyed the helicopter. The helicopter was being operated by the United States Forest Service (USFS) as a public flight to transport the firefighters from Helispot 44 to another location. The helicopter was registered to Carson Helicopters, Inc. (CHI) of Grants Pass, Oregon, and leased to Carson Helicopter Services, Inc. (CHSI) of Grants Pass. The USFS had contracted with CHI for the services of the helicopter.⁴ Visual meteorological conditions prevailed at the time of the accident, and a company visual flight rules flight plan had been filed.

D. DETAILS OF THE INVESTIGATION

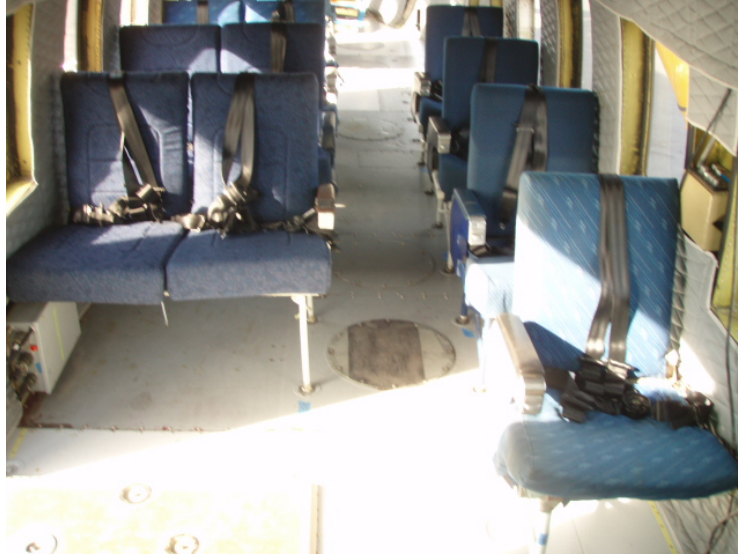
Figure 2. Photograph of N61NH interior cabin looking aft

On October 29, 2008, the Survival Factors Group visited Carson Helicopter Services, Inc. in Grants Pass, Oregon to document the cabin of a similarly configured S61N helicopter (sister-ship.) The sister-ship was registration N61NH. N61NH was configured with 5 rows of double seats on the right side of the cabin, similar to N612AZ, however, the aft right seat faced aft instead of forward (as in N612AZ.) There were 4 single forward facing seats on the left side of the cabin in N61NH, compared to the 6 single forward facing seats in N612AZ. N61NH also had aft facing double seat on the right side of the cabin, and N612AZ's right rear double seat was forward facing. N61NH was configured with Burns 650 and Aerosmith H25-A1 series seats that were the same design as the seats installed in N612AZ. All the seats in N61NH were equipped with Schroth (Part 1-10-Y30401, manufactured 05/08.) See Figure 2 showing the cabin interior of N61NH.

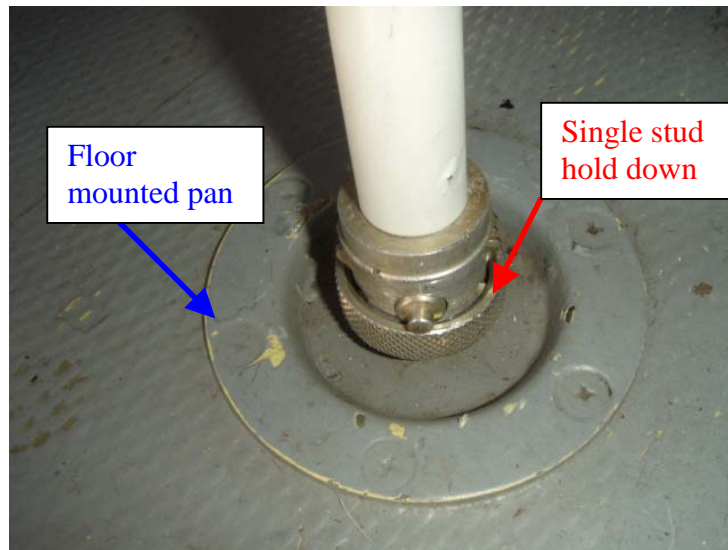
Figure 3. S61N seat leg attachment to the cabin floor

The Burns 650 inboard seat legs attached to the cabin floor by depressing a spring loaded pin on the single stud hold down fitting at the base of the seat leg. When the pin is depressed, the stud hold down fitting's steel collar can be moved upwards to release cleats that pivot outward and release from the floor mounted pan fitting. The inboard seat legs can be folded underneath the seat. See the photograph in Figure 3 showing the seat attachment to the cabin floor.

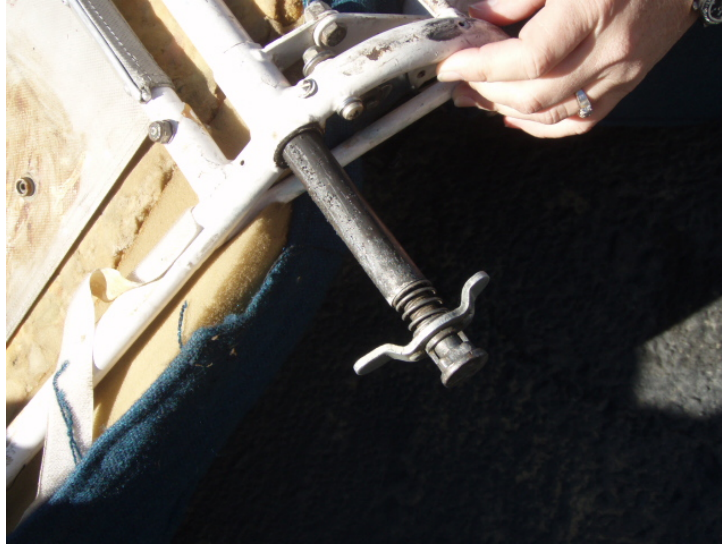
Figure 4. Photograph of a single pin hold down fitting

The outboard seat mount consists of a seat track mounted to the side of the cabin (about 15 inches above the floor.) Forward and aft single pin hold down fittings provides

seat attachments to the cabin sidewall. The aft single pin hold down fitting is spring-loaded and locks the seat into the cabin sidewall seat track. See the photograph in Figure 4 showing a view of the bottom of a seat with an extended aft spring-loaded single pin hold down fitting.

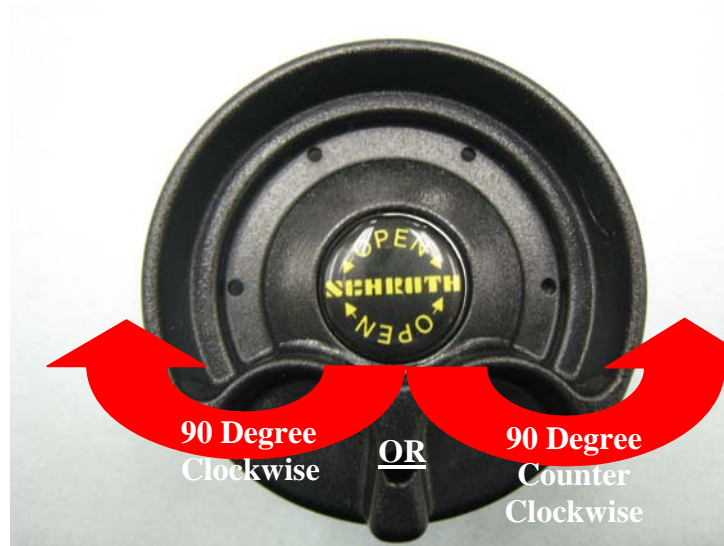
FIGURE 5. Schroth Buckle Cover Movement

The Schroth rotary buckle (part number SL 12.5) on the 1-10-Y30401 restraint is certified to meet the requirements of Society of Automotive Engineering (SAE) AS8043A. Schroth rotary buckle SL 12.5 unlatches by twisting the buckle cover 90 degrees in either direction as shown in Figure 5 below. This particular buckle series incorporates what is known as a “lost motion” feature. For a “lost motion” buckle, the first approximate 30 degrees of rotation in either direction does not actuate the locking pins (i.e., release of the latches). This feature is designed to prevent items such as tool belts, firearms worn by passengers or crew from inadvertently unlatching the buckle.

SAE Aerospace Standard (AS) 8043B “Restraint Systems for Civil Aircraft” specifies that the rotational force by twisting/torsion motion shall release with less than 13Kn or 30 pounds of force. According to the Schroth Qualification Test Report, the buckle release force with load applied to the lap and shoulder belts ranged between 9.7 and 14.2 pounds.

Twisting the buckle cover actuates a cam style component within the buckle the movement of the cam creates a downward motion on a spring-loaded plate. The plate is designed to capture the spring loaded locking pins of the buckle. The locking pins have a flanged end installed below the plate. A downward motion on the plate causes the pins to move down, and tilt members convert the rotational motion into a vertical motion causing the release plate to move down and forcing the flanged pins to move down. As the pins move down, the latches retained within the buckle are simultaneously released. The latches are pushed out of the buckle by springs located at the tip of each latch. The springs are installed in the buckle-retaining cage. (A description of the retaining cage follows in the latch installation section.)

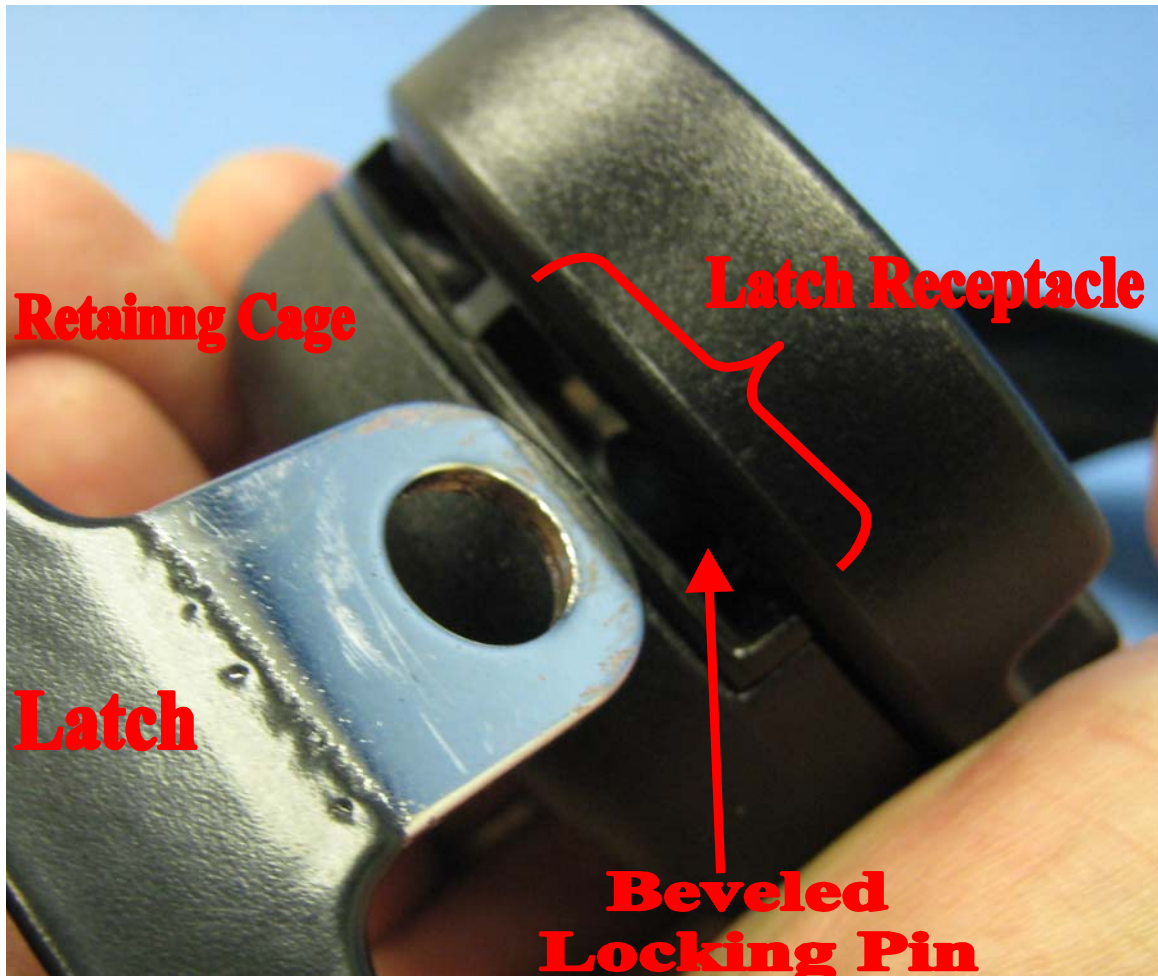
FIGURE 6. Insertion of Latch into a Schroth Buckle

Schroth rotary buckle SL 12.5 is designed with receptacles for insertion of 5 latches into the buckle. The accident restraint design did not include a fifth point latch connection and therefore the bottom or anti-submarine receptacle was not used in its design. The retaining cage includes a hole within each receptacle space for the locking pin to protrude. Four of the five locking pins are designed to accept latches and the fifth pin is fixed to one side of the restraint. The fixed pin holds the restraint to the buckle. When the buckle is rotated and releases the latches the fixed pin does not move and the latch in this position remains engaged in the buckle. The locking pins that do move and can accept a latch for locking the occupant into the restraint are beveled. As the latch is

inserted, the bevel on the pin creates a downward force that makes the pin move down and out of the way of the latch. As soon as the hole in the latch is lined up with the pin the pin moves upward and captures the latch. Figure 6 below identifies the components mentioned in the description above.
