NATIONAL TRANSPORTATION SAFETY BOARD
OFFICE OF AVIATION SAFETY
WASHINGTON, D.C.

**SURVIVAL FACTORS SPECIALIST'S FACTUAL REPORT OF
INVESTIGATION**

A. ACCIDENT : ERA12FA056
LOCATION : Key West, Florida
DATE : October 31, 2011
TIME : 1940 eastern daylight time (edt)¹
AIRPLANE : Gulfstream G-150, N480JJ

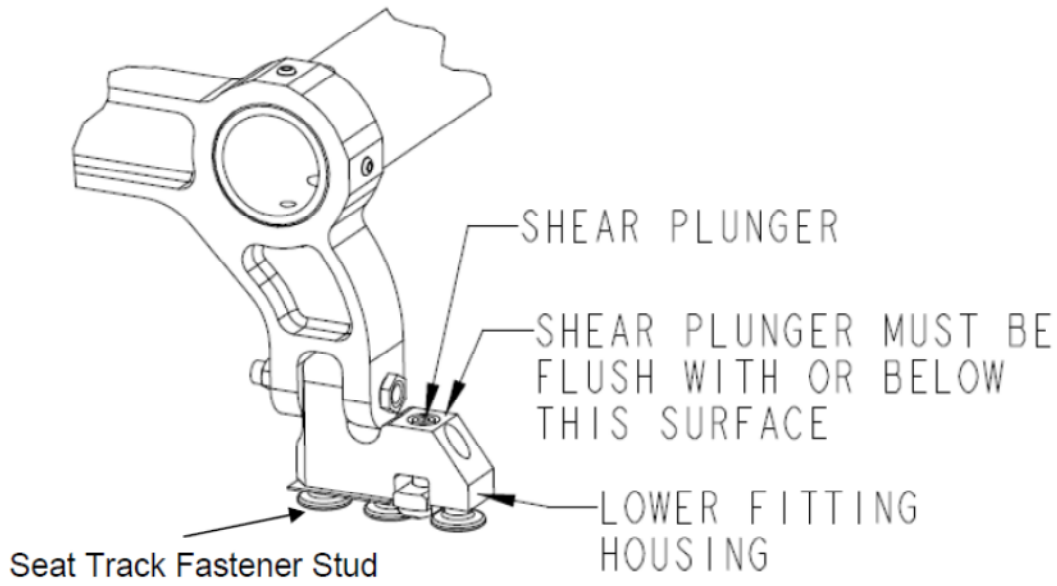
Figure 2
Fixed base floor fitting.

The fixed base seat is designed to attach to the floor track with four lower fitting housings. To install the seats, the shear plunger is raised to maximum height to allow for positioning the seat track fastener studs into the seat track. The seat is then slid forward or aft ½ inch and the shear plunger is tightened so that is at or below the top surface of the lower fitting housing. The shear plunger is supposed to be tightened to a torque value of 30-50 in. lb. See figure 2.

The cabin was inspected and documented in Key West, Florida, on November 2, 2011. The group found that Seat L/H #2 separated from the seat track and the seat's shear plungers were not tightened so the plungers were at or below the top surface of the lower fitting housing. The other five cabin seats were properly installed with the shear plungers positioned at or below the top surface of the lower fitting housing. Please see Factual Report of On-scene Cabin Documentation.
