NATIONAL TRANSPORTATION SAFETY BOARD
OFFICE OF AVIATION SAFETY
WASHINGTON, D.C.

Survival Factors Group Chairman's Factual Report of Investigation

A. Accident : DCA00MA030

Airplane : Boeing 737-3T5, Flight 1455, N668SW

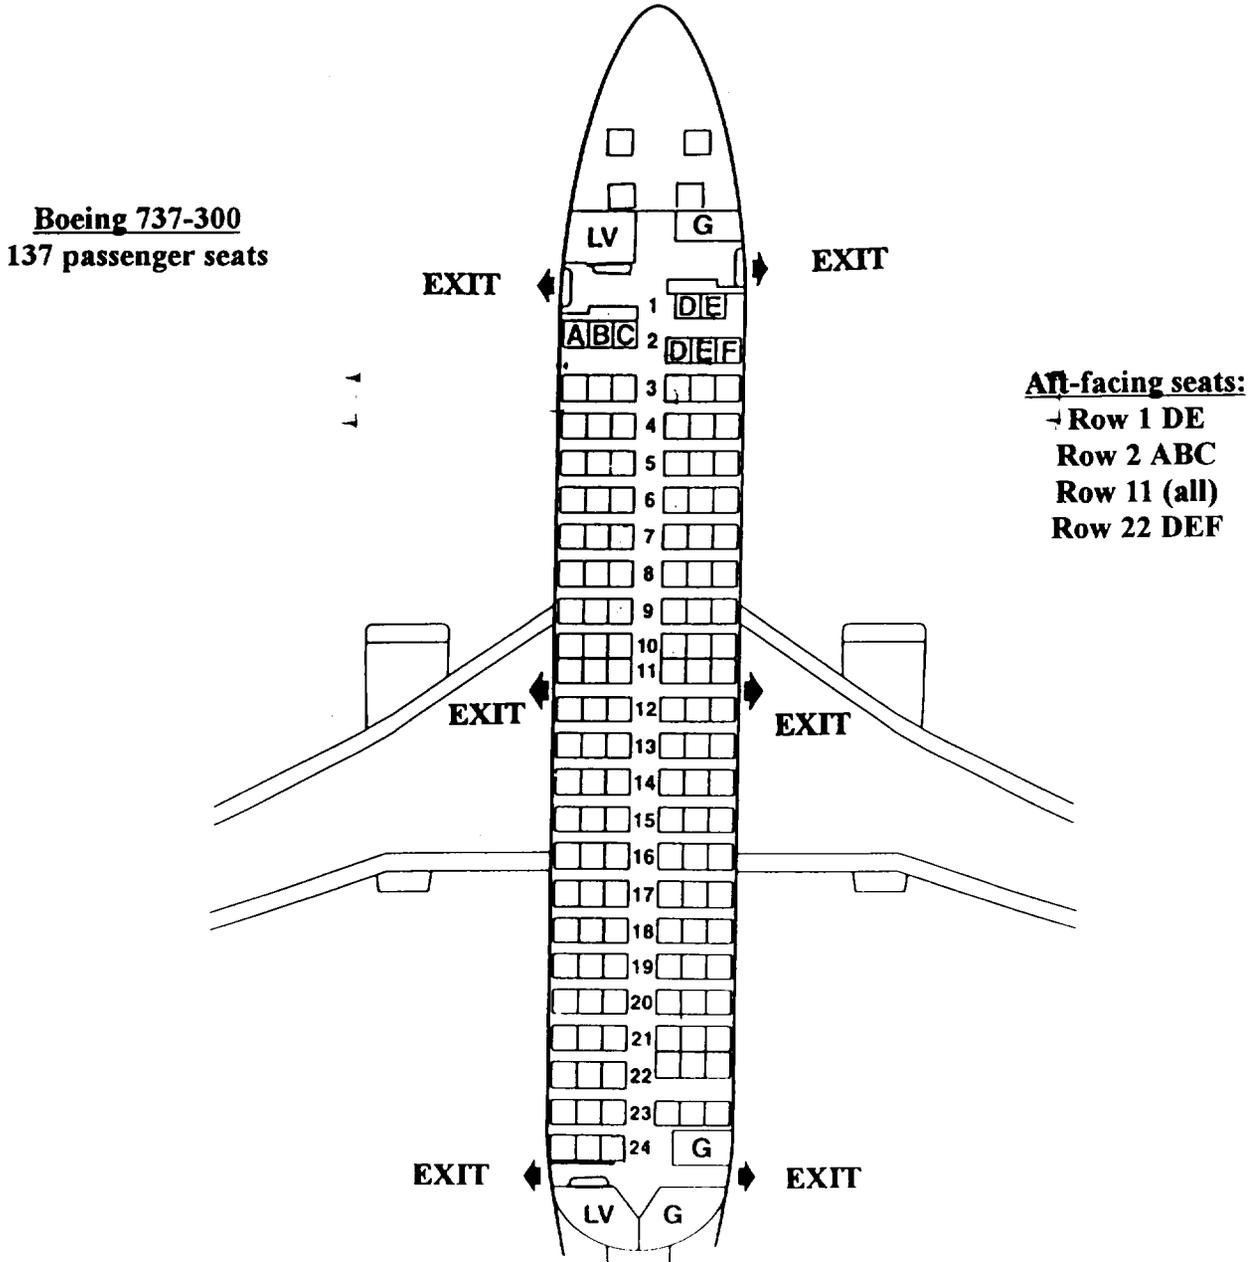
Figure 1.
Cabin configuration

The airplane was configured with 137 coach-class passenger seats, 2 cockpit flight crew seats, 2 cockpit observers' seats, an aft-facing double flight attendant jump seat on the forward bulkhead, and a forward-facing double flight attendant jumpseat on the aft bulkhead (see figure 1, cabin configuration).
