NATIONAL TRANSPORTATION SAFETY BOARD  
Office of Aviation Safety  
Washington, DC 20594

**SURVIVAL FACTORS GROUP CHAIRMAN'S FACTUAL REPORT**

Operator : Comair, Inc.  
Aircraft : Bombardier CL-600-2B19 [N431CA]  
Location : Lexington, KY  
Date : August 27, 2006  
Time : 0609 Eastern Daylight Time<sup>1</sup>  
NTSB # : DCA06MA064

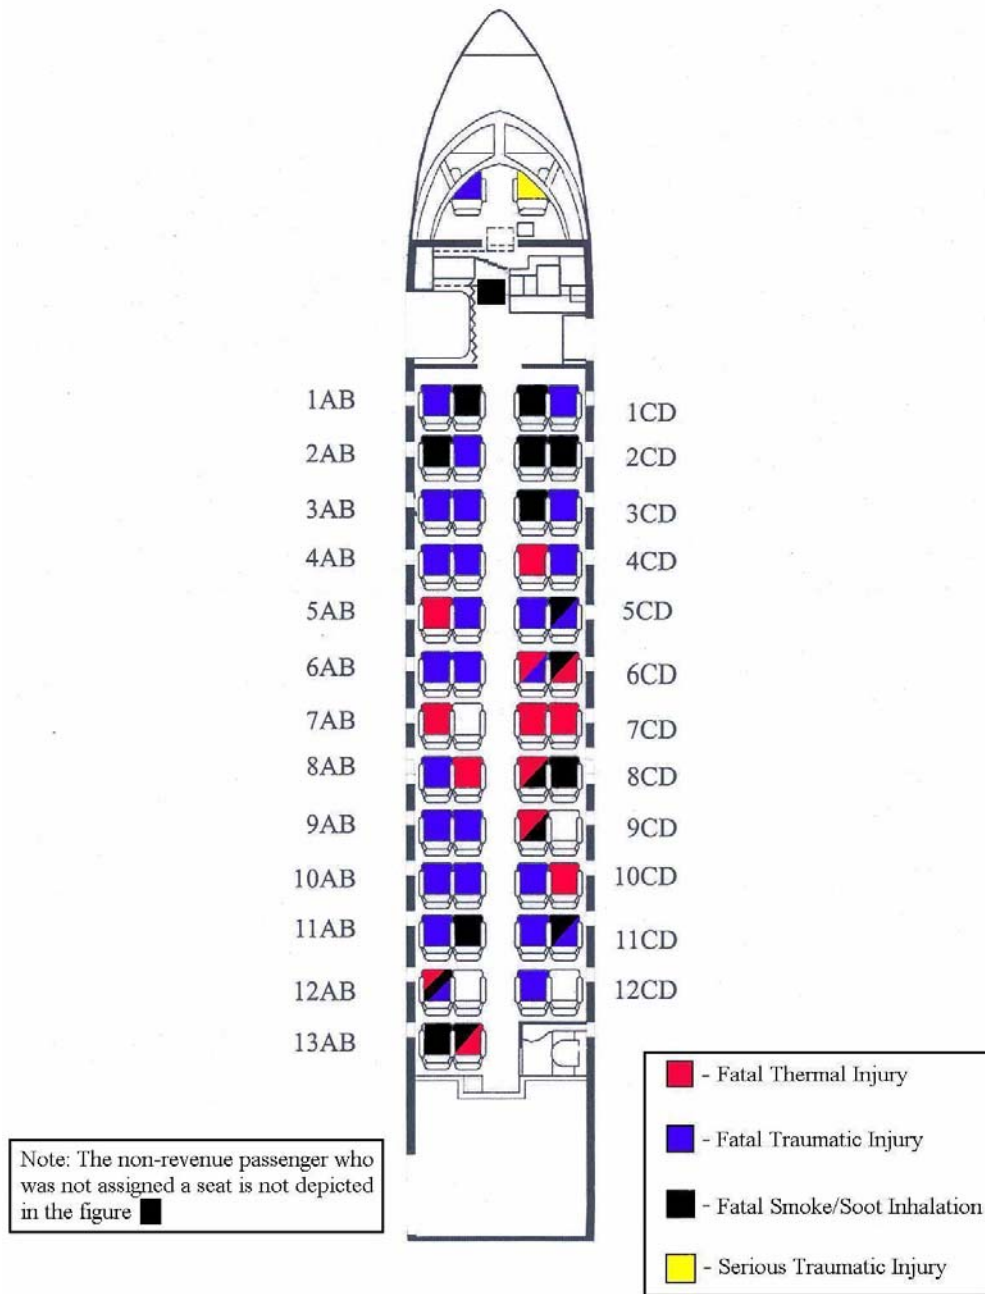
**Figure 6.<sup>9</sup> Summary of victims' injury information**

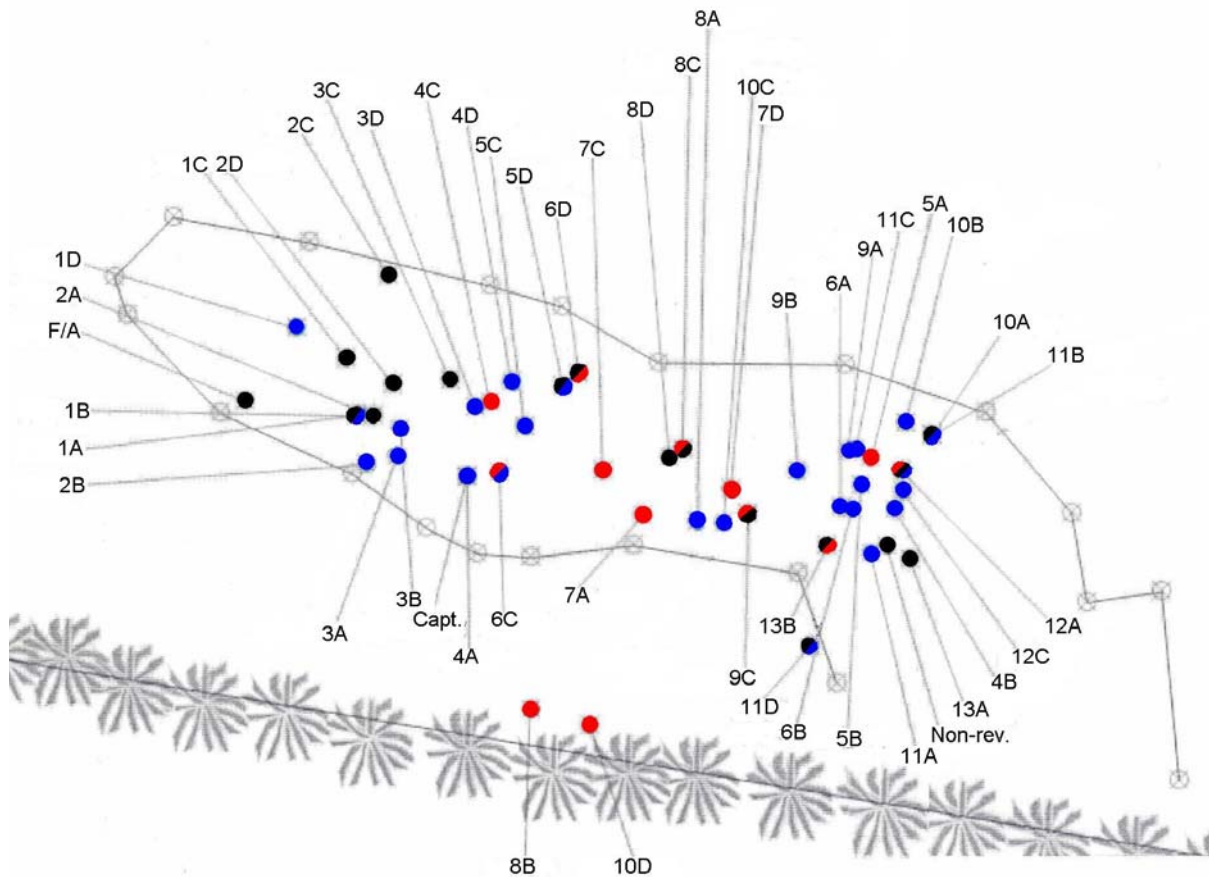
**Figure 7.<sup>10</sup> Victim location plot (cockpit to left)**

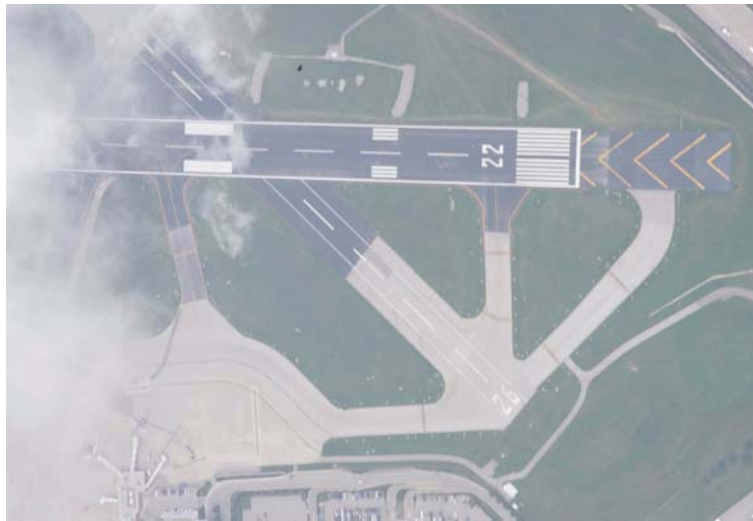
- There were two taxiway lead-in lines and one taxiway lead-off line that diverged from the T/W A, runway 8/26 hold short position.<sup>20</sup> From the left to the right, the lead-off line led to runway 26, and the two lead-in lines led to T/W A and the closed portion of old T/W A.<sup>21</sup>

- The lead-in lines and lead-off line were yellow in color and the pavement appeared lightly colored.
- The hold short position sign for runway 4/22 on T/W A was visible from the runway 26 hold short position.

- When taxiing onto runway 26 from T/W A the painted number '26' was to the right of the airplane and not rolled over.
- Runway 8/26 was marked as a VFR runway. It was 150' wide but was marked to 75' in width with edge stripes and shoulder markings.

**Figure 8. Photograph of the pavement configuration north of runway 26 at the time of the accident**

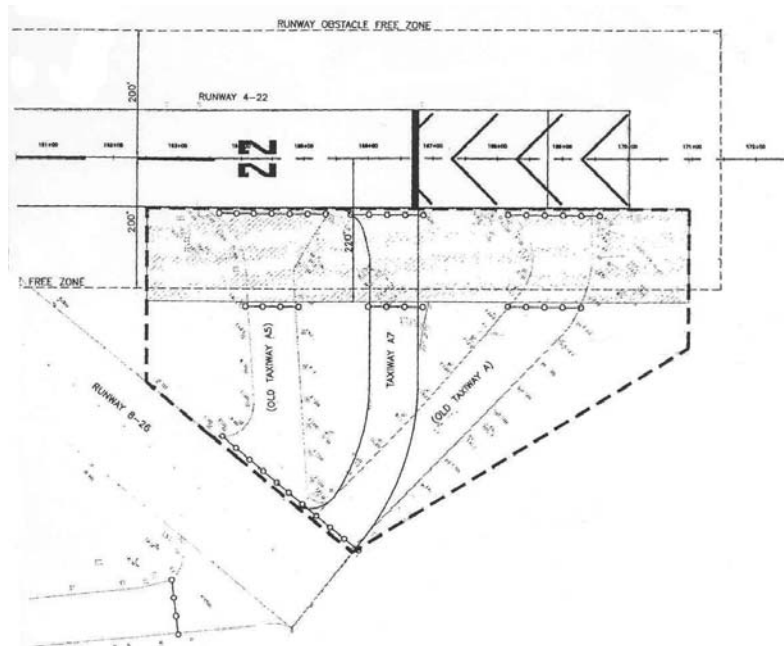
The pavement configuration and signage in place on the day of the accident was not accurately reflected by either the National Aeronautical Charting Office (NACO) or the Jeppesen chart. Mr. Woodford was asked about the discrepancy between the published charts for LEX. He stated that on August 2/3, 2006 the new Airport/Facility Directory (AFD) and NACO charts came out but the Jeppesen airport and approach charts did not reflect the change. (Mr. Woodford stated that the FAA told the airport that because it was an enroute airport, which had a different publication date, and because the flight check showed a problem with one of the “markers” a change had not been made to the approach charts.) He stated that the Jeppesen chart had a scheduled revision 9/28 at which time he believed that the final airport configuration would be shown.<sup>29</sup>

**Figure 9. Diagram showing the locations of old T/Ws A and A5 and new T/W A7**
