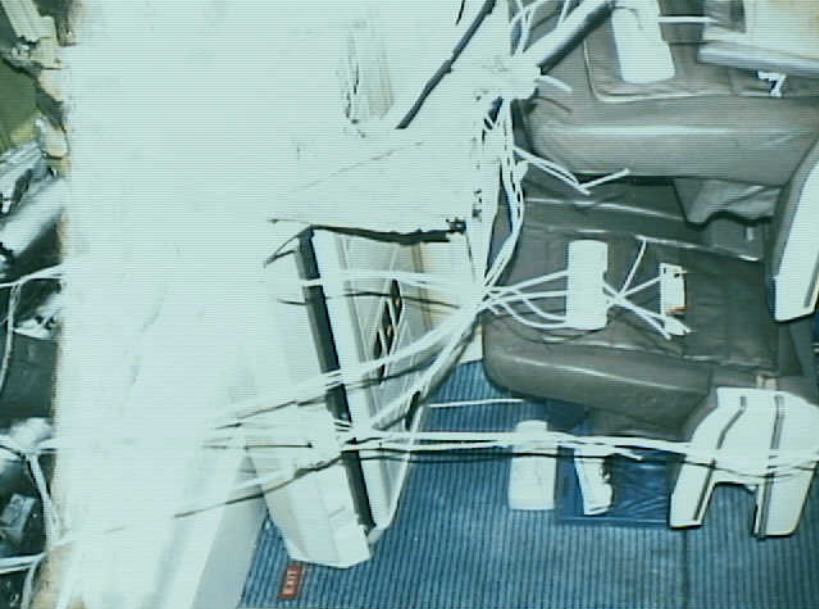
Survival Factors 6 - Photo 33. Interior damage, seat unit 4 EF, showing floor disruption.
