Air America Inc.
San Juan, Puerto Rico
June 3, 2017
ERA17FA195

SURVIVAL FACTORS SPECIALIST'S REPORT

Operator	:	Air America Inc.
Aircraft	:	Piper PA-23-250 [N21WW]
Location	:	San Juan, Puerto Rico
Date	:	June 3, 2017
Time	:	1418 AST ¹
NTSB #	:	ERA17FA195

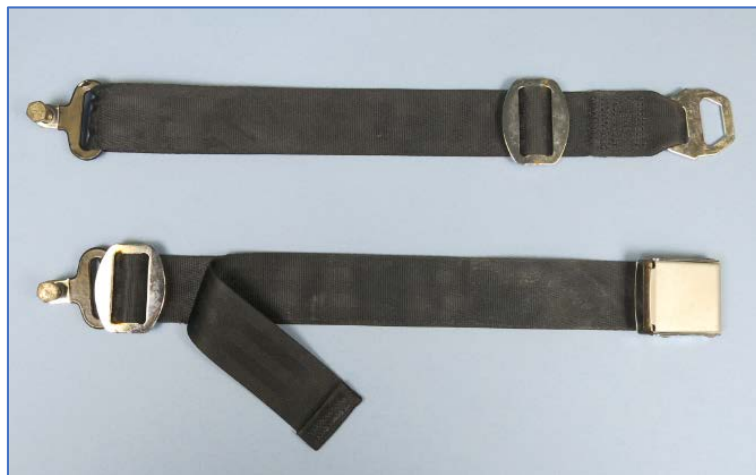
The restraint system was photographed in the NTSB Materials Laboratory (see figure 1). The buckle-side webbing was intact with no tears or cuts and did not appear to be faded. The lift latch-style buckle release could be rotated through its full range of travel, approximately 180 degrees (see figure 2). It was noted that the insert tab released from the buckle about the 90 degree point (see figure 3). The spring inside the buckle lever showed some evidence of corrosion (see figure 4), but no restriction in motion was evident. The restraint latched as designed when the insert tab engaged the buckle. There were minor wear scratches observed on the buckle and insert tab but no fresh scrapes or witness marks at the area of interaction between the buckle and insert tab. The webbing on the insert tab portion of the lap belt was intact with no cut or tears and did not appear to be faded. The seatbelt attachment points were intact with no visible signs of deformation. The buckle released from the insert tab as shown in figure 3. The adjusted length of the restraint (as received) when latched measured 38 ³/₄ inches. The adjusted buckle portion measured 18 ⁷/₈ inches and the insert tab portion measured 19 ¹¹/₁₆ inches. The overall length of the restraint when latched measured 68 ³/₁₆ inches. The overall length of the buckle portion measured 37 inches and the insert tab portion measured 31 ³/₁₆ inches.

Figure 1- Overview of restraint system.

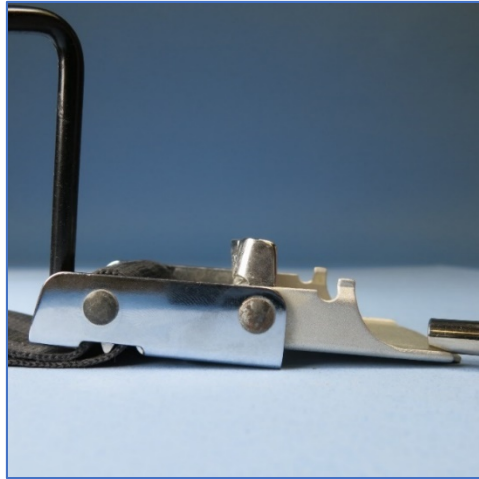
Figure 2 - View of lift latch-style buckle lever in full 180-degree release point.

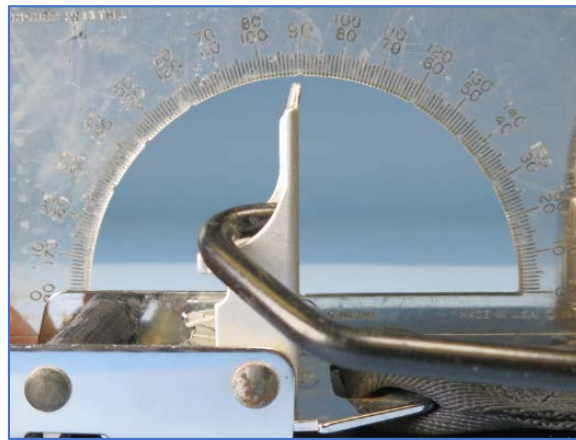
Figure 3 – Insert tab released from the buckle about the 90-degree point.

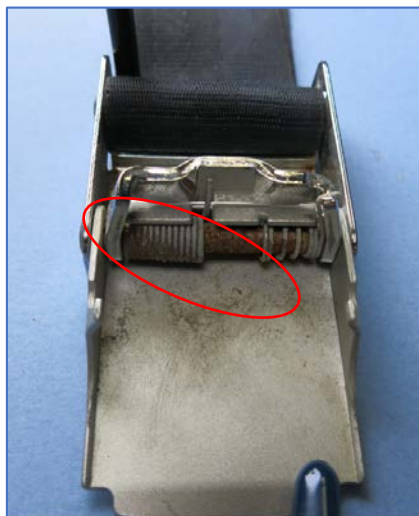
Figure 4 – Corrosion inside buckle lever.
