**Docket No. SA-532**

**Exhibit No. 6-E**

**NATIONAL TRANSPORTATION SAFETY BOARD**

Photographs

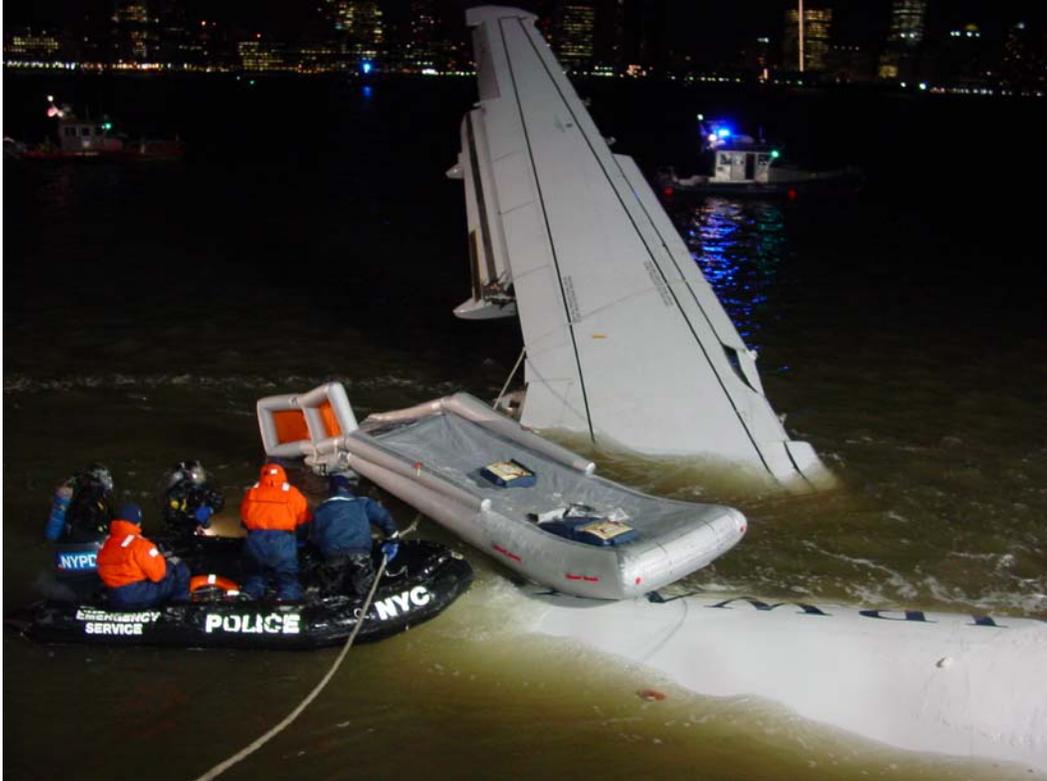
Photo 18. Condition of the airplane and left offwing slide when NTSB investigators arrived on the evening of January 15th

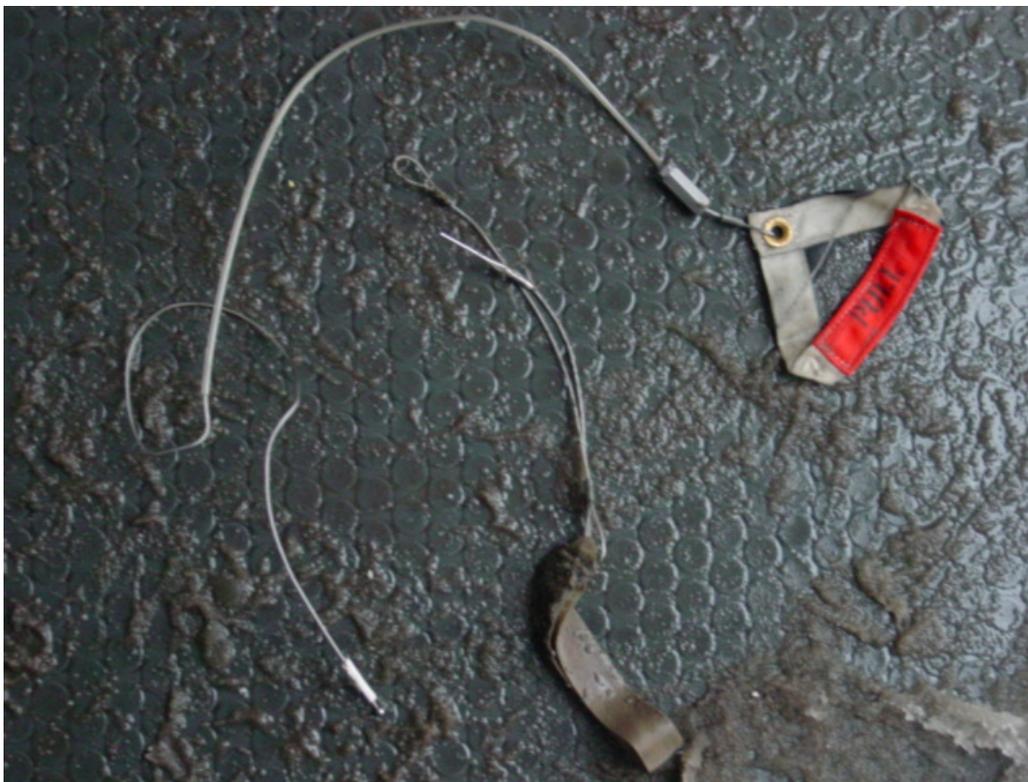
Photo 25. Manual inflation lanyard and ditching release handle found on the floor in the forward galley

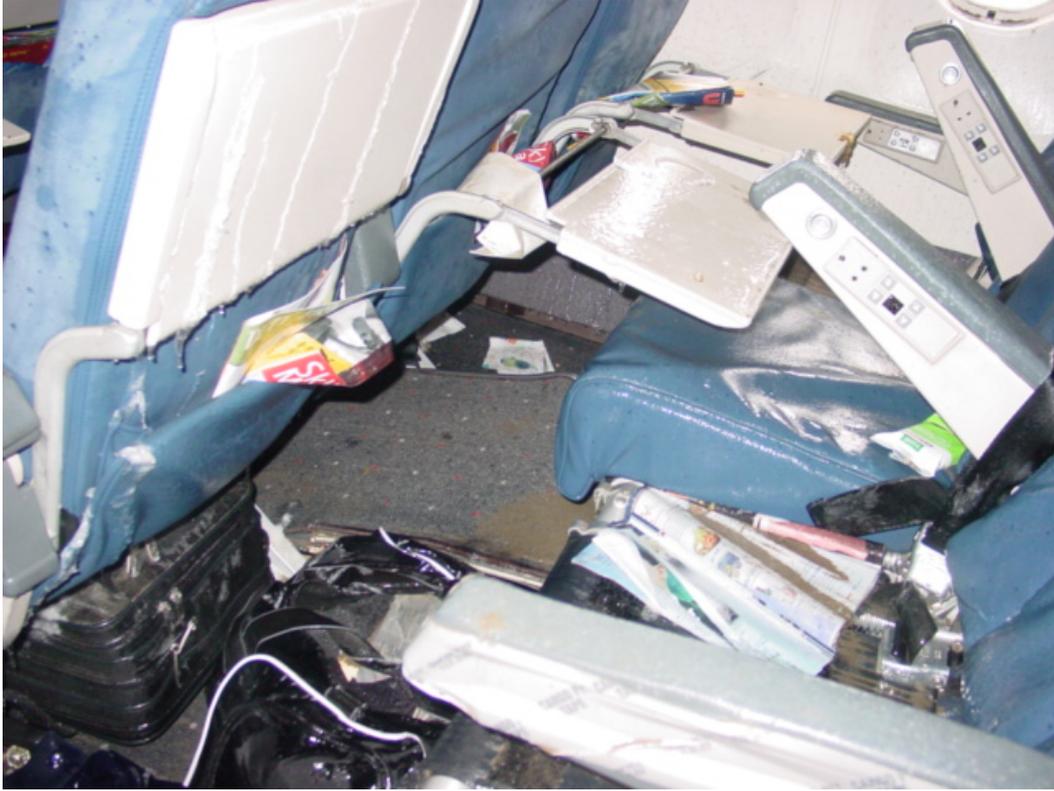
Photo 33. View of row 22 DEF showing floor damage

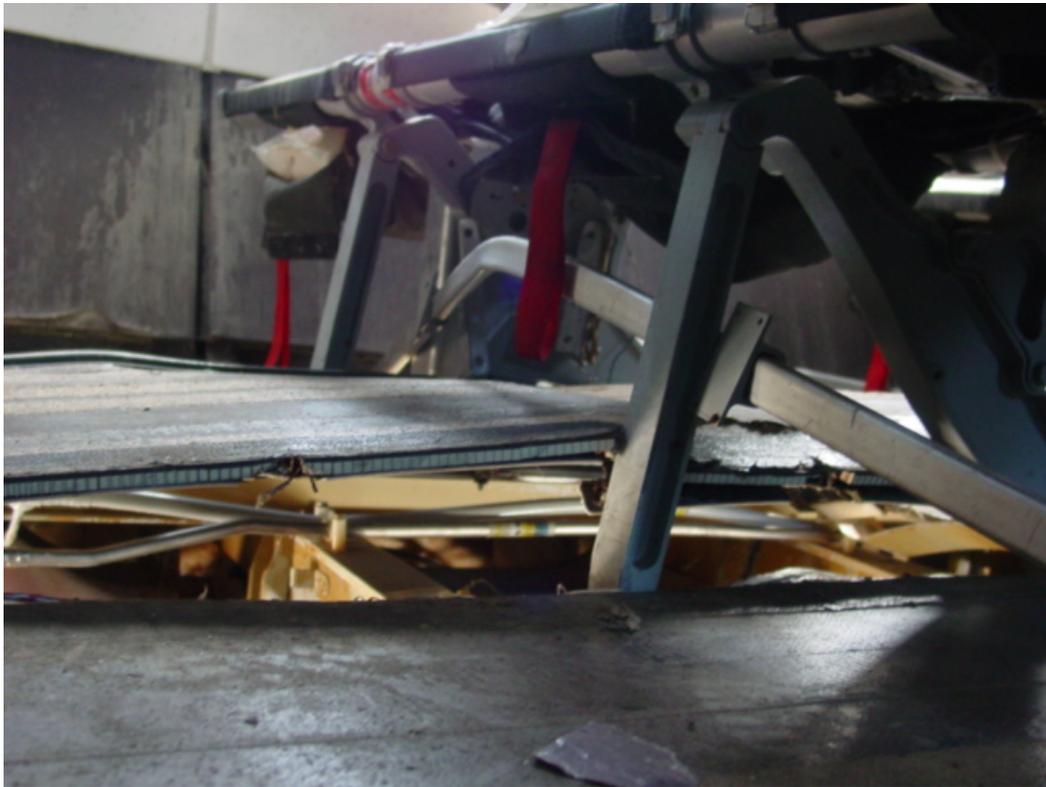
Photo 34. Similar view of row 22 DEF with baggage and carpet removed

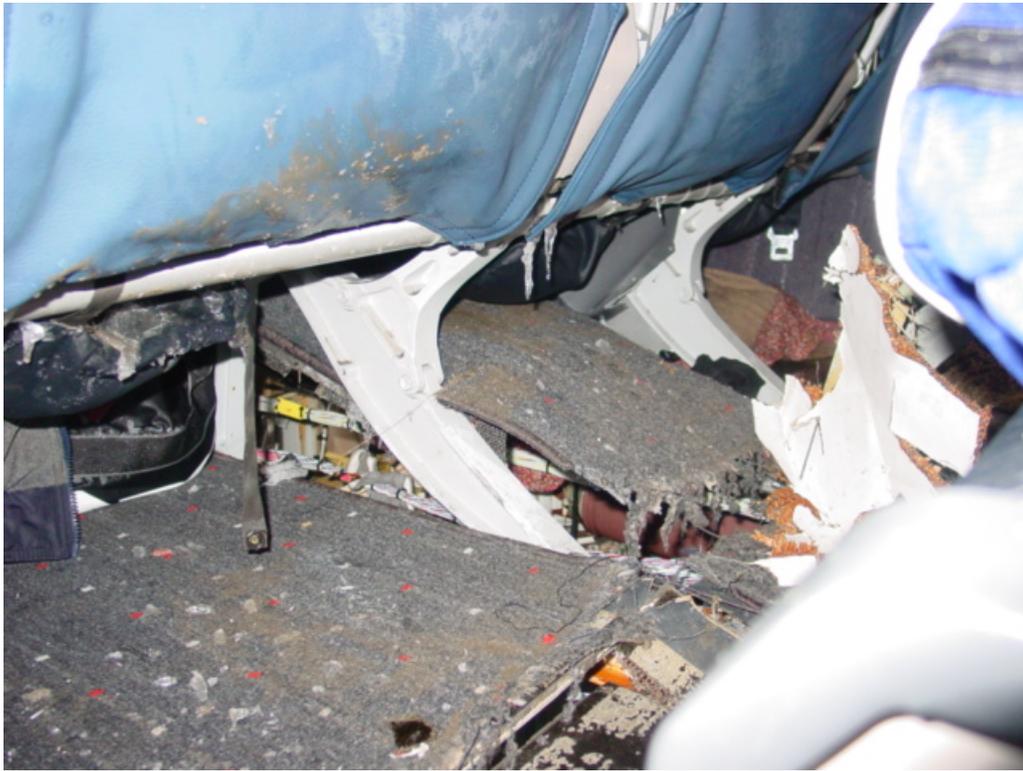
Photo 35. View of the floor damage beneath seat 22E (viewed from row 23 DEF)

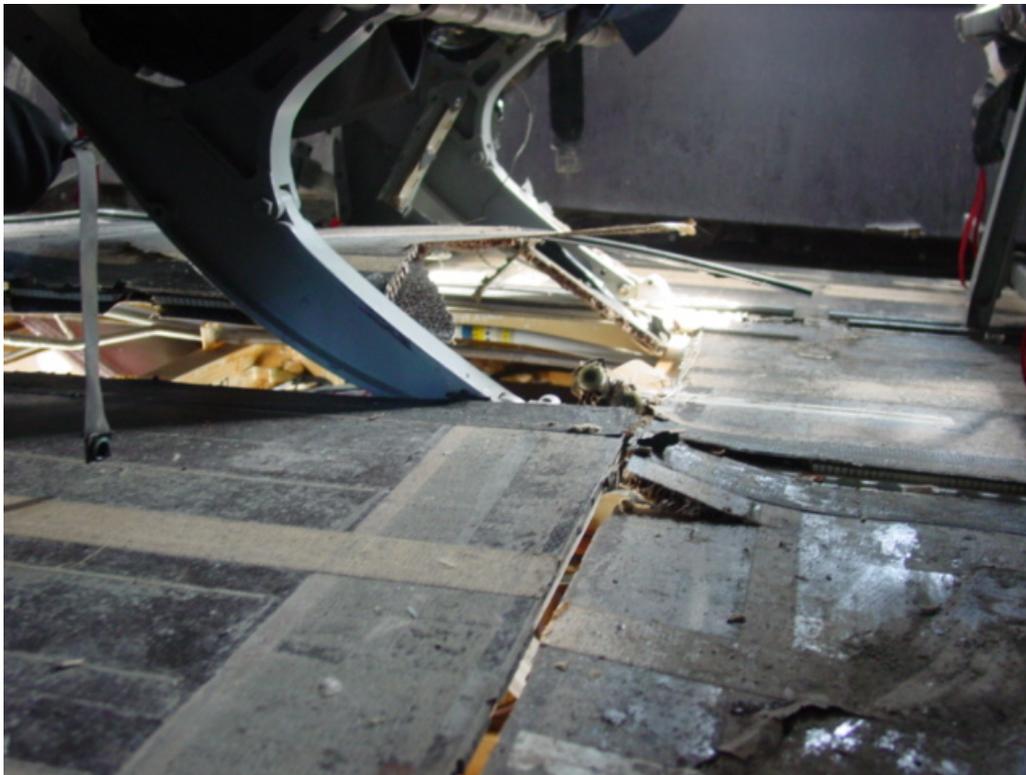
Photo 36. Similar view of the damage beneath seat 22E with baggage and carpet removed

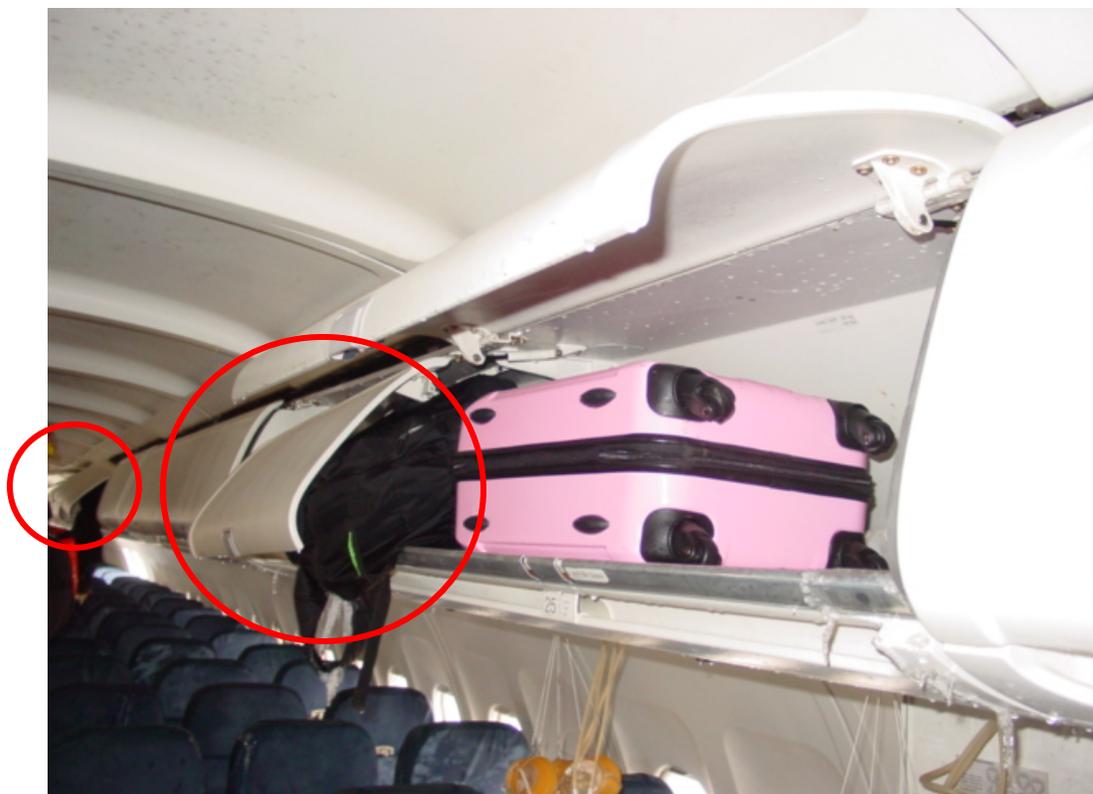
Photo 37. Forward-facing view of the two overhead bins with fractured hinges (18/19 DEF and 23/24 DEF)

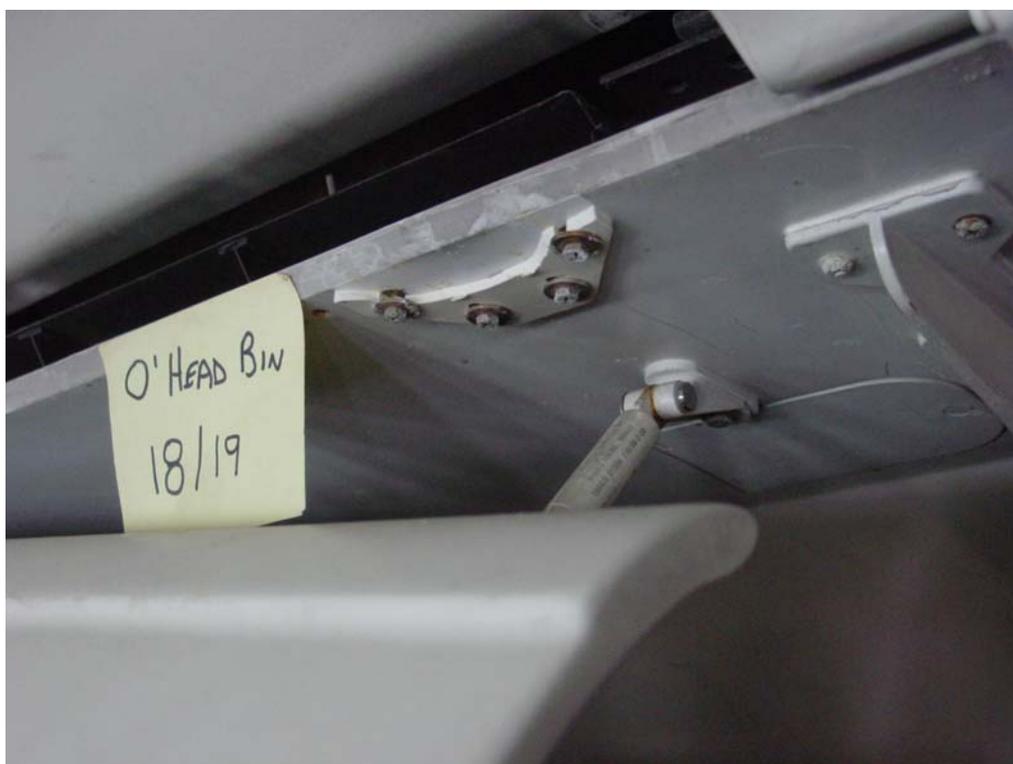
Photo 38. Fractured aft hinge of overhead bin at row 18/19 DEF

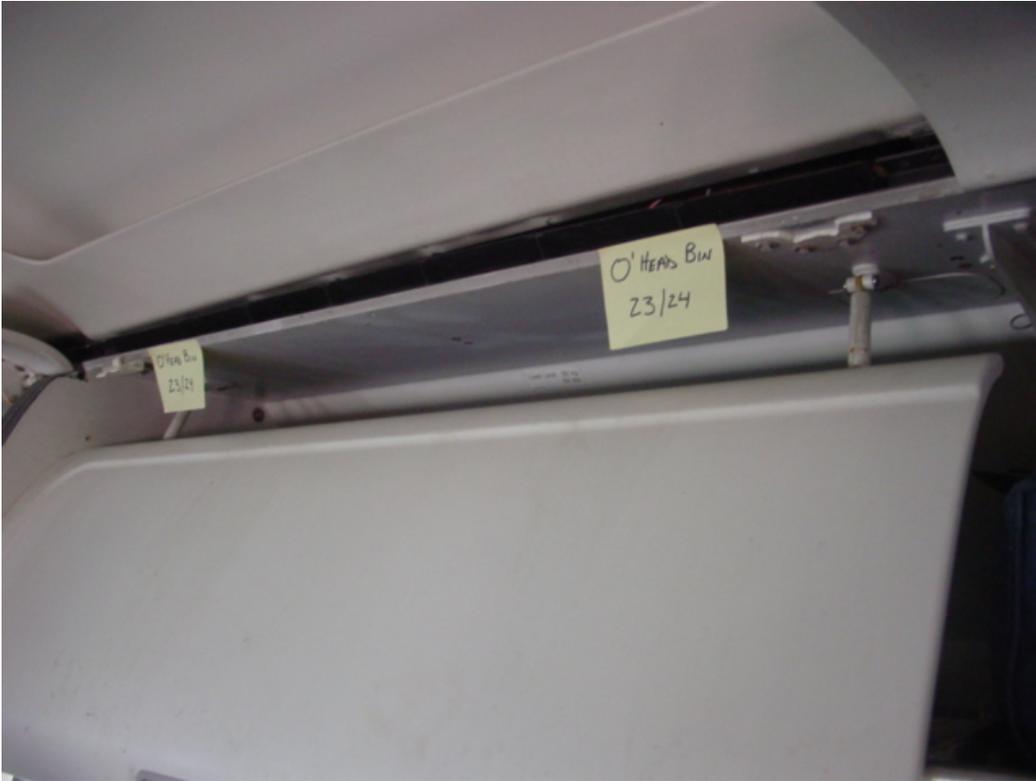
Photo 39. Fractured hinges of overhead bin at row 23/24 DEF

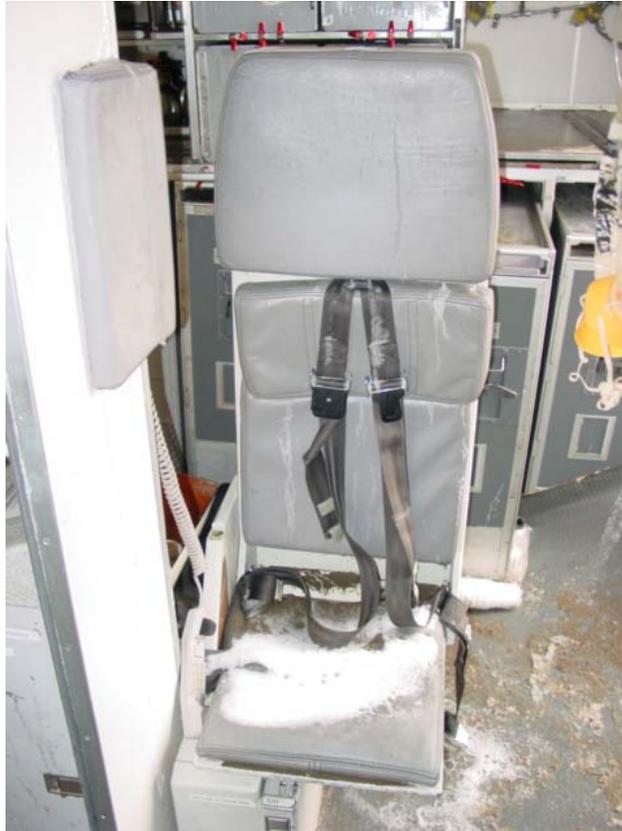
Photo 41. Position of “direct view” jumpseat as found by investigators

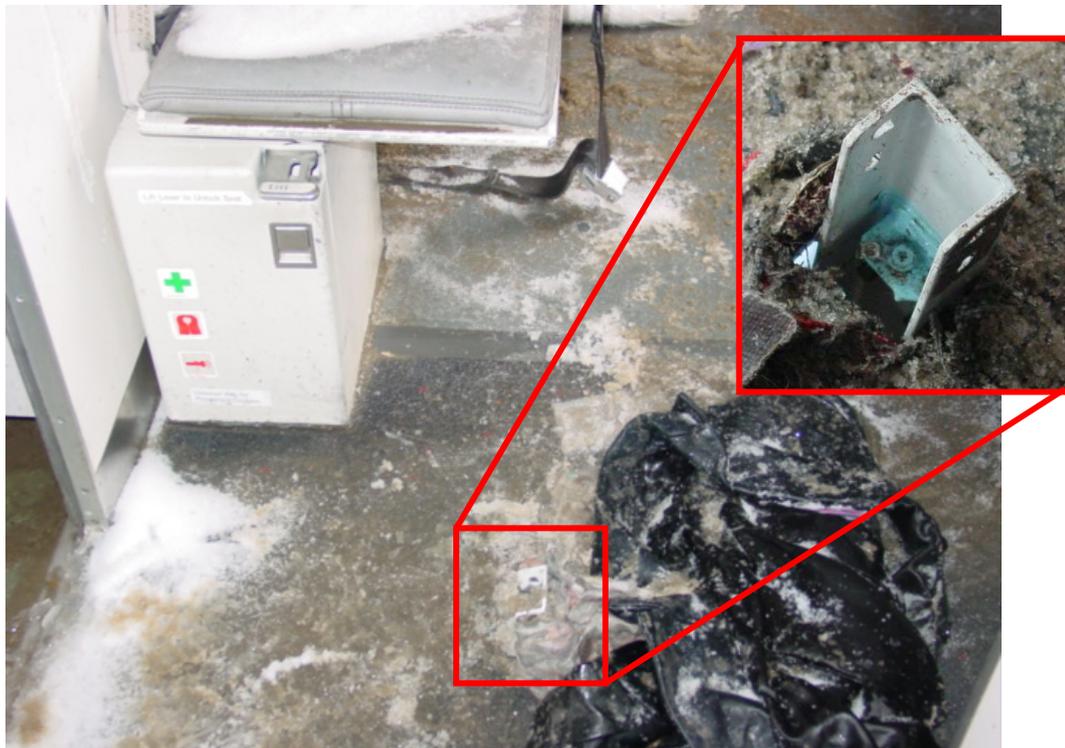
Photo 42. Location where vertical beam 65 penetrated the floor of the cabin

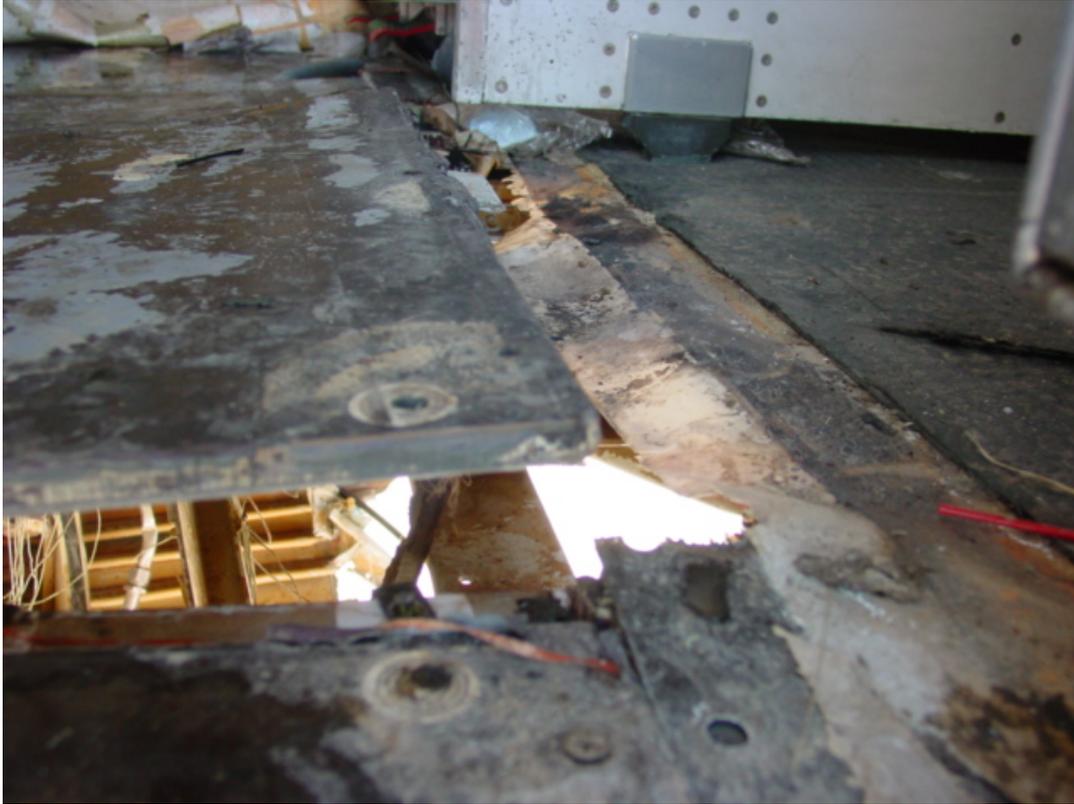
Photo 51. Damage to the center floor panel of the aft galley and surrounding area

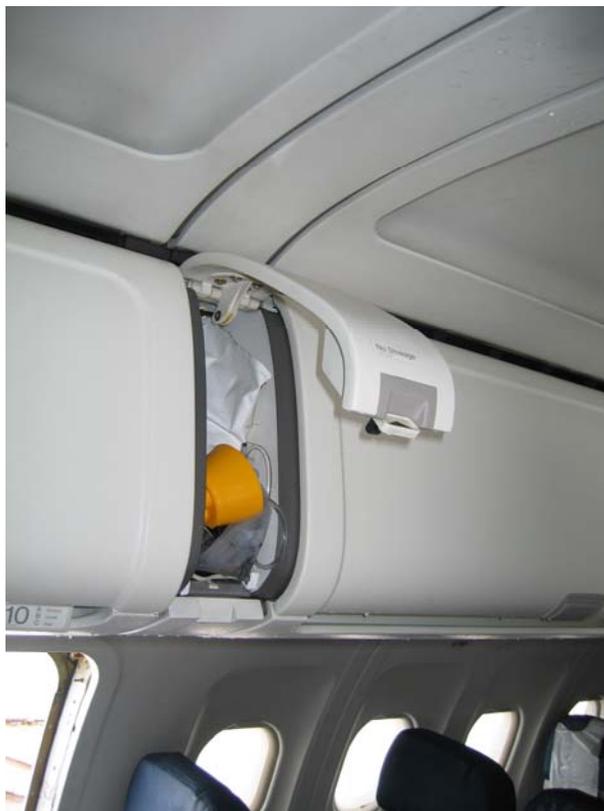
Photo 60. Demo kit found inside life line stowage at row 10 ABC
