**Survival Factors Attachment:**

**Photographs**

**Oakland, Ia.**

**HWY18MH003**

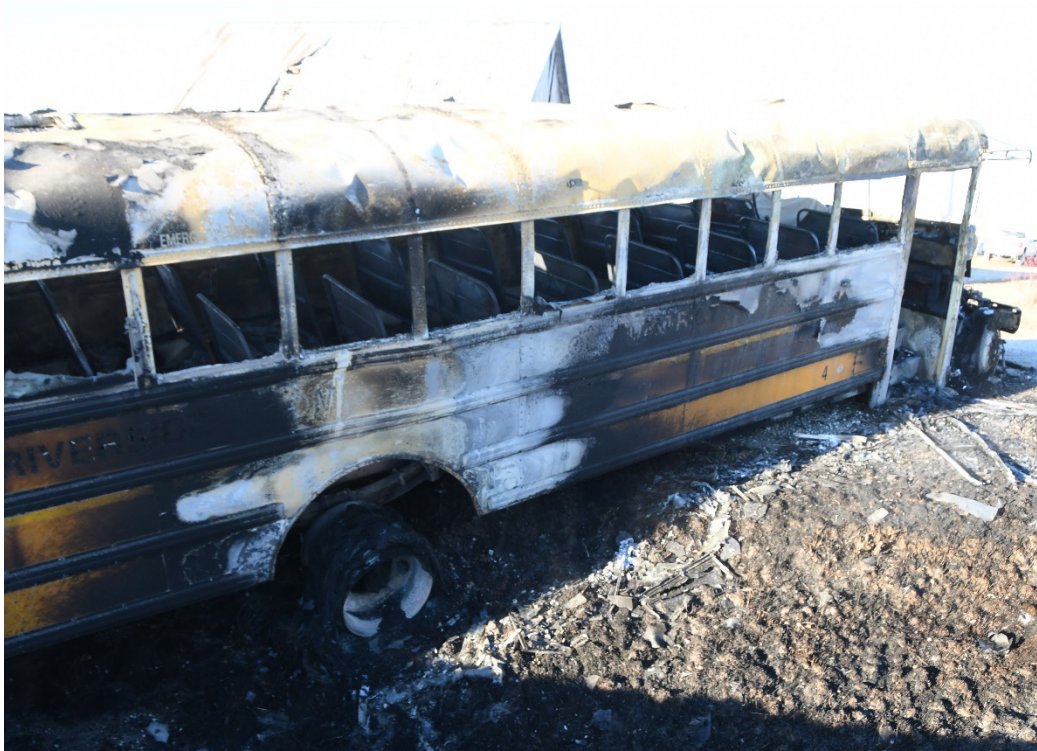
Photo #1: Exterior of school bus showing extensive fire damage at the scene

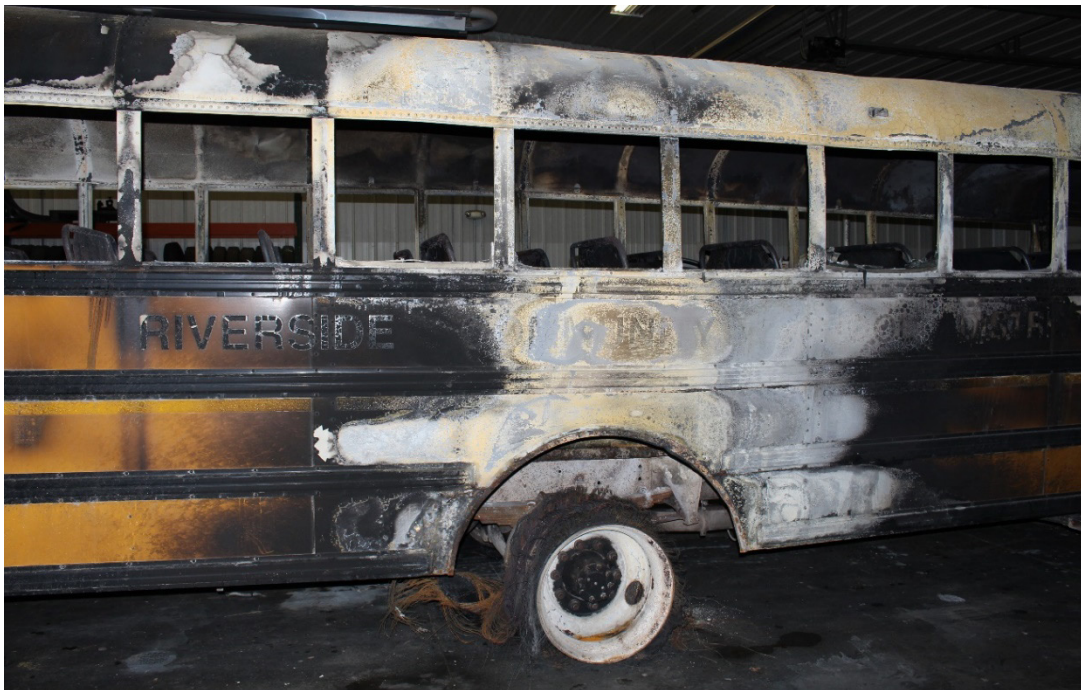
Photo #2: Left side exterior view of school bus showing extensive fire exposure.

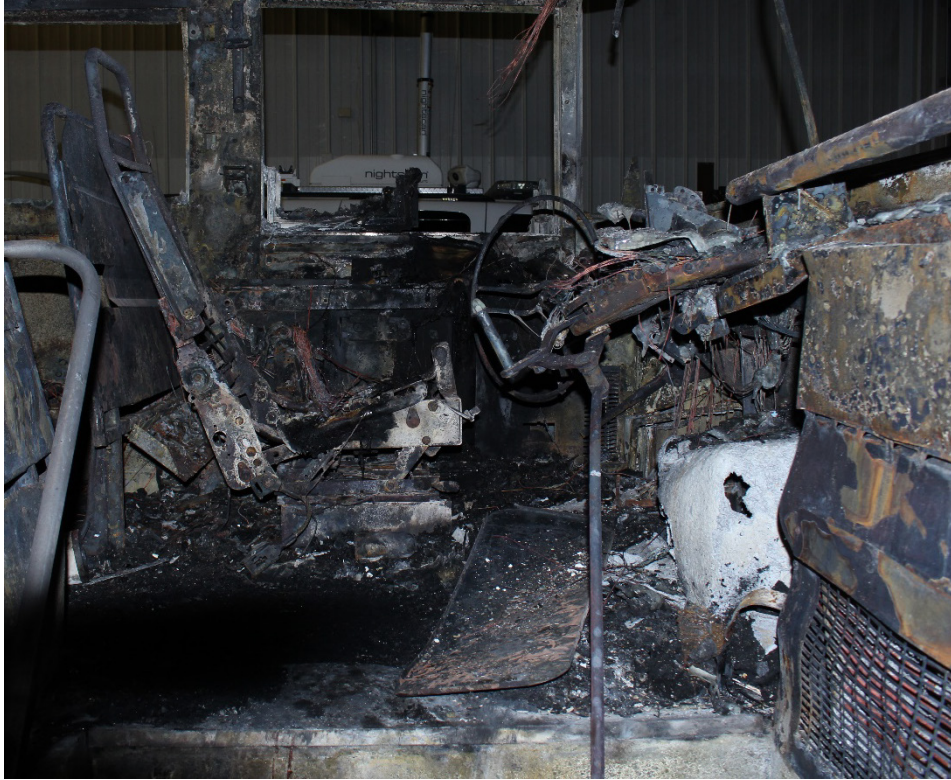
Photo #3: Front interior view of bus showing extensive fire damage at location of manual door release handle

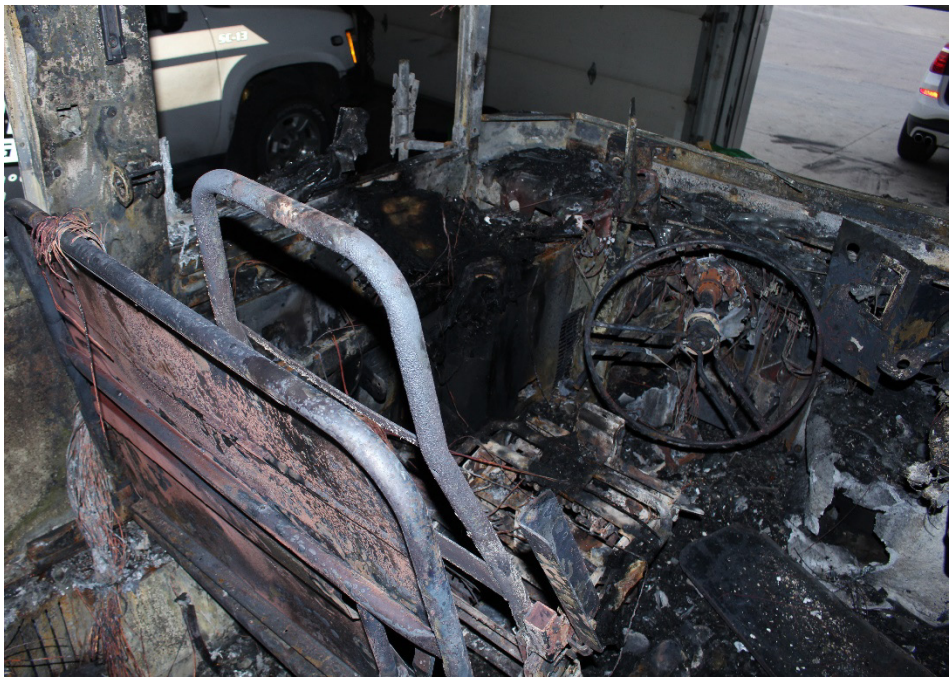
Photo #4: Interior close-up of driver's area showing extensive fire damage

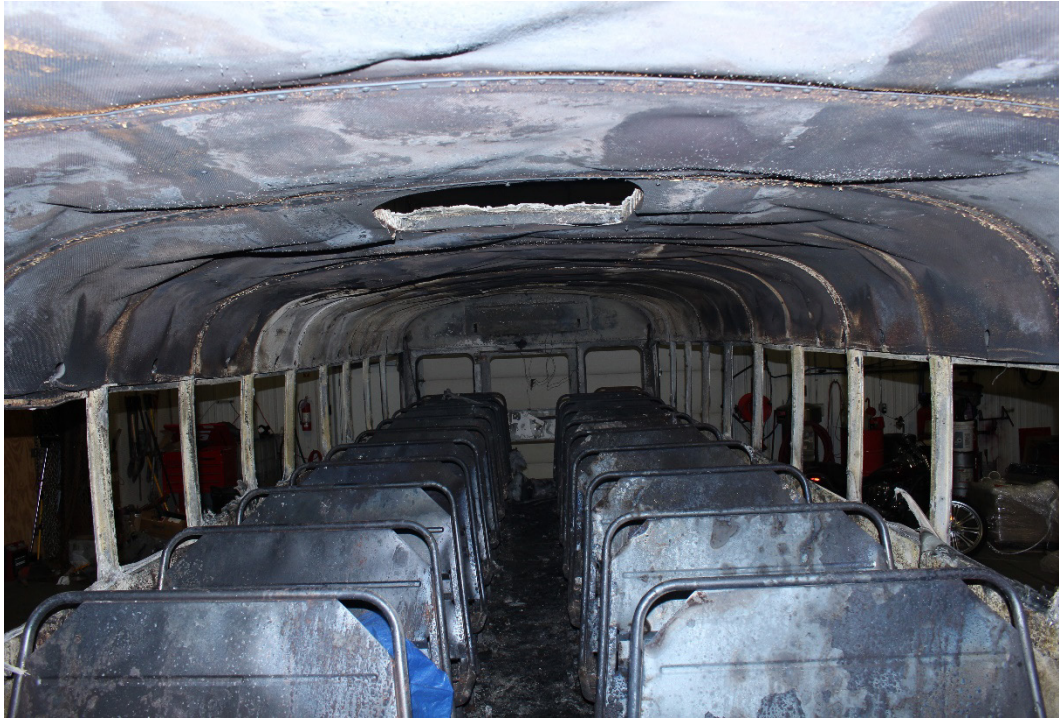
Photo #5: Interior of passenger compartment of school bus showing structural buckling

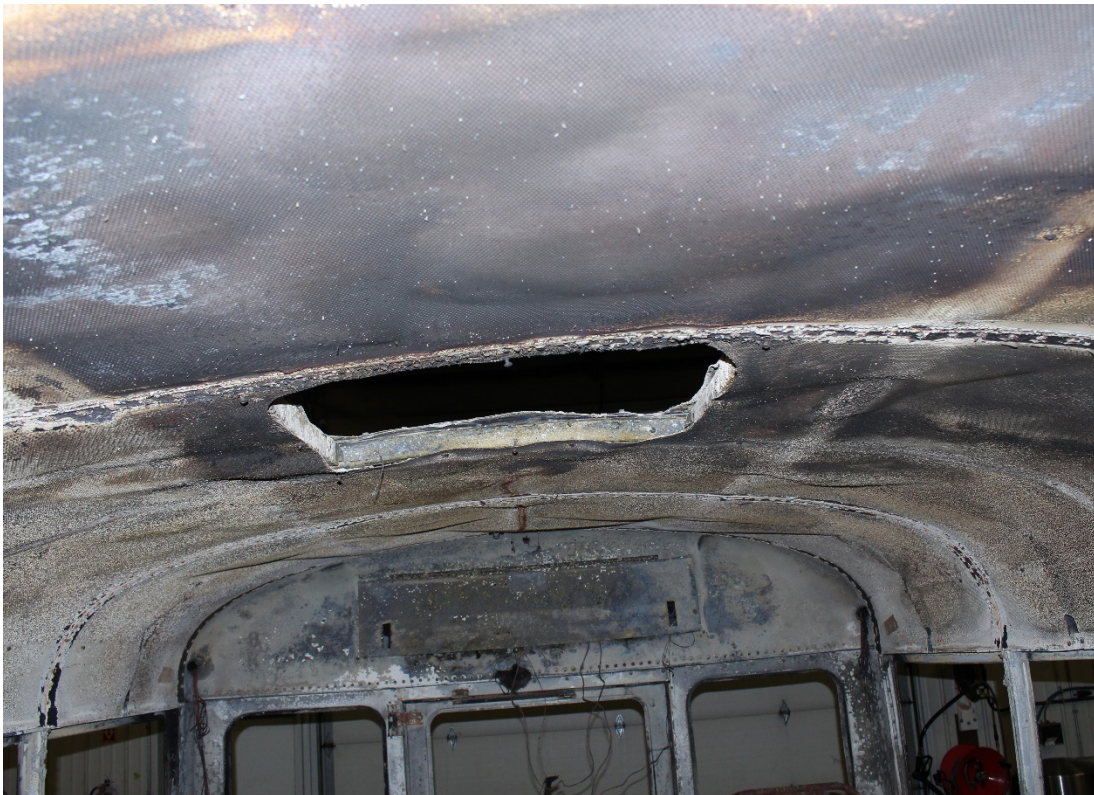
Photo #6: Interior close-up of rear roof hatch, missing cover and deformation to roof.

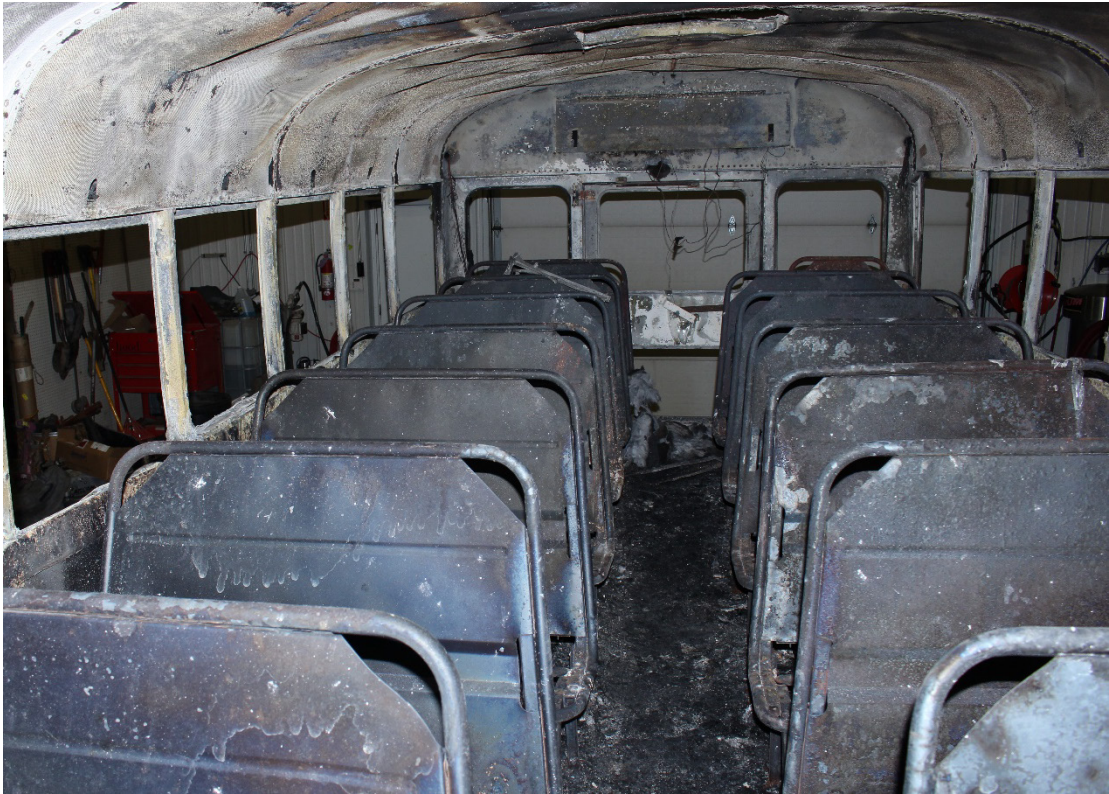
Photo #7: Interior view of the rear emergency door and fire damage to passenger compartment

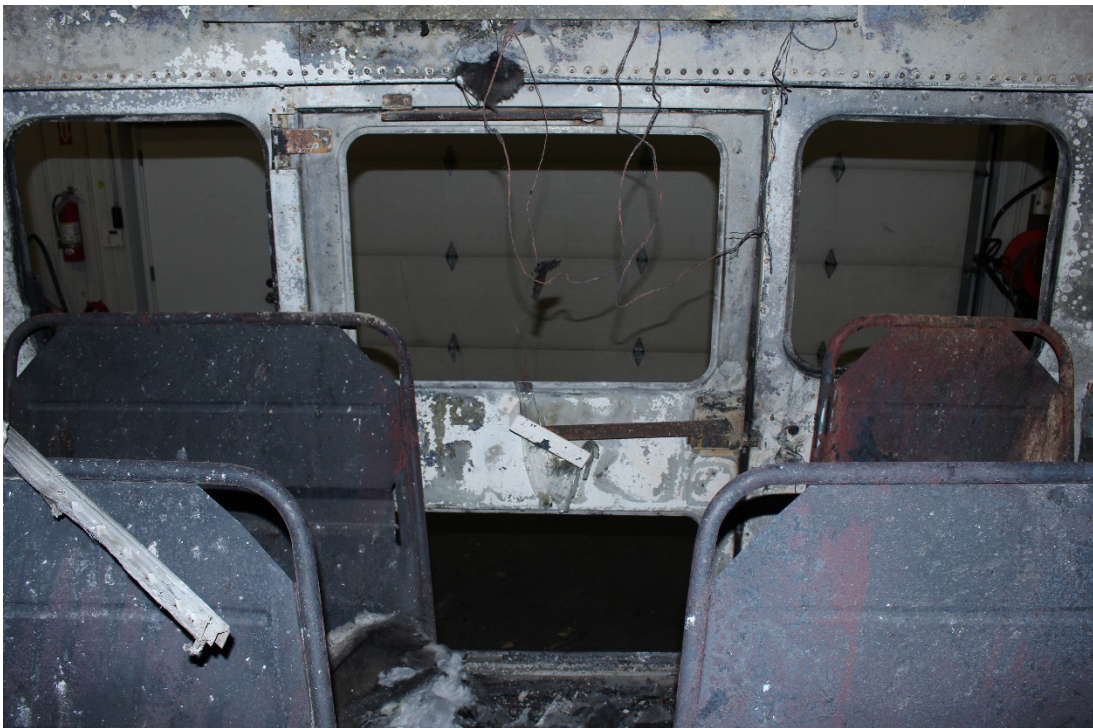
Photo #8: Interior close-up of rear emergency door and interior handle

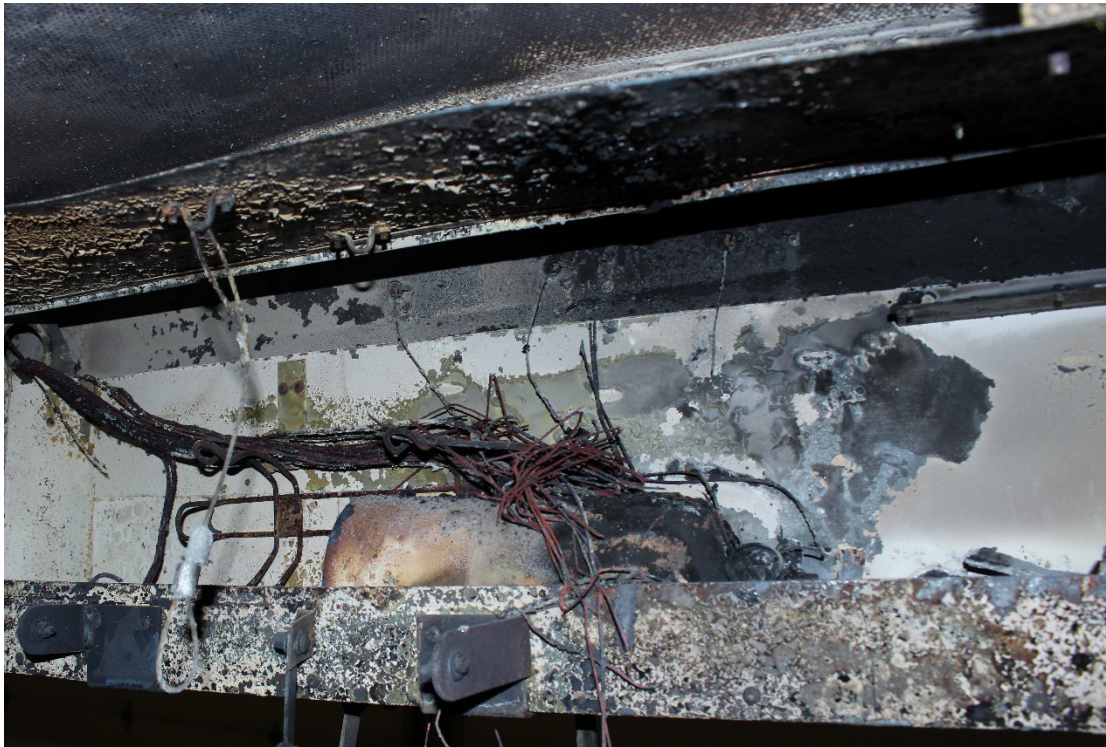
Photo #9: Photo of fire damaged fire extinguisher in overhead compartment

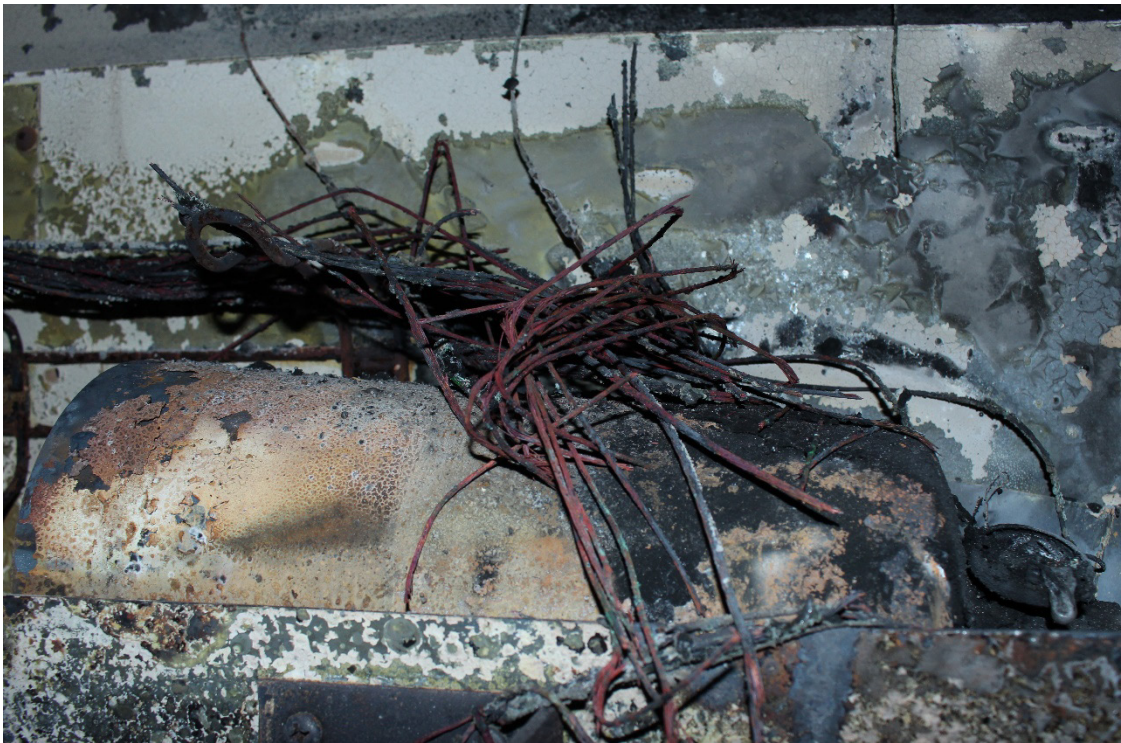
Photo #10: Close-up of fire damaged fire extinguisher in overhead compartment

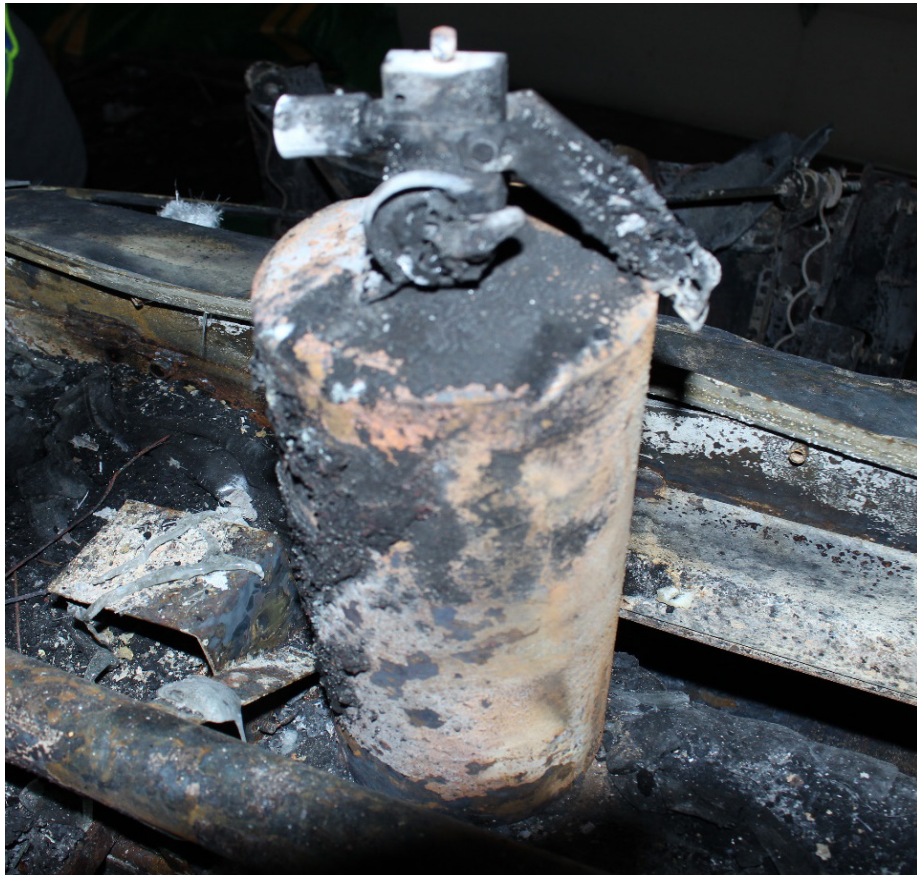
Photo #11: Close-up of fire damaged extinguisher
