Ameristar Air Cargo, Inc. dba Ameristar Charters Ypsilanti, Michigan March 8, 2017 DCA17FA076

NATIONAL TRANSPORTATION SAFETY BOARD WASHINGTON, D.C.

ATTACHMENT 3

Zodiac Aerospace CMM 3 - Pages

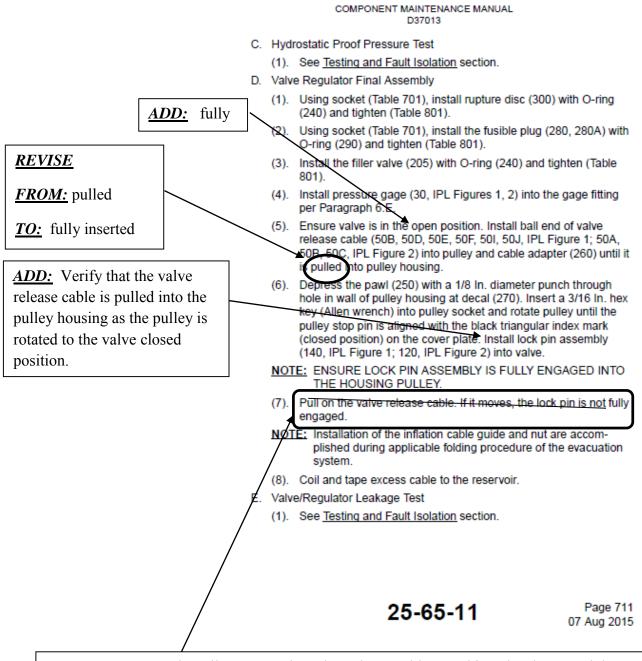
1. Add the following revisions to CMM Assembly section 3 paragraph D:

<u>REVISE TO:</u> Gently pull or tug on the valve release cable. Looking closely around the gaps in the valve cover assembly on the inflation valve, verify that there is slight movement of the pulley and the lock pin due to the movement of the valve release cable. The valve release cable should not pull free of the inflation valve assembly. If the valve release cable can withdraw from the valve assembly, either the lock pin is not fully engaged or the inflation cable was not fully inserted into the pulley during the arming procedure. Repeat steps (5) and (6) to resolve unacceptable cable movement.

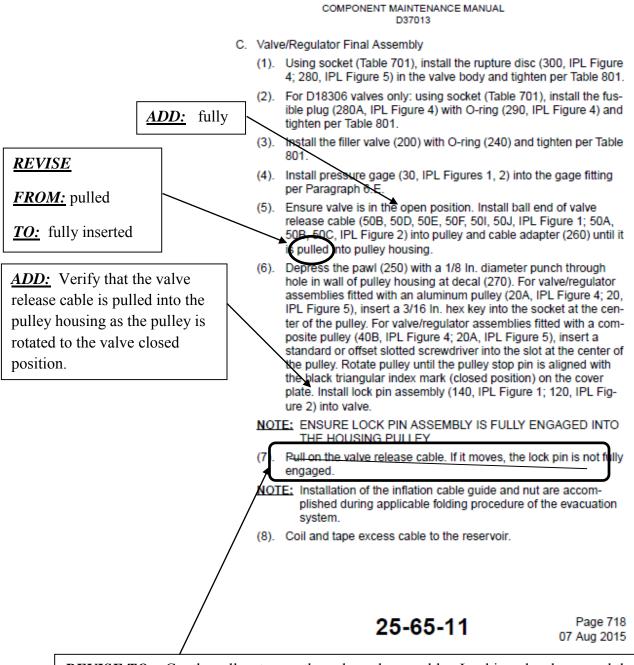
2. Add the following revisions to CMM Assembly section 3A paragraph C:

<u>REVISE TO:</u> Gently pull or tug on the valve release cable. Looking closely around the gaps in the valve cover assembly on the inflation valve, verify that there is slight movement of the pulley and the lock pin due to the movement of the valve release cable. The valve release cable should not pull free of the inflation valve assembly. If the valve release cable can withdraw from the valve assembly, either the lock pin is not fully engaged or the inflation cable was not fully inserted into the pulley during the arming procedure. Repeat steps (5) and (6) to resolve unacceptable cable movement.
