Survival Factors Attachment: Scene photographs

Biloxi, Mississippi

HWY17MH010010

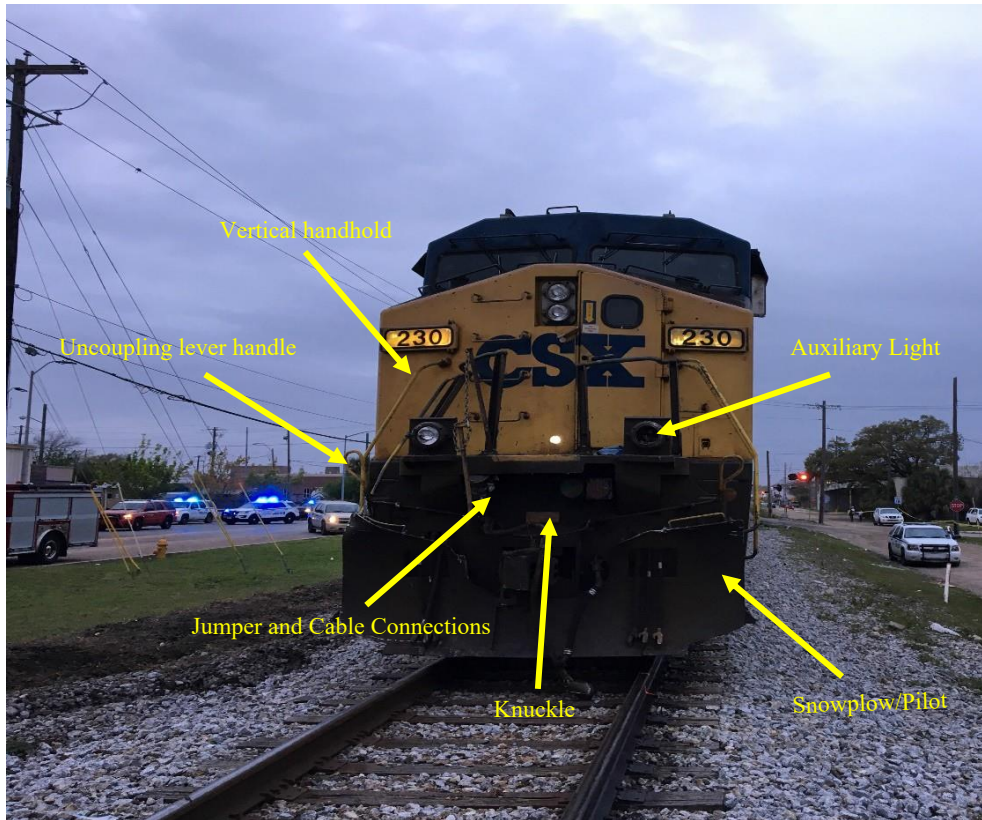
Photo #1: The lead locomotive showing the impact area and collision damage

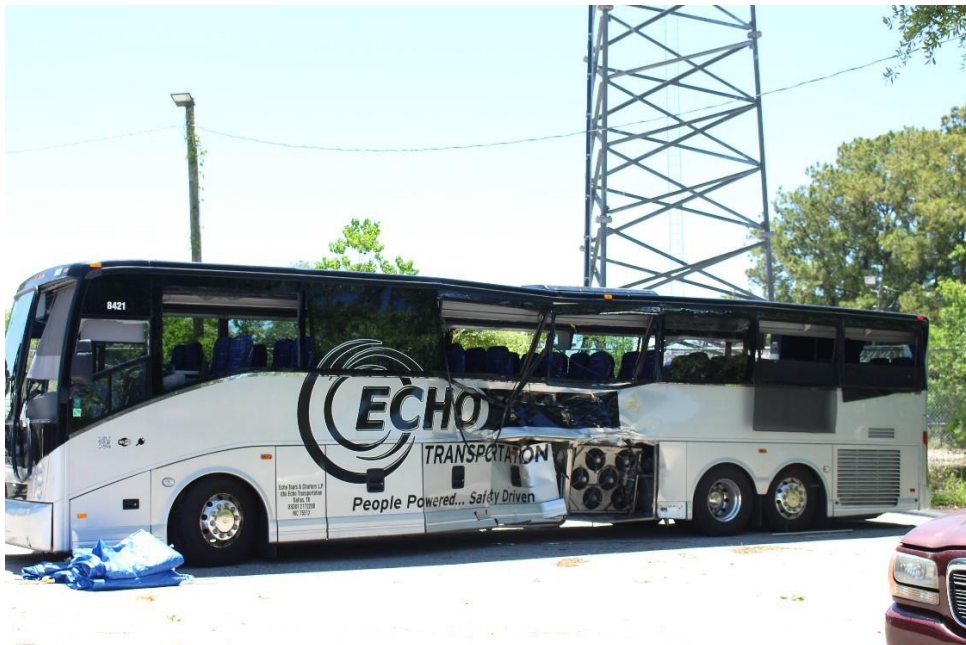
Photo #2: The exterior left side of motorcoach showing impact damage

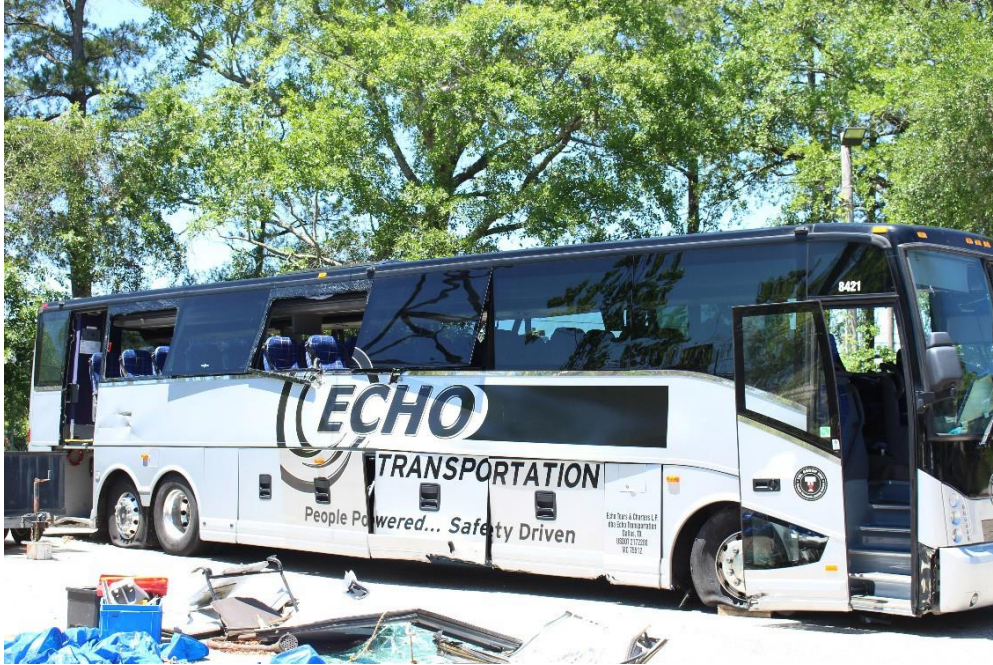
Photo #3: Exterior right side of motorcoach showing the cut away rear door

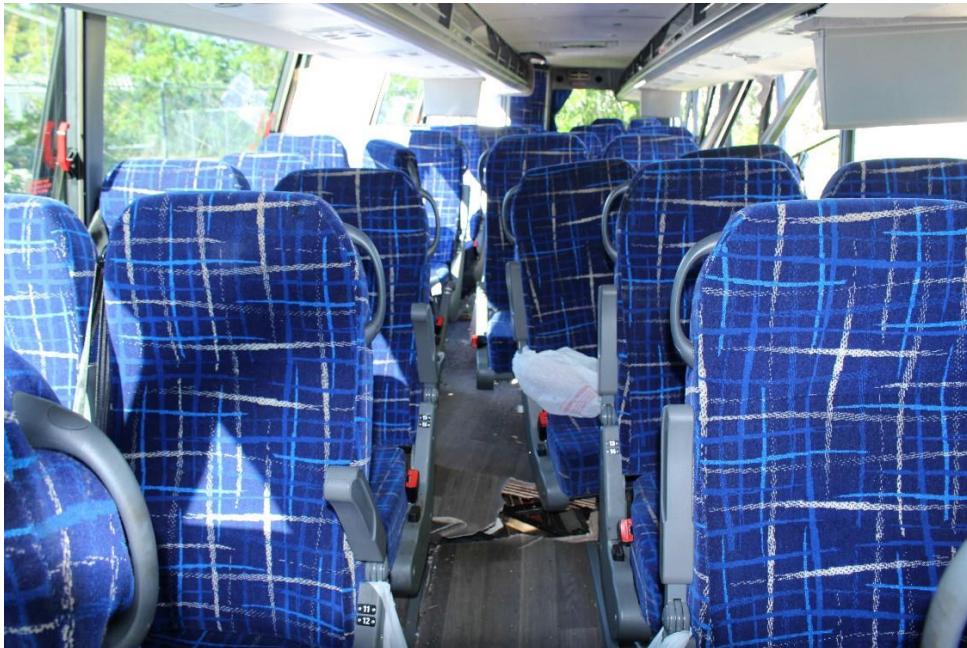
Photo #4: Interior of motorcoach at point of impact with the train

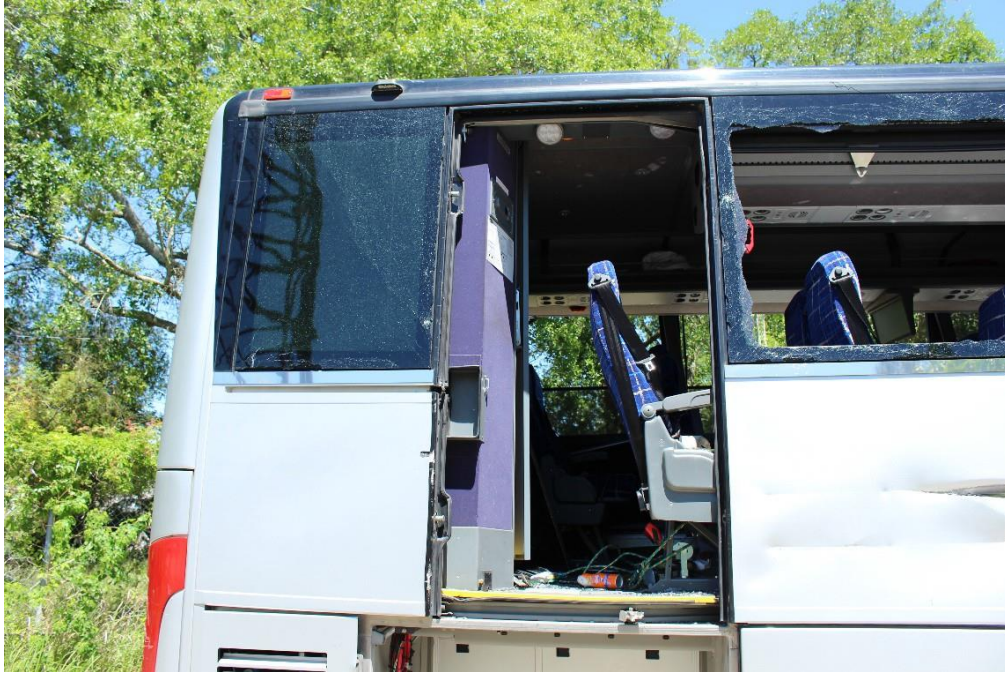
Photo #5: Exterior close-up view of cut away rear door of motorcoach

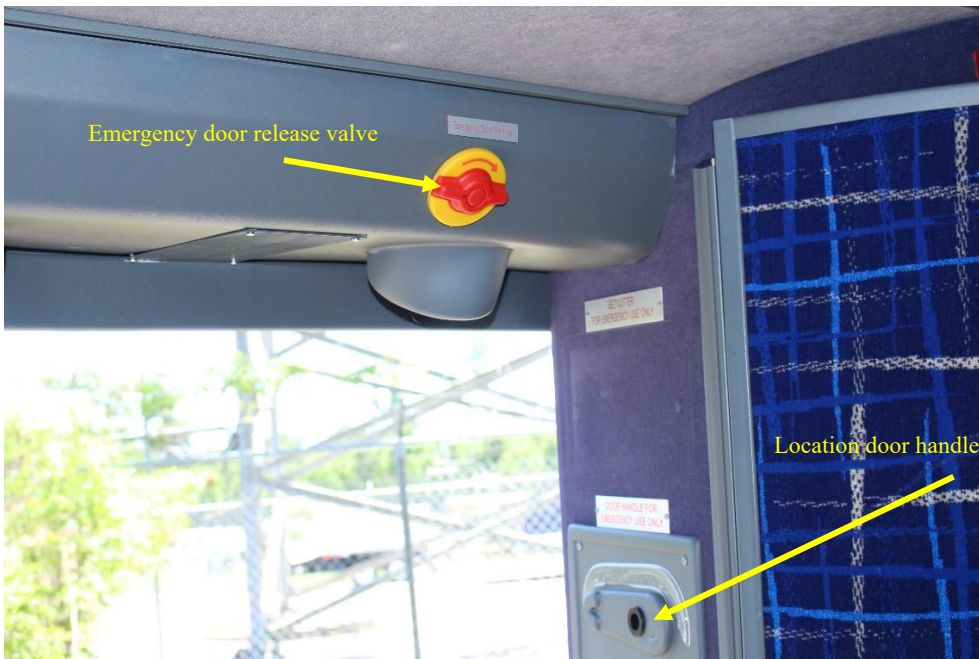
Photo #6: Interior view of rear door emergency release valve and handle location

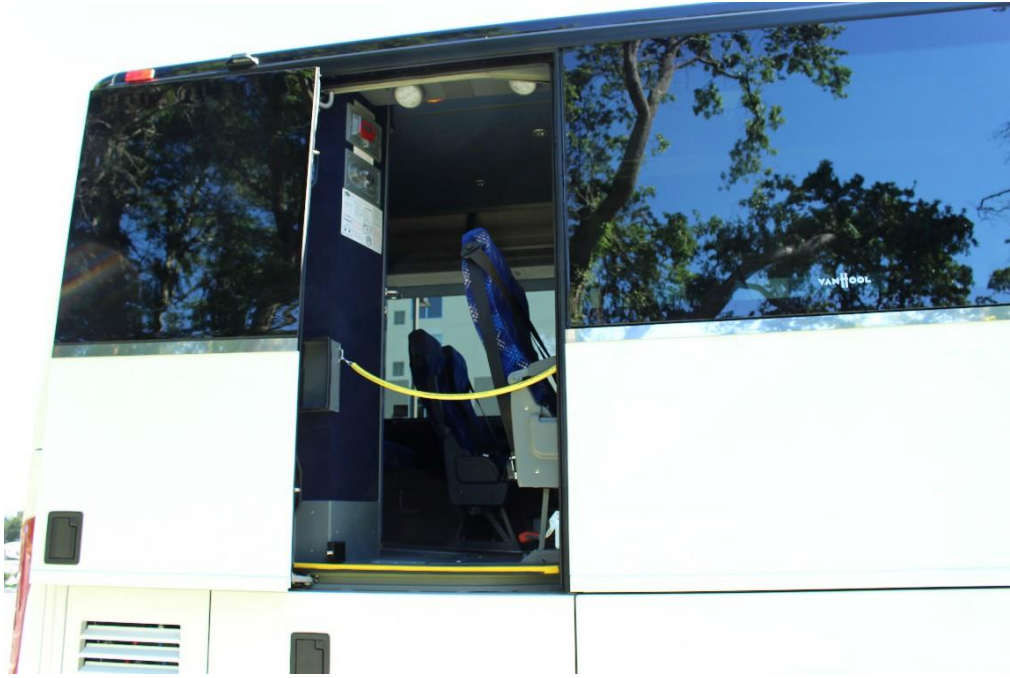
Photo #7: Exterior view of rear door on exemplar motorcoach

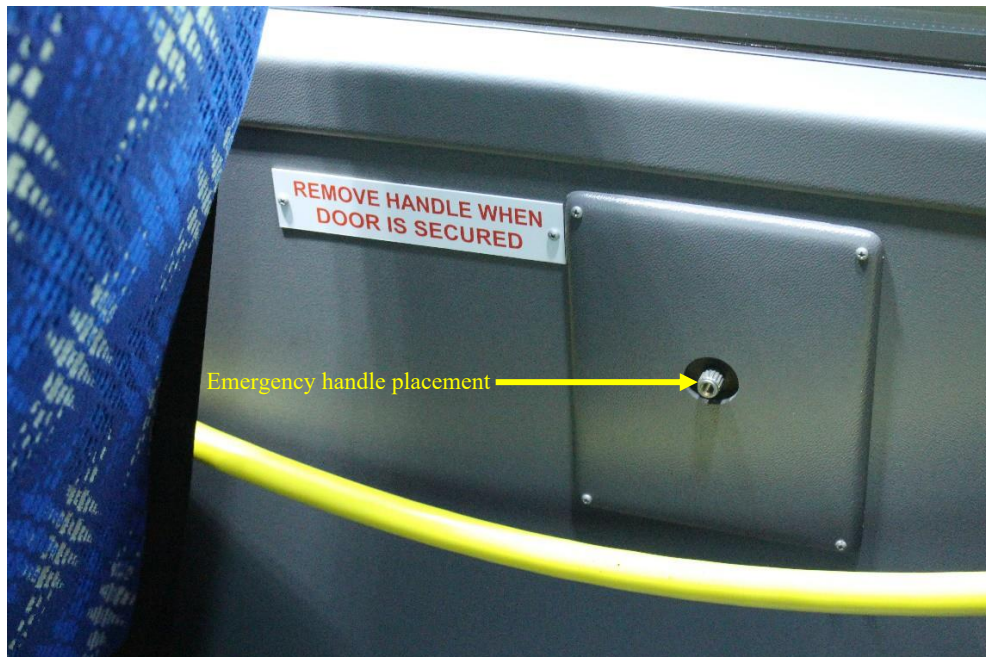
Photo #8: Interior close-up view of emergency door handle placement

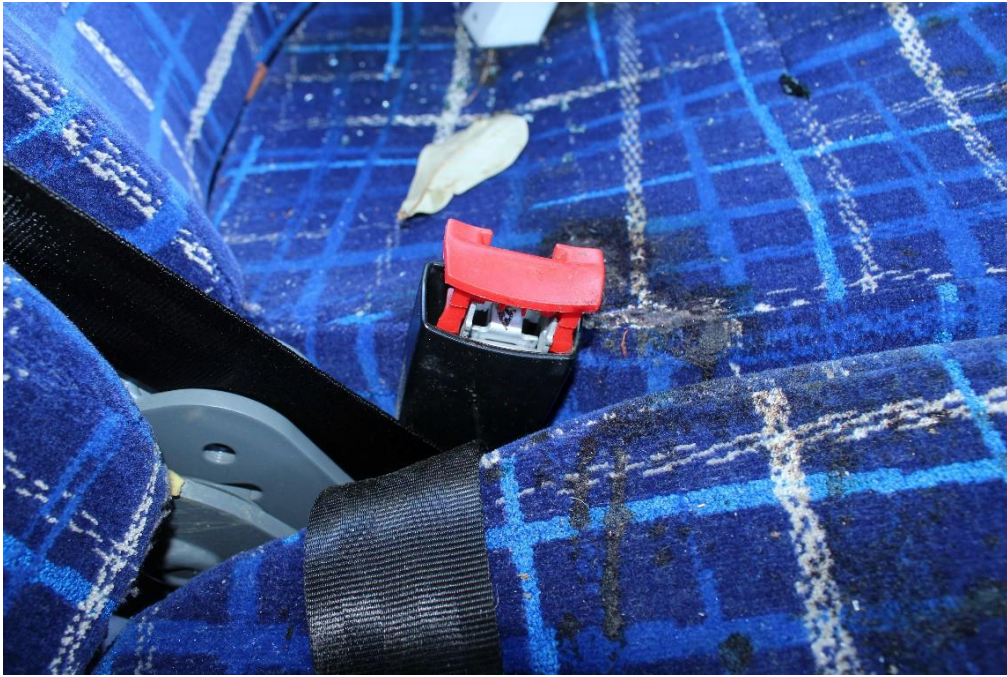
Photo #9: Defective seatbelt buckle on motorcoach

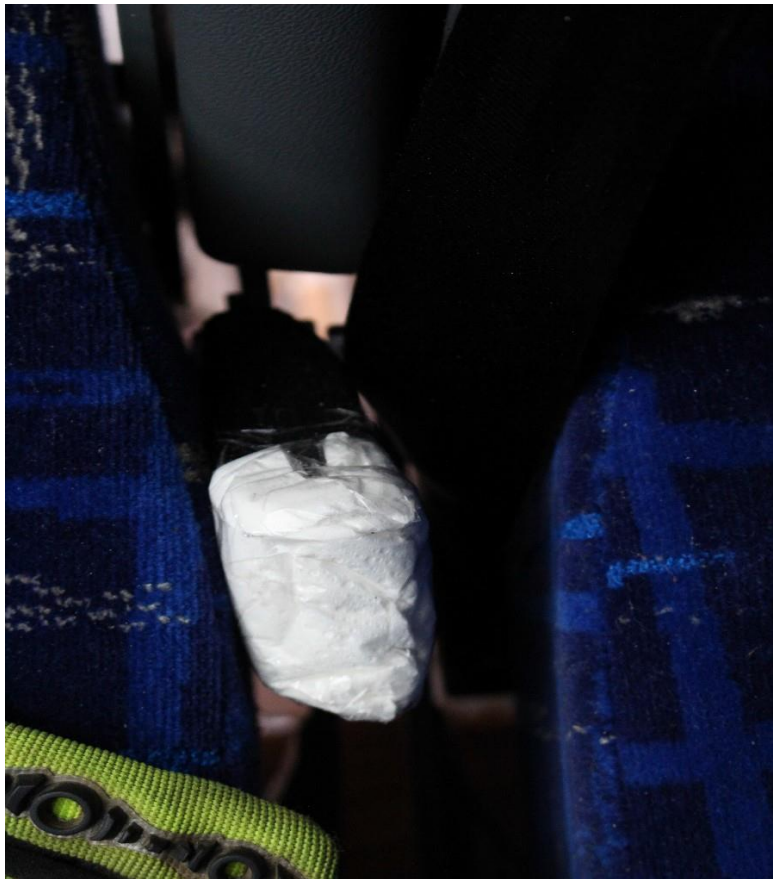
Photo #10: Taped defective seatbelt buckle on motorcoach

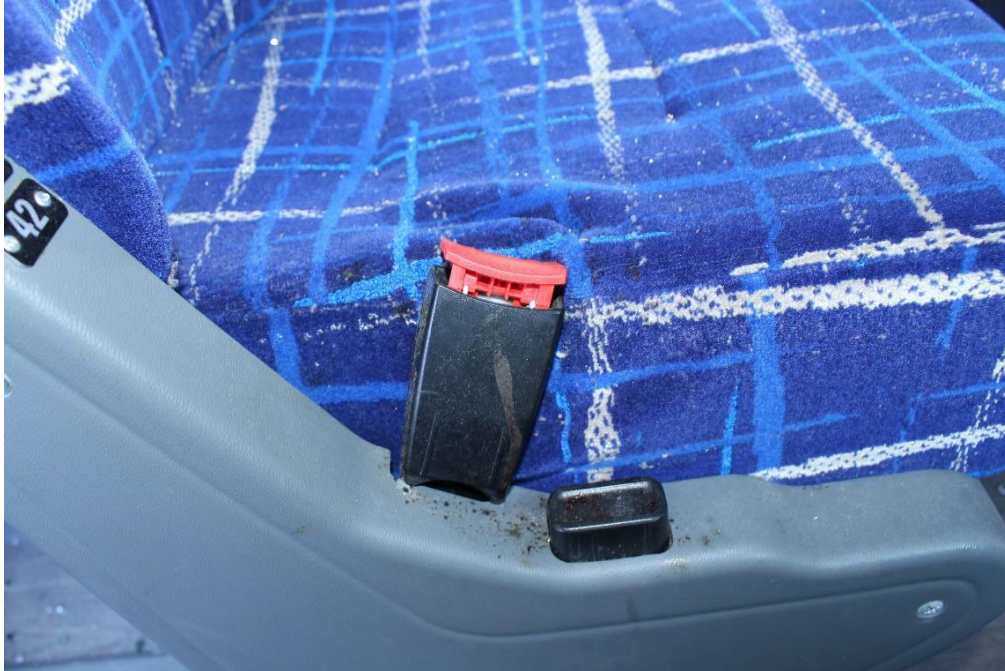
Photo #11: Defective aisle seatbelt buckle on motorcoach

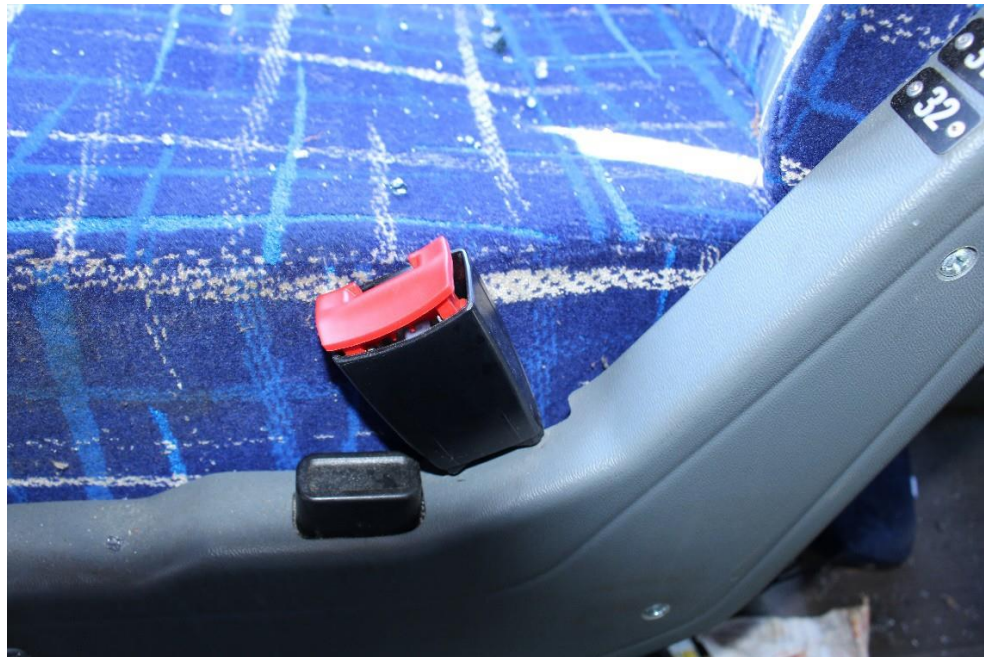
Photo #12: Defective aisle seatbelt buckle on motorcoach

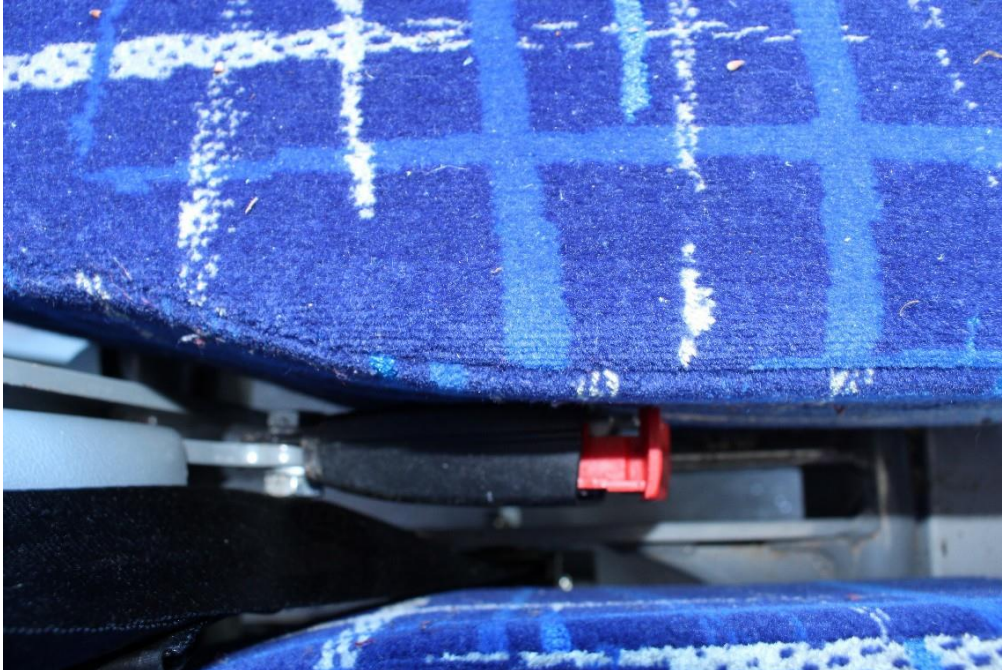
Photo #13: Defective seatbelt buckle for window seat

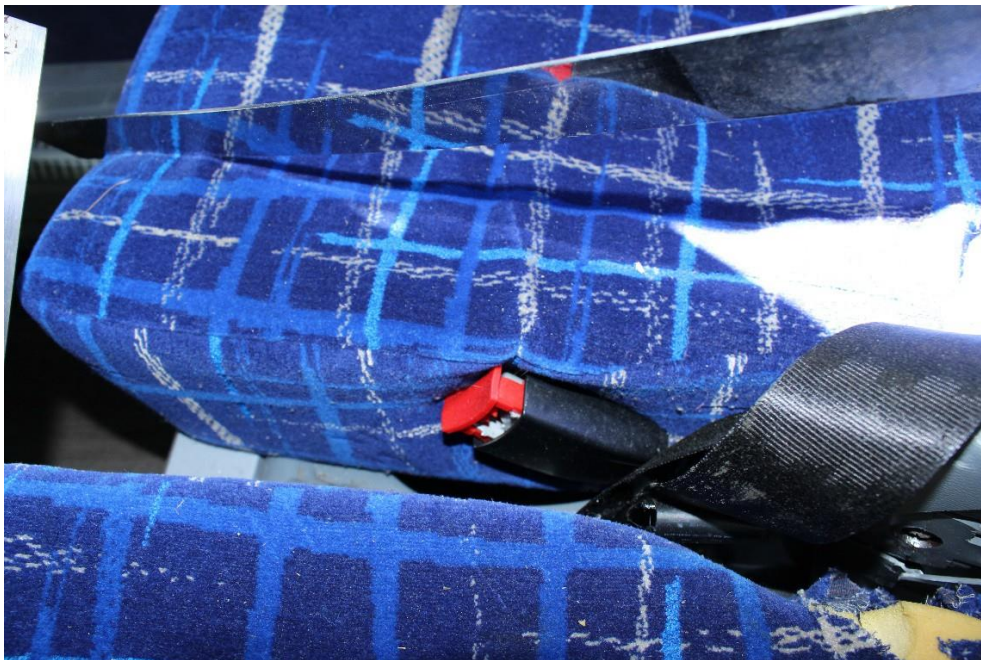
Photo #14: Defective seatbelt buckle for window seat
