Survival Factors - Factual Report of Group Chairman

Survival Factors Group Chairman's Factual Report of Investigation

A. Accident : DCA13MA133

Airplane : Airbus A-300-600, N155UP

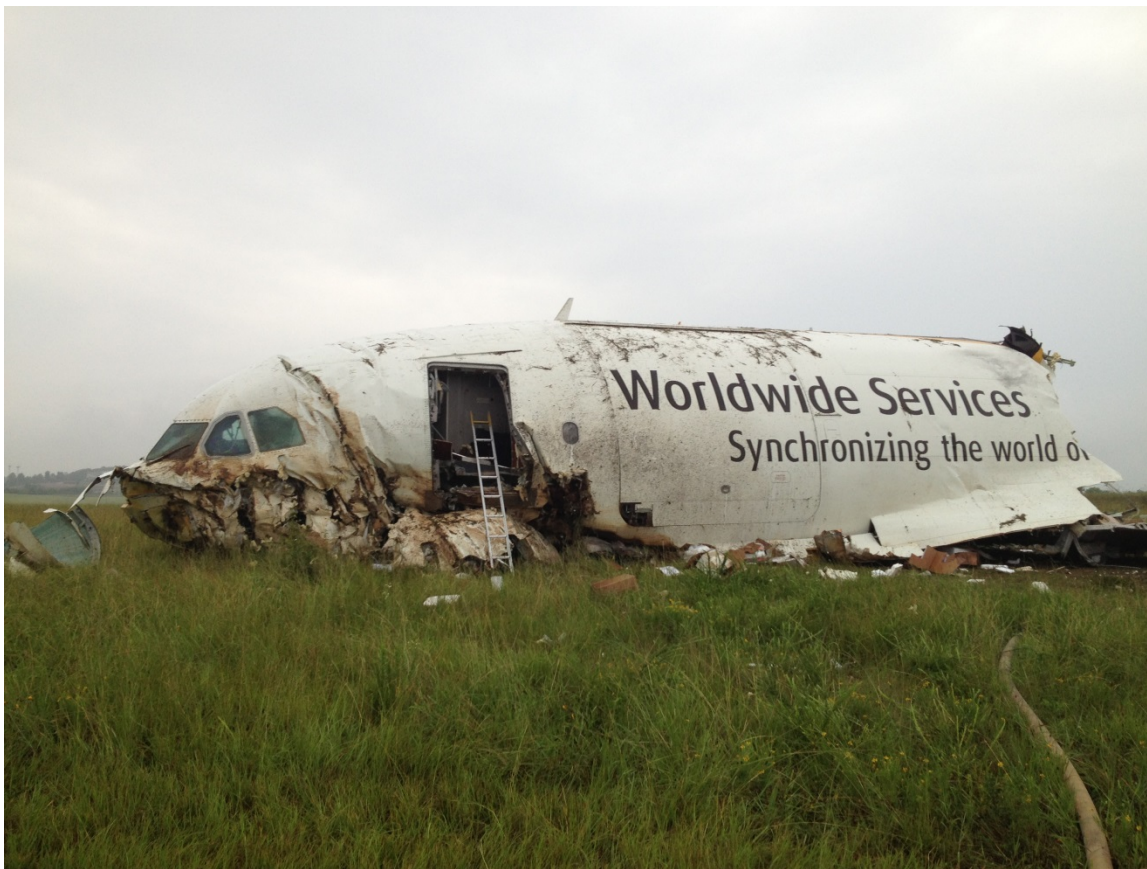
The airplane was severely damaged by impact and post-crash fire. The forward fuselage, including the flight deck, was largely intact (photo 1), although severely damaged by impact. The lower portion of the fuselage, under the flight deck, sustained severe impact damage (photo 2). The wings and aft fuselage, including the tail, were fragmented and/or burned.

Photo 1. Forward fuselage.

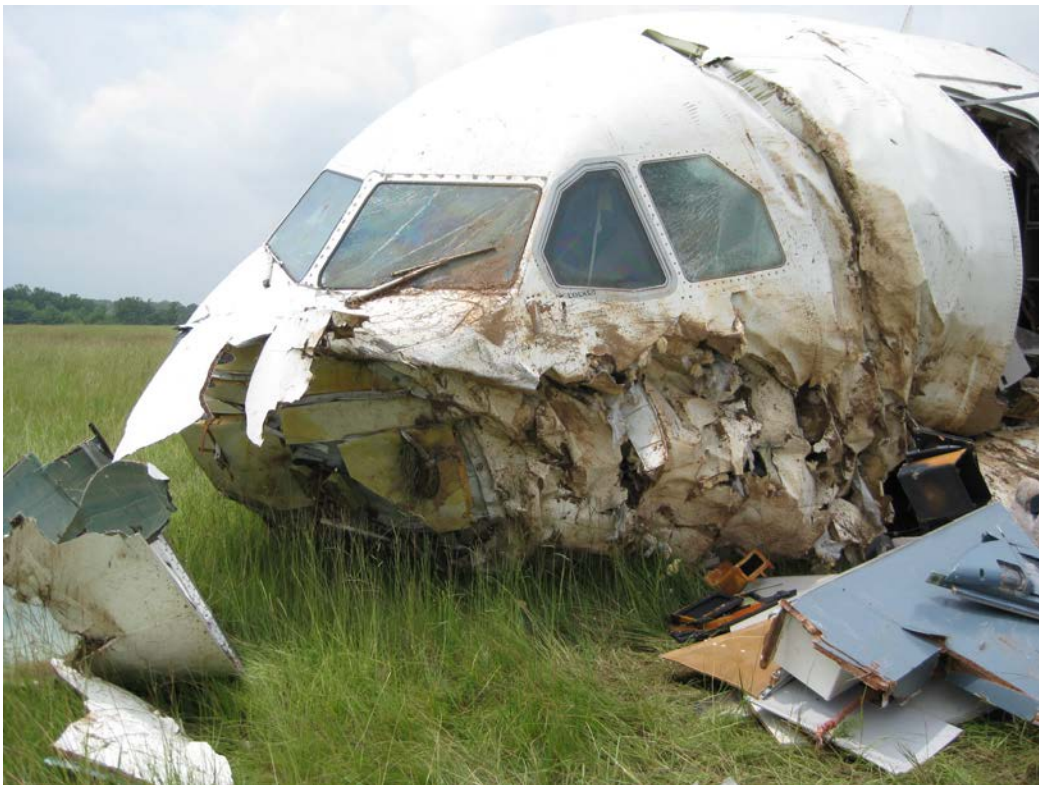
Photo 2. Damage under flight deck.

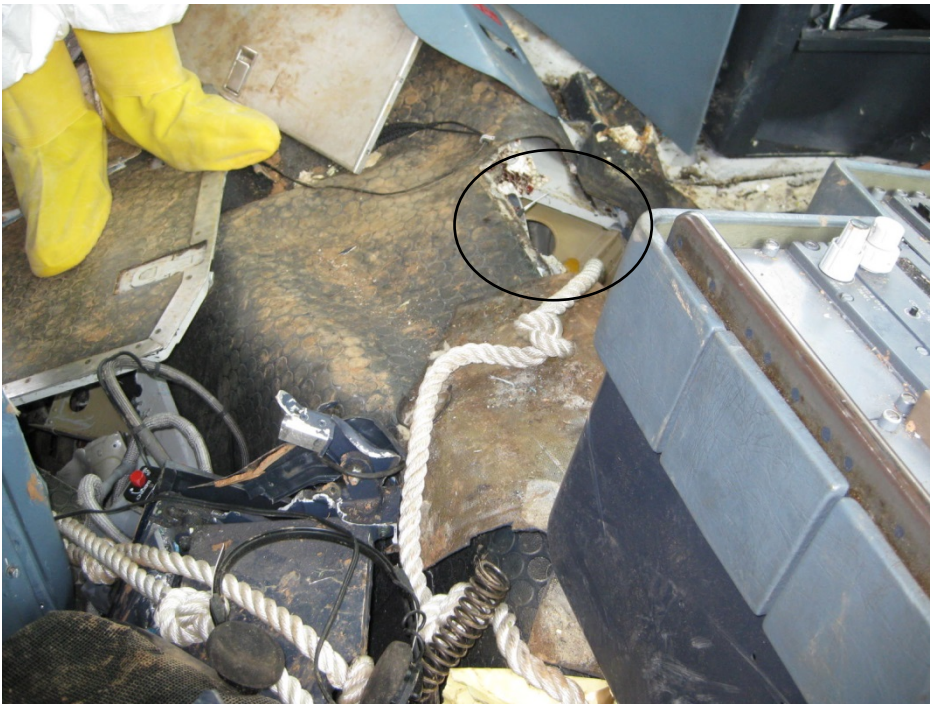
The captain's seat was found outside the airplane, lying next to the forward fuselage. The seat was mostly intact, and the forward seat pan area was bent downward. The floor under the seat was buckled upwards several inches and the seat pedestal base mounting structure was pitched forward, accordingly. The pedestal base was severed at the floor, consistent with reported extrication efforts (photo 3).

Photo 3. Buckling of flight deck floor, oval denotes original position of captain's seat base.

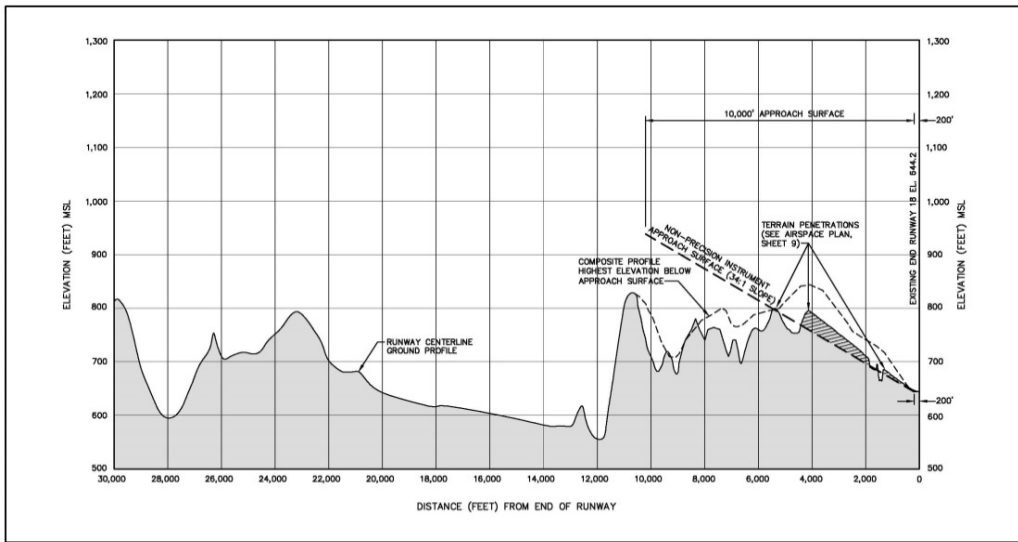
PAPI installed on the left side of runway 18, approximately 1161 feet from the runway threshold. There was no PAPI on Runway 36. Runway 18 had a 26:1 approach slope due to rising terrain from the threshold (figure 3).

The PAPI for runway 18 was owned and operated by the FAA. It was set to project a glide path of 3.2 degrees, due to the 26:1 approach surface. The published threshold crossing height (TCH) was 48 feet. The PAPI was ground tested on May 8, 2013, and was found within specifications. It was again ground tested on August 14, 2013 at 0753 local, and was again found to be adjusted correctly. The FAA conducted a flight check of the PAPI on August 16, 2013, and found it to be functioning properly and within specifications for the approach (attachment 1).

Figure 3. Runway 18 approach profile.

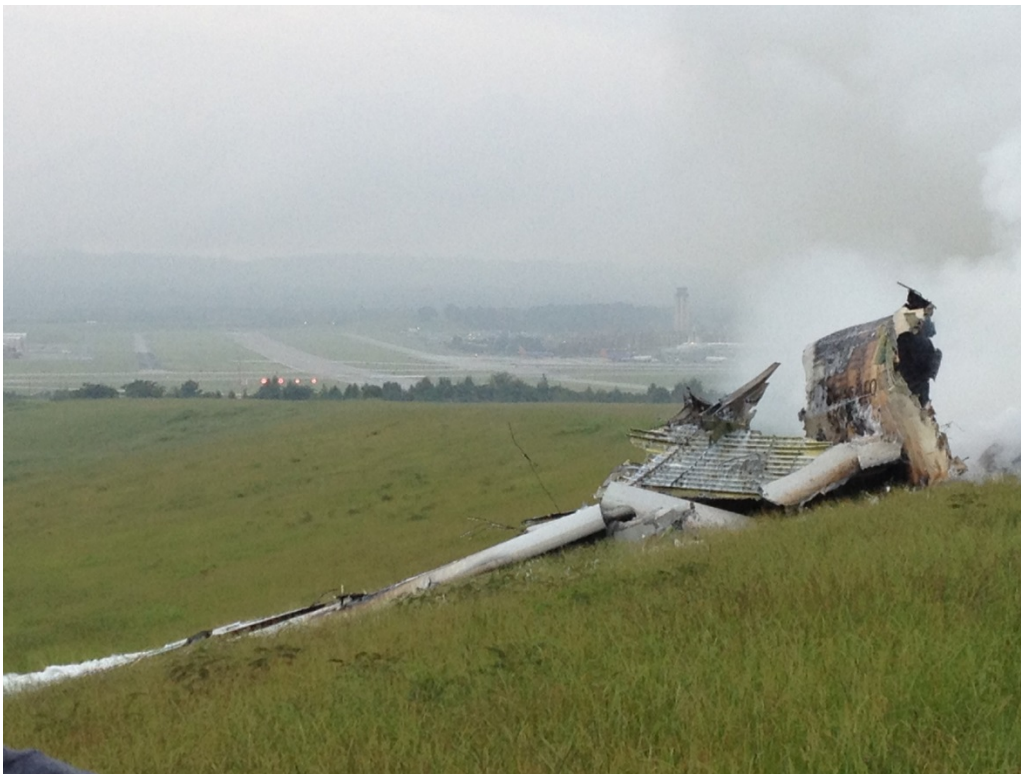
Photo 3. View from the accident site looking toward runway 18 approach.

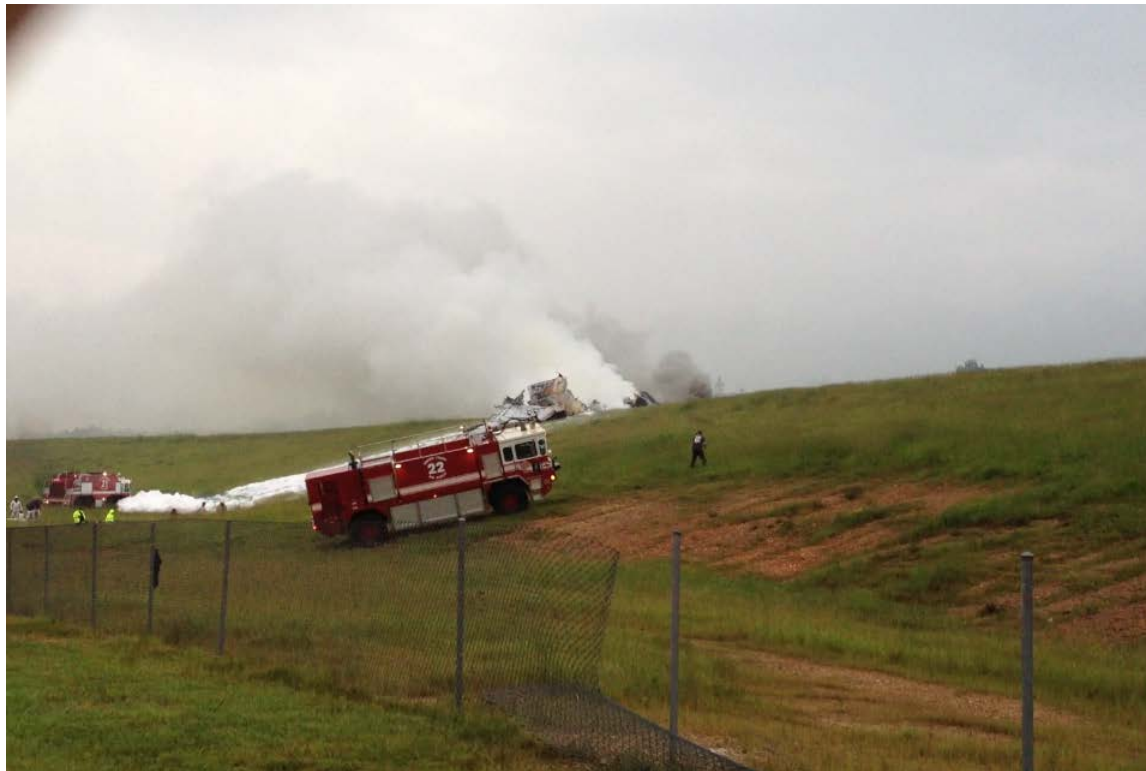
Photo 4. Redbird 21 and 22 at the accident site.

The chief of Battalion 3 reported that he was dispatched “around 0400,” through an “all call” that was sent to all city fire stations. He was initially given the wrong location of the accident, but received corrected information en route. He noted that the initial error did not delay his arrival. Once he arrived at the scene, he realized the fence need to be removed to access the crash site, so he had the firefighters remove the fence to gain access. It took “about a minute and a half” to remove the fence. Redbird 21 arrived at the scene slightly before the battalion chief. Redbird 21 and 22 were the first two vehicles to engage the fire with foam.
