Continental Airlines
Boeing 737-500
Denver International Airport
Denver, Colorado
December 20, 2008
DCA09MA021

National Transportation Safety Board
Washington, DC

Survival Factors Group Chairman's Report

Photographs

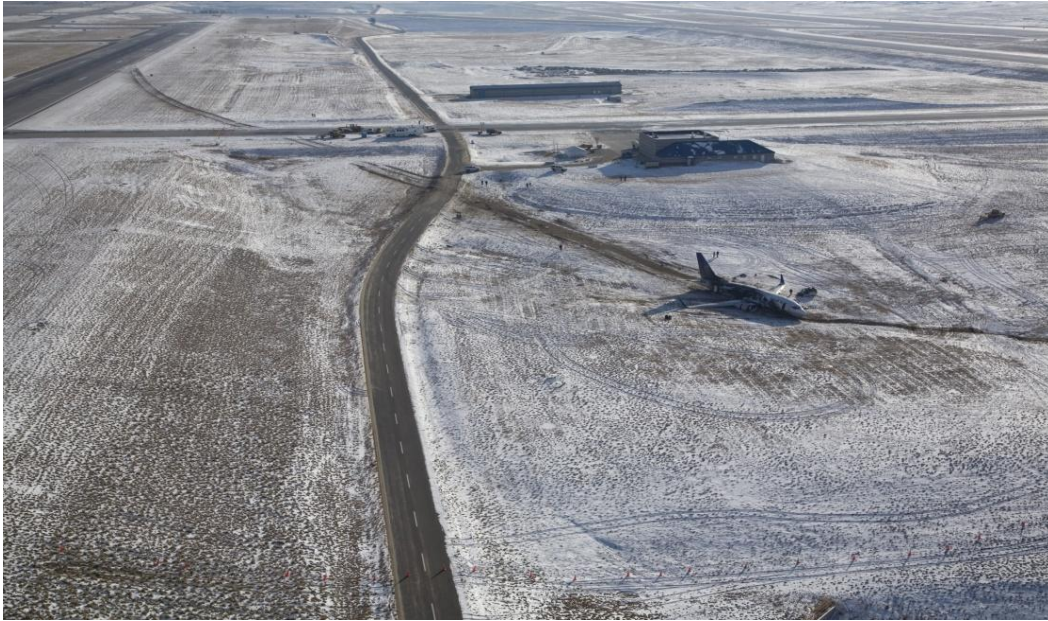
Photograph 1: Ground track of airplane from Runway 34R .

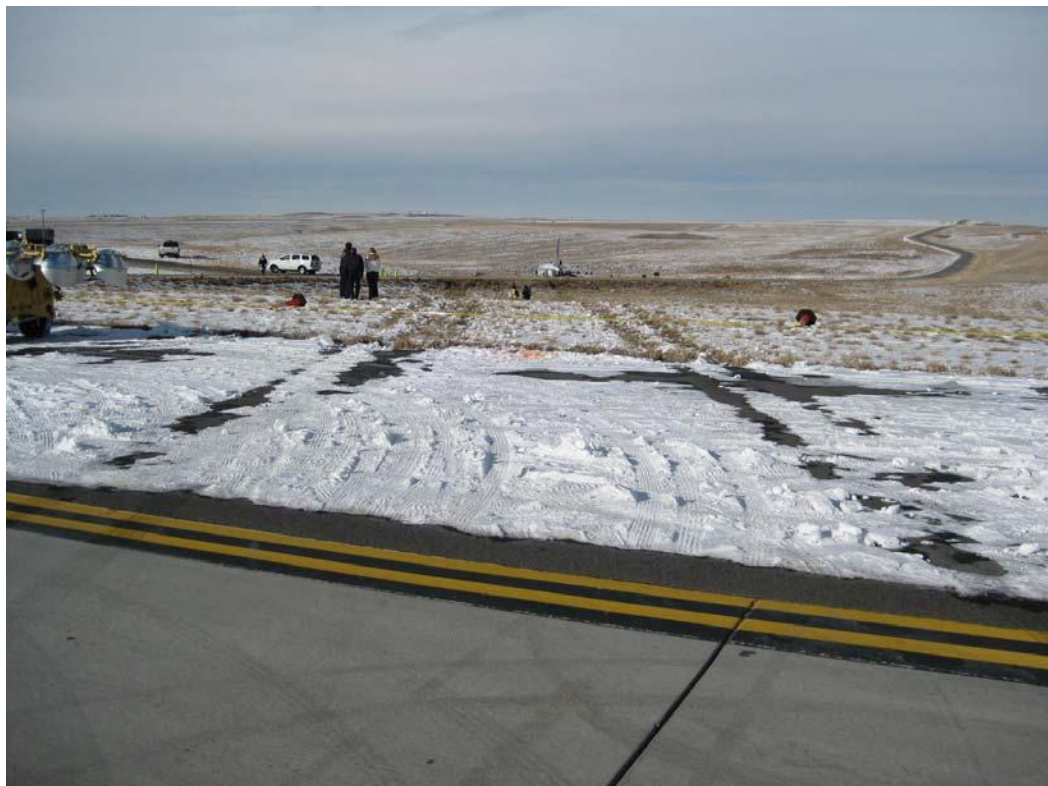
Photograph 2: Crash site as viewed from Taxiway WC.

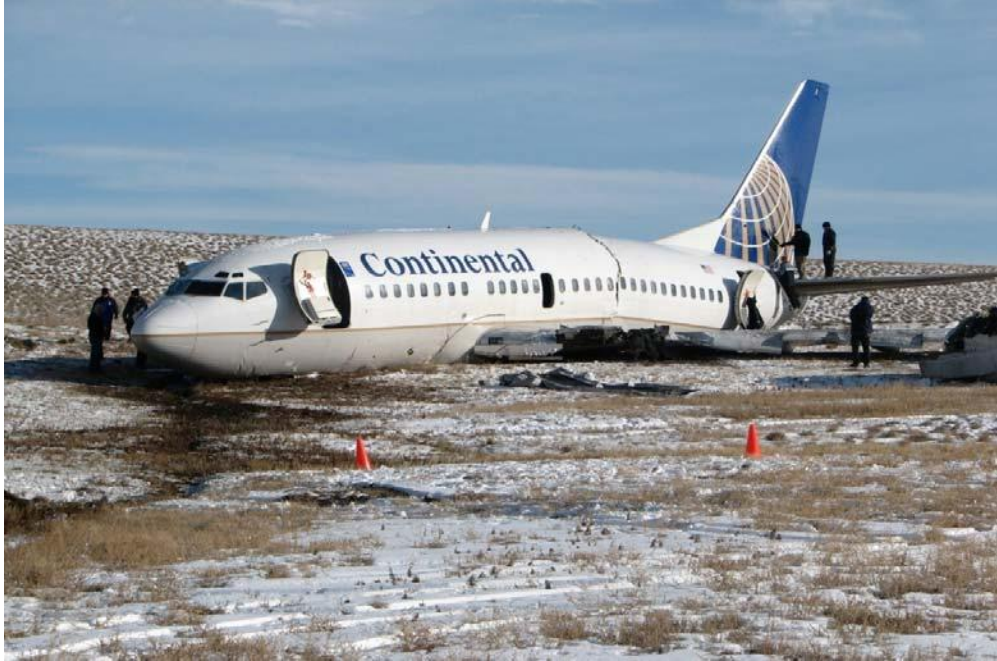
Photograph 3: Left side of airplane.

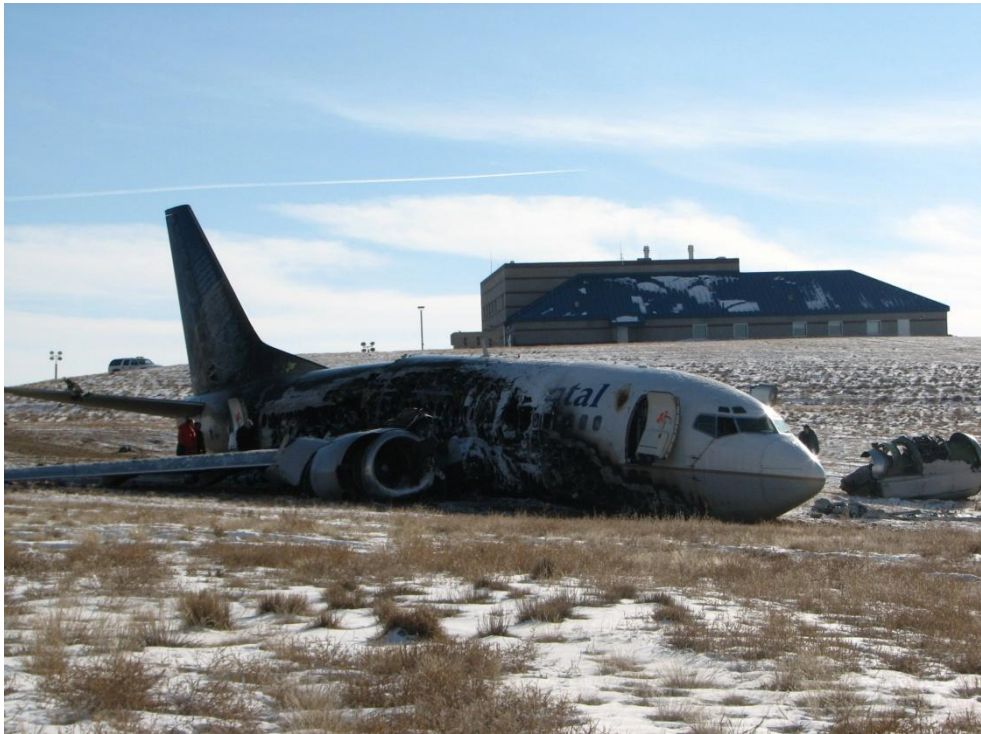
Photograph 4: Right side of airplane, with ARFF 4 fire station in the background.

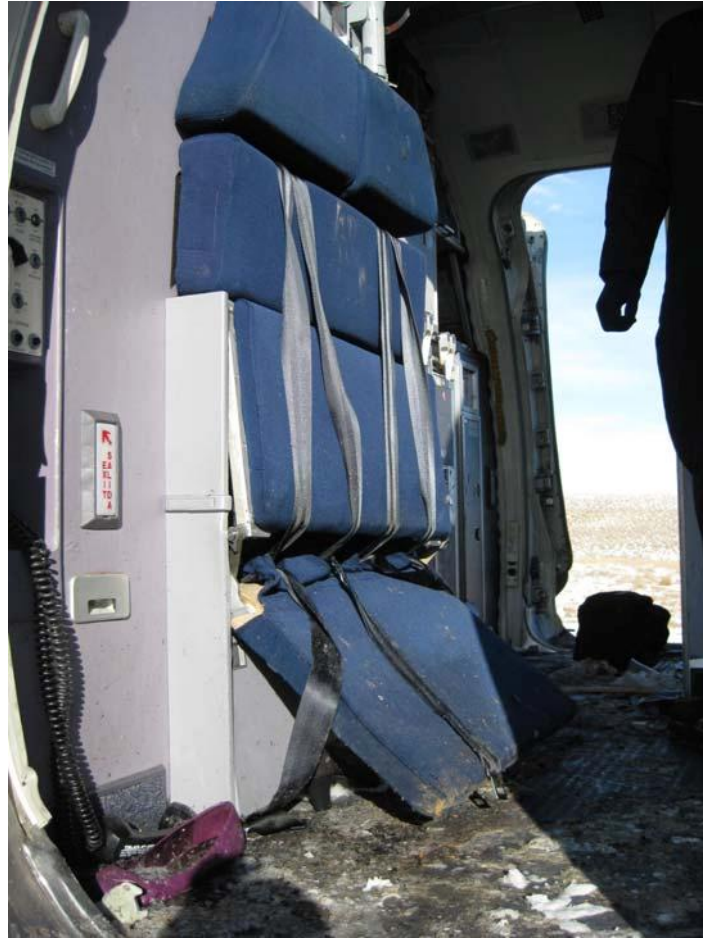
Photograph 5: Flight attendant jumpseat at door 1L.

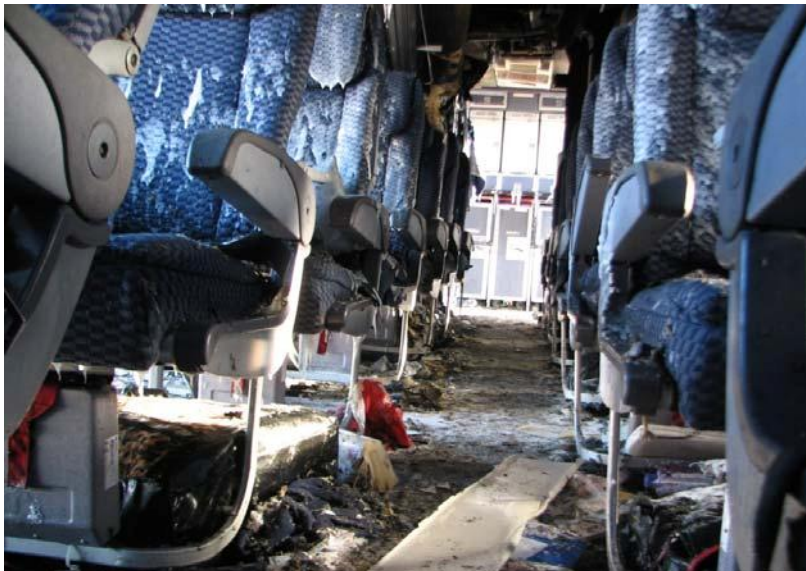
Photograph 6: Interior of airplane, looking aft.

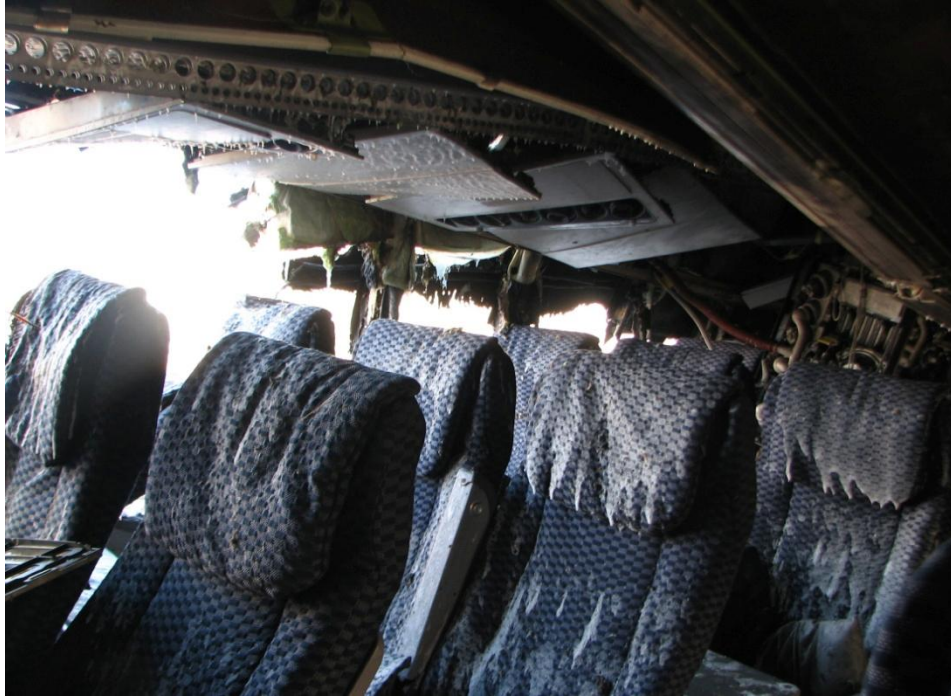
Photograph 7: Right interior of airplane.

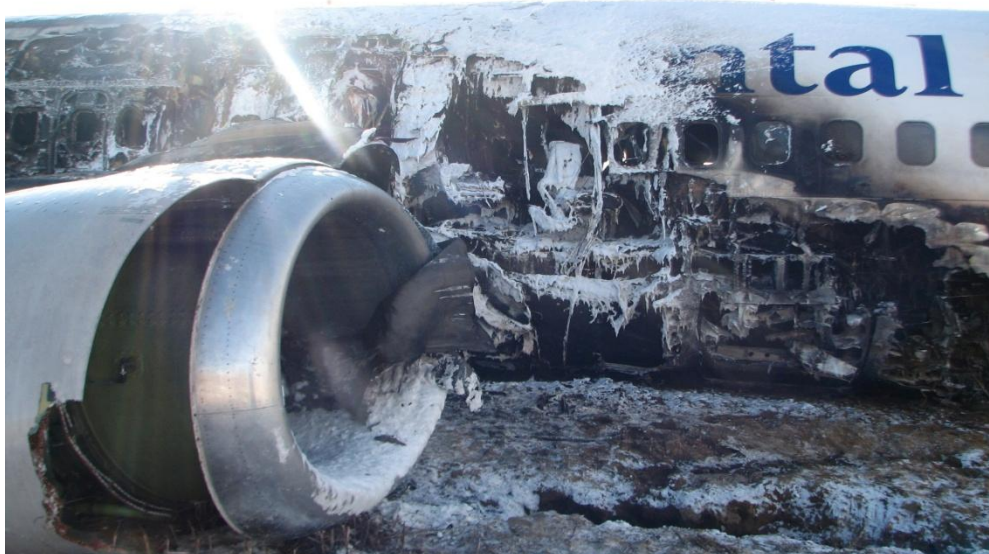
Photograph 8: Exterior burn damage.

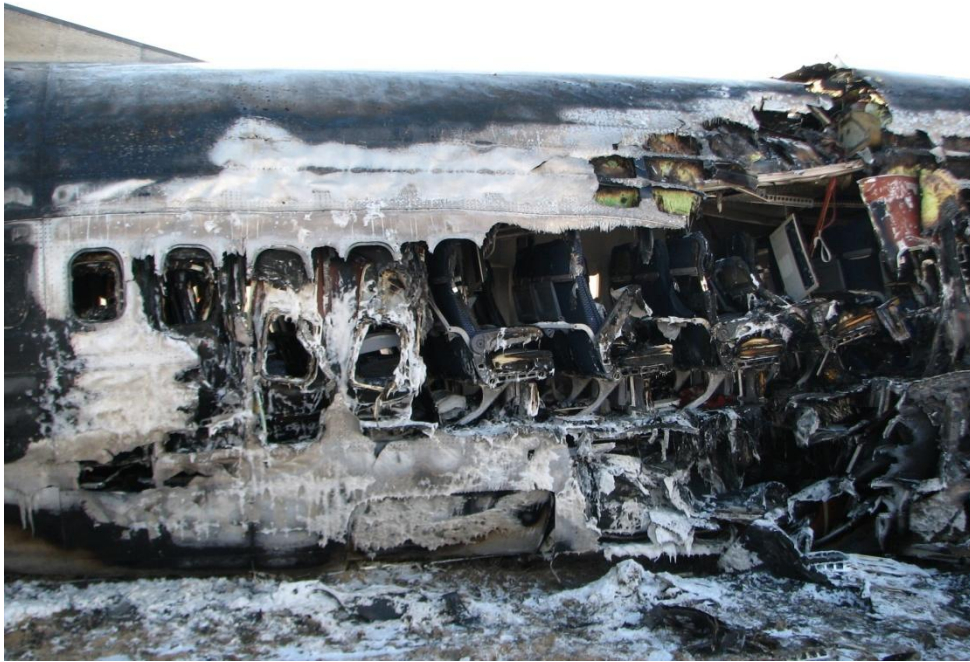
Photograph 9: Exterior burn damage.

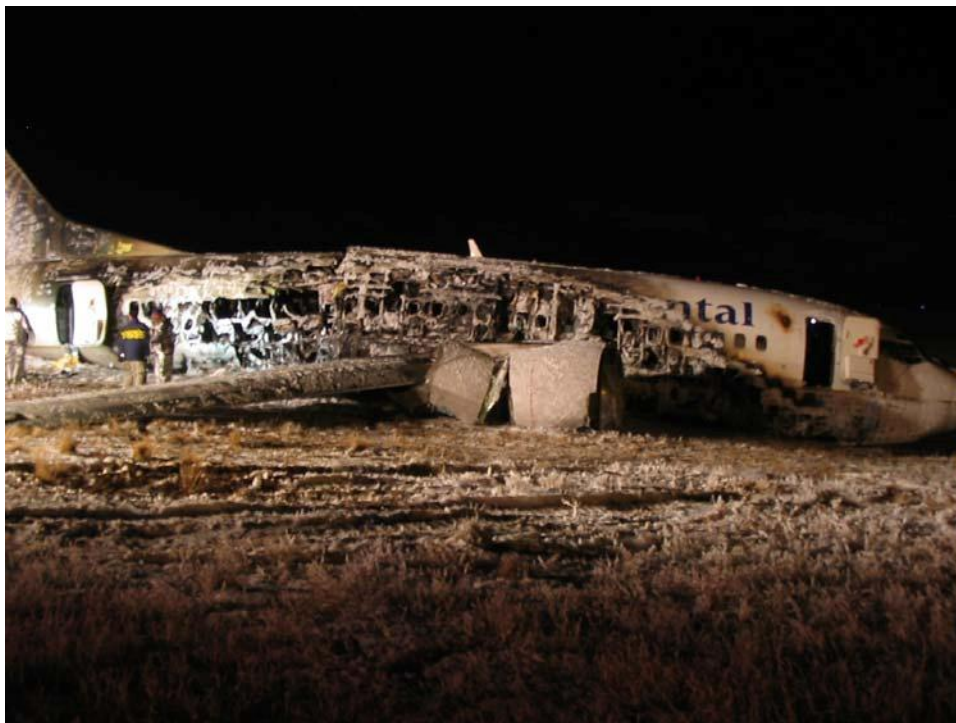
Photograph 10: Exterior burn damage.

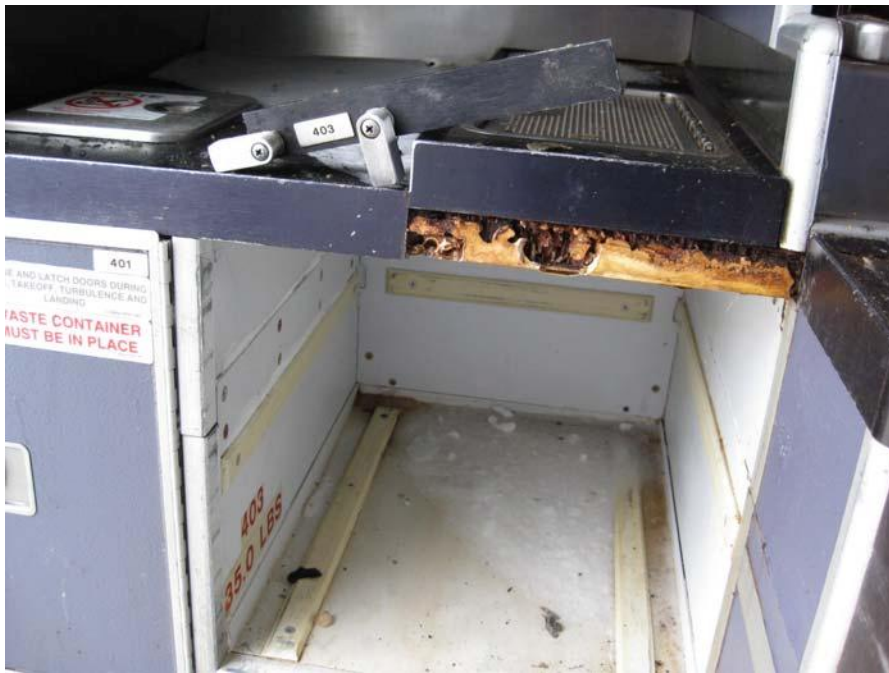
Photograph 11: G4B galley in aft cabin, showing broken latch plate.

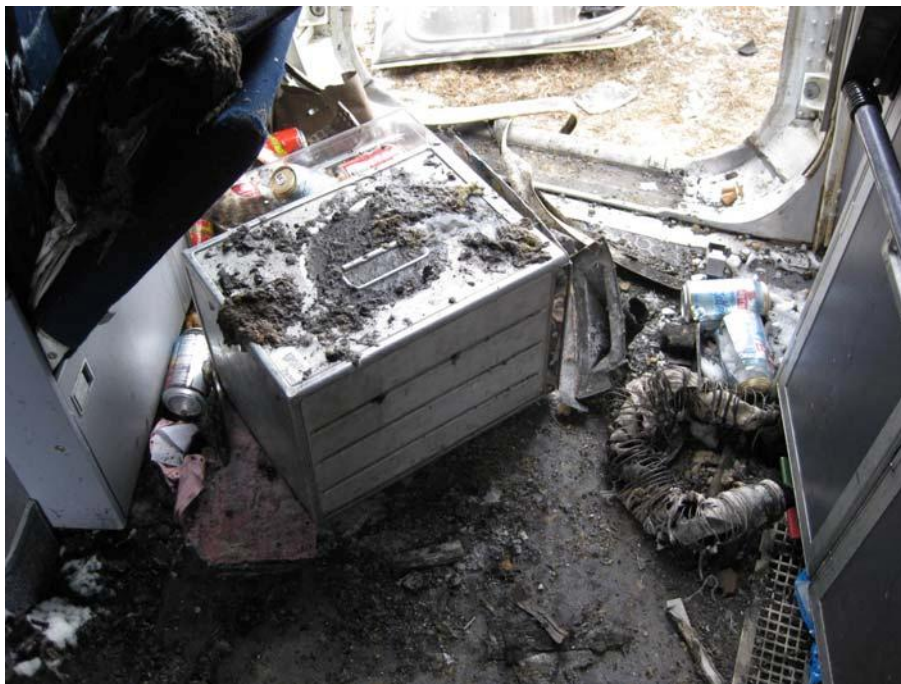
Photograph 12: Vestibule area at door 2R; galley carrier from aft galley on floor under aft-facing flight attendant jumpseat.
