NATIONAL TRANSPORTATION SAFETY BOARD
Office of Aviation Safety
Washington, DC 20594

SURVIVAL FACTORS GROUP CHAIRMAN'S FACTUAL REPORT

July 23, 2015

Operator : Scaled Composites, LLC
Vehicle : Model 339 SpaceShipTwo [N339SS]
Location : Koehn Dry Lake, CA
Date : October 31, 2014
Time : 1007 Pacific daylight time (PDT)¹
NTSB # : DCA15MA019

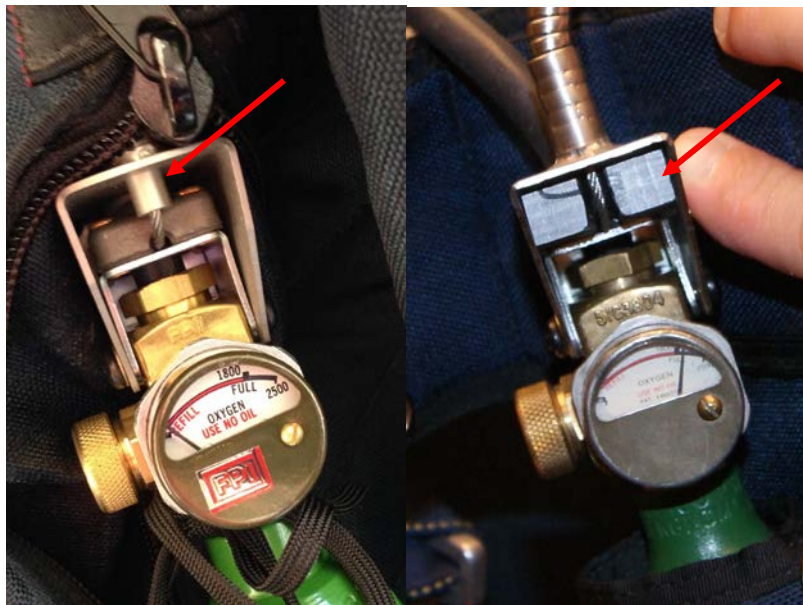
The test design bracket marginally reduced the pull force necessary to activate the bottle by approximately 10% (4 lb.). The test design bracket compromises the profile of the parachute system; the cable housing creates a snagging hazard because it routes out-and-up the pack where the current design routes straight up the parachute pack.

Figure 4. A photograph of an unmodified oxygen bottle (left), and one modified by Scaled Composites with a Delrin block (right, red arrow)

⁷ Note that the cable housing was cut off flush with the bracket (red arrow, left picture).

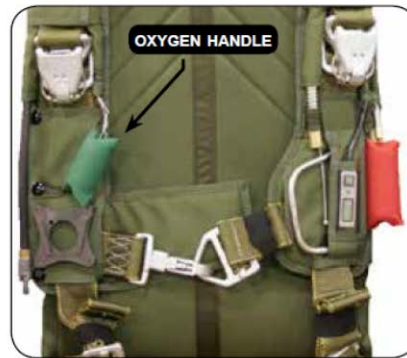
Pull the handle forcefully downward and apply sustained force on the cable until you receive oxygen. You will only achieve a short stroke before the cable stops. Keep applying sustained force until you receive oxygen.

Figure 5. BPS *High Altitude Emergency Parachute System User's Guide* revision C.

When asked for possible causes about the higher values achieved in these tests compared to those in the BPS May 2014 tests, BPS replied that they had performed additional testing in-house that also showed higher average values (44 lbs. with a standard deviation of 6.9). They stated “it is possible that the nipples we had back then were on the low end, or that our instrumentation or test method was somehow different. If you look at the construction of the nipples, it is going to be very difficult to get a consistent breaking force with a low scatter.” Additionally the company added that “we are continuing to research the matter and we will work towards finding a better solution, both internally and working with Scaled/Virgin... we do intend to emphasize to our customers that the bottle is designed to be activated inside the aircraft, prior to egress, with a two hand activation motion, and as soon as you recognize an oxygen failure (whether bailout is required or not). We will also emphasize that single handed operation may not be achievable.”

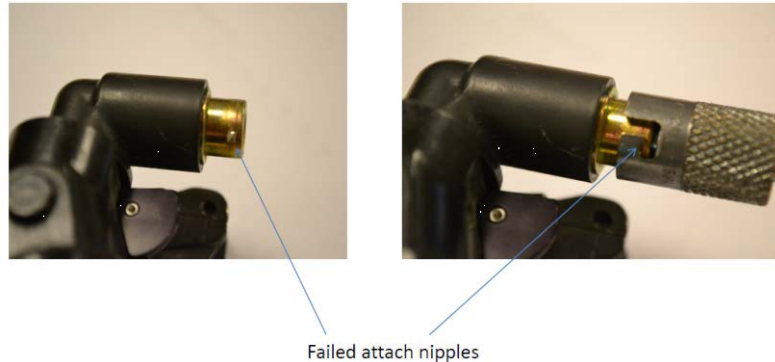
As stated in section 2.6.1, the pilot’s oxygen hose was found disconnected from the CRU-60 adapter. Scaled Composites performed two tests to investigate whether pulling the hose fitting from the CRU-60 was possible, what loads would be required to do so, and whether such loads would cause visible damage to either component.

The hose failed at the brass ferrule of the interconnect at approximately 18 lbs. It was noted that the hose seemed to stretch and stay stretched after the test. The amount of stretch was estimated to be about 10%. The second test pulled on the actual interconnect fittings that fasten the hose into the CRU-60. The failure occurred when the attach nipples on the CRU/60 were sheared off. The load at failure was 204 lbs. No deformation of the attach fitting was noted after the test.

Figure 6. Damage to CRU-60 hose fitting after Scaled Composites testing.
