**SURVIVAL FACTORS GROUP CHAIRMAN'S
FACTUAL REPORT**

**MULTIPLE VEHICLE ACCIDENT
Chattanooga, TN**

HWY15MH009

**NATIONAL TRANSPORTATION SAFETY BOARD
OFFICE OF HIGHWAY SAFETY
WASHINGTON, D.C.**

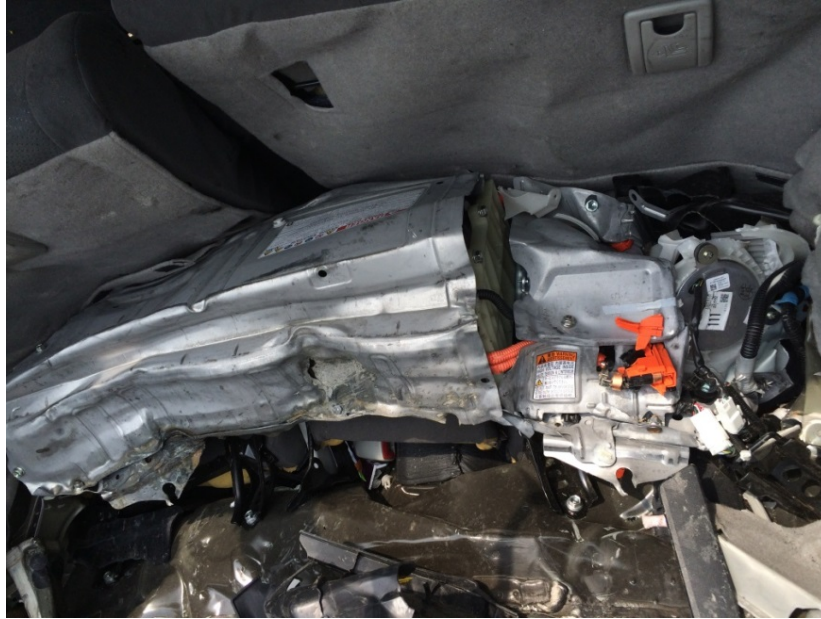
The rear portion of the car was heavily crushed forward and the rear deck lid was displaced. The battery compartment and back of the rear seats were exposed. The metal cover over the battery pack was crushed and partially displaced forward. The battery pack itself was partially damaged but not ruptured, as shown in Figure 1.

Figure 1. Cargo Area of the Prius with Damaged Battery Pack
