Survival Factors Group Chairman's Factual Report

Crashworthiness Investigation

July 29, 2016

Railroad: National Railroad Passenger Corporation (Amtrak)
Train No. 4
Location: Cimarron, Kansas
Date: March 14, 2016
Time: 12:02 am CDT¹
Number: DCA16MR004

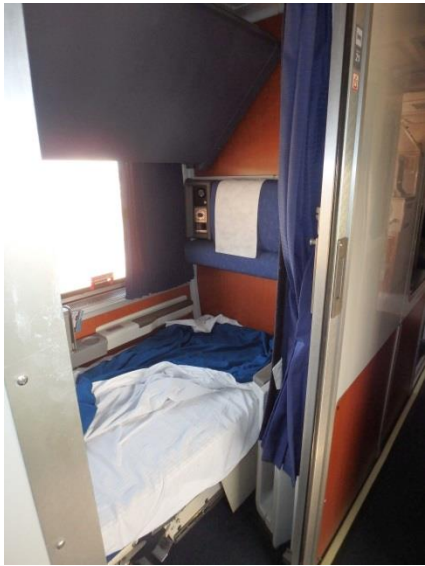
The first three passenger cars, sleeper cars 39023, 32109, and 32071, came to rest upright. Inside of the cars, there was no significant damage or evidence of injury. All of the windows were in place.

Figure 1- Coach 39023 Room 21

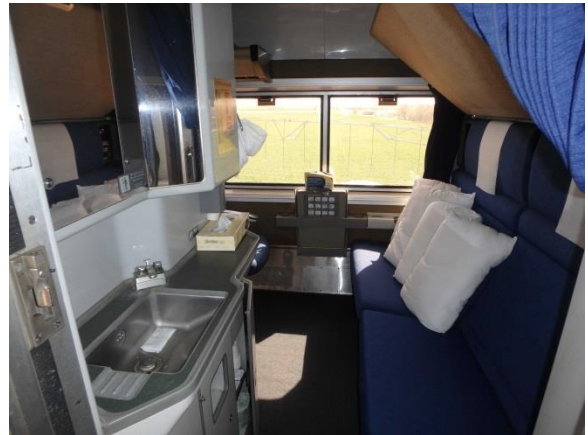
Figure 2- Coach 32109 Room B

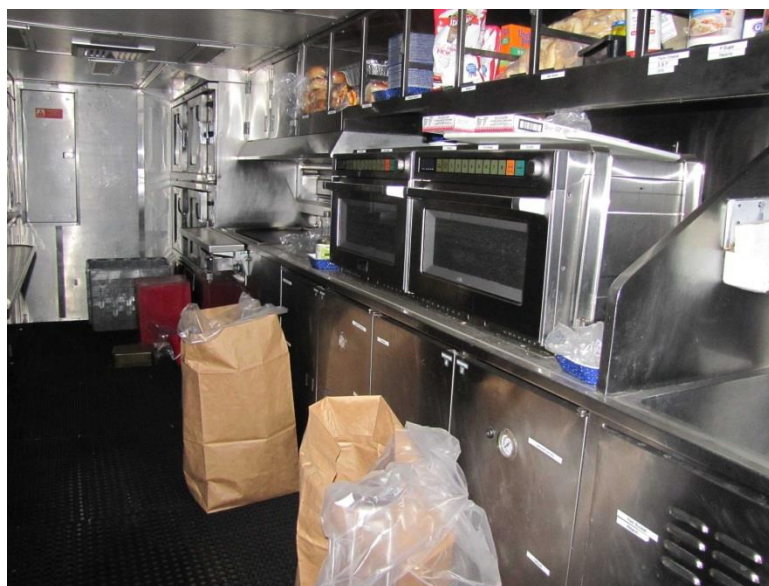
The fourth passenger car, diner 38044, came to rest upright. On the lower level in the kitchen, the appliances were secure, and kitchen supplies remained on the storage shelves. On the upper level in the seating area, the seats and tables were secure. Some service items such as bowls of condiments had fallen on the floor.

Figure 3- The cooking area in diner 38044

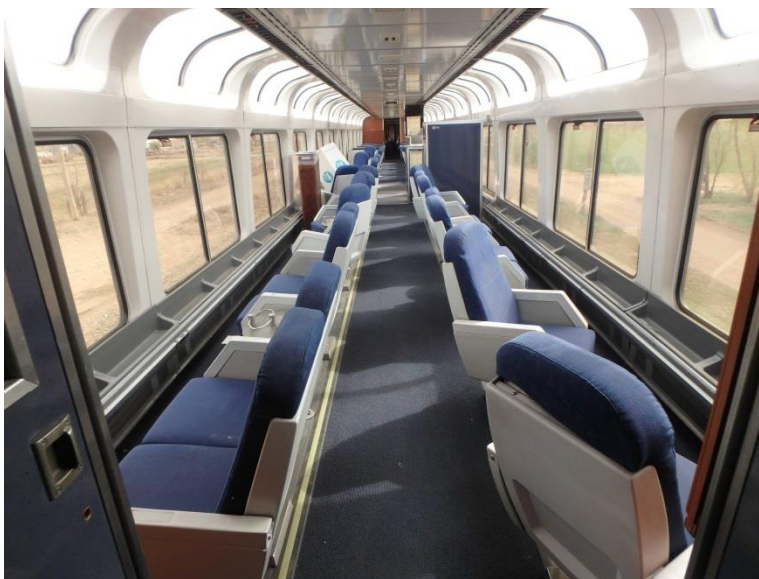
The fifth passenger car, lounge 33020, came to rest tilted about 30 degrees to the north. On the upper level in the seating area, the seats and tables were secure. Some service items such as napkins had fallen on the floor. On the lower level, the seats and tables were secure. One emergency window was removed from inside of the car. The emergency tools and supplies were in place in their cabinets on both levels.

Figure 4- Lounge 33020

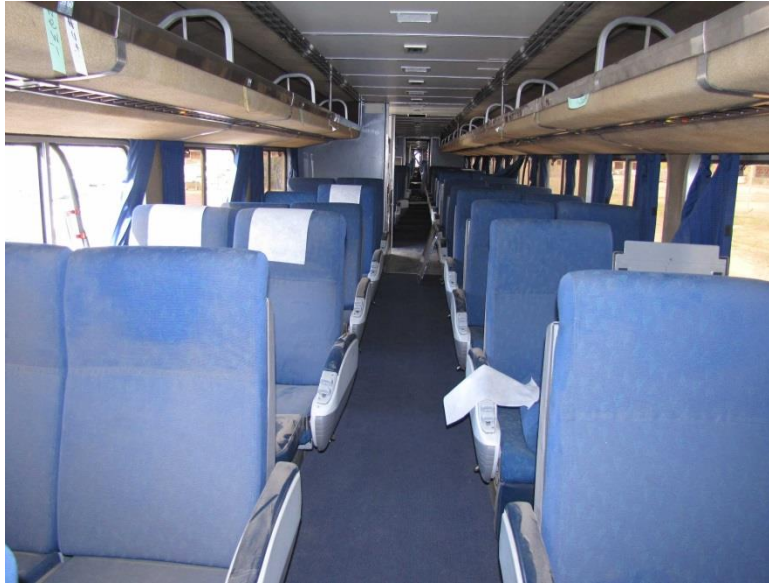
The sixth passenger car, coach 34042, came to rest tilted about 80 degrees and leaning onto a dirt berm. On the left side of the car, two exterior zip strips on the second and tenth upper level windows were partially pulled out.² The exterior zip strip from the second lower level window was not in place. The bottom of the side entry door was bent inward. On the right side of the car, the center frame section of the sixth window (next to the interior stairwell) was cut, and the windows were removed. Three emergency windows were removed from inside of the car.

Inside of coach 34042, five interior emergency window zip strips were found torn. Seven seat pairs on the right side of the upper level were unlocked and partially rotated. The emergency equipment and supplies were in the upper level cabinet. On the lower level of the car, there was a large pile of ballast and dirt at the side entry door. The cord securing the American's with Disabilities (ADA) ramp in its storage area was not secure. Three lower level seats were unlocked and partially rotated. The emergency tools and supplies were in the lower level cabinet.

Figure 5- Coach 34042

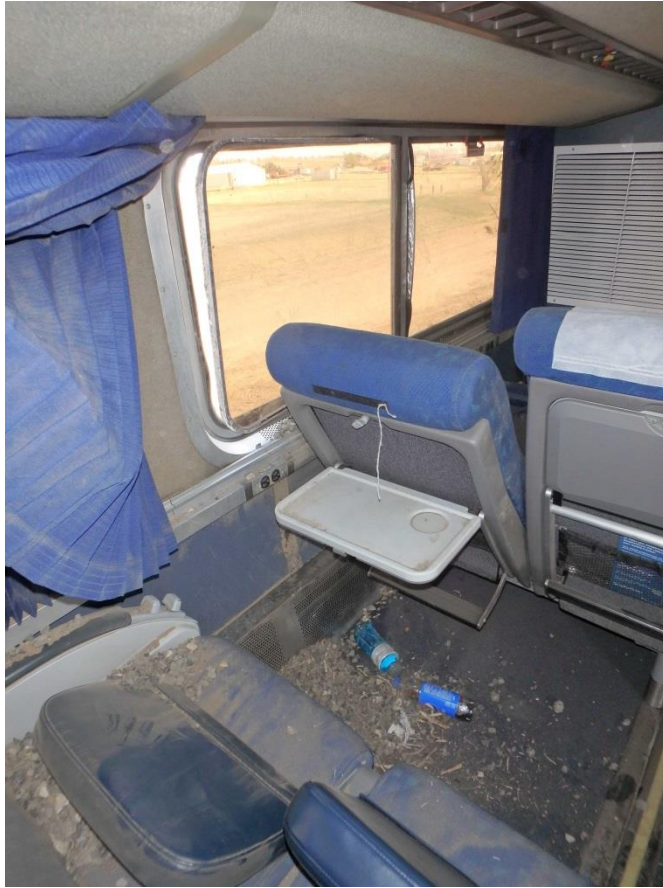
The seventh passenger car, coach 31013, came to rest tilted about 80 degrees and leaning onto the dirt berm. On the left side of the car, the exterior zip strip on the first upper level window was partially pulled out, and the window and its frame (next to seat pair 55/56) was dislodged inward into the car. On the second upper level window, the zip strip and gasket were partially dislodged. On the eleventh upper level window, one window (next to seat pair 1/2) was completely separated from the window frame. For the side entry door and the baggage area door, the bottoms of the doors were bent inward into the car. The battery compartment doors were compromised, and debris entered the battery area. Near the battery area and baggage door, wires were stripped out of a junction box. On the right side of the car, five right side upper level windows were removed.

Inside of coach 31013, near the dislodged window at seat pair 55/56, there was dirt and ballast on the floor and seats behind this seat pair. Near the dislodged window at seat pair 1/2, there was a large pile of dirt between this seat and a bulkhead behind the seat. On the upper level, three seat pairs on the right side were unlocked and partially rotated. The light sticks were removed from the upper level emergency tool cabinet. On the lower level, there was a large amount of ballast and dirt at the baggage door and a small amount dirt and ballast at the side entry door. The emergency tools and supplies were in the lower level cabinet.

Figure 6- Coach 31013 near seat pair 55/56

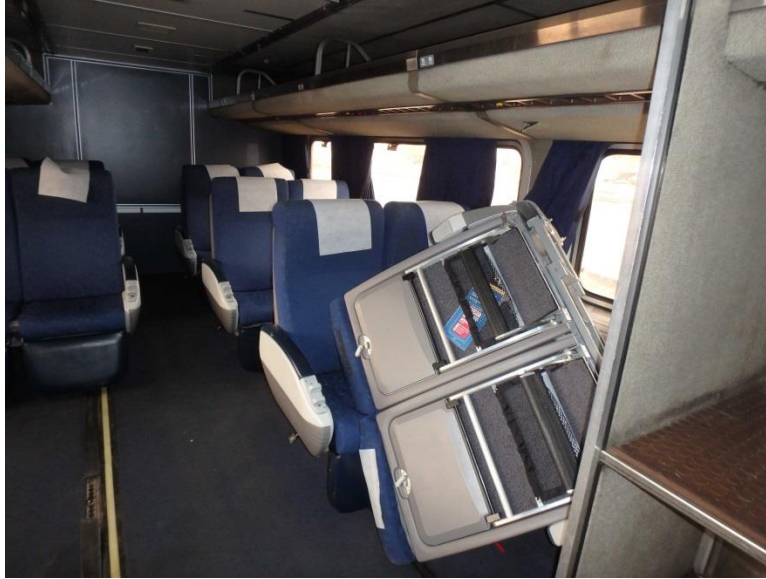
Inside of coach 34056, in the stairwell, there were smears of blood on the walls and window. On the lower level, one right side seat pair, 73/74, was completely separated from its floor and wall attachment points. The cord securing the ADA ramp in its storage area was not secure. There was a small amount of ballast and dirt at the side entry door. The emergency tools and supplies were in the lower level cabinet. On the upper level of the car, the light sticks were removed from the emergency tool cabinet.

Figure 7- Coach 34056 Seats 73/74

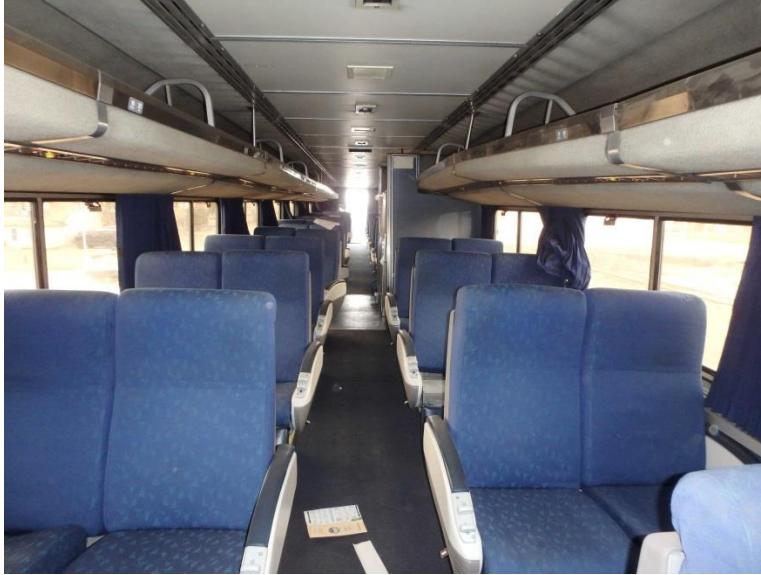
The ninth passenger car, coach 34046, came to rest tilted about 80 degrees and leaning onto the dirt berm. On the left side of the car, there was horizontal scraping on the side sheet and flattening of the roof line above the fourth through eighth windows. The leading edges of the second and eleventh windows were slightly pushed inward.

Inside of coach 34046, on the upper level, seven seat pairs on the right side of the car were unlocked and partially rotated. The stairwell bulkheads were separated from the ceiling. The luggage racks on the left side of the car were bent and displaced upward. The emergency tools and supplies were in the upper level cabinet. On the lower level of the car, the emergency tools and supplies were in the cabinet. The cord securing the ADA ramp in its storage area was secure.

Figure 8- Coach 34046
