**National Transportation Safety Board**  
Office of Railroad, Pipeline and Hazardous Materials Investigations  
Human Performance and Survival Factors Division  
Washington, D.C. 20594

**Survival Factors Group Chairman's Factual Report**

**April 10, 2017**

Railroad: New Jersey Transit  
Train No. 1614  
Location: Hoboken, New Jersey  
Date: September 29, 2016  
Time: 0838 am EDT<sup>1</sup>  
Number: DCA16MR011

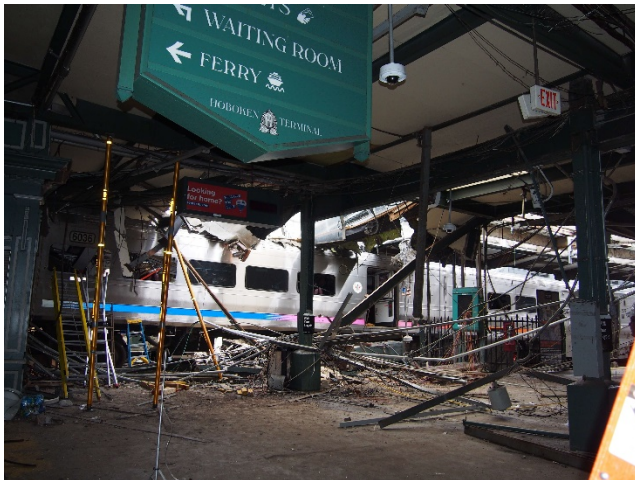
Figure 2- A view of the left side of the accident site and cab car

The train struck the bumping post at the end of the track. The cab car, including its front truck, rode up onto the terminal platform and struck a wall between the station and ticket office. Underneath the rear of the cab car, the bumping post was pivoted forward into the concrete platform. Inside of the ticket office, the office ceiling and wall were damaged, and components from these structures fell into the ticket office. A picture of an exemplar bumping post on an adjacent track is shown in figure 3 below.

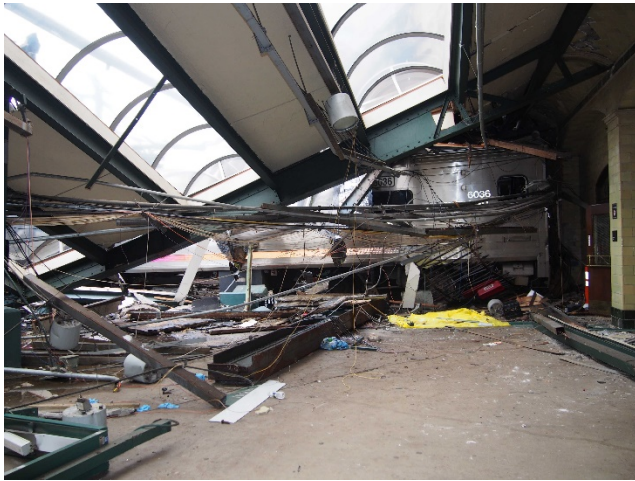
Figure 4- A view of the right side of the cab car

The terminal canopy and its support beams collapsed onto the cab car and the station floor. On the right side of the cab car, a vertical canopy beam had fallen onto the platform, and the concrete base of the beam was fractured. A horizontal canopy beam perpendicular to the track and above the station platform fell onto the platform. On the left side of the cab car, a canopy structural beam was lodged in between the cab and the station wall. The right side of the accident site and an undamaged section of the terminal are shown in the pictures below.

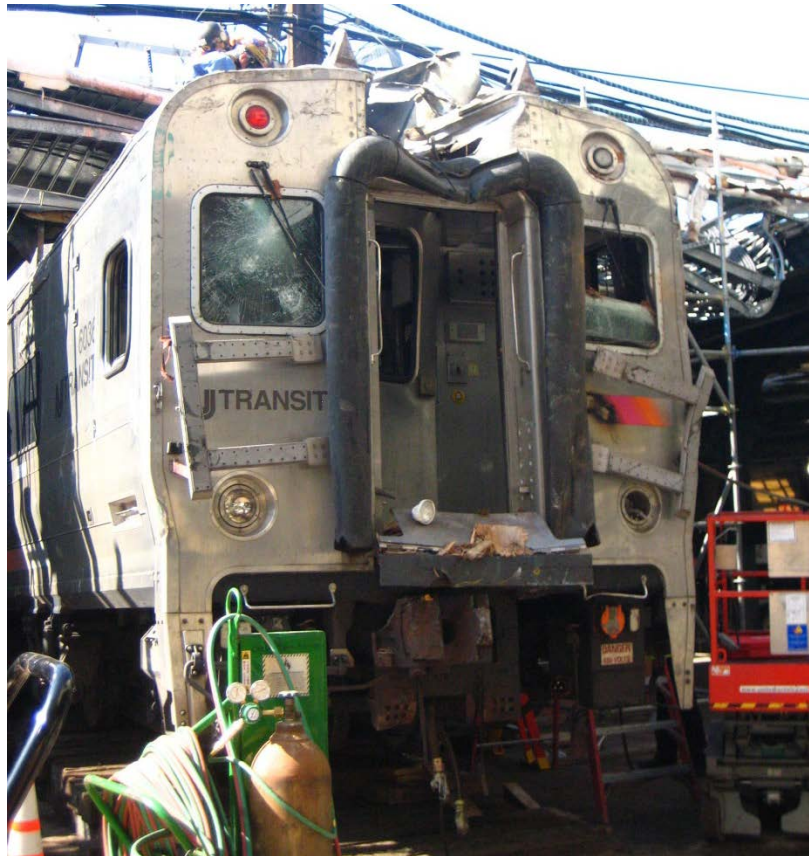
Figure 6- The front of the first car (Credit: Volpe Center)

On the top of the cab car, the leading HVAC unit was sheared from the roof of the car and was wedged up against a horizontal canopy beam above and perpendicular to the track. On the front end of the cab car, the anti-telescoping plate was bent inward. (See figure 6.) The collision posts, corner posts, and side roof rails were undamaged. Inside of the cab car, a horizontal canopy beam parallel to the track pierced through the interior of the car up to the center vestibule doors. Components from the roof of the cab car and the station canopy collapsed into the forward passenger seating area.

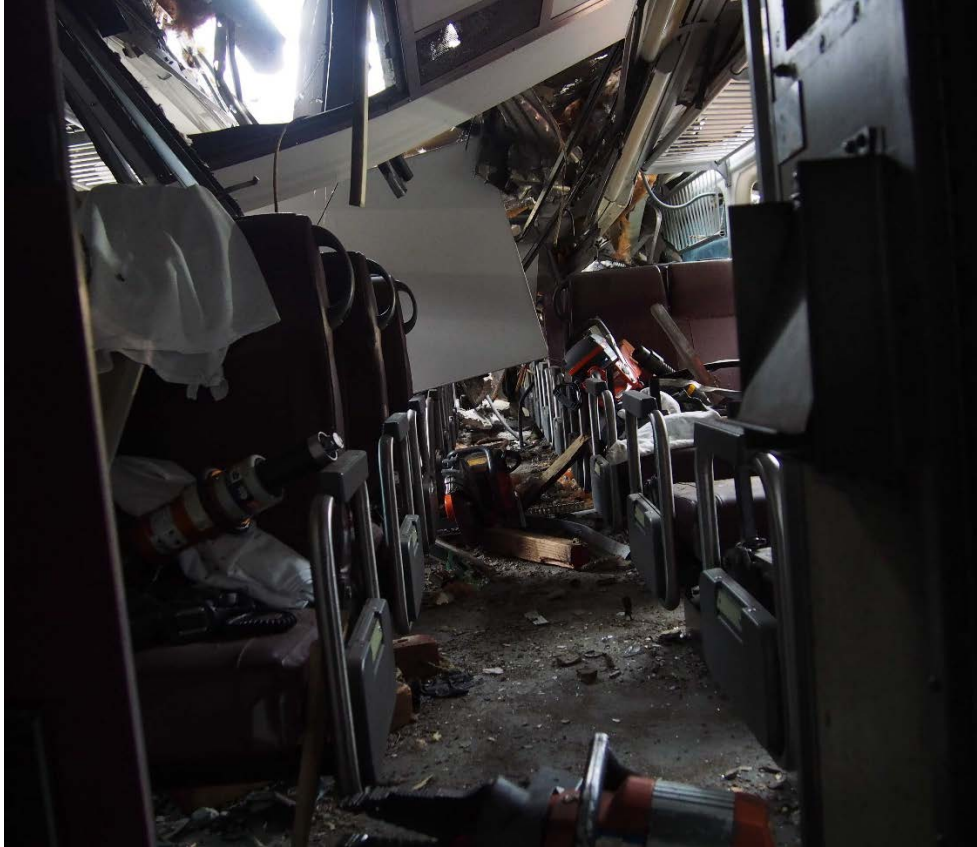
Figure 7- The front seating area of the cab car

Because of the structural damage to the cab car and the station canopy, entry into this car was limited to the cab and trailing end of the car. A picture of the interior of the cab car as viewed from the cab compartment is shown below.

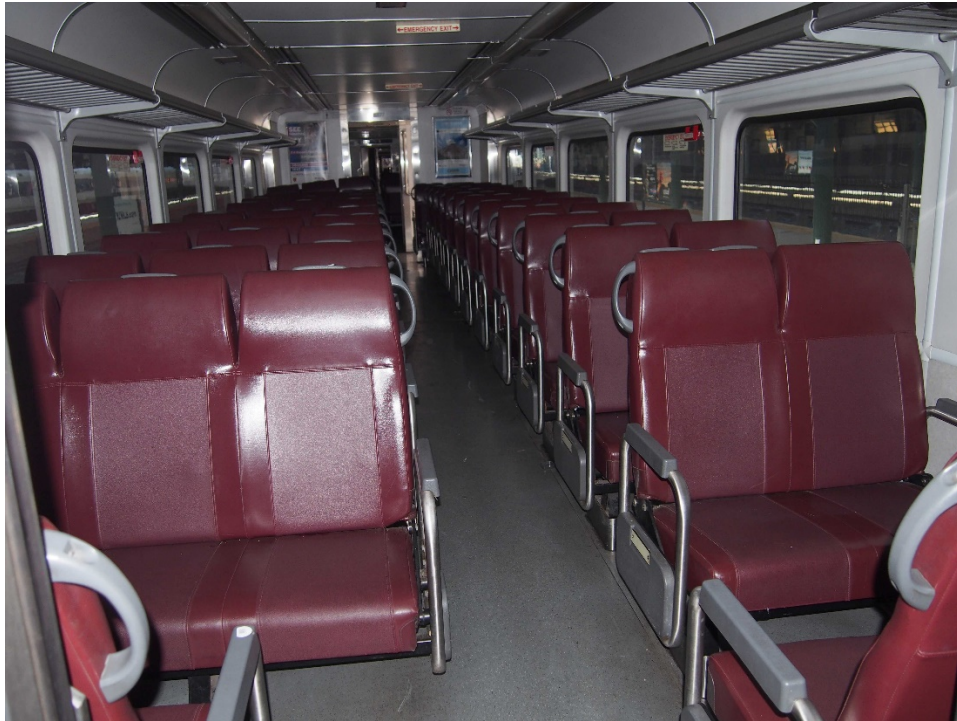
Figure 8- The interior of car 6577

Inside of the car, one left side emergency exit window release was partially pulled, but the window was not removed. There were four seat backs (left seating rows 18, 19, and 21; right

seating row 12) were partially lifted from the mounting supports. There were a few blood drops near the right-side seat row 13.
