Survival Factors Group Chairman's Factual Report

June 5, 2017

Railroad: Long Island Rail Road
Train No. 2817
Location: Brooklyn, New York
Date: January 4, 2017
Time: 0818 am EST¹
Number: DCA17FR002

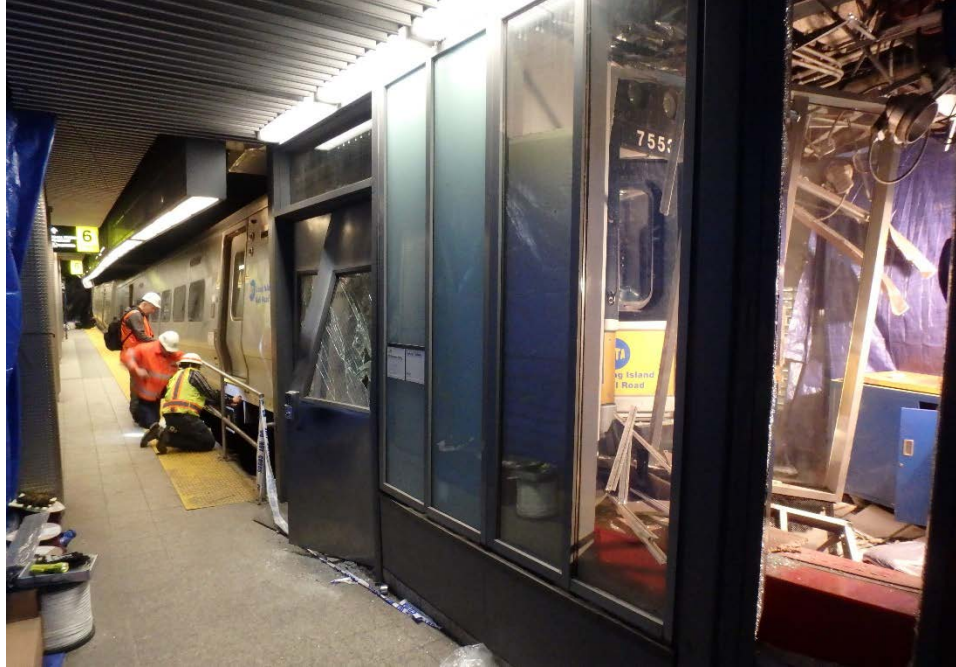
The train struck the bumping post at the end of the track. The first car overrode the bumping post. The front truck impacted the concrete platform, separated from the carbody, and remained wedged between the running rail and the platform. The third axle of the rear truck remained on the track, and the fourth axle derailed. The carbody came to a stop in a secure employee-only access hallway. The front office wall collapsed into the office. The office windows were shattered, and the ceiling collapsed.

Figure 1- A view of the accident site

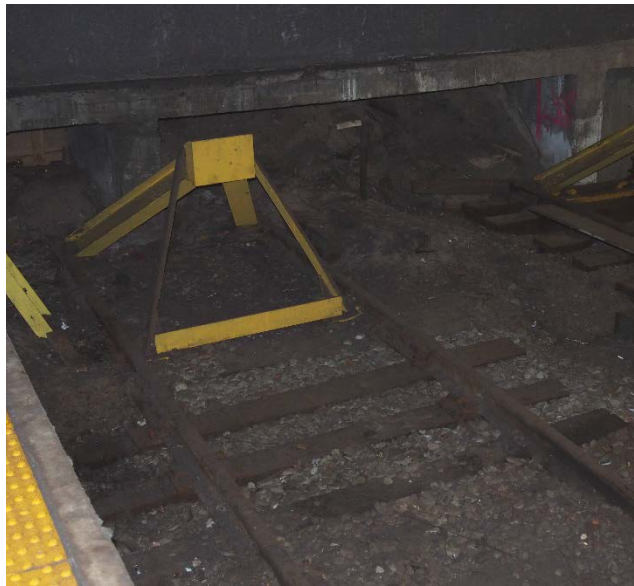
Segments of each rail, which were bolted to the bumping post, separated from the rest of the track and pivoted forward and upward toward the floor of the first car. The figure below shows a bumping post on an adjacent track.

Figure 2- A bumping post on an adjacent track

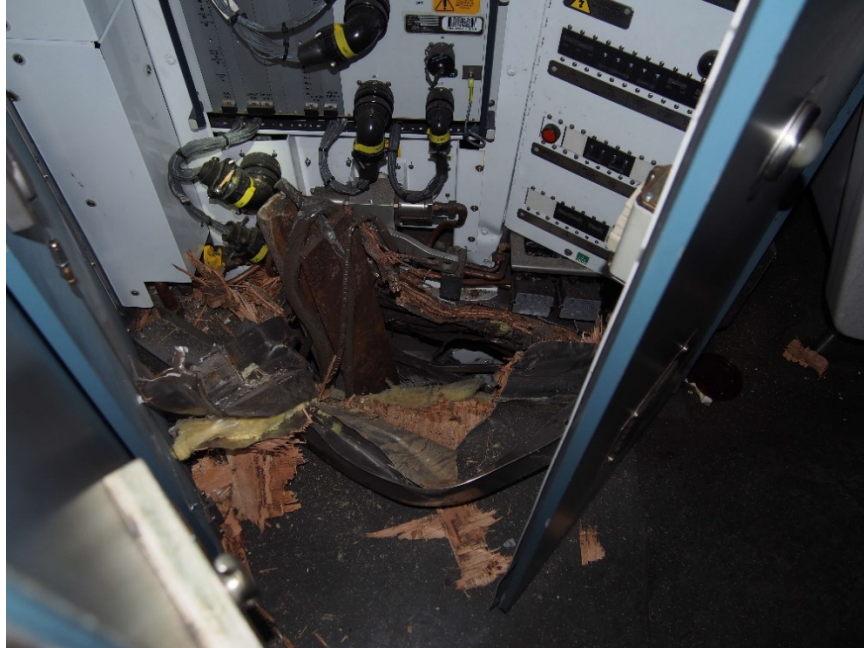
Inside of the car, a segment of the north-side rail punctured through the car's floor into the electrical cabinet behind the operating cab. The picture below shows the inside of the electrical cabinet.

Figure 3- A view of a rail that punctured the floor of the car 7553

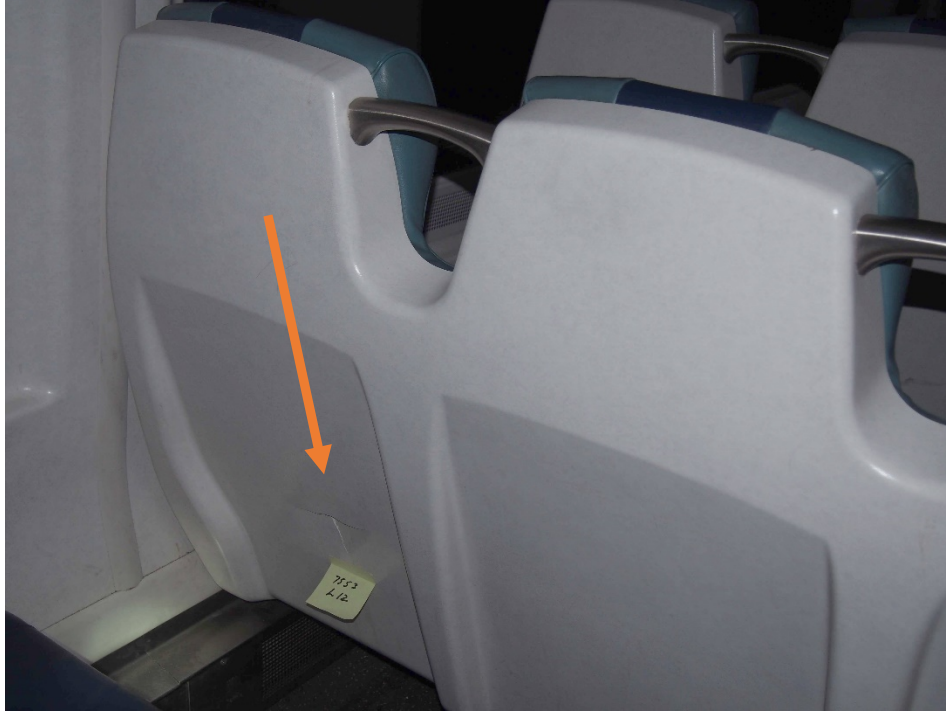
In the passenger area, seven seat backs were cracked. On the right side, the seat backs next to the windows in rows 11, 12, 14, 15, and 19 were cracked. On the left side, the seat back next to the window in row 12 and the seat back next to the aisle in row 13 were cracked. Blood drops were found on the seat cushion and floor near the left-side row 14 seat. The forward and rear right side door release covers broken, and the releases were in the pulled position. One right side emergency window was removed. There was no evidence of damage to the pull handle from this window.

Figure 4- An example of a cracked seatback
