**NATIONAL TRANSPORTATION SAFETY BOARD
OFFICE OF HIGHWAY SAFETY
WASHINGTON, D.C.**

**SURVIVAL FACTORS GROUP CHAIRMAN'S
FACTUAL REPORT**

Location: Northbound US Highway 83 (US-83) near milepost 553.4 in Uvalde County, 6.5 miles north of Concan, Texas

NTSB #: **HWY17MH011**

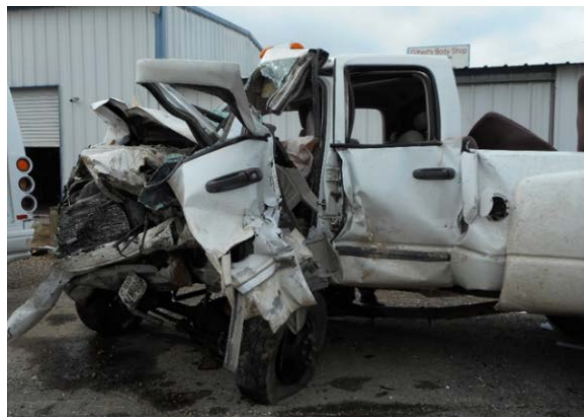
The pickup truck sustained extensive damage to the front end with damage extending down the left side of the truck, as shown in **Figure 1**.¹ The truck’s front end was shifted to the left. The roof of the cab was buckled upwards approximately 10 inches. The front left wheel assembly was displaced aft of the drivers A-pillar. The drivers A-pillar was cut by first responders approximately 5 inches from the top of the dashboard. Post-crash the wheelbase on the drivers side measured 95 inches and 167 inches on the passenger side (the original wheelbase was 160.5 inches).² The drivers door was separated at the upper hinge and the door frame folded over/collapsed. First responders pried open both the front driver and passenger doors while extricating the driver. The rear door on the drivers side was displaced rearward and jammed closed.

Figure 1. Left side profile view of front end deformation to Dodge Ram.

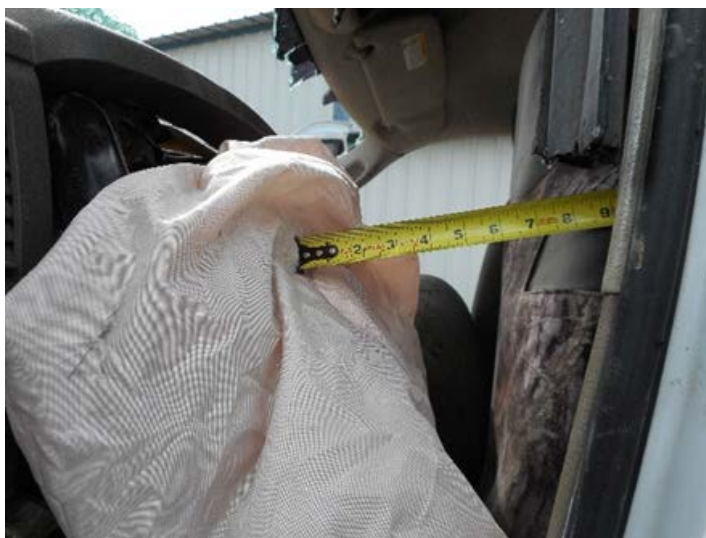
The drivers compartment was severely compromised in the crash. The steering wheel, instrument panel, and footwell regions were all displaced aft into the drivers seating position. Post-crash, the distance from the drivers steering wheel to the drivers seatback was approximately 7 inches, as shown in **Figure 2**.³

Figure 2. Close-up view showing drivers steering wheel approximately 7 inches from the center of the steering wheel to the drivers seatback.

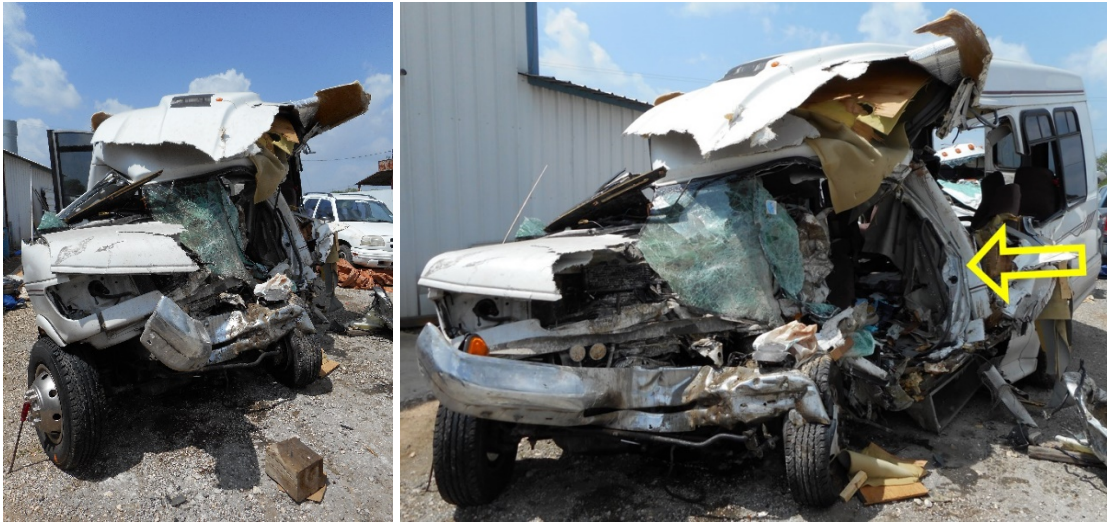
The bus sustained extensive front end damage that extended down the left side as the pickup truck overrode the bus bumper and frame resulting in extensive intrusion into the driver and passenger compartments. The entire drivers compartment collapsed such that the A-pillar on the drivers side was aligned with the B-pillar on the passenger side of the bus. Similarly, the B-pillar on the drivers side was displaced rearward such that it was aligned with the rear window bow of the first window on the passenger side of the bus. **Figures 3 and 4** show the damage to the

front and left side of the bus and the accordion style deformation, marked with yellow arrow, to the bus's left sidewall structure.⁶

Figures 3 and 4. Photo on left is a frontal view and photo on right is a front left angle view of deformation to front end of Ford E350 bus. (Note; yellow arrow indicates area of accordion style crush to B-C pillars)

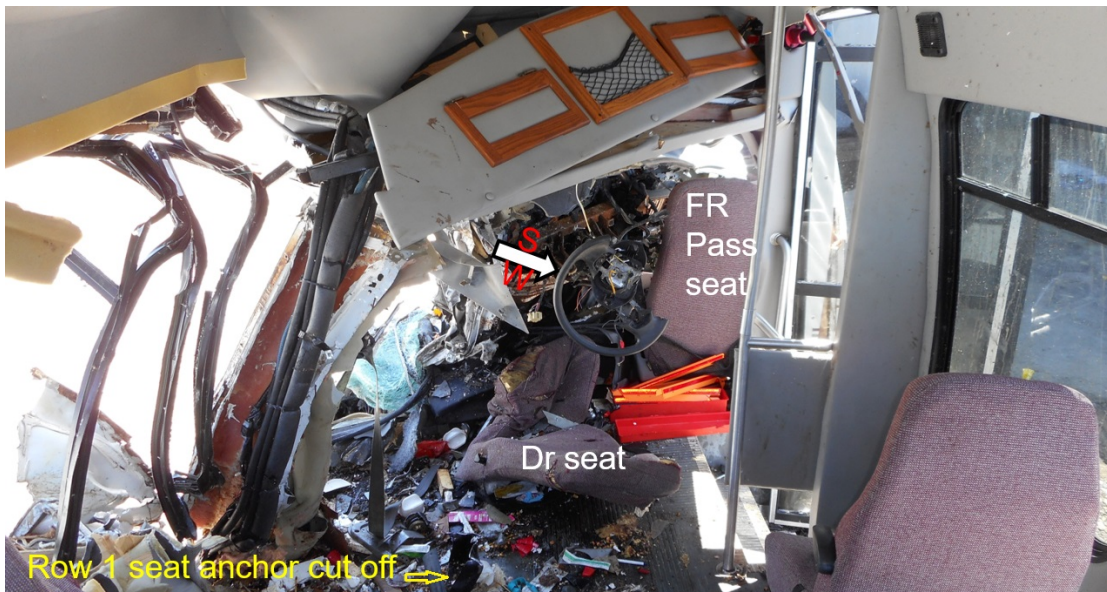
Due to the severity of the intrusion, the drivers seat was displaced aft and toward the right side of the bus such that it was found adjacent to the right side loading door (in the first row of passenger seats). The drivers steering wheel was deformed and displaced aft and inward so that it was about 12 inches aft of the back of the front passenger seat's seatback (Refer to **Figure 5**).⁸ The steering wheel measured 16 inches horizontally and 14 inches wide. Approximately a quarter of the steering wheel was cut by first responders in the 7-5 o'clock position. Extrication of passengers resulted in the removal of the first row of 2-passenger seats behind the drivers seat. The second row aisle seat was also removed on the left side of the bus. The first and second row of 2-passenger seats were severely damaged by the intrusion and impact forces such that the seat backs were bent backwards and the sidewall attachment (for the first row) was torn away from the attachment point. (Note that the sidewall experienced the accordion style deformation pattern described above.) The seats and restraint systems are described further in the following sections.

Figure 5. Interior view of Ford E350 from rear looking forward at interior intrusion and deformation. NOTE: Row 1 cut out during extrication process. Above abbreviations, SW is Steering Wheel, Dr = Driver, and FR = Front right passenger.

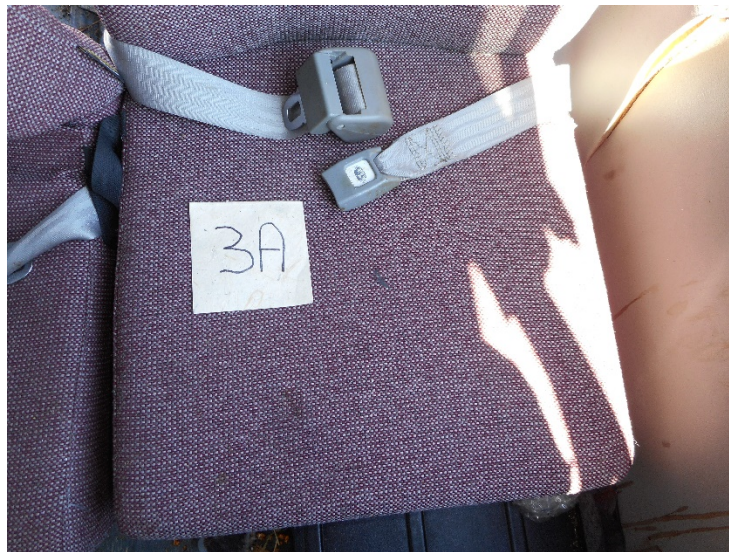
Figure 6. View of lap belt in seat 3A showing the “web winder” with latch and buckle.

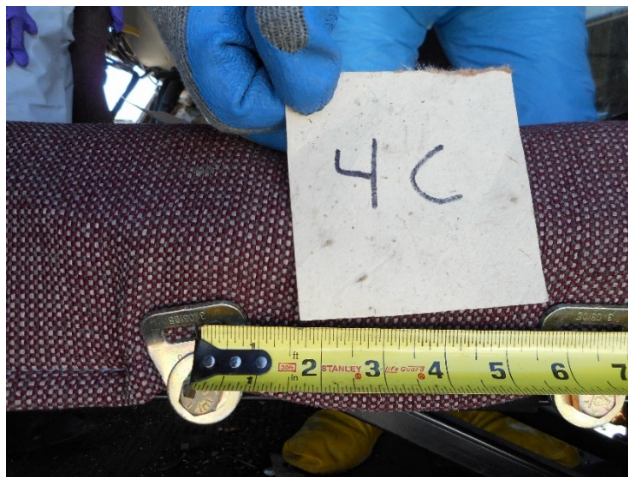
fourth row only, the lateral lap belt attachment points were 6.5 inches apart (see **Figure 7** below).¹⁵ The 6.5 inch (165 mm) spacing is allowable under Federal Motor Vehicle Safety Standards (FMVSS) 210.¹⁶ According to the Representative from Freedman Seating, as of October 1, 2017 Freedman will no longer be installing their lap belt anchors at the 6.5-inch lateral spacing. They have increased the lateral lap belt anchor spacing to an average of 10 inches, with spacing ranging from 8.5 to 12.5 inches.

Figure 7. Close-up view of lateral lap belt attachment points on seat frame in row four.

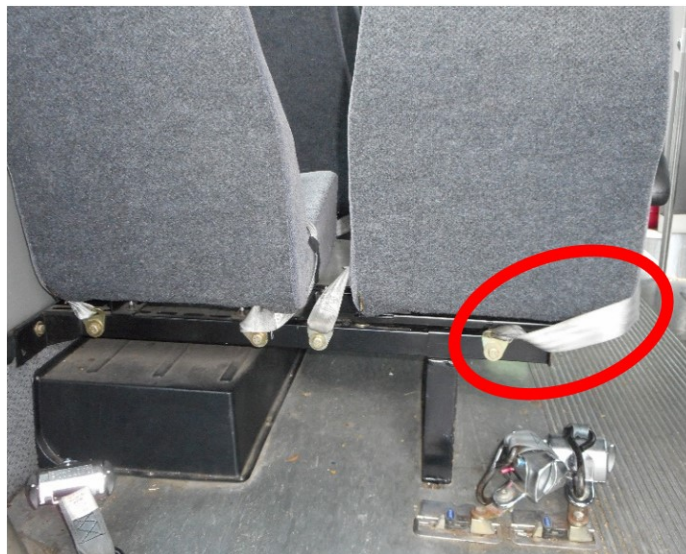
There were several issues found during the examination of both the crash involved bus and an exemplar vehicle. For example, the positioning of the lap belt attachment points, as shown in Figure 8, did not line up with the seat especially when the seat slider was utilized.²² However, none of the slider seats in the crash involved bus were slid over at the time of inspection.

Figure 8. View of belt positioning to side (highlighted in red) in sister vehicle when side slide mechanism is utilized.
