National Transportation Safety Board

Survival Factors Group Chairman's Factual Report of Investigation

A. Accident : ANC10MA068

Airplane : DeHavilland DHC-3T, N455A

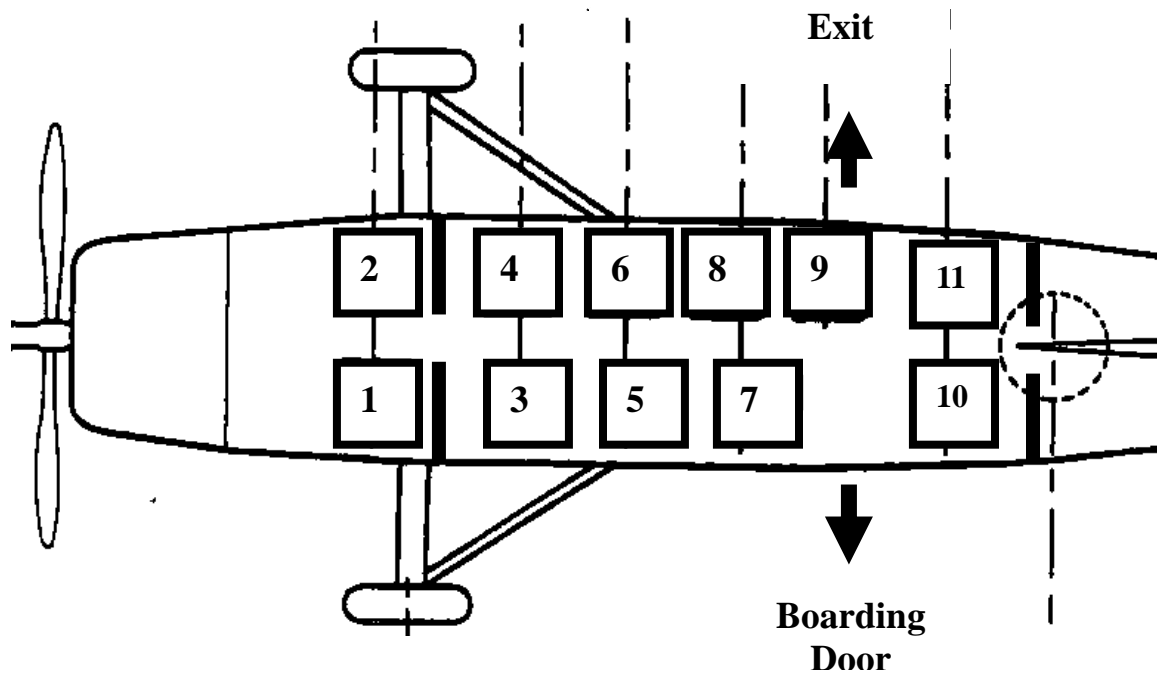
Figure 1. DHC-3 cabin configuration

The airplane was configured with 9 passenger seats and 2 pilot seats. (Figure 1). There was a floor-level passenger door on the left side of the cabin and a floor-level passenger exit on the right side of the cabin. On the accident flight, the pilot occupied seat 1, and a passenger was in seat 2.

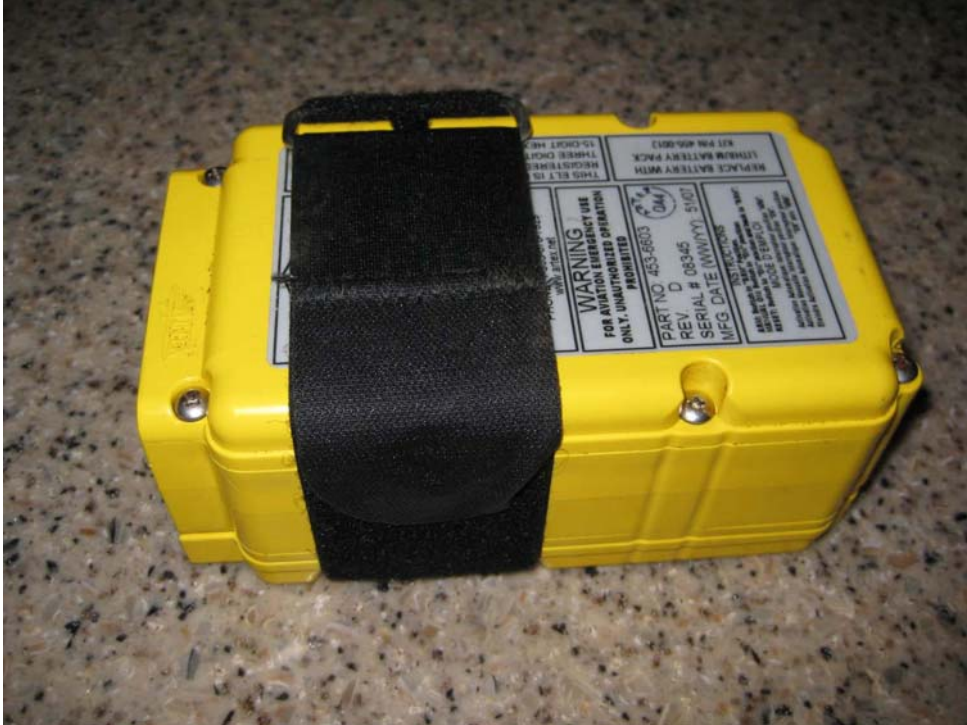
During the passenger rescue, an Air National Guard pararescueman (PJ) found the ELT detached from its mounting bracket, lying on the floor in the aft section of the airplane. Both the antenna and power cable had separated from the unit. The PJ believed the ELT was transmitting because he could hear a tone over his radio headset when he

The ELT unit was examined at Artex facilities in Prescott, AZ on August 25, 2010. Artex personnel found no physical damage to the ELT tray or module. Electrical exams of the ELT module were conducted, and it was determined that the 121.5 MHz and 406 MHz beacons and the G-switch operated normally. Artex personnel also examined a photograph of the ELT tray mounted in the accident airplane (Photograph 2), and noted that the Velcro retention strap “appeared to be slid toward the aft section of the tray, out of its molded groove.” They noted that under normal installation practices, the retention strap should not be physically able to be placed in this position. Other than photographs, Safety Board investigators did not examine the mounting tray prior to its removal from the wreckage, therefore, it is not known if the retention strap was actually incorrectly positioned following the accident. Details of the examination are in Attachment 6.

Photograph 1. Artex ME406 ELT in mounting tray, secured by Velcro strap.

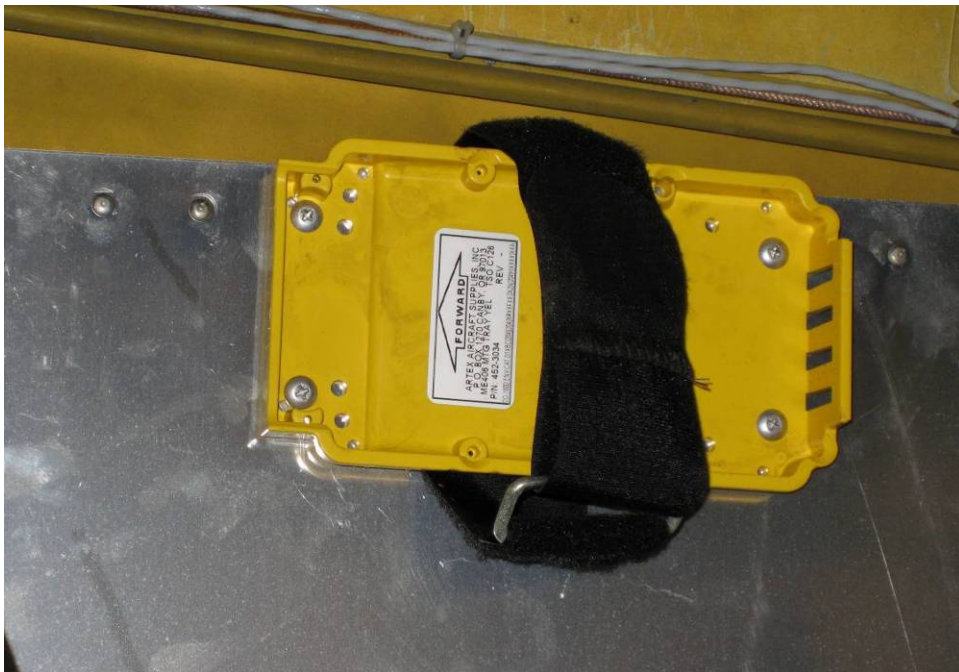
Photograph 2. ELT tray mounted on sidewall of accident airplane.
