National Transportation Safety Board
Office of Railroad, Pipeline and Hazardous Materials Investigations
Human Performance and Survival Factors Division
Washington, D.C. 20594

SURVIVAL FACTORS GROUP CHAIRMAN'S FACTUAL REPORT

Emergency Response

Train: Metrolink train 111
Train: Union Pacific train LOF 65-12
Location: Los Angeles, California
Date: September 12, 2008
Time: 1623 PDT¹
Number: DCA-08-MR-009

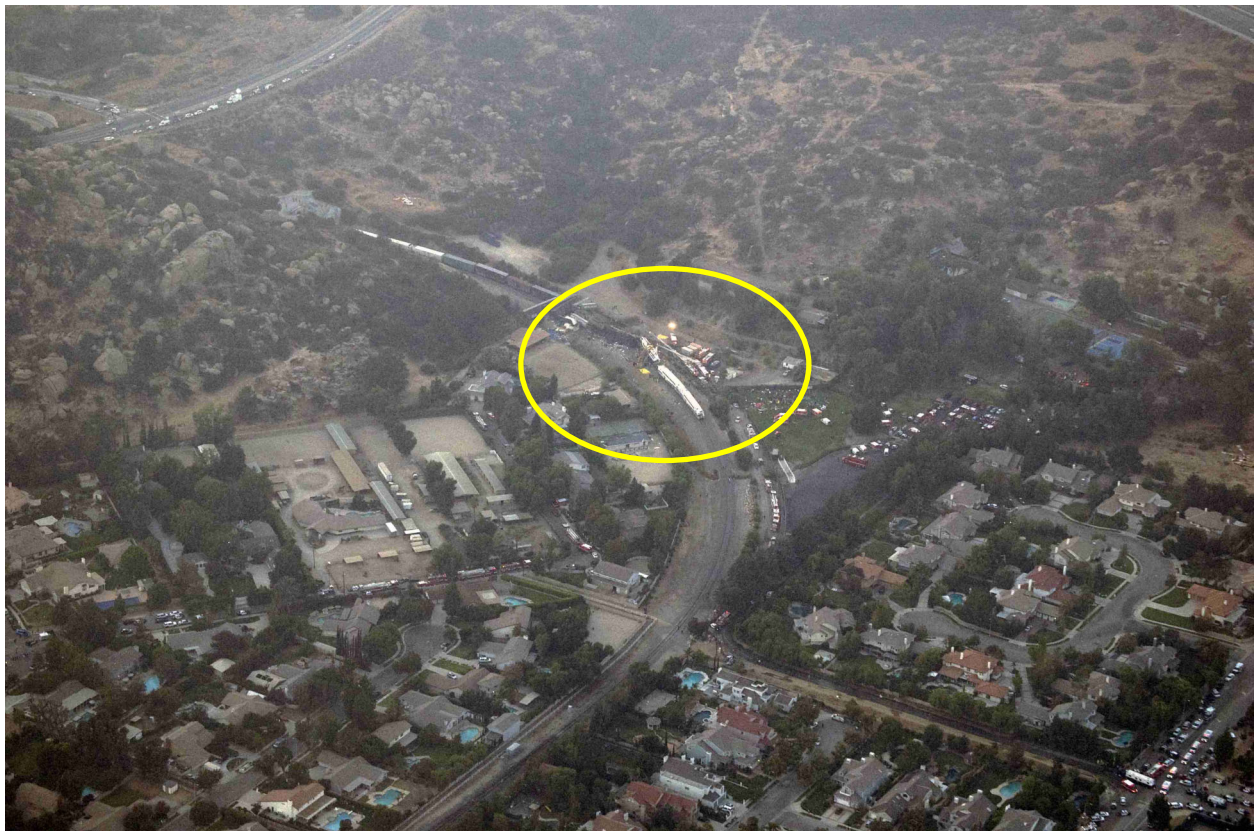
Photo 1. An aerial view of the accident area. The Metrolink train is circled. North is toward the top of the photo. (Courtesy: Metrolink)

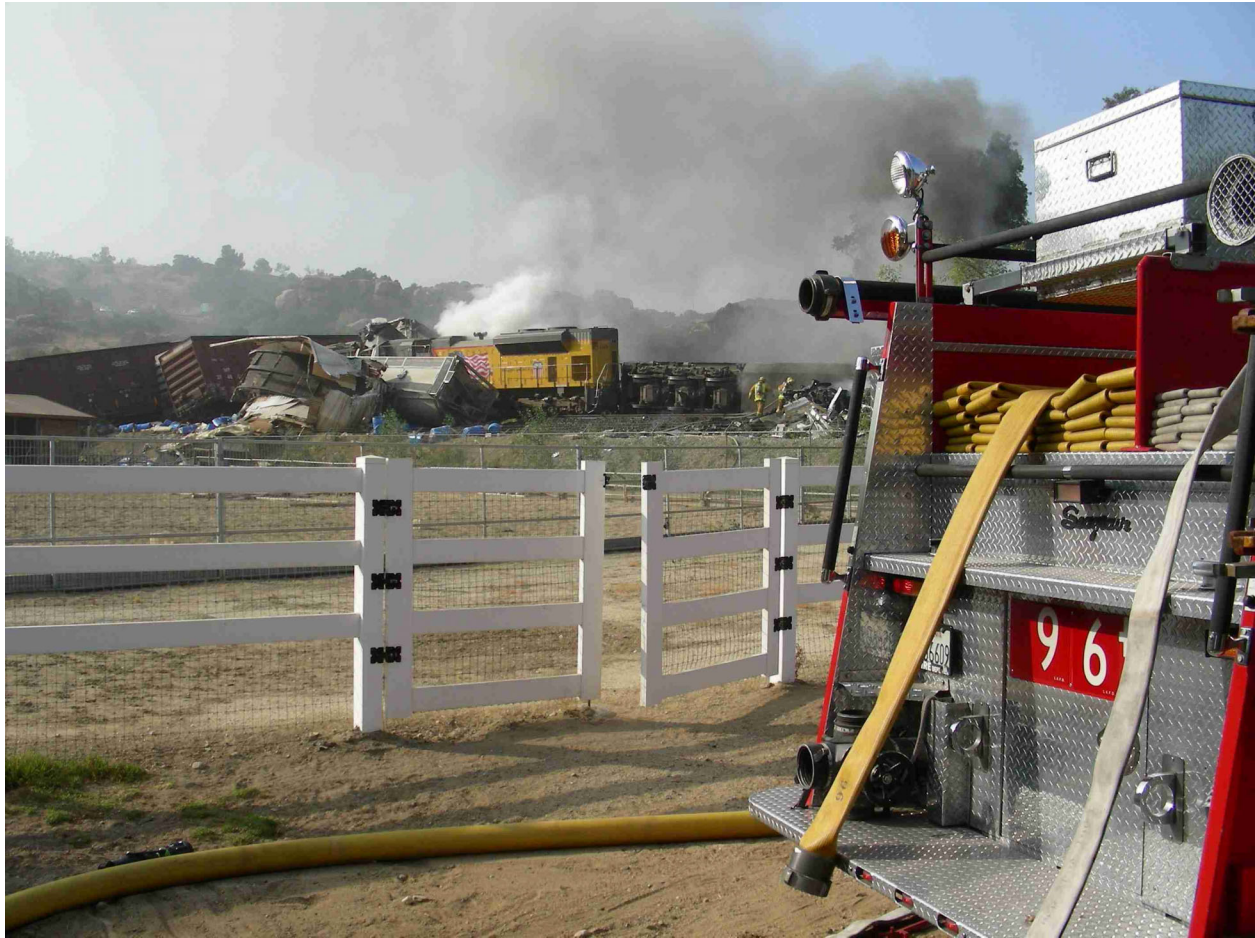
Photo 2. A view of the accident area from Heather Lee Lane. (Courtesy: LAFD)

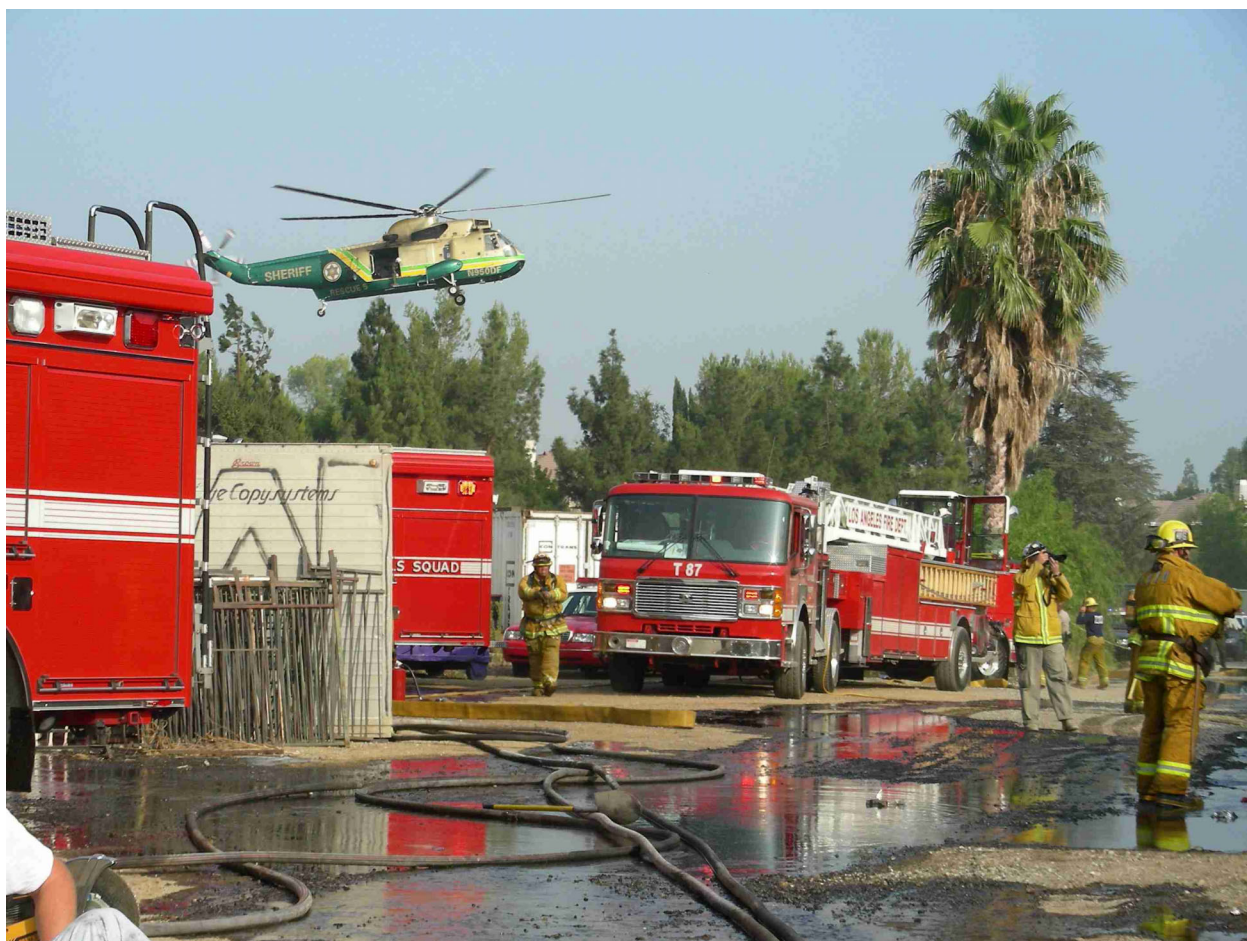
Photo 3. Companies responding next to the accident area. (Courtesy: LAFD)

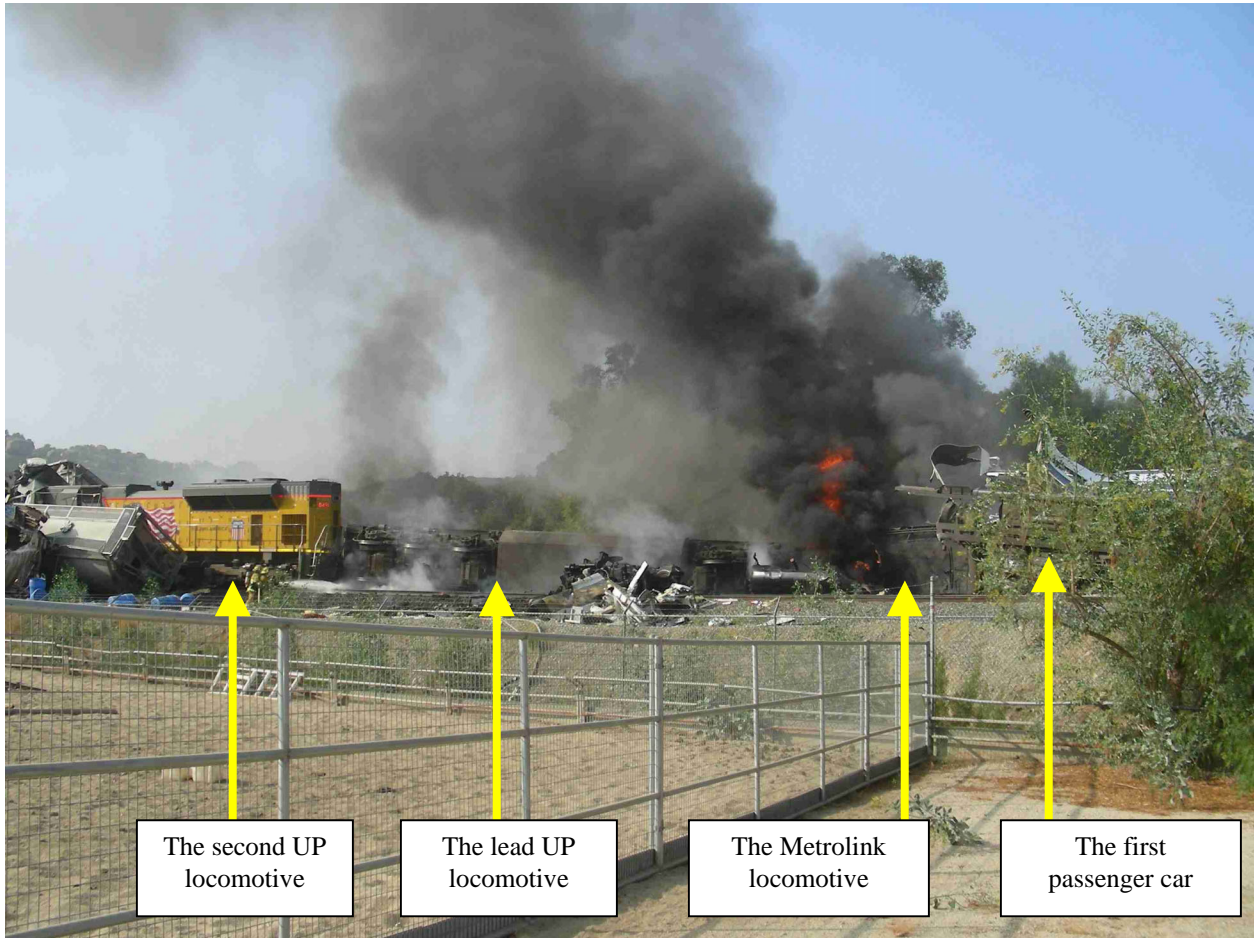
Photo 4. The locomotives, the first passenger car, and the post-accident fire. (Courtesy: LAFD)

I went back to the north side of the train where [it] connects with the locomotive normally, and there was some surface fire going down. Engine 107 was there with me and we decided to pull a line and attack it, and looked inside the train...and my light force was already inside...were inside with some of the patients.

He described the fuel spill as “probably about maybe an inch to an inch and a half saturation, and over time, the earth started absorbing it, and it started leaching into the earth.” Engine 107 has foam capability, and foam was used to blanket the area to prevent a second ignition.

The ranking captain of Task Force 96 said that they were able to knock down the fire and prevent it from extending into the first passenger car. He estimated that this occurred about 10 minutes after he arrived on scene. After the fire was extinguished, he said that he saw passengers exiting the first passenger car from the rear door.

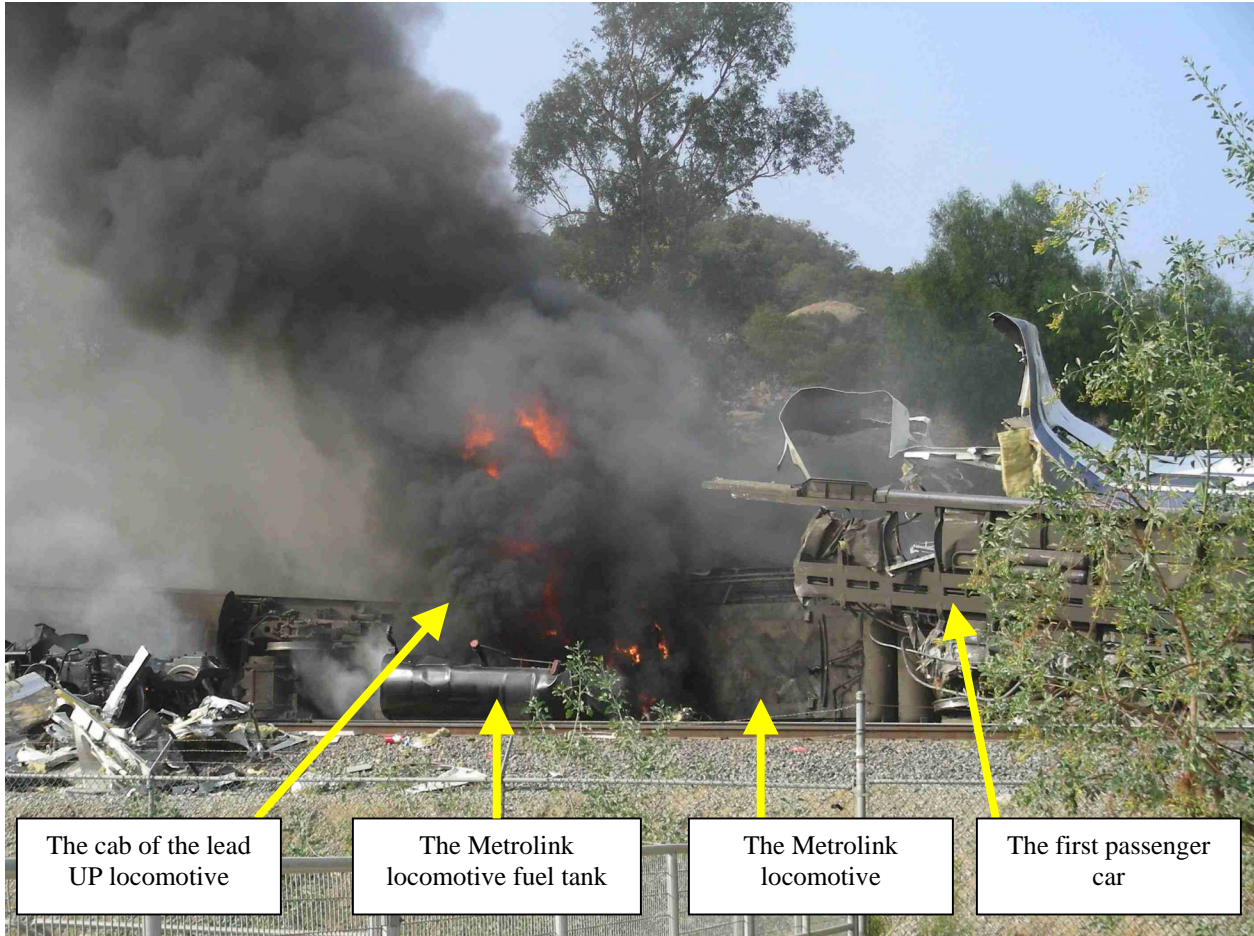
A captain and his company were assigned to the extrication group. The fire was being fed by fuel leaking from the fuel tank that separated from the Metrolink locomotive. The fuel tank came to rest next to the occupied cab of the lead Union Pacific locomotive. While fire suppression was continuing, firefighters thought they heard some pounding coming from the lead Union Pacific locomotive. When they looked inside through the cab windows, they saw that the crew was trapped inside of the cab. Firefighters tried to break the windshield and cut a front window. The window still could not be removed. As they continued working, they were able to remove the rubber strip from around the window. When they removed the window, they saw that the cab was filled with smoke.

Photo 5. A closer view of the lead Union Pacific locomotive, the Metrolink locomotive, and the first passenger car. (Courtesy: LAFD)

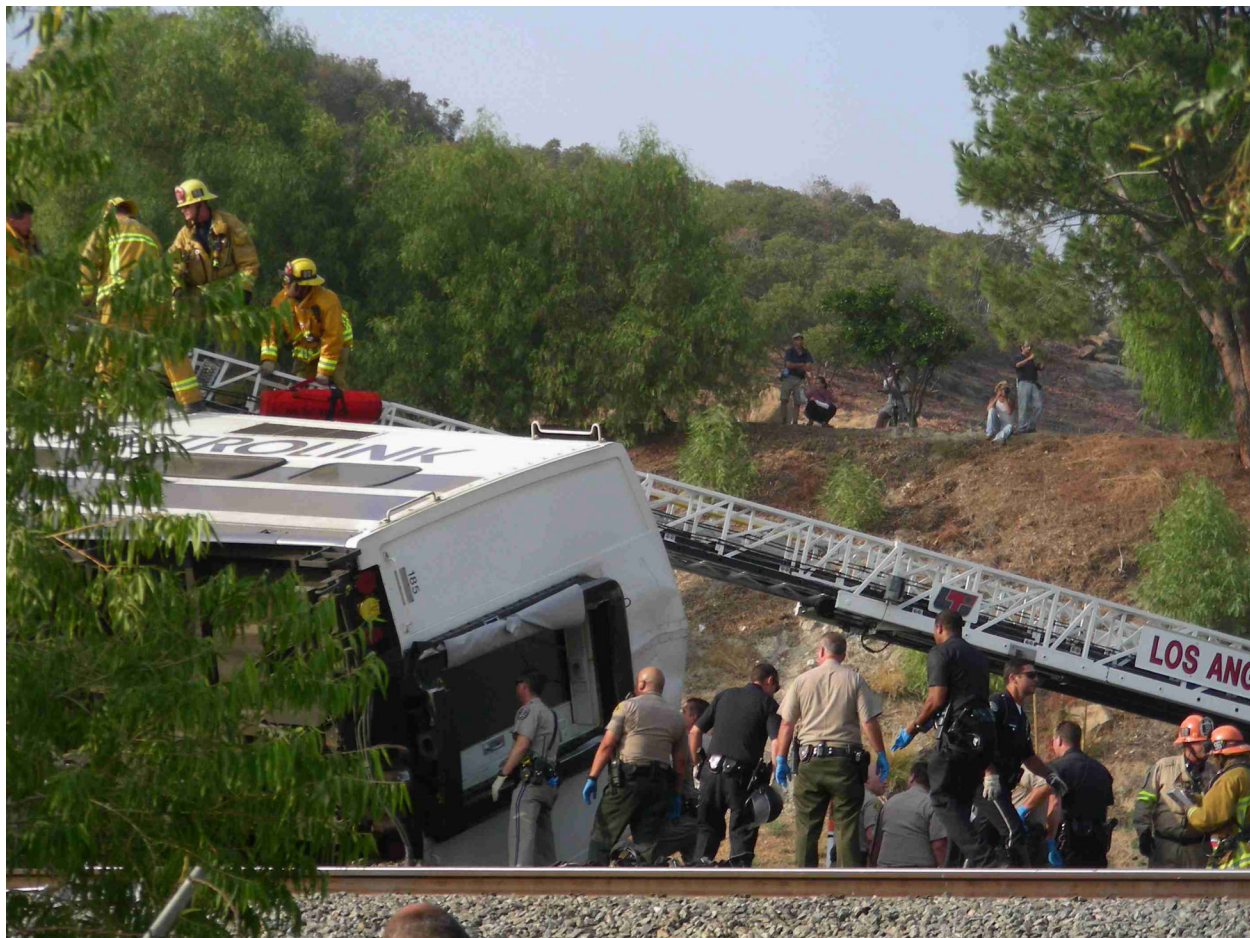
The sheriff's deputy (the deputy who arrived with the fire department) went to the rear door of the first car and found a passenger who was trying to exit the car. The deputy helped to pull the passenger from the car. The deputy later crawled into the rear door. Firefighters were also in the car trying to extricate passengers. At this time, additional deputies and officers from

Photo 6. Law enforcement officers and firefighters responding to the rear of the first passenger car. (Courtesy: LAFD)

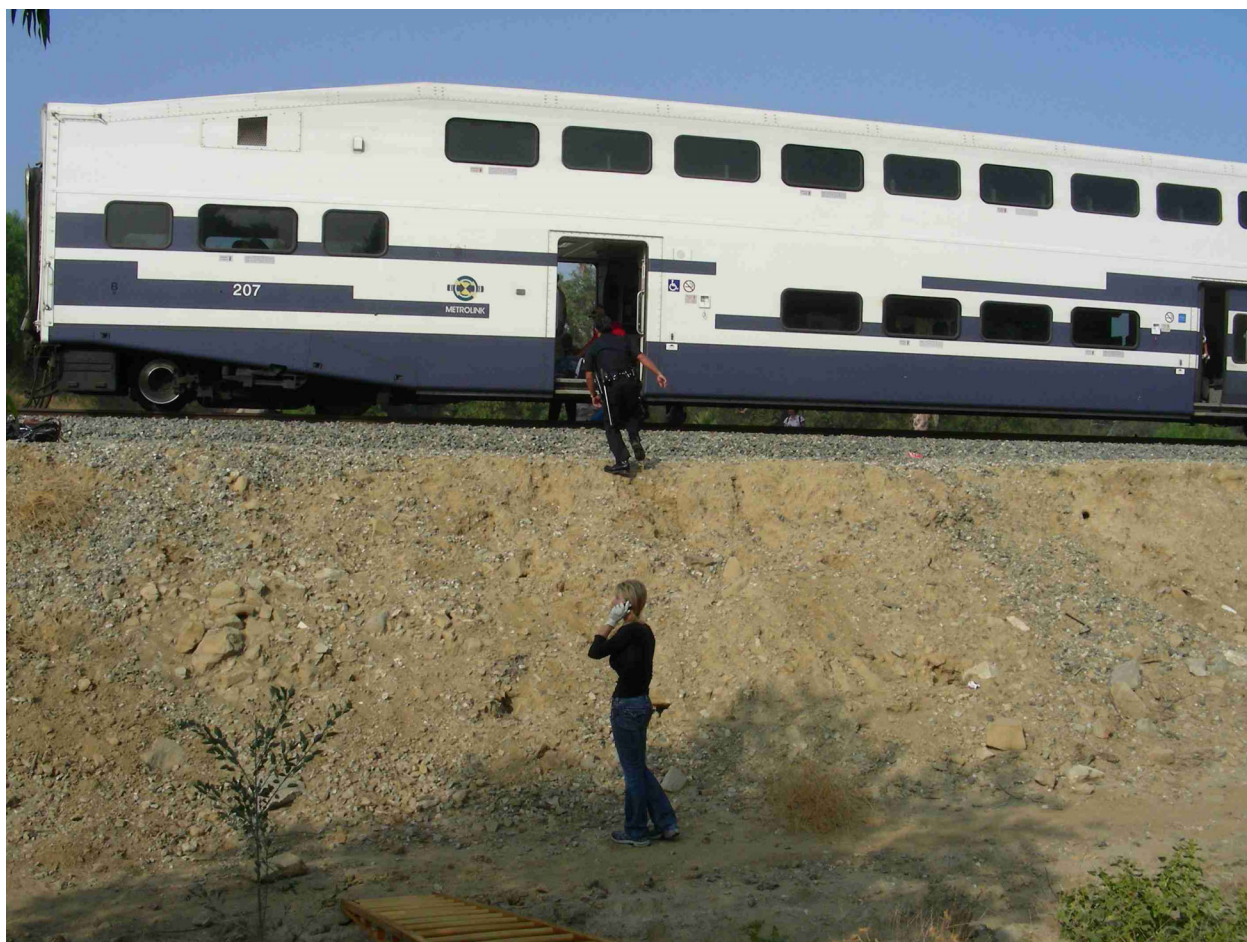
During this time, the police officer and deputy probation officer became part of teams that searched the second and third passenger cars. When the police officer entered the second passenger car, he saw that most passengers had exited the train. He recalled that about six people that were still in the car and could not move. Three were on the first level, and three were on the second level. Firefighters from the Los Angeles County Fire Department also arrived at these cars and began triaging the passengers. There were also about four or five people in the third passenger car that received assistance. The police officer recalled that there was at least one person on the second level, and the deputy probation officer recalled that there were two people on the first level. The police officer reported that he opened an emergency window on the upper level of the second car for ventilation. The deputy probation officer reported that there

Photo 7. A police officer responding to the third passenger car. (Courtesy: LAFD)

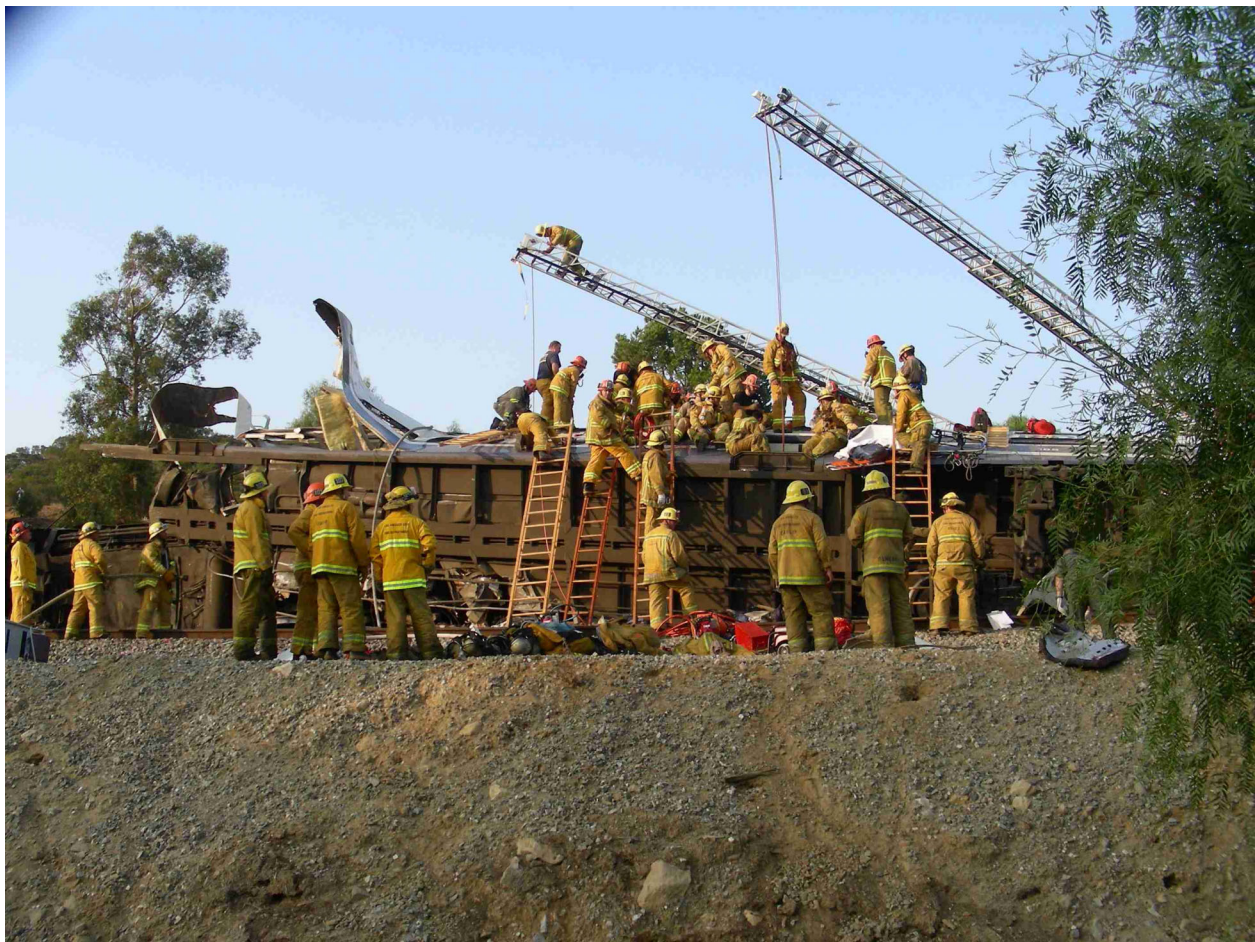
Photo 8 Firefighters during daytime operations at the first passenger car. (Courtesy: LAFD)

We ended up using saws to cut through some of the metal rather than the shears. We have shears that will cut through metal, but it -- some of it was so hard, it wouldn't cut it. And we had spreaders that push,

but it seemed like the metal in that train had such a high strength and a memory that we would stretch, push it out of the way, and as soon as we'd retract the spreader, it would come right back about halfway.

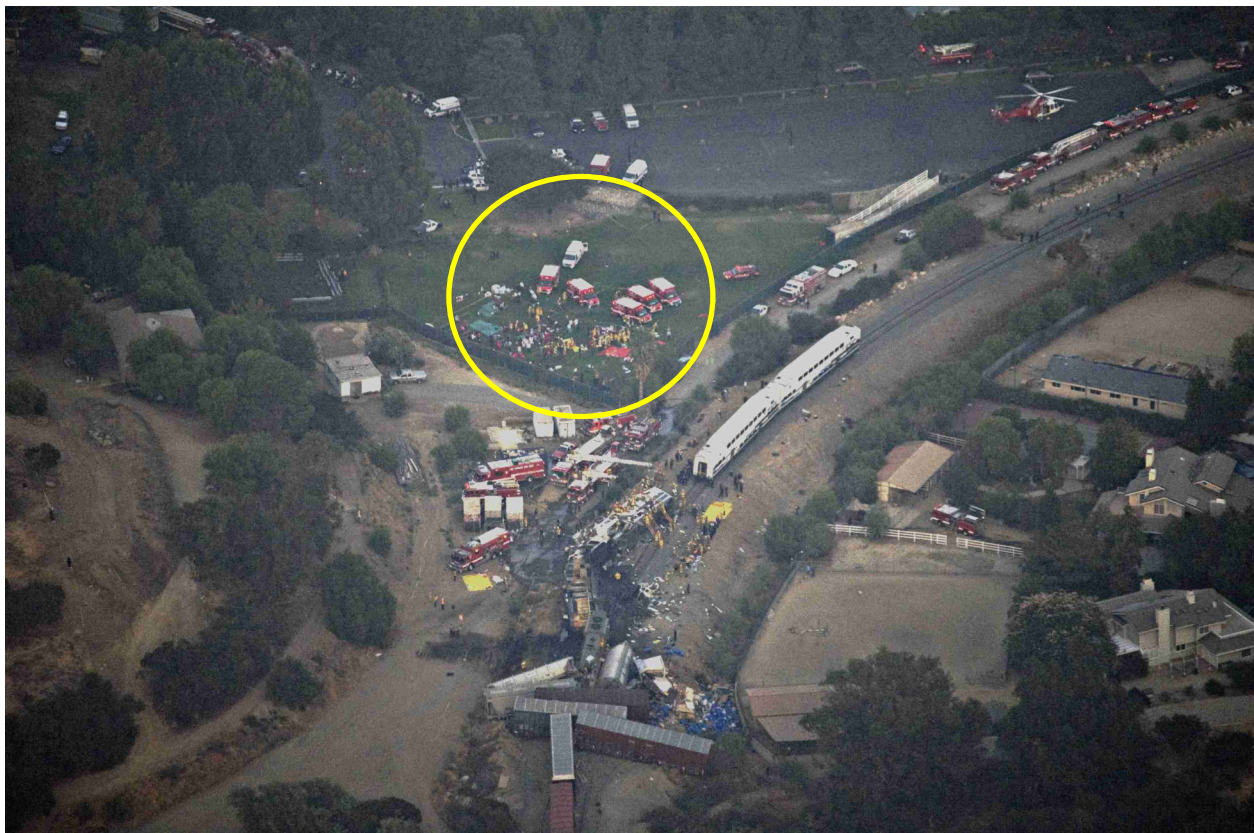
Photo 9. An aerial view of the accident area. The triage area is circled. (Courtesy: Metrolink)

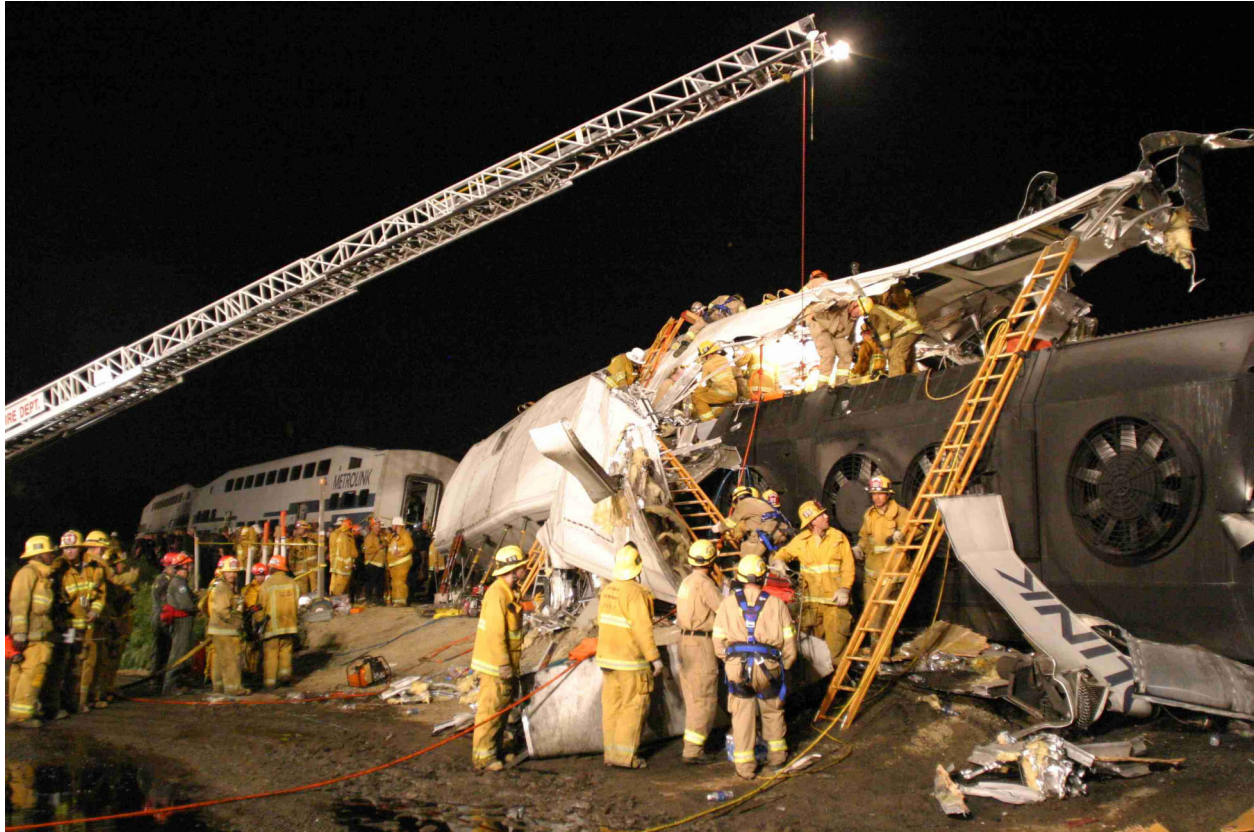
At about 2100 to 2200 hours, a 30- to 40-foot long piece of the carbody side (on the “top” of the car) was hanging over the side of the car. This piece needed to be removed from the car. The fire departments began to plan for safely removing this piece and addressing any structural hazards that could result during the removal. A Metrolink employee assisted with this effort and provided the fire department with information about safely removing this piece. This employee remained at the site to provide the fire department additional information about structure of the car.

Photo 10. Firefighters during nighttime operations at the first passenger car. (Courtesy: LAFD)

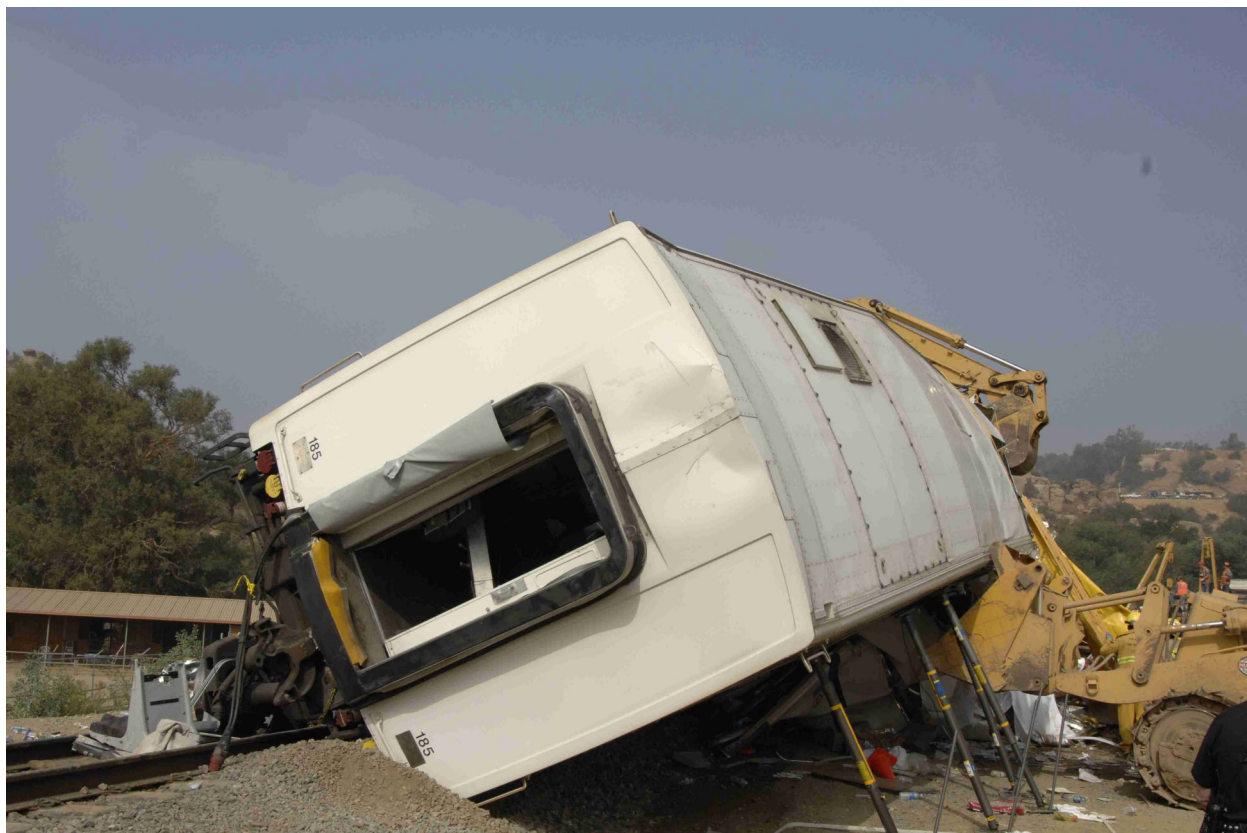
Photo 11. An exterior view of the first passenger car during operations on September 13. (Courtesy: FBI)

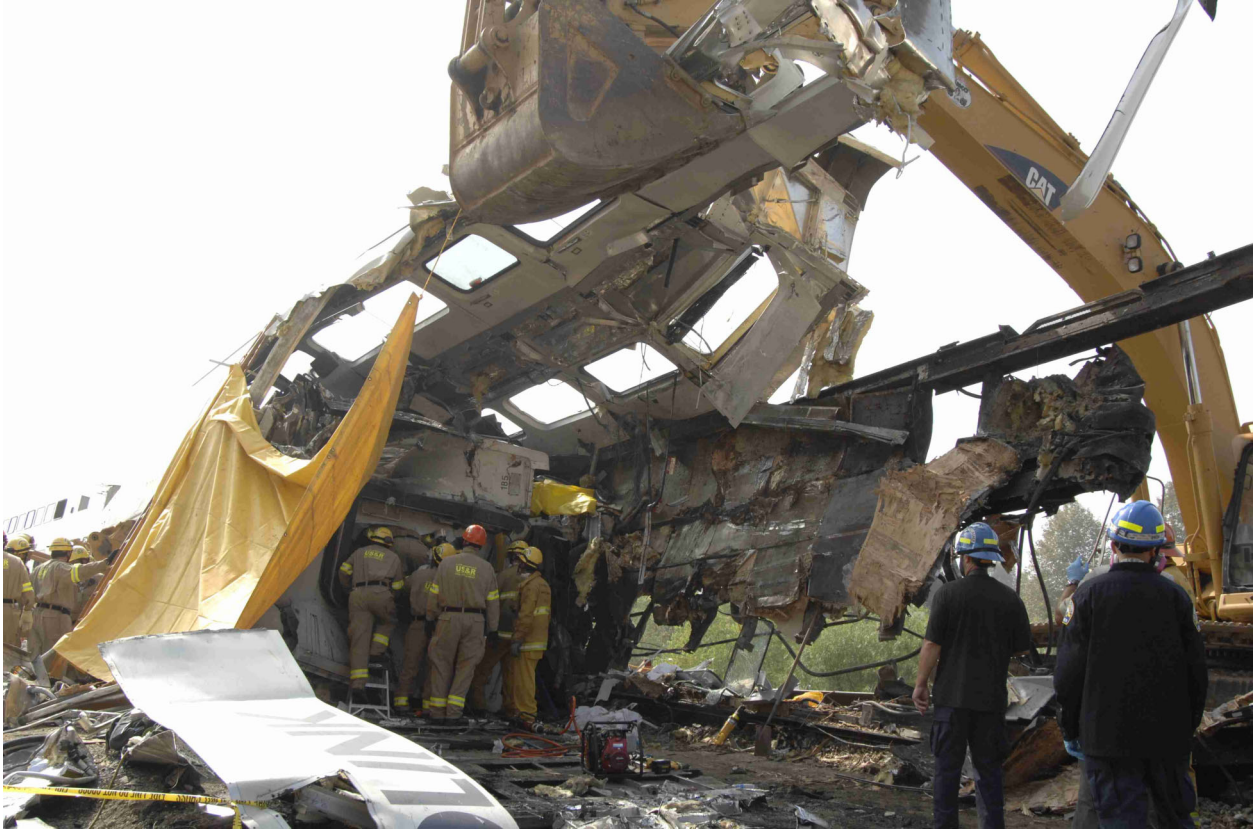
Photo 12. An interior view of the first passenger car on September 13. (Courtesy: FBI)
