**SURVIVAL FACTORS  
GROUP CHAIRMAN'S FACTUAL REPORT**

**Fatal Grade Crossing Accident  
Midland, TX; 11/15/2012**

**HWY-13-MH-003  
(19 Pages)**

**SURVIVAL FACTORS INVESTIGATION  
FACTUAL REPORT**

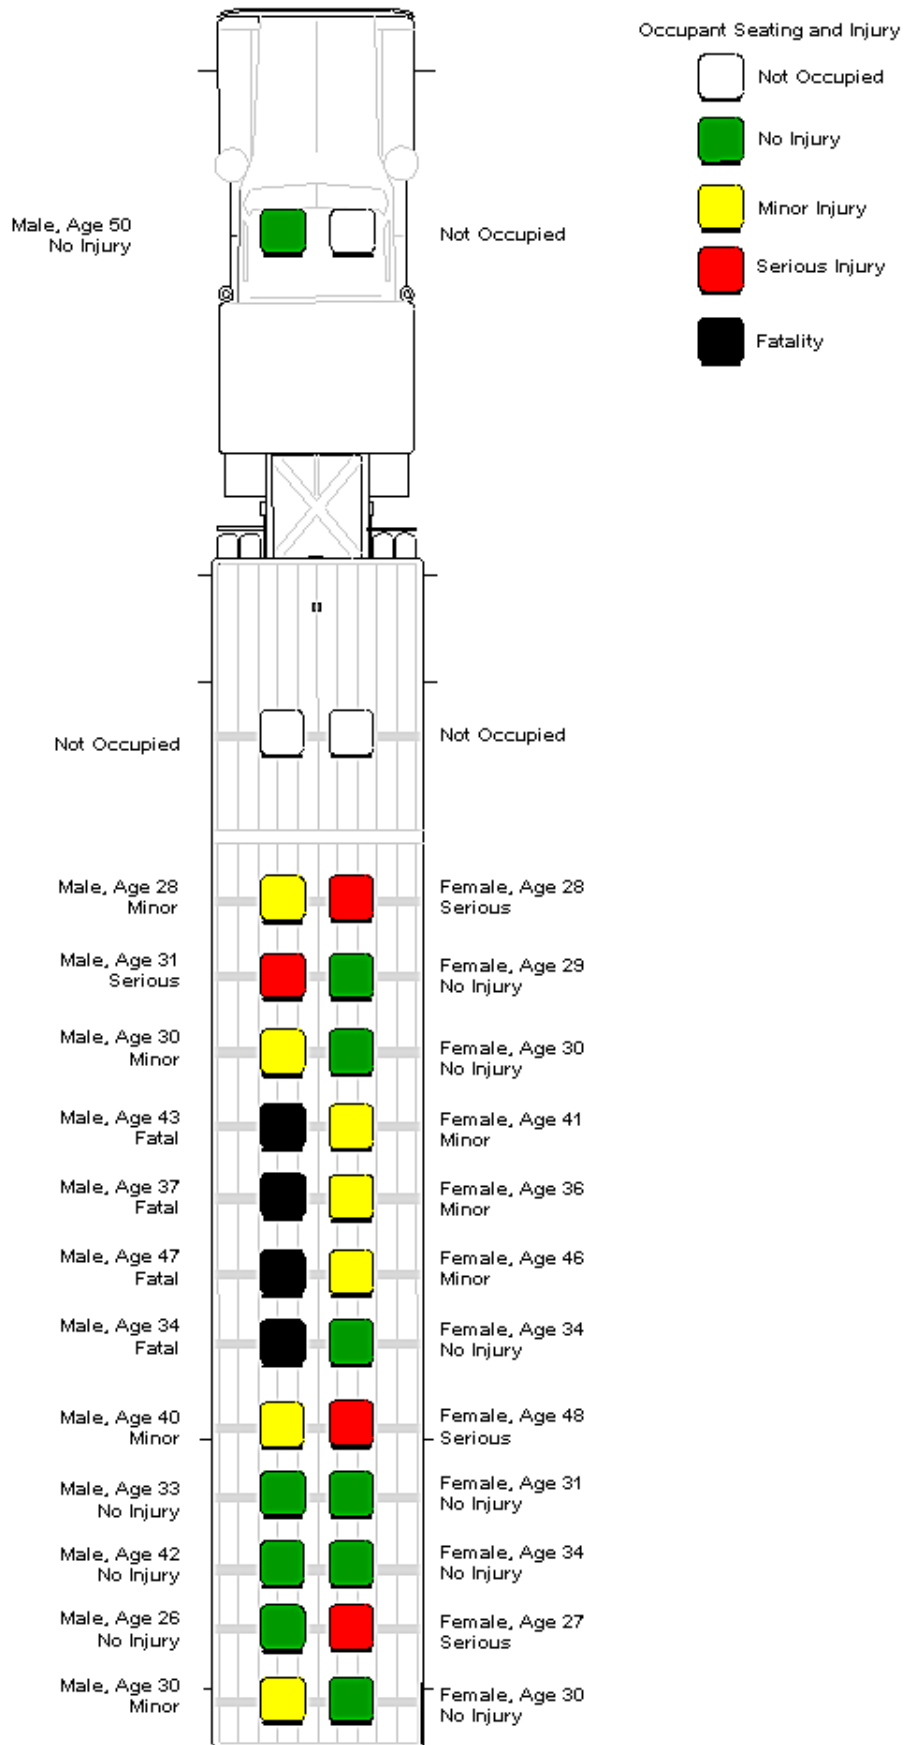
**Figure 1: Accident Truck (Parade Float) Seating Chart**

A total of 28 people were involved in the accident. The injury severity for the occupants of the various accident vehicles is provided in Table 2, and a seating chart depicting the gender, age, and injury severity of the accident truck occupants is provided in Figure 1. The injury levels are defined according to Title 49 CFR 830.2.<sup>4</sup> Detailed medical information is provided in Section C.
