National Transportation Safety Board
Office of Railroad, Pipeline and Hazardous Materials Investigations
Human Performance and Survival Factors Division
Washington, D.C. 20594

Survival Factors Group Chairman's Factual Report

December 8, 2015

Railroad: National Railroad Passenger Corporation (Amtrak)
Train: Train 188
Location: Philadelphia, Pennsylvania
Date: May 12, 2015
Time: 9:21 pm EDT¹
Number: DCA15MR010

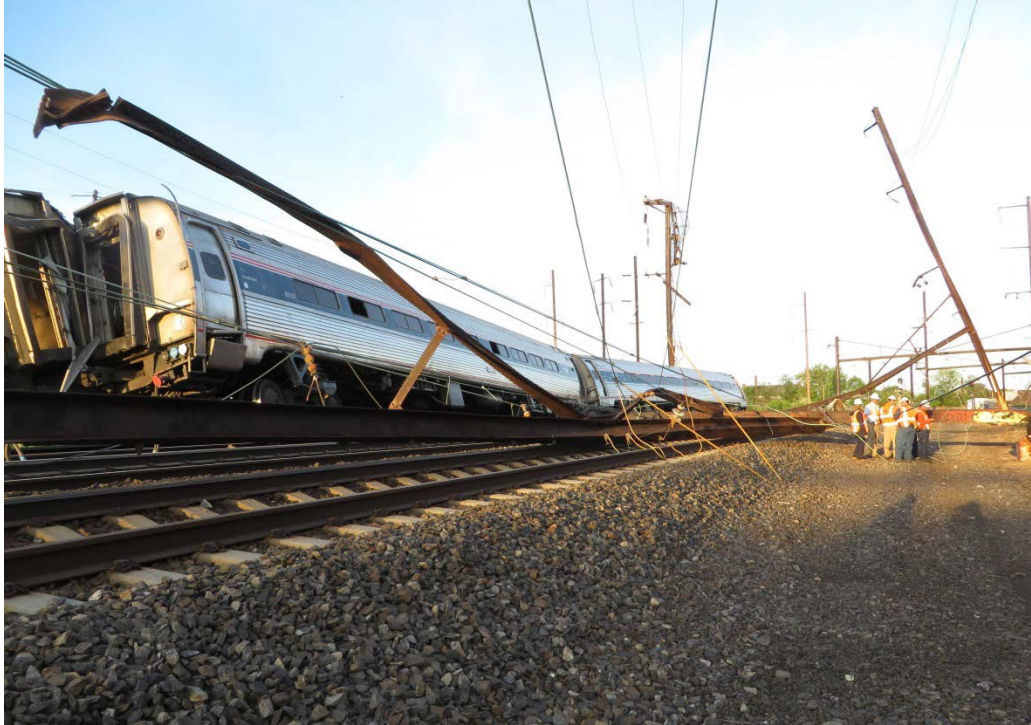
Figure 3. A view of the accident site showing the damage to the catenary system.

For the first catenary structure, N-121, the west side pole and horizontal cross member were bent down toward the tracks.³ The horizontal cross member came to rest on and across the tracks near the seventh passenger car. The east side of the structure had two vertical poles. The outer pole was upright, but leaning, toward the tracks. The inner pole was separated from its foundation. A catenary pole was found near the sixth and seventh passenger cars. Near the east side pole foundations, there were several broken catenary wire insulators scattered along the ballast. For the second catenary structure, N-122, the west side pole was broken near its concrete foundation, and it came to rest on and across the tracks near the sixth coach. The cross member came to rest on the tracks, generally in line with the direction of the tracks. The east side pole was rotated 90 degrees counterclockwise (in the north direction) at its foundation and was embedded into the ballast parallel to the sixth passenger car. Near this pole, there were red pantograph components on the ground. On the pole, there were sections of material that looked like plymetal and carpet.

For the third catenary structure, N-123, the entire structure remained upright. The base of the east side pole was rotated counterclockwise (the north direction). A section of undercar piping and an undercar equipment box was found near the base of this pole. For structure 4, the west side pole was fractured at its base. This pole was twisted and embedded into the top and sides of the second passenger car. The east side pole and cross member were bent down toward the track.

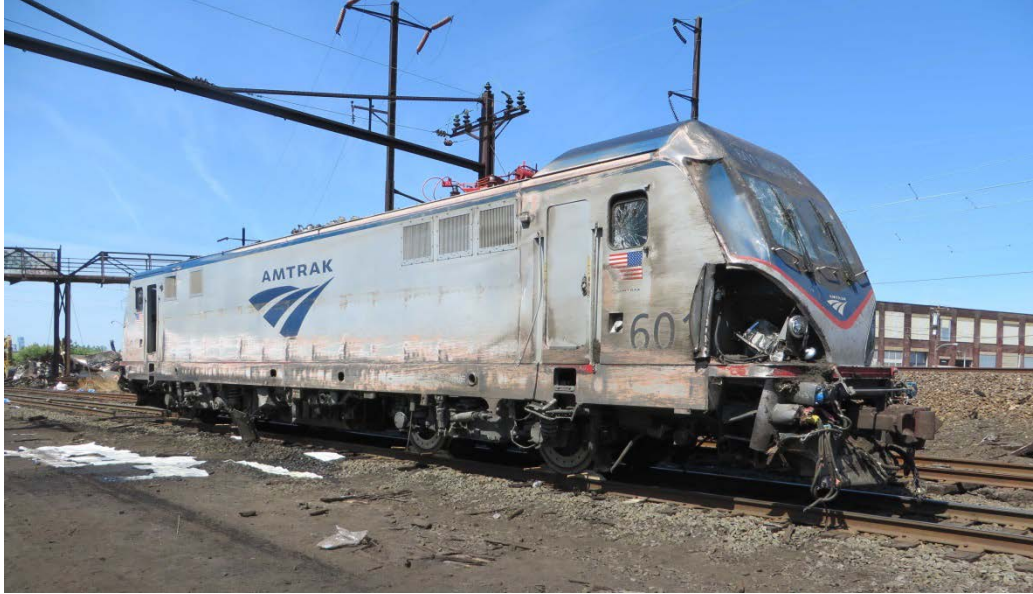
Figure 5. The front and right side of locomotive 601.

On the front of the locomotive, there were two round cracks in the left side glazing panel. The right side glazing panel was cracked and in place. On the front right corner, the body panel housing the light and marker was not present, and the light and marker were damaged. Above this area, the body panel next to the right glazing panel was crushed inward.

On the right side of the locomotive, the side window was cracked and in place. Near the front right side door, the sill steps at the door were bent upward and rearward. The two vertical hand holds were in place, but the lower half of the rear hand hold was bent and separated from the unit. There was horizontal scraping along the locomotive body sheathing. Forward of the cab door, this scraping extended along the full height of the unit. Behind the side door, there was horizontal scraping on the lower half of the body sheathing and on about two-thirds of the length of the roofline. At the rear of the right side, both steps were bent upward and rearward.

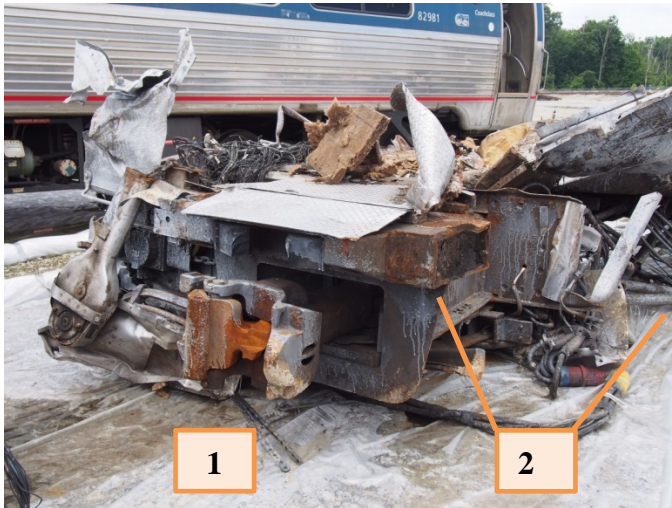
Figure 7. Section 1, looking rearward.

1. Undamaged coupler

2. Missing front left corner structure:
collision post, corner post, and entry
steps

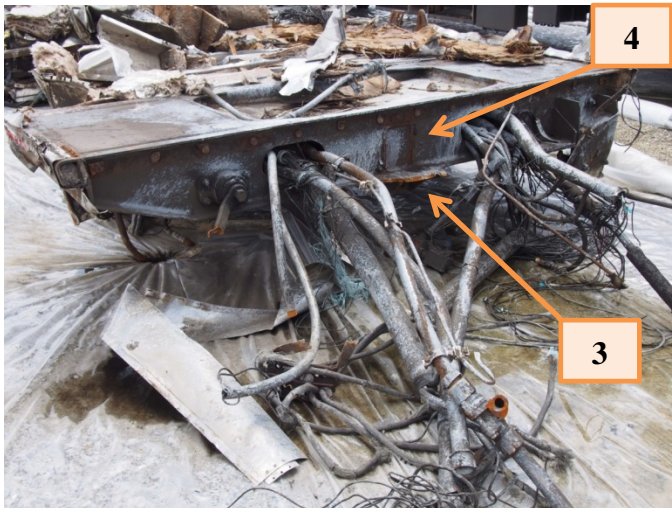
Figure 8. Section 1, looking forward.

3. Fractured body bolster plate

4. Fractured center sill bolster weld

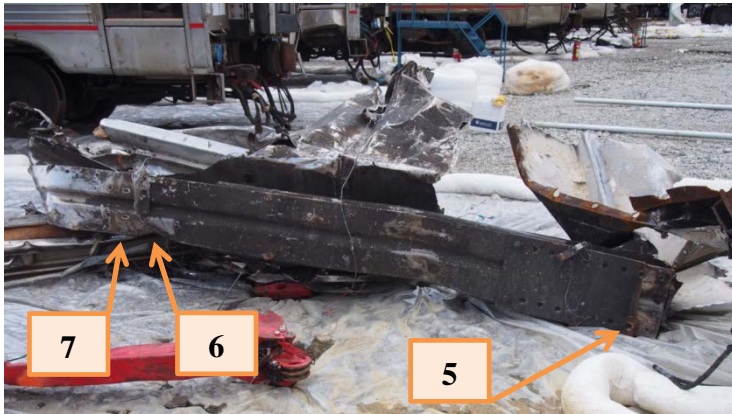
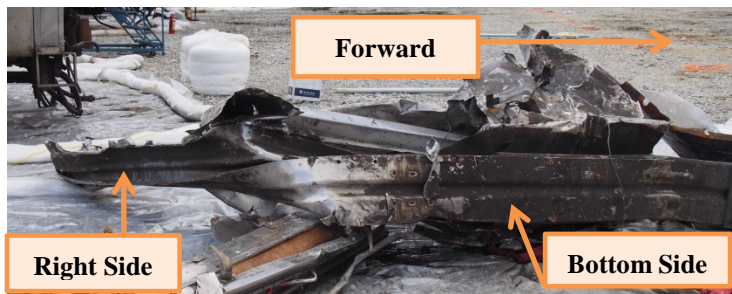
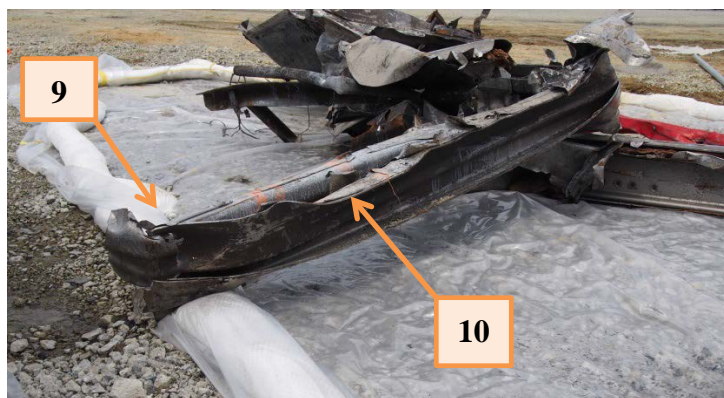
Figure 9. Section 2, the bottom of the center sill.

Figure 10. Section 2, the forward section of the center sill.

Figure 11. Section 2, the top and right side of the center sill.

5. Mating piece of the fractured body bolster plate

6. Strike mark and dent on the bottom of the center sill

7. Cross bearer separated from the center sill

8. Center sill: twisted to the right about 45 degrees and bent vertically about 80 degrees

9. Center sill: bent to the left about 45 degrees

10. Widening of the center sill

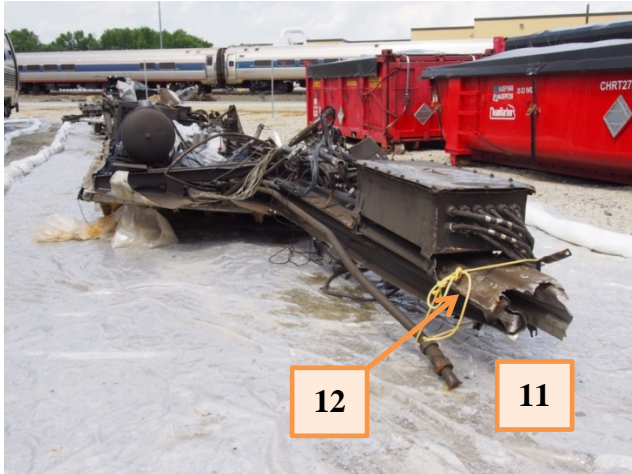
- 11. Center sill fracture
- 12. Cross bearer separated from the center sill

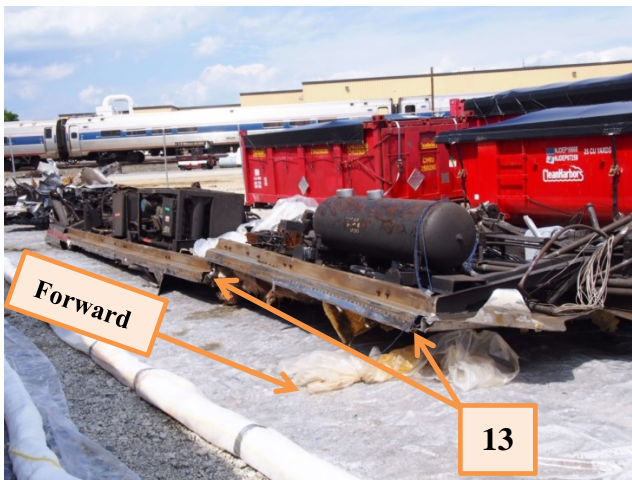
- 13. Fractures of the left side sill forward of the cross bearers

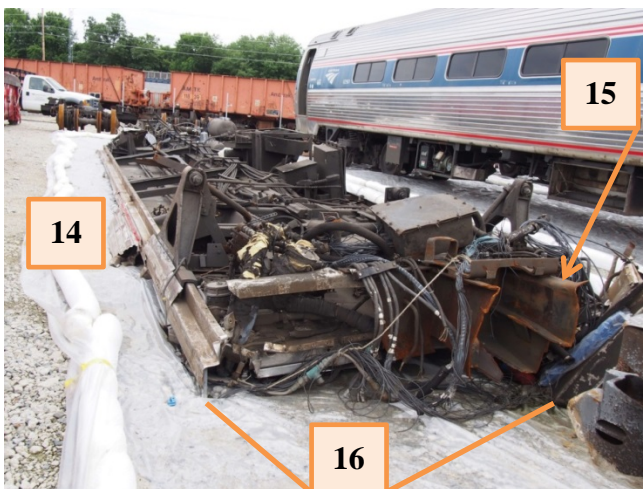
- 14. Right side sill intact
- 15. Draft pocket and coupler carrier fractured
- 16. Carbody end structure missing: end frame, coupler, and entry steps

Figure 14. Section 3, the right side of the underframe.

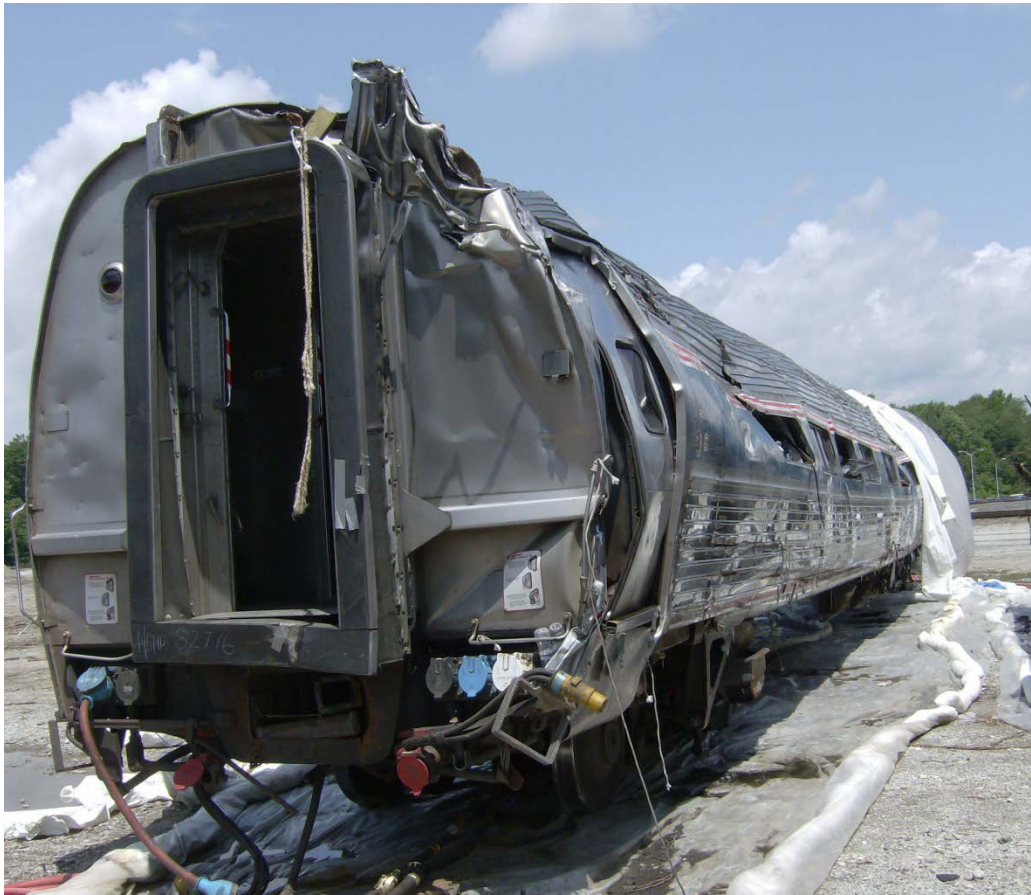
Figure 15. The right side of the second passenger car as viewed from the rear of the car.

At the front of the car, the front right corner of the car was crushed rearward into the vestibule door. The vestibule door window was not in place. The roof and top third of the carbody side was crushed downward. On the right side of the car, the middle third of the length of the car bulged outward, and the bottom third of the car was scraped along the side sill. There was some vertical scraping on the blue decal near the R1 and R9 window and side doors, but minimal horizontal scraping on the decal.⁴ The rear top corner of the car was crushed downward.

On the right side of the car, the R1 and R2 windows were not in place. The R3 and R4 windows were separated from the opening and dislodged inward into the car. The R5 and R6

windows were slightly dislodged inward, and their zip strips were not in place. The R7 window separated from the opening and dislodged inward into the car, and the frame of the window was warped. The R8 window was slightly dislodged inward, and its zip strip not in place. The R9 window was not in place.

On the left side of the car, above the L2 window, there was a breach in the carbody that extended over and across the roof extending to the right side of the car near the R3 and R4 windows. The L1 and L2 windows were not in place. The L3 through L5 windows were in place. The L6 window was not in place. The L7 through L9 window frames and gaskets were in place, but the glazing panels were not in place.

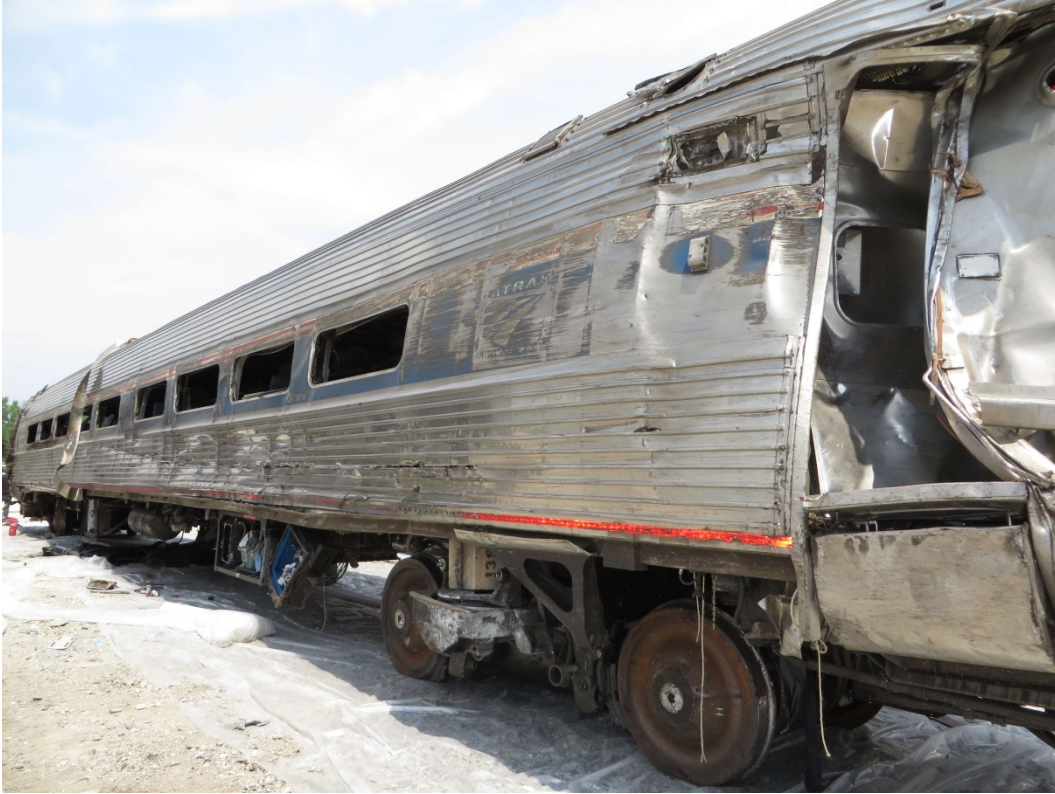
Figure 16. The right side of the third passenger car as viewed from the front of the car.

At the front of the car, right corner was crushed rearward, inward, and upward. On the right side of the car, the front vestibule door was crushed rearward and inward into the vestibule. The vestibule door was not in place. There was horizontal scraping on the blue decal along the length of the car. None of the windows were in place on the right side of the car. There was a tear and indentation on the lower side sheet that began ahead of the R1 window and extended rearward toward the R5 window. There was a tear between the side sheet and side sill that extended between the R2 and R4 windows. Between the R2 and R4 windows, the side sheet was deformed inward, and the side sheet corrugations were flattened. The rear vestibule door was pushed inward, and there was dirt, debris, and tree branches in the vestibule. The vestibule door window was in place.

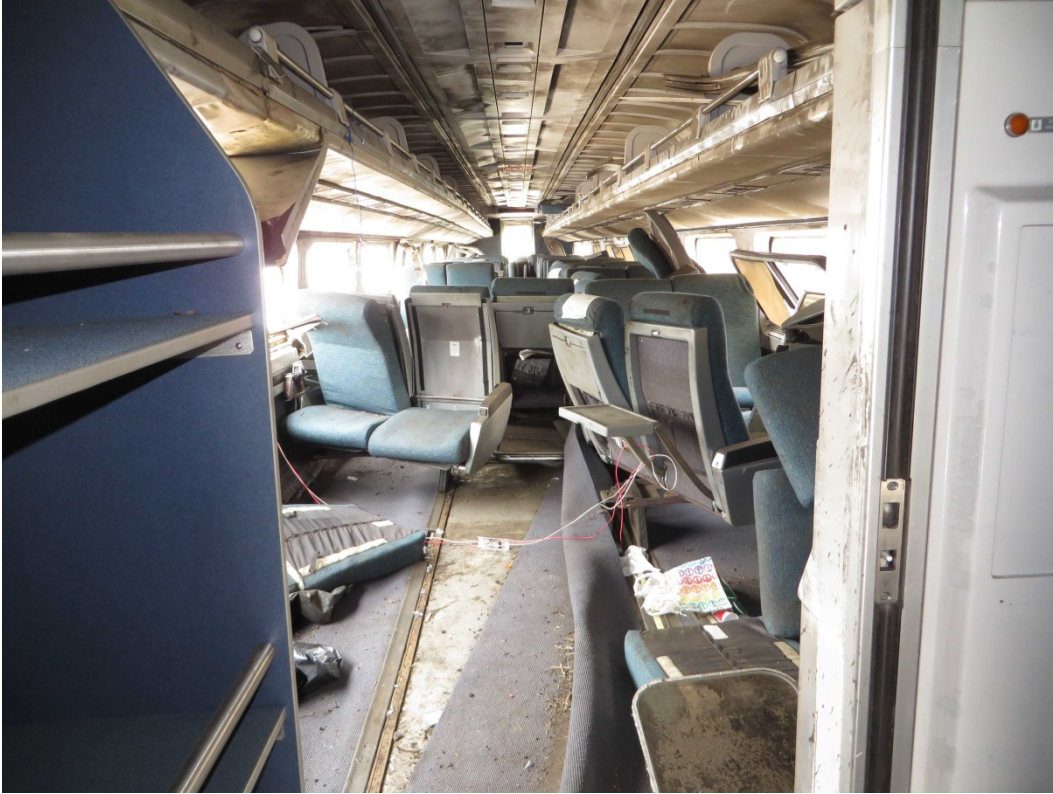
Figure 17. The interior of the third passenger car as viewed from the front of the car.

In the passenger compartment, dirt covered all interior surfaces of the car increasing in amount toward the rear of the car. Seat cushions window components were found in the baggage racks.

On the right side of the car, the seats in rows 2, 4, 5, 6, and 13 were fully separated from the car. Two windows were on the floor in the aisle near seat row 3. Wall panels around the windows were torn and separated from the walls. Ten seat pairs on the left side of the car and ten on the right were shifted out of their locked position. At the rear of the passenger area, dirt, debris, a zip strip section, and a glazing panel were packed in the left side baggage rack. Three windows were found in this area of the baggage rack.

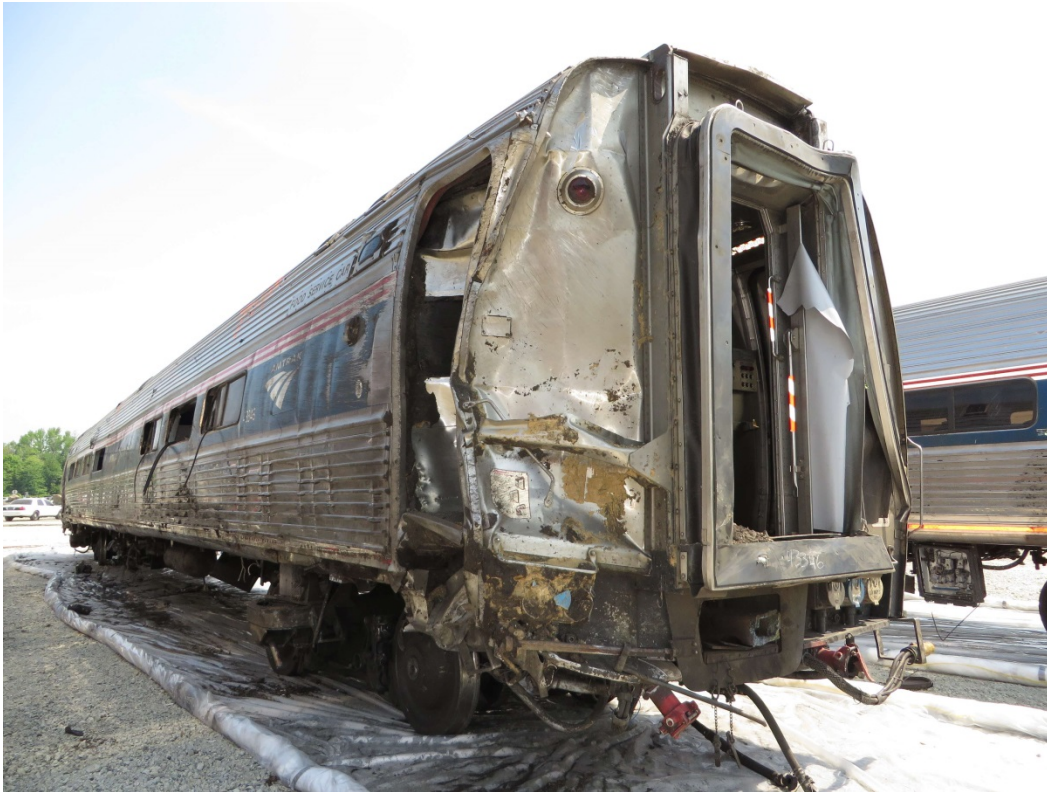
Figure 18. The right side of the fourth passenger car as viewed from the front of the car.

At the front of the car, the right corner was crushed rearward, inward, and upward. On the right side of the car, the front vestibule door was crushed rearward and inward into the vestibule. There was horizontal scraping on the blue decal; the heaviest scraping was between the front of the car and the first window. Between the side sill and top of the windows, the side sheet corrugations were flattened and scraped the length of the car. At the rear of the windows, the R1 and R3 windows were dislodged inward. The zip strips were partially pulled. The R2 window was not in place. The R4 and R7 windows were not in place. The R5 and R6 windows were

partially dislodged inward, and their zip strips were not in place. There was dirt on the windows and embedded in the window gaskets. The rear, right corner of the car and entry steps were deformed rearward.

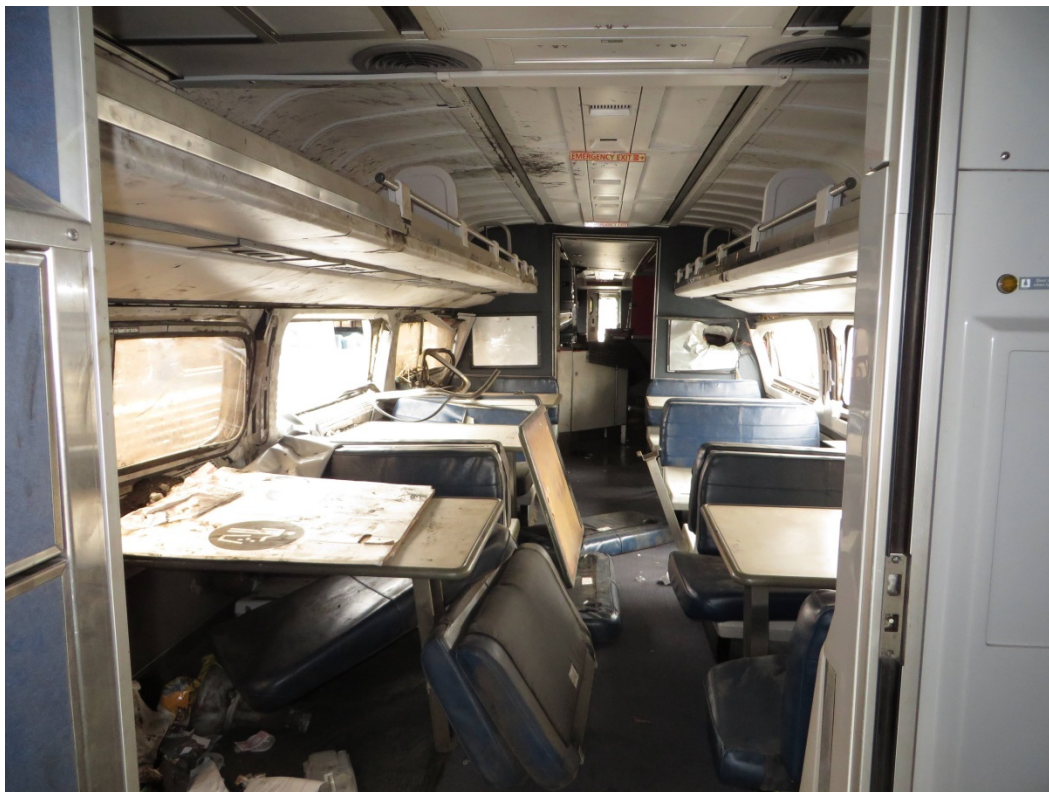
Figure 19. The interior of the fourth passenger car as viewed from the front of the car.

In the front of the car, there was a dirt film on the floors, tables, and the right side wall and ceiling. The emergency tools were out of the storage cabinet. Seat cushions were dislodged from the seats. On the left side of the car, second table on the left side was separated from the wall and its support. The wall panel around the window at the third table was torn. There was a large hole in the bulkhead behind the third table. On the right side, pieces of insulators, sections

from window frames, and sections of window gaskets and glazing were found at the third table and seats. One section of glazing was broken. The wall panel at around the window at this table was torn.

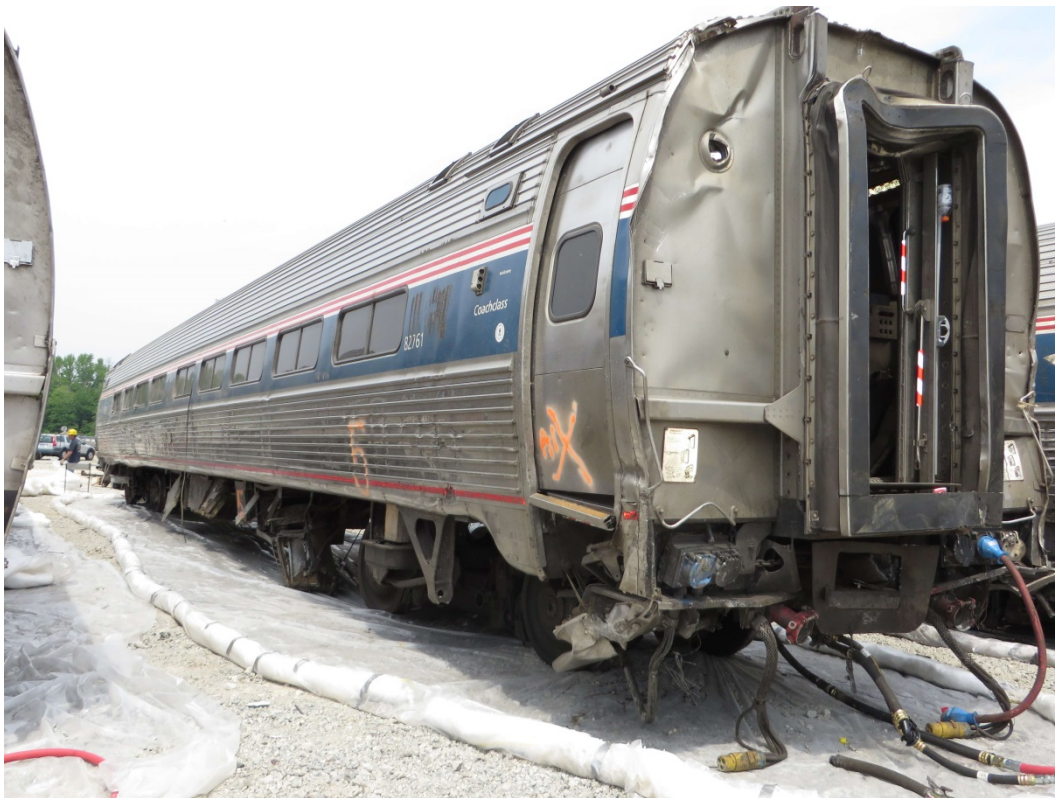
Figure 20. The right side of the fifth passenger car as viewed from the front of the car.

On the right side of the car, the lower front corner of the car was slightly deformed upward and rearward. Below the windows, there were sections of the side sheet and corrugations that were flattened and scraping on the side sill. The R1 through R4 windows were intact and in place. On the R5 window, the zip strip was partially pulled. Beginning near the R5 window, there were horizontal scrape marks that extended to the rear of the car on the blue decal. The R6 window was intact and in place. On the R7 window, the zip strip was partially pulled. For the R8 and R9 windows, the zip strips were partially pulled, and the rear, top corners of the windows were pushed inward. The rear right corner was deformed forward into the vestibule door.

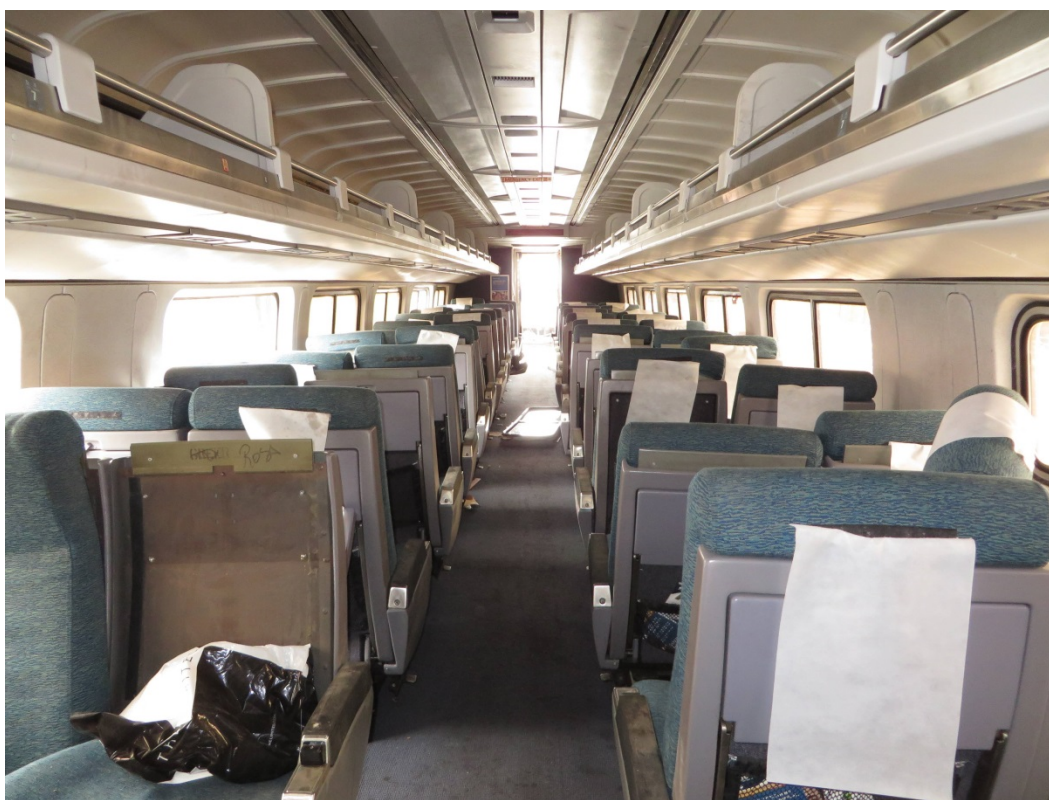
Figure 21. The interior of the fifth passenger car as viewed from the rear of the car.

In the front vestibule, the right side door was wedged closed, and there was a gap between the door and the steps. The left side door was wedged open a few inches, and there was dirt and debris pile on the floor near the left side door. On the left side of the car, the aisle armrest of the row 4 seat pair was broken. A window was on the floor in the aisle in the center of the car. Two small (few inch) blood smears on the aisle face of the baggage rack. The emergency equipment was in cabinet. The right rear vestibule door was wedged partially open, and the left vestibule door was open.

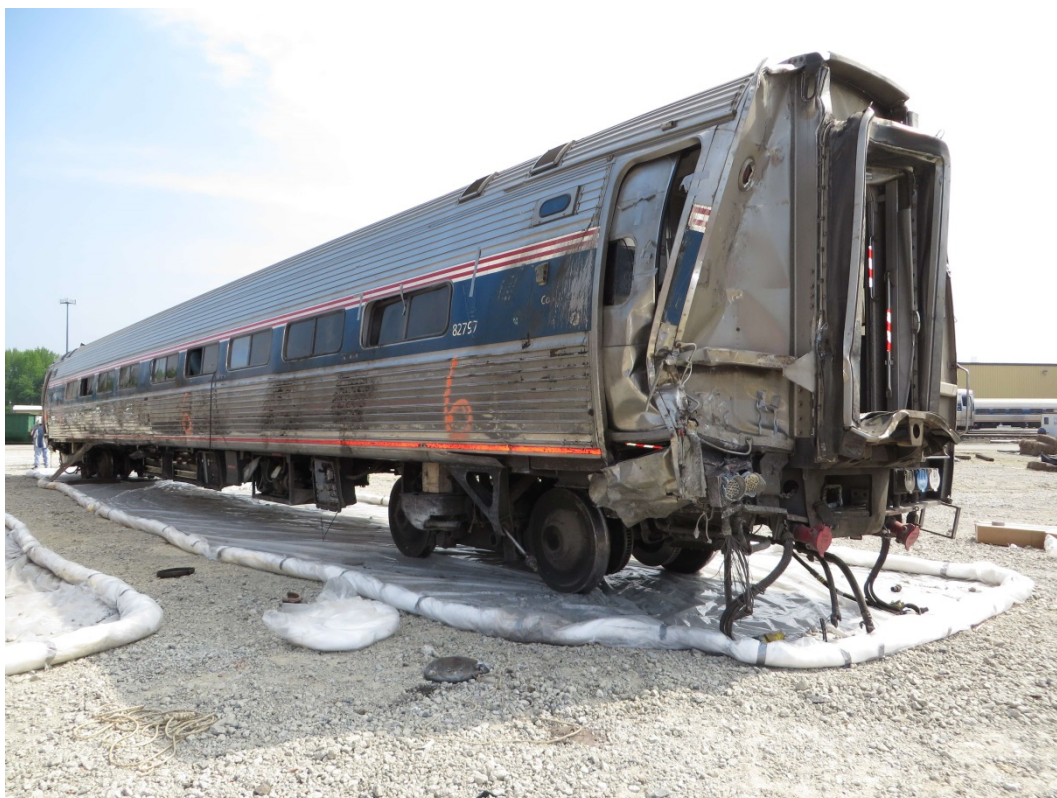
Figure 22. The right side of the sixth passenger car as viewed from the front of the car.

On the right side, the front corner of the car was crushed upward and rearward into the side passenger door. There was vertical scraping between the front side door and the R1 window. There was horizontal scraping along the side sill, and inward bending of the side sheeting beginning near the R4 window and continuing to the rear of the car. Portions of the sheet corrugations were flattened, and there was dirt on some areas of the corrugations. The rear of the R1 window was dislodged inward. The R2 and R3 windows were intact and in place. For the R4

window, the exterior zip strip was partially pulled from the gasket, and the interior emergency window was not in place. For the R5 window, the zip strip was partially pulled from the rear corner of the window. For the R8 and R9 windows, the zip strips were fully pulled from the window, and the windows were partially dislodged inward. For the R8 window, the interior emergency window was not in place. There were sections of horizontal scraping on the blue decal between the R5 window and rear side door. The rear right corner of the car and the vestibule steps were bent and deformed rearward. On the left side of the car, the two interior emergency windows were not in place.

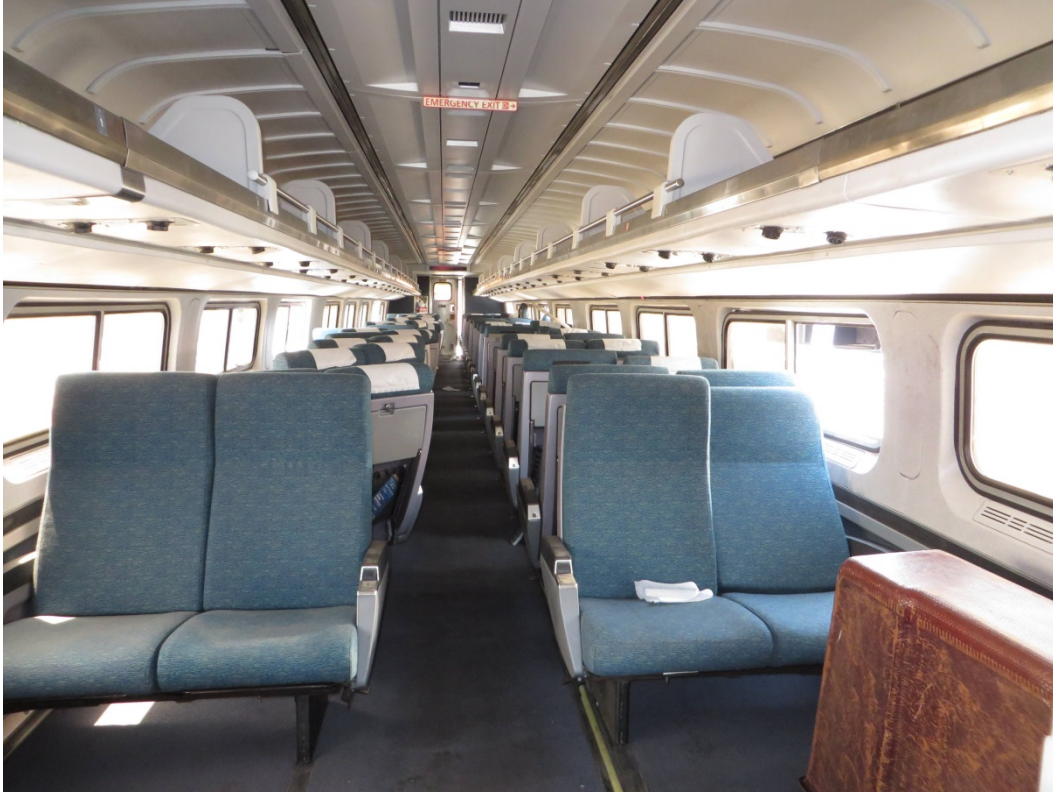
Figure 23. The interior of the sixth passenger car as viewed from the rear of the car.

Inside of the car, the front center vestibule door was jammed closed, and there were streaks of blood on the door. The door release panel was broken. There were some smears of blood on the tray table in front of the right aisle seat in row three, the left aisle seat in row three, and the right aisle seat in row seven. There were smears of blood on both aisle armrests for seating row 19. The armrests for the left side seats in rows 16 and 19 were broken. On the left side of the car, seat pairs in rows 3, 4, 5, 6, 7, and 9-17 were shifted out of their locked position. The pry bar, maul, and first aid kit were in the emergency tool cabinet. About four of the 10 glow sticks were not in their box. In the rear vestibule, the right side door was wedged partially open. There was a pile of ballast on the floor near the door. The left side door was open.

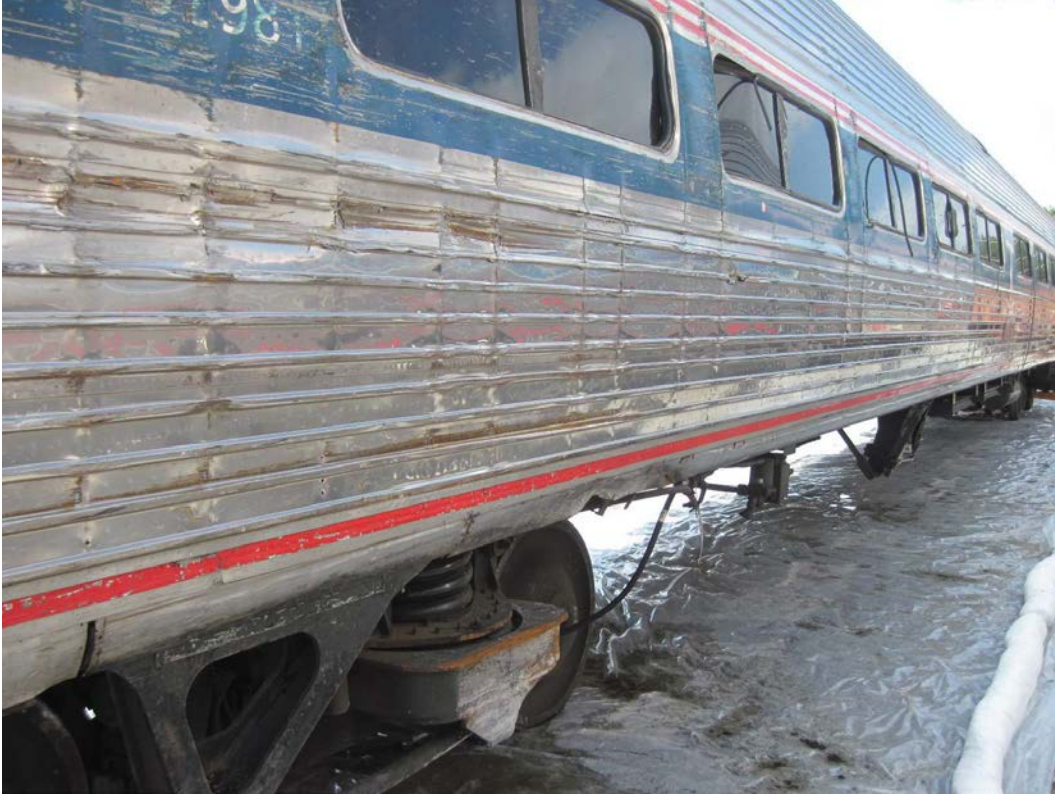
Figure 24. The right side of the seventh passenger car as viewed from the rear of the car. (Credit: Amtrak)

On the right side of the car, there was a rectangular-shaped impression mark with brown discoloring next to the front side door. There was horizontal scraping on the blue decal that began between the vestibule door and the R1 window and extended along the length of the car. There was scraping and tears on the side sheeting that began between the front side door and the R1 window. This scraping continued toward the rear of the car along the lower third of the carbody. The R1 and R2 windows were in place. The R3 and R9 windows were in place, and their zip strips were partially pulled. The rear sides of windows R8 and R9 were partially dislodged inward. The right rear corner of the car was bent and deformed rearward.

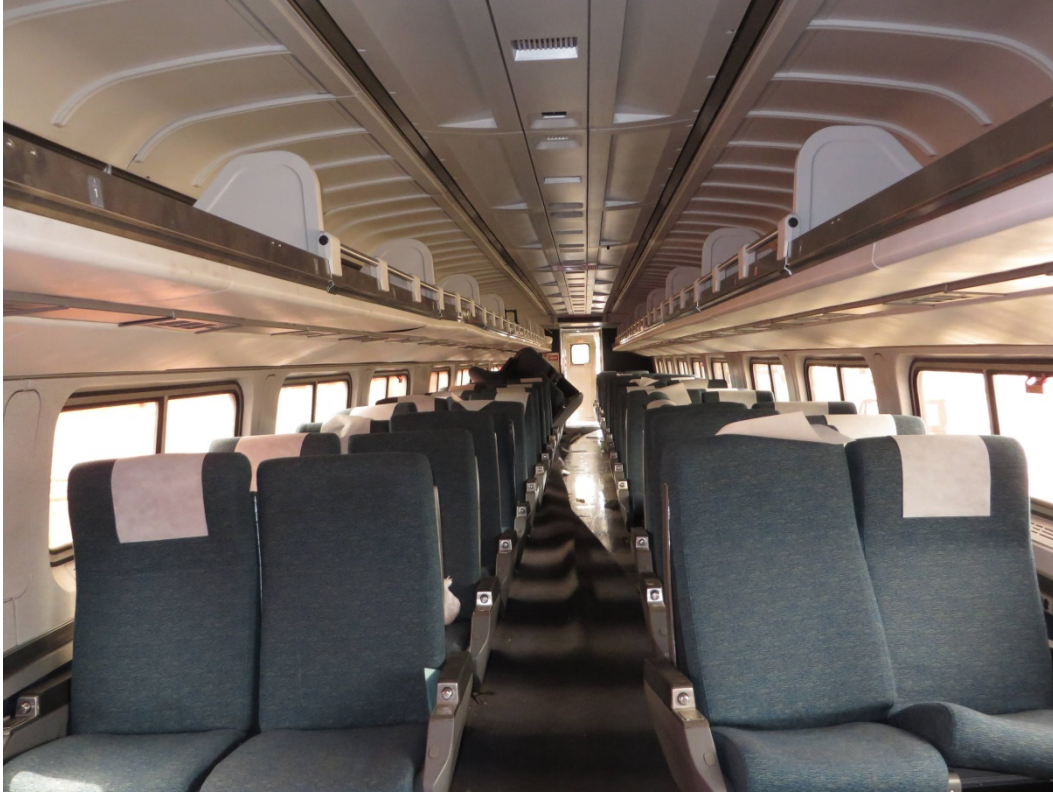
Figure 25. The interior of the seventh passenger car as viewed from the front of the car.

In the front vestibule, the right side door was closed, and the door window was not in the door. The left side door was open. There was a dent under the left-side baggage rack near the row 5 seats. The zip strip for the rear right side interior emergency window was partially pulled. The frame of this window was bent inward. The pry bar and maul were not in the emergency equipment cabinet. The first-aid kit was not used. At least one glow stick was used and found on the floor. In the rear vestibule, the left side door was open. The right side door was wedged closed, and the window was in the door. There was an opening between the door and rear corner of the car. There was blood on the door and a grab iron. There was ballast and debris on the floor next to this door.

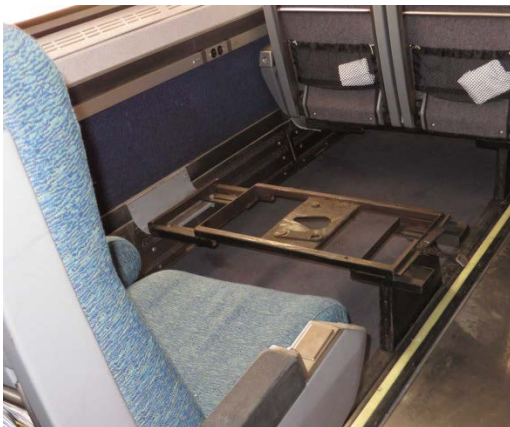
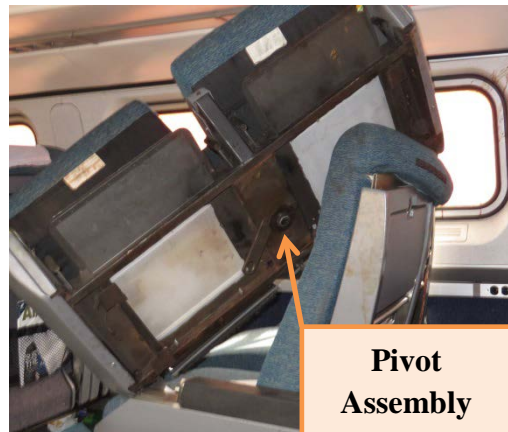
On the left side of the car, the row 12 seat pair separated from its frame. The seat pair was found on top of the right side seats. There was an extensive amount of blood on the right side seats and on the wall at rows 12 and 13. The pivot assembly was found separated from the frame and attached to the seat.

Figure 26. The row 12 seat frame.

Figure 27. The separated seat.

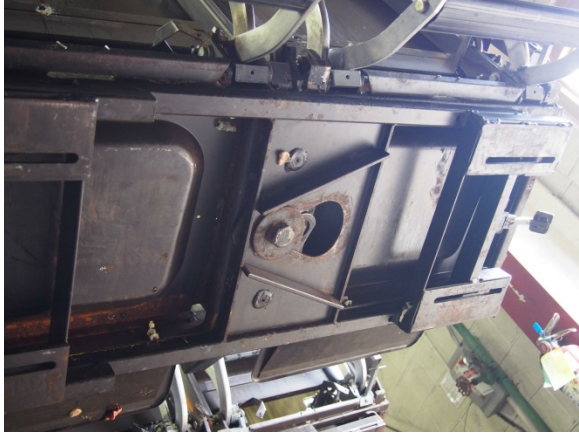
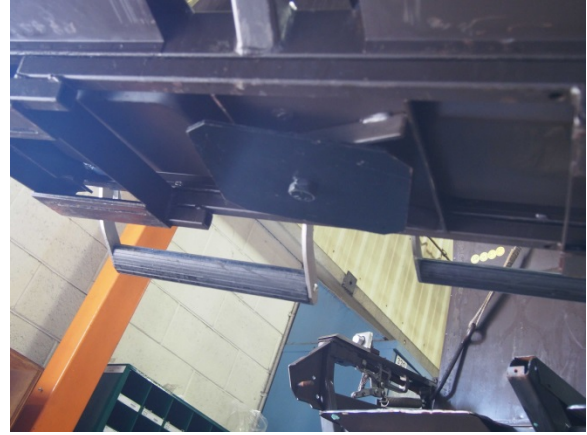
Figure 29. A view under the frame of a Coach and Car seat.

Figure 30. A view under the frame of an AMI seat.

Beginning in July 2015, Amtrak began replacing the original pivot assembly, with the disk base, on Coach and Car seats during the interior overhaul of the cars. The interiors of the cars are overhauled every 8 years. The pivot assemblies will be replaced on all Coach and Car seats. Additionally, Amtrak created a written procedure for the overhaul process for passenger seats.
