**SURVIVAL FACTORS GROUP CHAIRMAN'S
FACTUAL REPORT**

Palm Springs, CA

HWY17MH005

A. CRASH INFORMATION

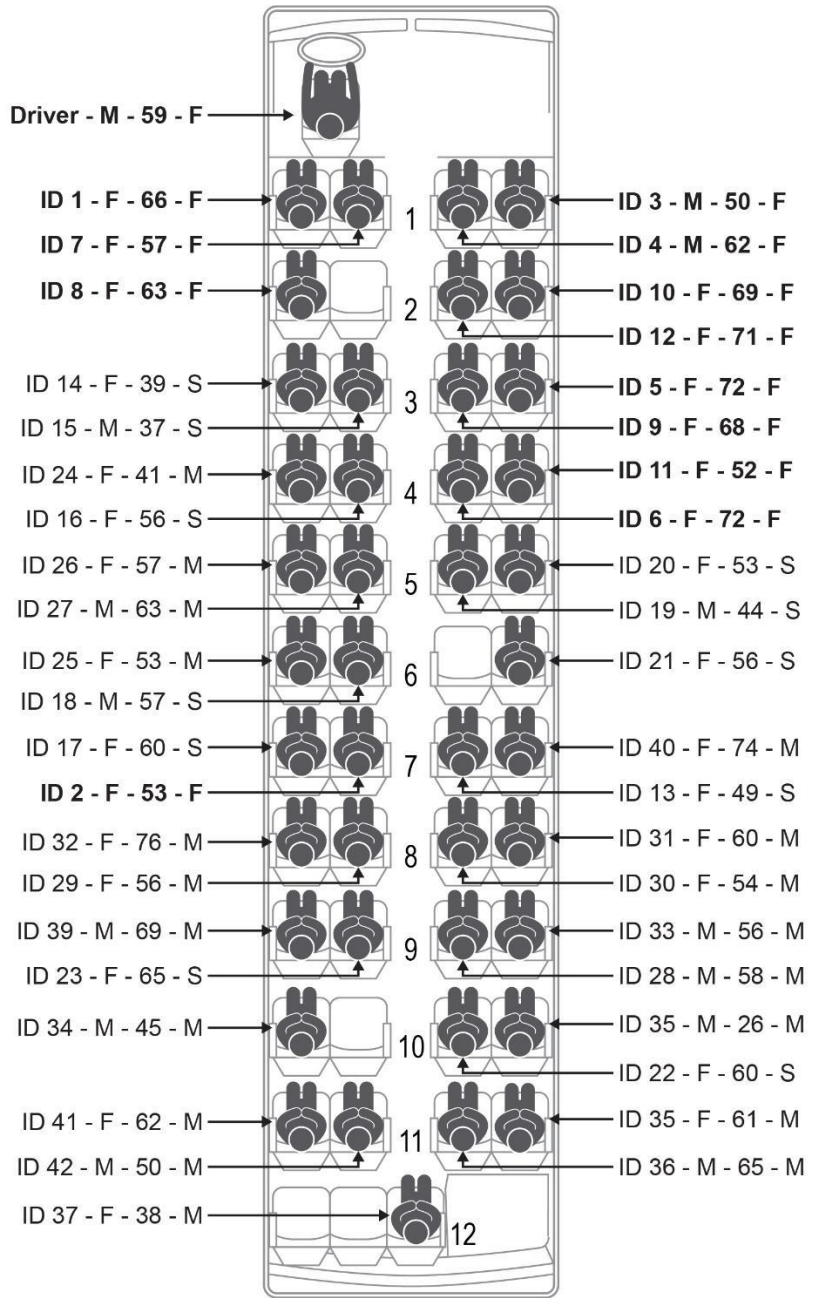
Figure 1: Motorcoach Interior Configuration

INJURY LEGEND	
ID # = PASSENGER REFERENCE NUMBER	
F = FEMALE	M = MALE # = AGE
M = MINOR	S = SERIOUS F = FATAL
SAMPLE	
INJURY LEVEL	→
AGE	→
GENDER	→
PASSENGER REFERENCE (FOR IDENTIFICATION IN SECTION 2)	→
	ID 7 F 60 S
Source: NTSB
