**SURVIVAL FACTORS GROUP CHAIRMAN'S
FACTUAL REPORT**

HWY17MH007

**NATIONAL TRANSPORTATION SAFETY BOARD
OFFICE OF HIGHWAY SAFETY
WASHINGTON, D.C.**

Location: Eastbound Frederick Avenue between South Monastery Avenue and South Morley Street, Baltimore, Baltimore County, Maryland

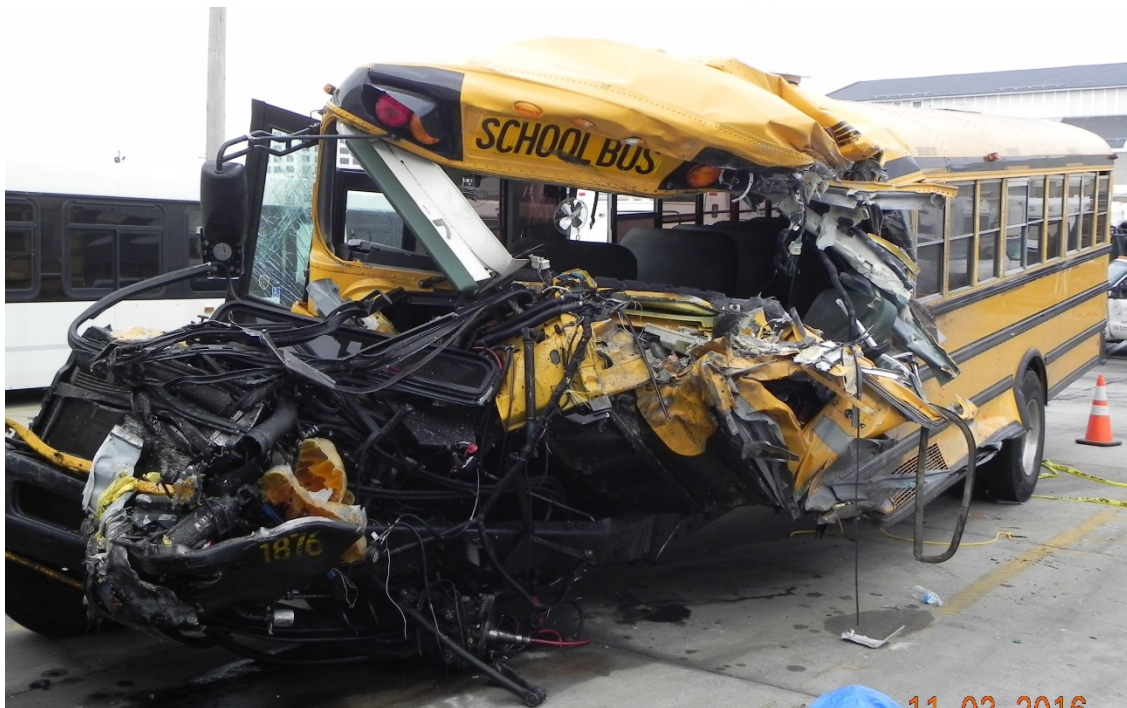
The school bus sustained two impacts. The first impact was to the front of the bus colliding with rear of the 2012 Mustang. The second impact was to the front left bumper corner when it collided with the transit bus causing damage to the front end with the damage extending down the left side.

The deformation to the bus's front end from impacting the Mustang could not be determined due to the severity of the school bus's impact with the transit bus. The estimated maximum crush was approximately 91 inches to the front bumper and 125 inches to the apex of the driver's side front windshield header and left A-pillar. The direct damage extended to the roof, which was also buckled aft. The overall impact resulted in the left frame rail being shifted to the right approximately 27 inches as measured at the upper front shock absorber mount, with an upward deflection. See **Figure 1** below¹

Figure 1. Exterior view of deformation to front end and left side of the crash involved school bus.

The impact resulted in buckling to the loading door/right A-pillar. The loading door side roof was buckled and extended to the mid-point of the bus. The left A-pillar was torn away. The

rear bumper was slightly separated from the chassis due to the frame deformation. The loading stairwell was also deformed with the stair steps shifted upwards and back.

The left exterior rearview mirror was broken off. The pop-out stop sign on the left exterior adjacent to the driver's seat was also torn off. Both windshield panes of the bus were broken out.

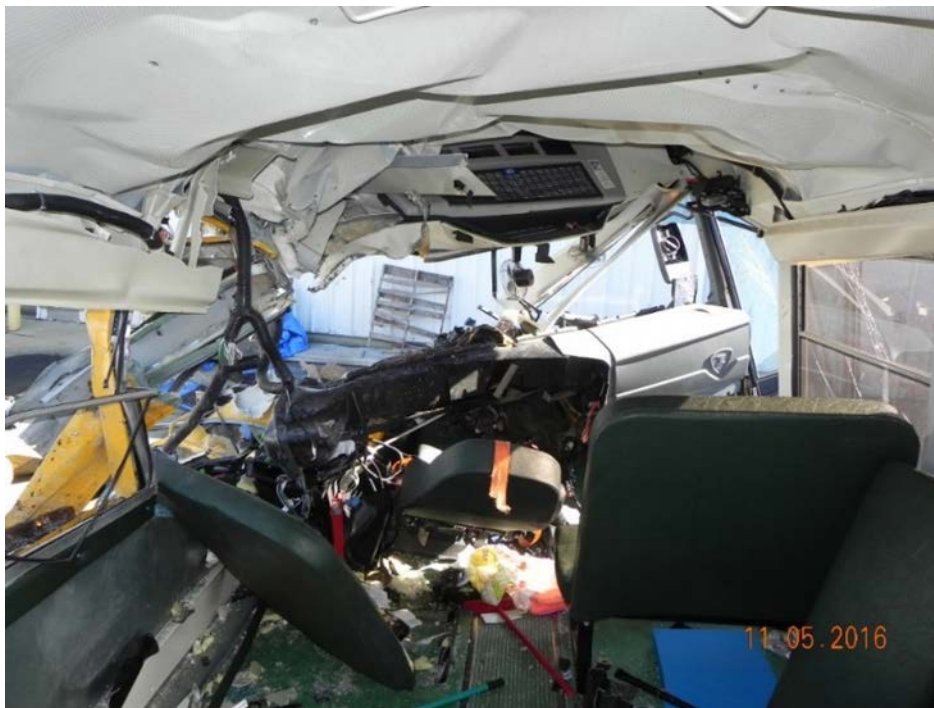
Figure 2. Interior view of intrusion to driver seating in the school bus.

As shown in **Figure 2**, the driver seat was significantly displaced aft and laterally towards the center of the bus due to intrusion from the transit bus.² First responders cut the driver's seatback

off to remove the entrapped driver. Inspection of the driver's lap and shoulder belt showed evidence it stretched and separated during the crash and had been cut by first responders.³ All instrument panel gauges were displaced and broken out. The driver's steering wheel was cut off from the column during the extrication process.

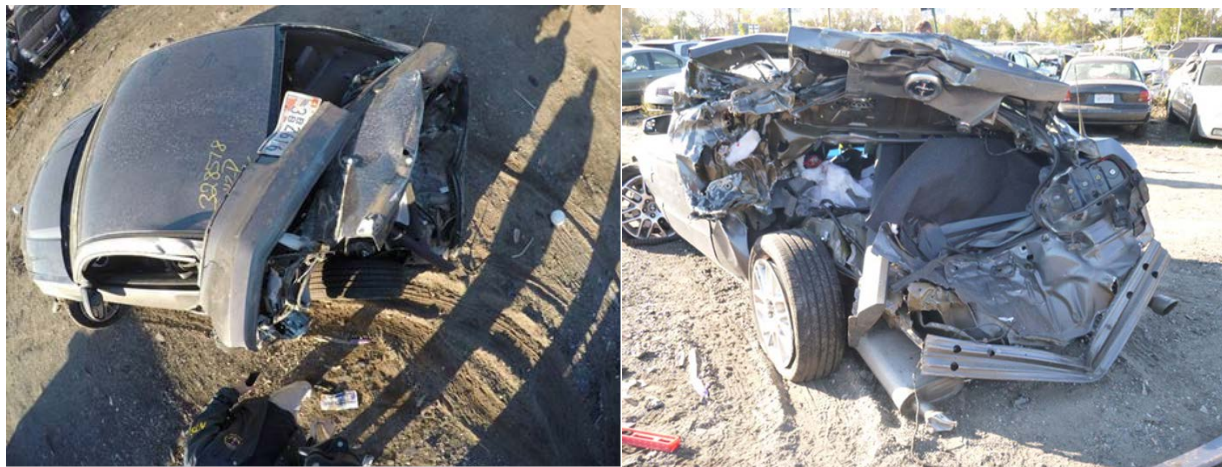
The impact was concentrated to the vehicle's rear on the driver's side (see **Figure 3a and 3b** below). The direct damage from the rear impact was 38 inches wide with the maximum crush of approximately 55 inches above bumper and approximately 28 inches at bumper level.⁶ The rear impact resulted in the driver's door being jammed closed. The right passenger door was operational.

Figures 3a and 3b. Overhead view of deformation to back end of Mustang and left rear angle view of deformation.

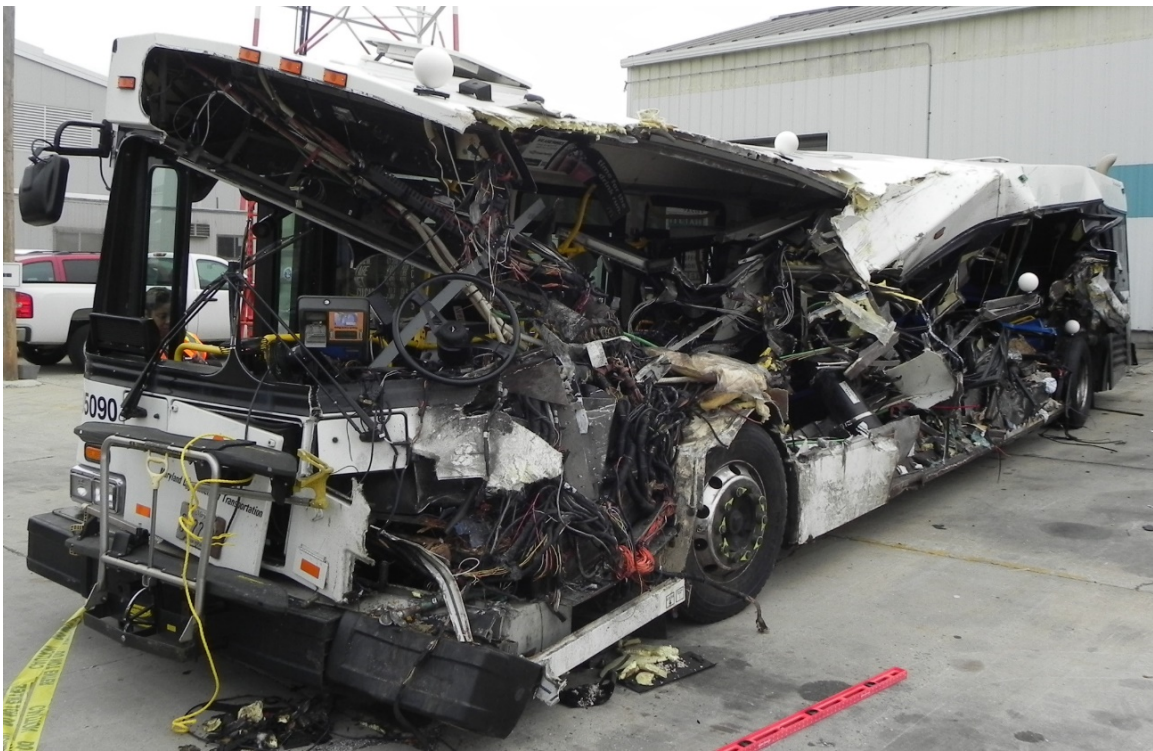
The transit bus sustained extensive damage as a result of the impact with the school bus. The impact damage started at the front left bumper corner and extended vertically to the windshield header. The damage extended down the left side tearing away the sheet metal and all seven transit bus windows including the driver's slider window creating an approximate 32-foot-long by 6-foot tall opening.⁹ (See **Figure 4** below) At the end of the left side damage, just past the rear wheels, there was an approximate 12-foot section of thin metal sidewall structure from the transit bus that was found folded up, accordion style.¹⁰

Figure 4. Exterior view of extent of deformation to front left bumper corner and down left side of New Flyer transit bus.

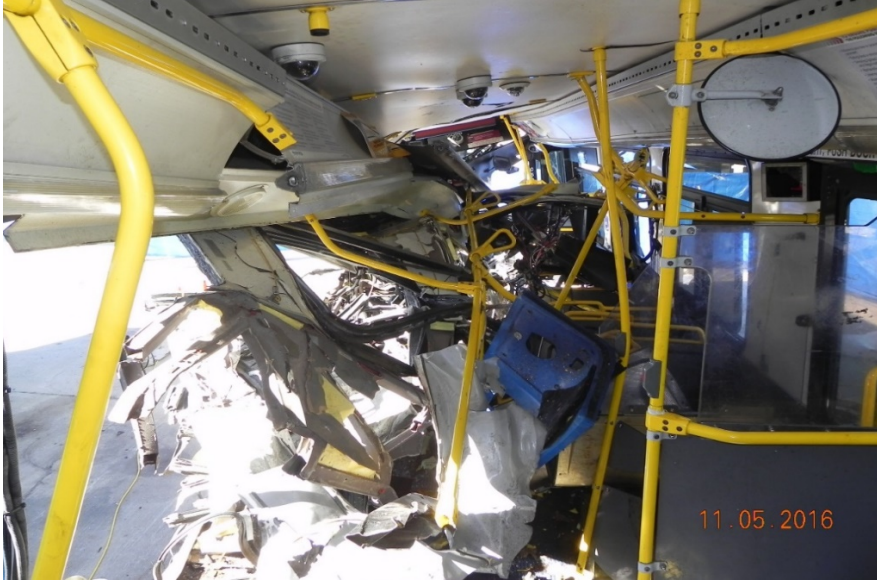
All the seats down the right side remained in place but sustained some damage as a result of the intrusion and flying debris. Intruding debris from the left side impact was displaced into the aisle and partially into the passenger seats on the right side.¹³ The intruding debris restricted access and the examination of seats 32-33 to 36-37. However, all the right-side seats remained intact even though some sustained dents and deep scratches from the intruding and flying debris. The overhead handrails on the right side were displaced from seat 30-31 to 38-39. See **Figure 5** on next page.

Figure 5. Interior view looking from rear to front showing extent of intrusion into occupant compartment in the crash involved transit bus.
